**Finalised Arboricultural Method Statement:
Jacobs Douwe Egberts, Ruscote Avenue, Banbury – Site 2**

Document reference: 707-22, Revision 0

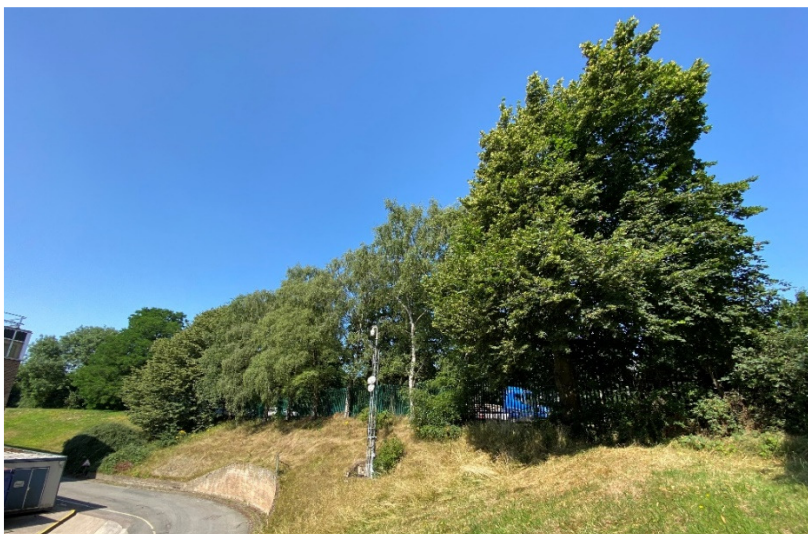
2.3 Trees 1, G2, 3 and 4, 5 and 6 grow to the rear of the boundary palisade fence at the upper crest of a steep sided embankment located beyond the existing perimeter road to the factory. These are located well beyond the area of proposed works and there will be no construction access to this area.

Photograph 1: Boundary trees on top of embankment viewed from the east.

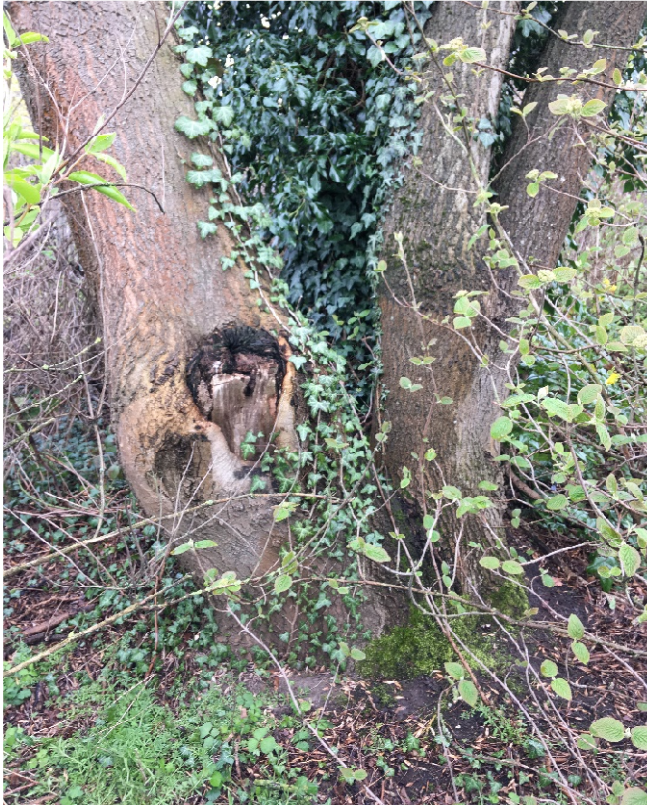
- 2.4 Tree 8 is coppice regeneration from a previously felled ash tree and grows amongst an outgrown shrubbery surveyed as group G9, for which the arboricultural elements are mainly restricted to younger self-sown trees of mediocre only form.

Photograph 2: Showing coppiced base of ash tree 8 (photograph taken in May 2019 when more visible).

Tree reference number	Common name	Specification for works
T8 T8 Cont.	Ash	Clear shrubbery from within 1.5m radius of trunk base. Sever and strip ivy from lowest 2m of trunks. Commission a re-inspection.

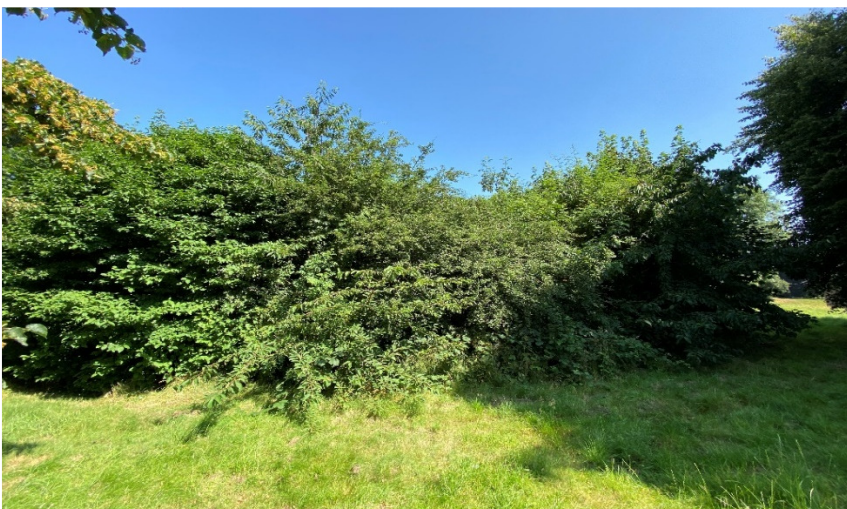
Photograph 3: Part of group G9 viewed from the south. The south eastern tip of this group will be cleared.

Tree reference number	Common name	Specification for works
G9	Various	<p>Clear designated section of group, including grinding out of any significant stumps to around 200-300mm beneath surface.</p> <p>From the remaining side of the newly created edge, young Norway maple trees of up to 100mm diameter to remain where more than 2m from edge of group. Formatively prune to promote best form.</p> <p>Coppice or reduce shrubs near edge (rose, cotoneaster and buddleia etc.)</p>
T10 to T16 inc		Remove including stumps.
T17	Lime	<p>Carefully dismantle to avoid any damage to remaining T18.</p> <p>Grind out stump to at least 300mm beneath surface.</p>
T18	Lime	<p>Cut back basal sucker growth. Crown lift by shortening secondary growth only to provide 2-3m clearance above ground.</p> <p>Selectively reduce any remaining lower branches on south eastern side where exposed following removal of adjacent tree.</p> <p>Remove dead and defective branches from remainder of crown.</p>

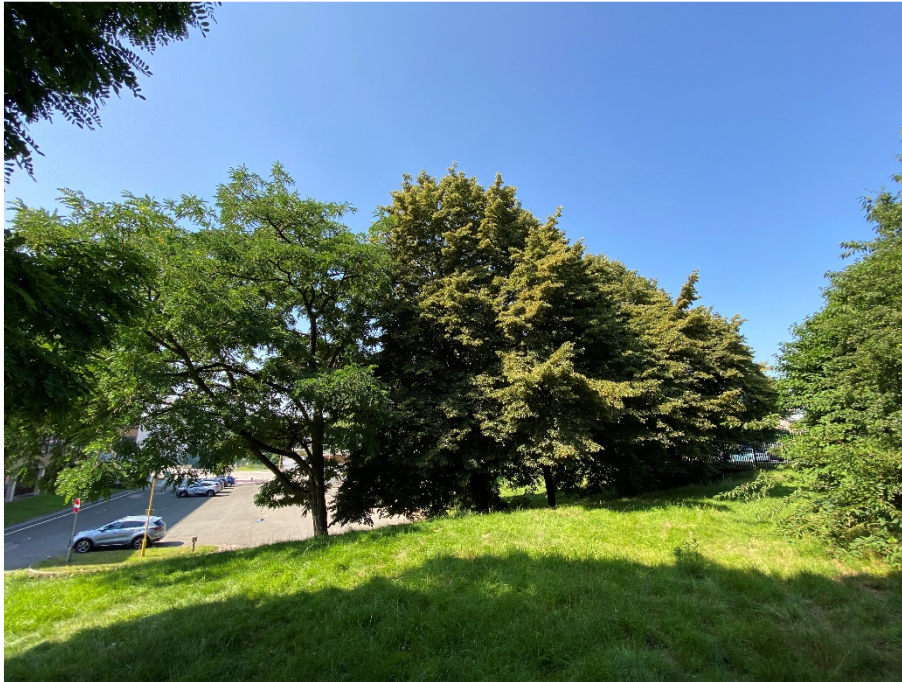
- 2.5 Trees 10 to 19 have a collective impact growing upon either the sloping embankments or the upper level of the landscaping mound. Trees 10 to 17 will be removed to facilitate the works.

Photograph 4: Showing trees 10 to 12 viewed from the north.

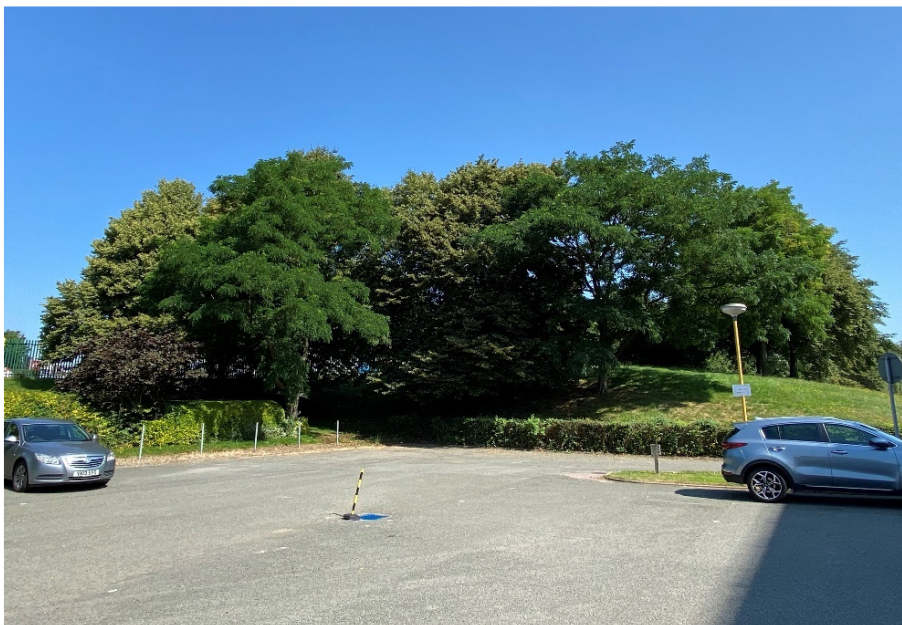
Photograph 5: Showing trees 10 to 19 inclusive viewed from the south.

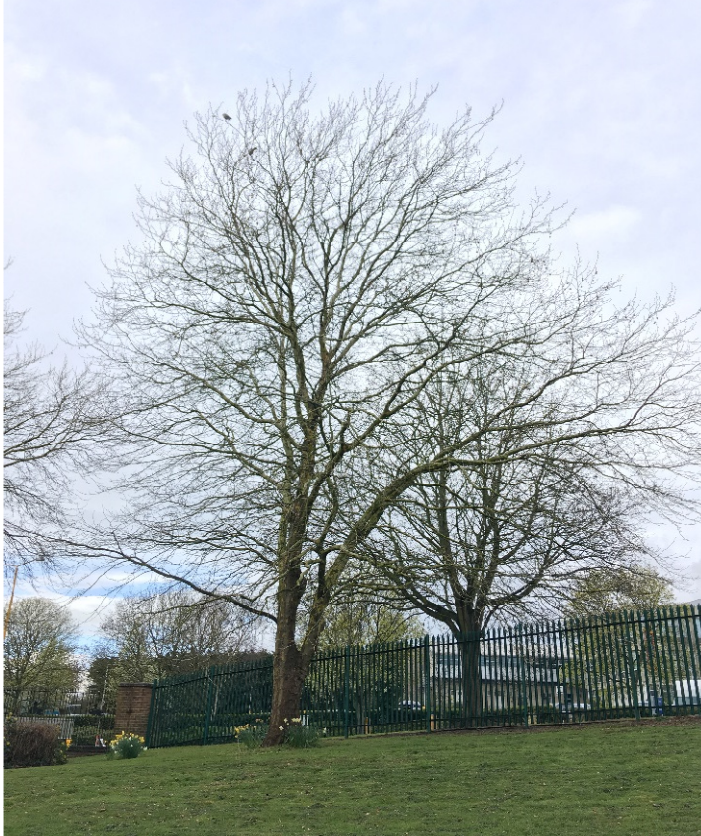
- 2.6 Tree 20 is a prominent frontage, high value London plane tree that has co-evolved with Norway maple tree G growing in the public verge, which will remain.

Photograph 6: London plane tree 20 viewed from the south east with Norway maple tree G visible in the background (photograph taken in May 2019).

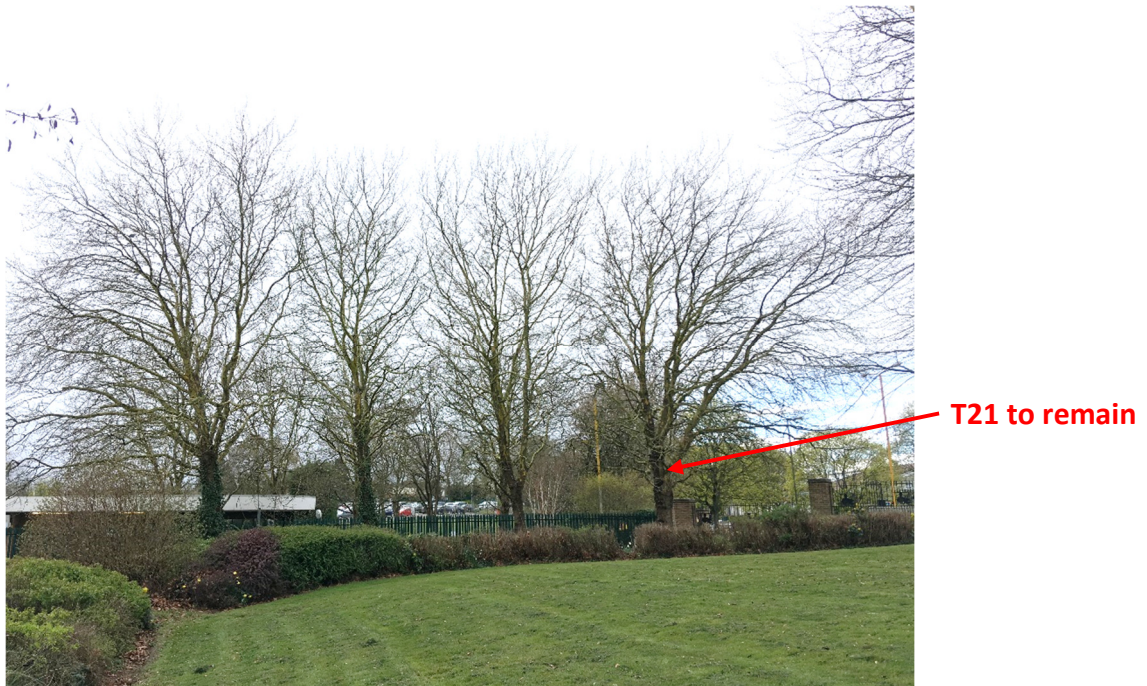
- 2.7 Plane trees 21 to 24 inclusive form one half of an avenue feature to either side of the main access into the site with the security lodge in the centre.
- 2.8 The north western tree, tree 21, is the best developed and grows in the most conspicuous location, is to remain, with the rest being removed.

Photograph 7: Plane trees 21 to 24 viewed from the east (photograph taken in May 2019).

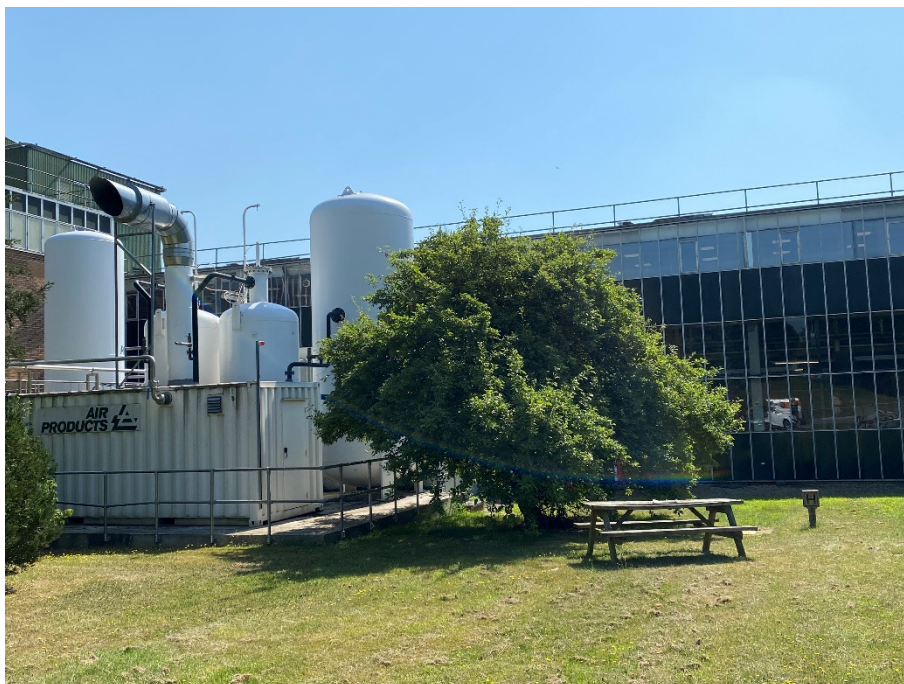
- 2.9 Apple tree 26 and group G27, formed from cypress and yew, are both to be removed. These are located within the amenity space set back slightly within the factory footprint close to the nitrogen production plant.

Photograph 8: Apple tree 26 viewed from the west.
