Ref: LAS_242_C
Date:23.01.2023

Site: Phase 10, Heyford Park Developments Ltd, Camp Road, Heyford Park

Arboricultural Impact Statement

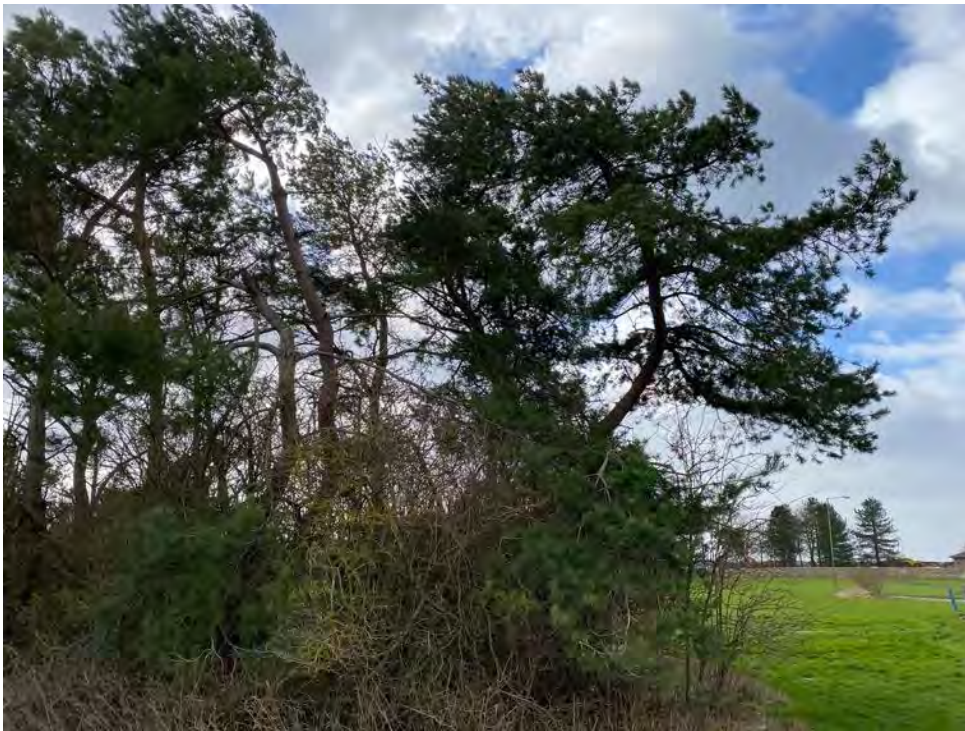
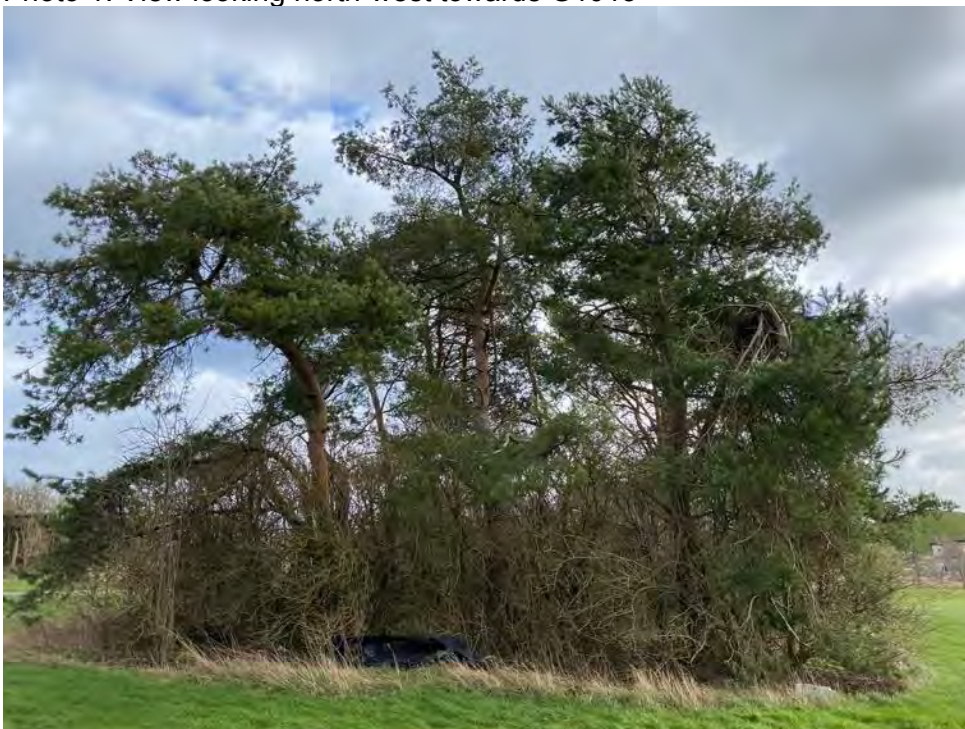
G1013 – C2: Photos 1, 2, 3, 4, 12 and 13.

Many pines within the group have had limb failures and tops snapped out. Most have poor shapes/structures. The trees (except for T1013d) are assessed as low quality (Category C).

Photo 1: View looking north-west towards G1013

Photo 2: View looking north-east towards G1013

With regard to G1013, this group will need to be removed to enable new parking and a dwelling to be constructed. Following pre-application feedback, this group was resurveyed to assess trees on an individual basis to see if any would justify a higher categorisation. All trees except T1013d are considered to be low quality due to structural condition and poor form. Many have suffered failures and or have poor form. Given many have already had branch failures and suffered storm damage, it is considered none except T1013d could realistically be retained on individual merit. Having grown as a group none appear to have a form or structural condition that would allow safe retention on an individual basis. The group would need to be either retained together or removed together. Given all but 1 of the trees are assessed individual as Category C and as a group Category C, these should not be viewed as a constraint to development.

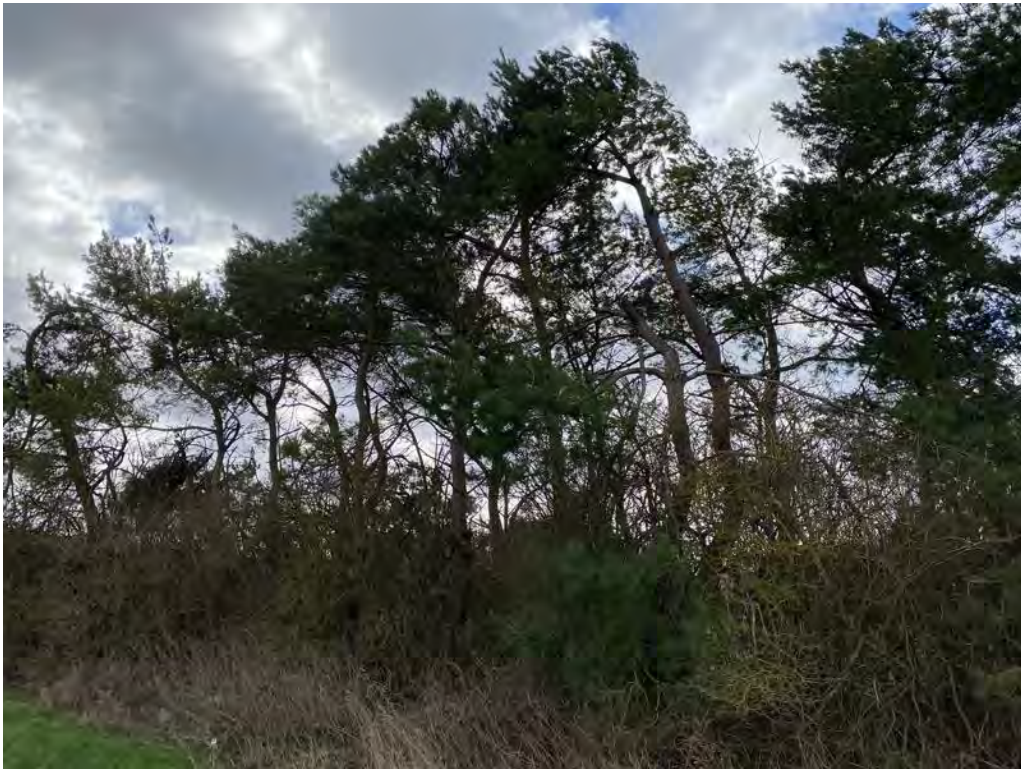
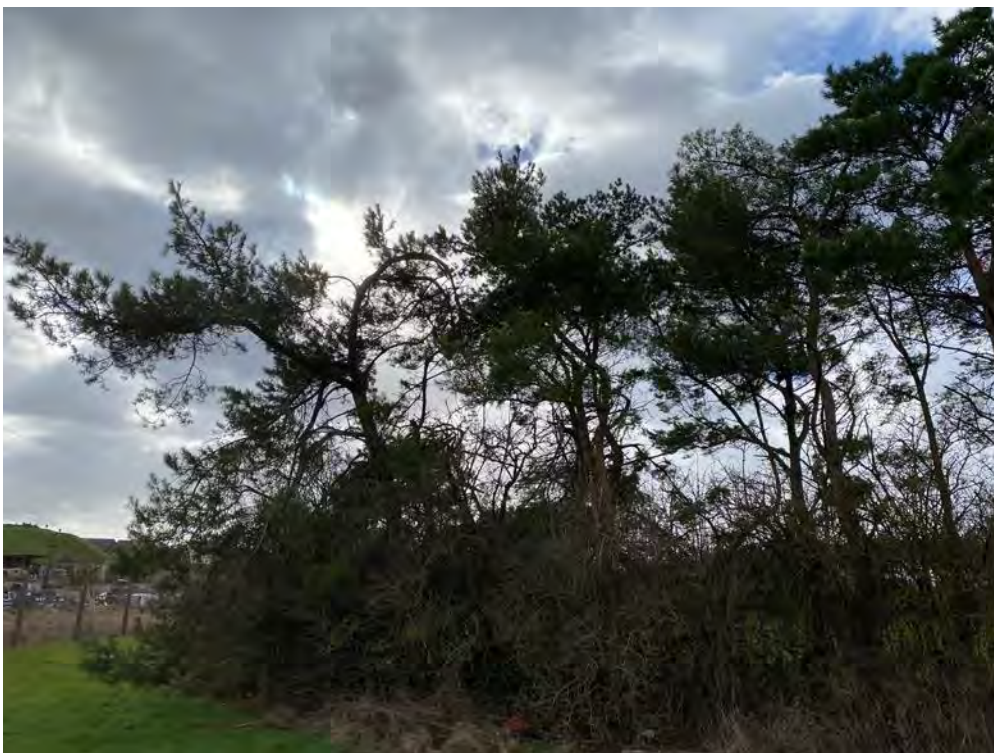
Photo 3: View south towards G1014

Photo 4: View south-west towards G1014

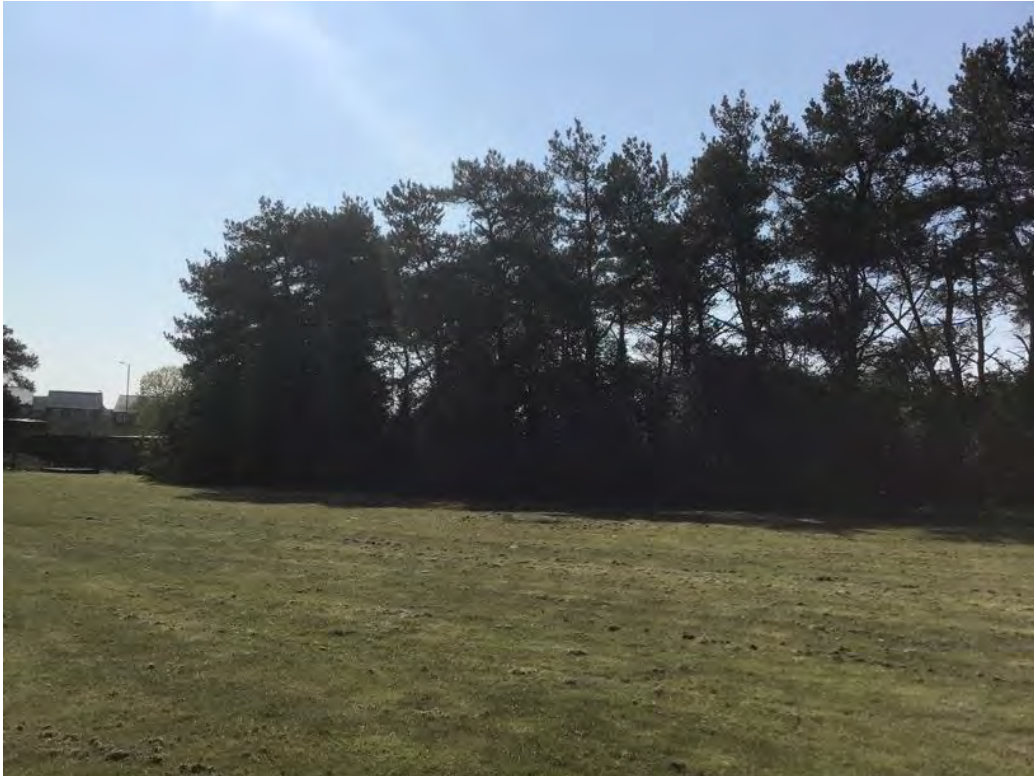
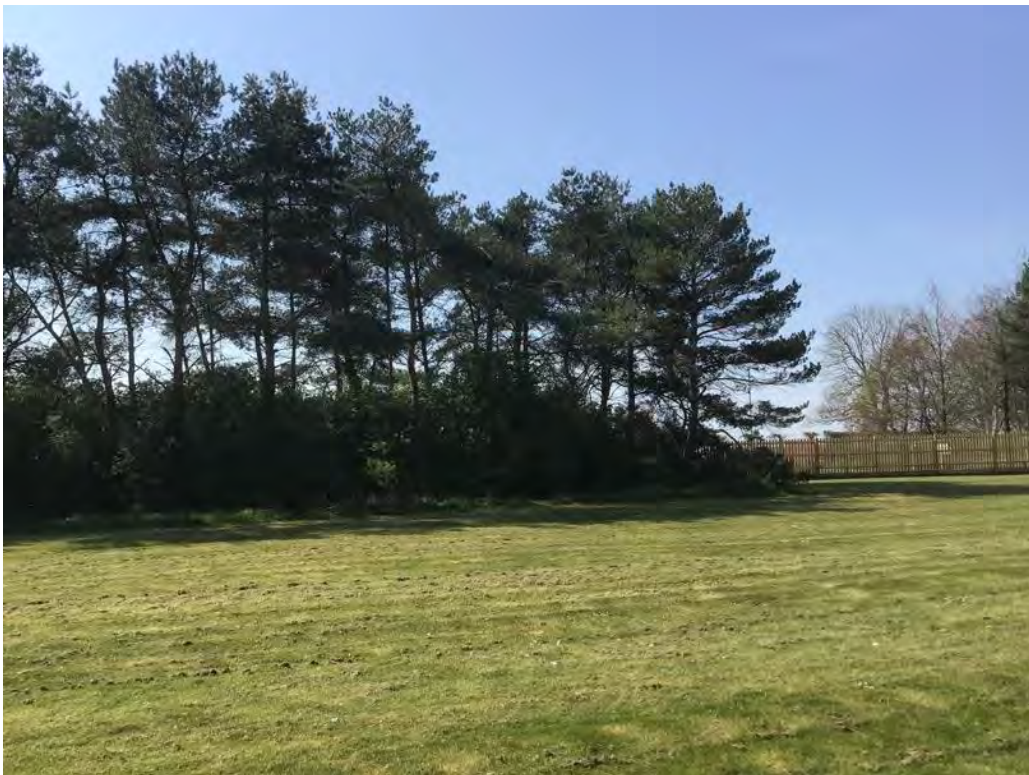
G1015-B2: Photos 5 and 6

Assessed as moderate quality (Category B), at lower end of scale. The group is fairly dense and in reasonably good condition.

Photo 5: View south-east towards G1015

Photo 6: View south-west towards G1015.

G1014 and G1015 will need to be removed to enable new built development. Trees within each of the two groups have grown together and therefore have a degree of dependability on each other for companion shelter. As a result the trees have generally grown taller and thinner which makes selective retention difficult as the trees could be expected to be vulnerable to wind load failures. Therefore in this context groups like these, if retained within development, would need to be retained together and located within open space. As set out within the pre-application advice, were designs amended to try and accommodate all or part of G1014 and G1015 it is highly likely that there would be future conflicts between new dwellings and the trees in terms of shading and overbearing issues, threatening the trees longevity. In light of the above ground constraints posed by these tree groups (shading, positions and extent of land take), removal and replacement is justifiable.

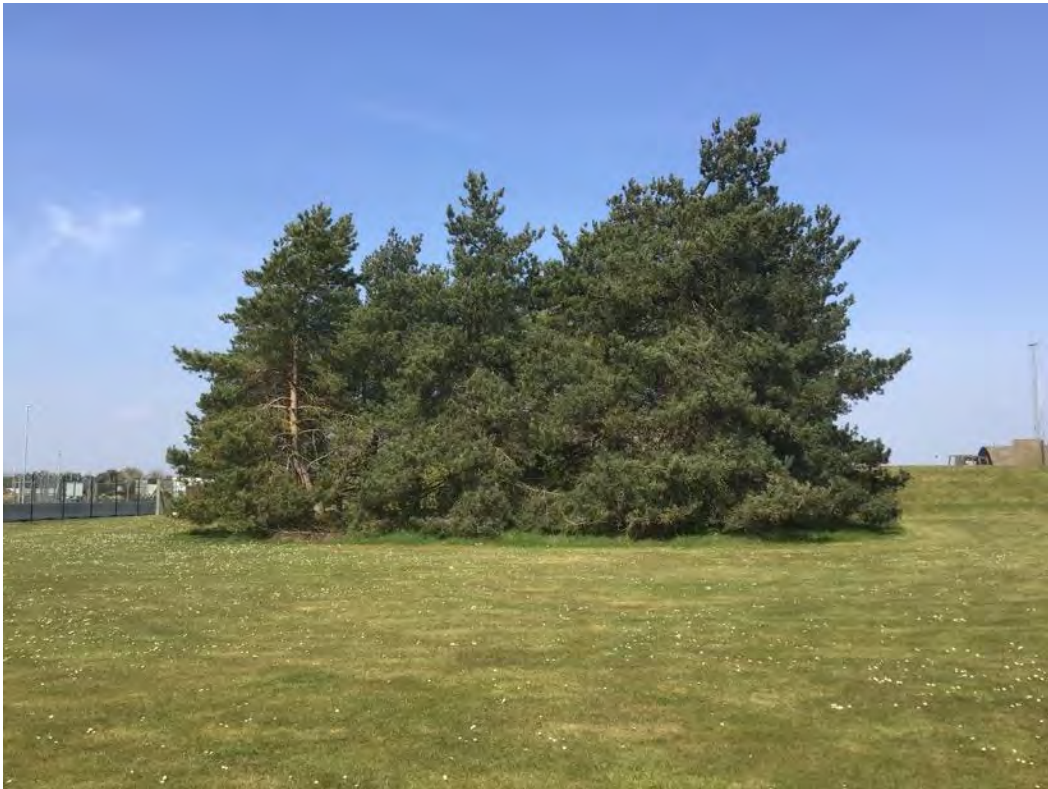
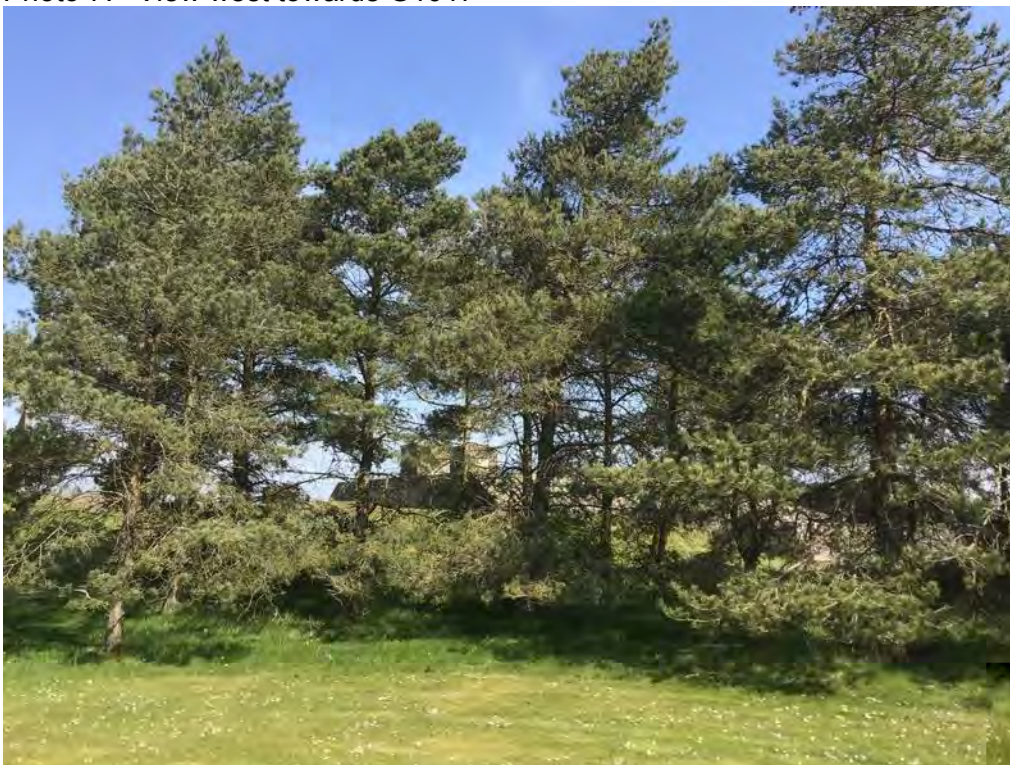
G1017 – C2: Photos 7 and 8

The group is Assessed as low quality (Category C).

Photo 7: View west towards G1017

Photo 8: View north towards G1017

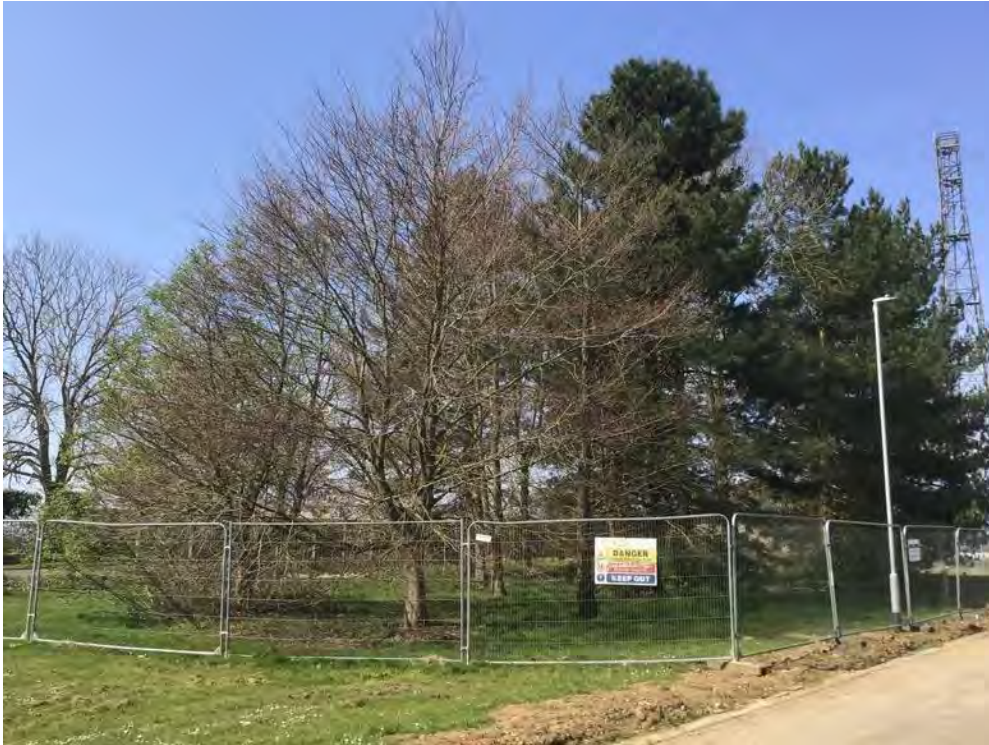
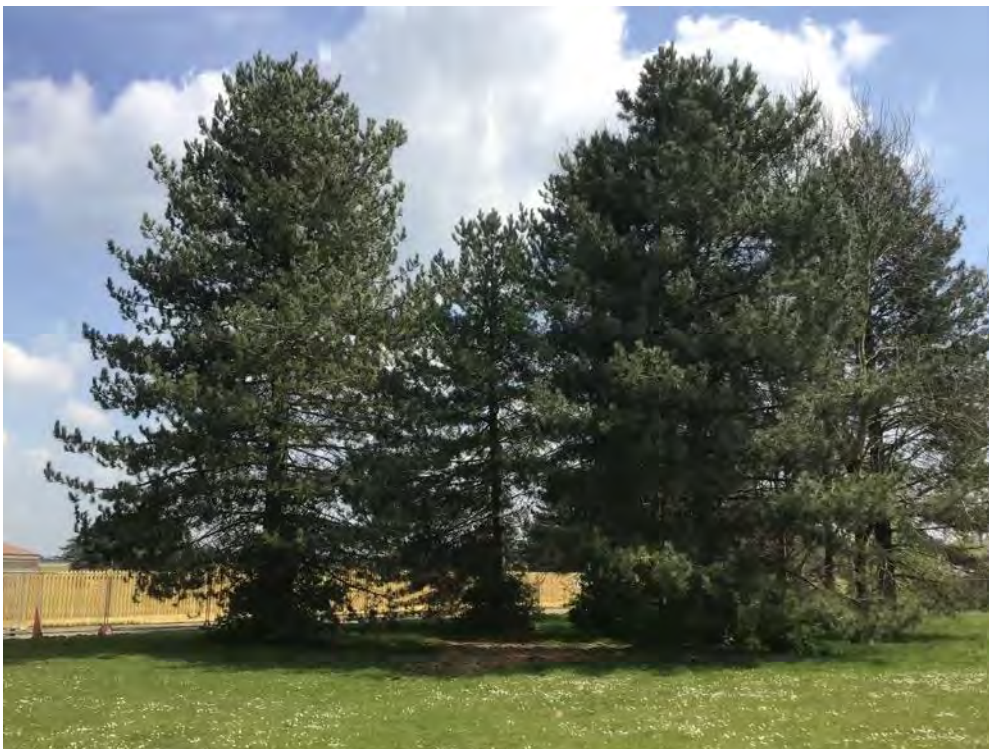
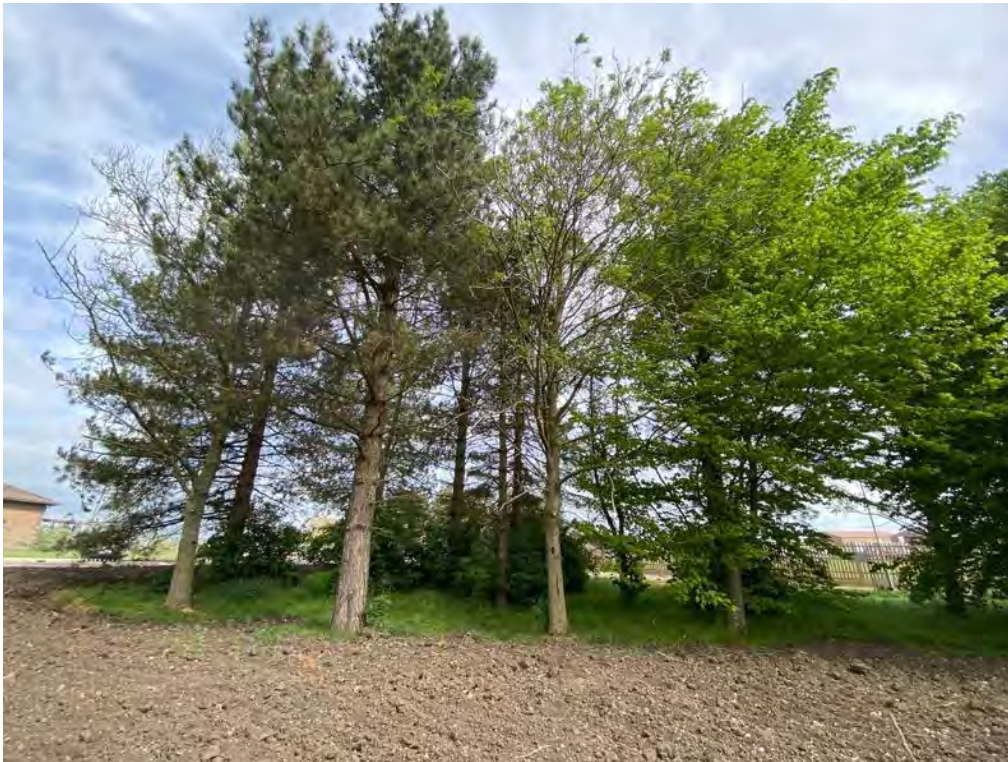
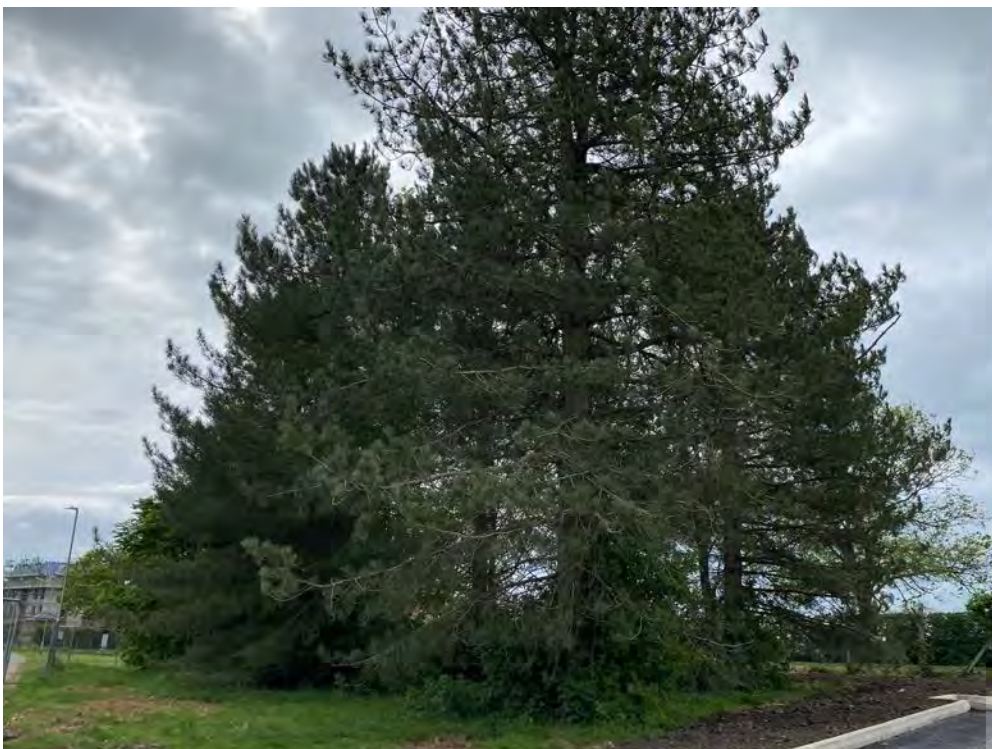
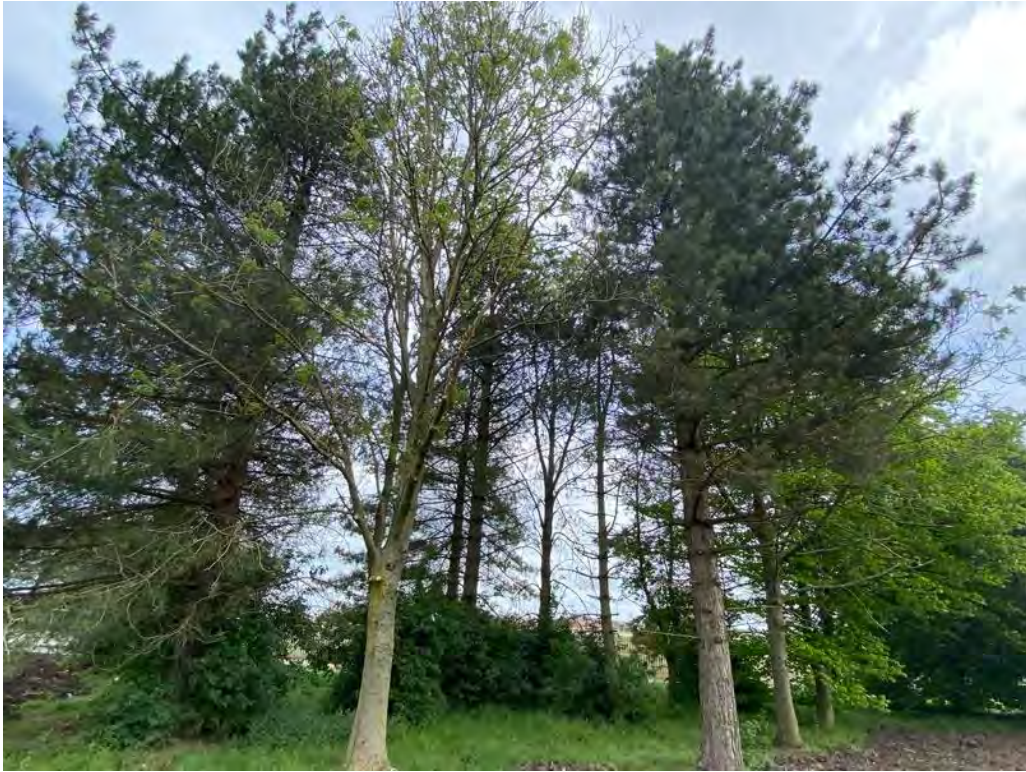
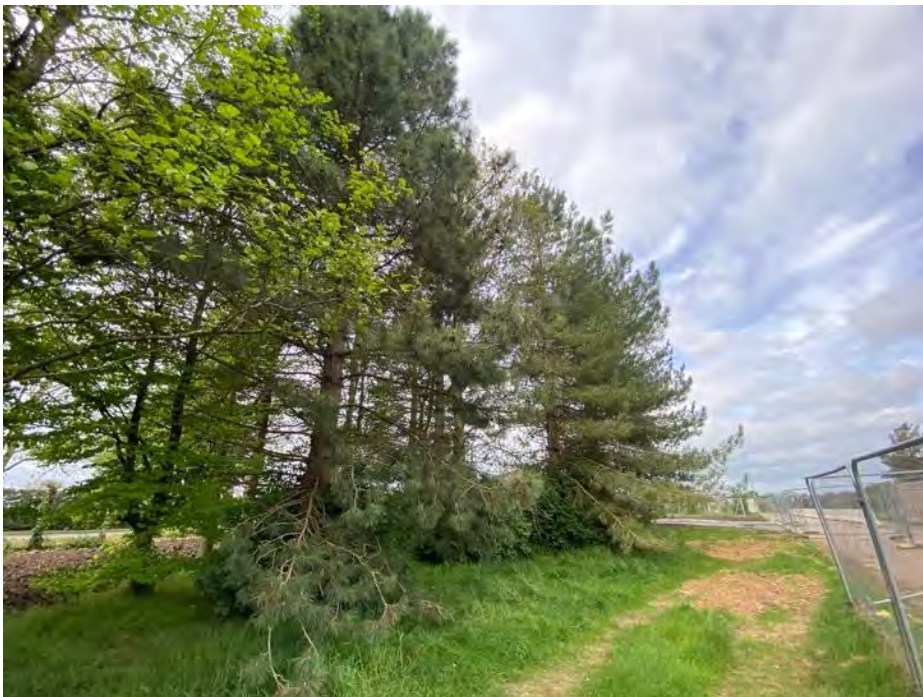
This group comprises a mix of deciduous and conifer species. Overall as a group is assessed as moderate quality (Category B). However, there are lower and poor-quality trees within and trees in poor condition.

Previous site plan designs (issued as part of pre-application) showed G1016 as requiring removal to enable development. However, designs in this area have been amended so that G1016 is now retained within the development. It was noted during the survey that some trees are in poor condition (g, o and k) and are therefore shown for removal due to condition.

Photo 9: View west towards G1016.

Photo 10: view north towards G1016.

Photo 11: View north towards G1016.

Photo 12: view south-east towards G1016.

Photo 15: View north towards G1016.

Photo 16: view west towards G1016.

It is likely G1016a, b and d will all need to be crown lifted to 2.5m to ensure clearance of the working area in relation to drainage installation.

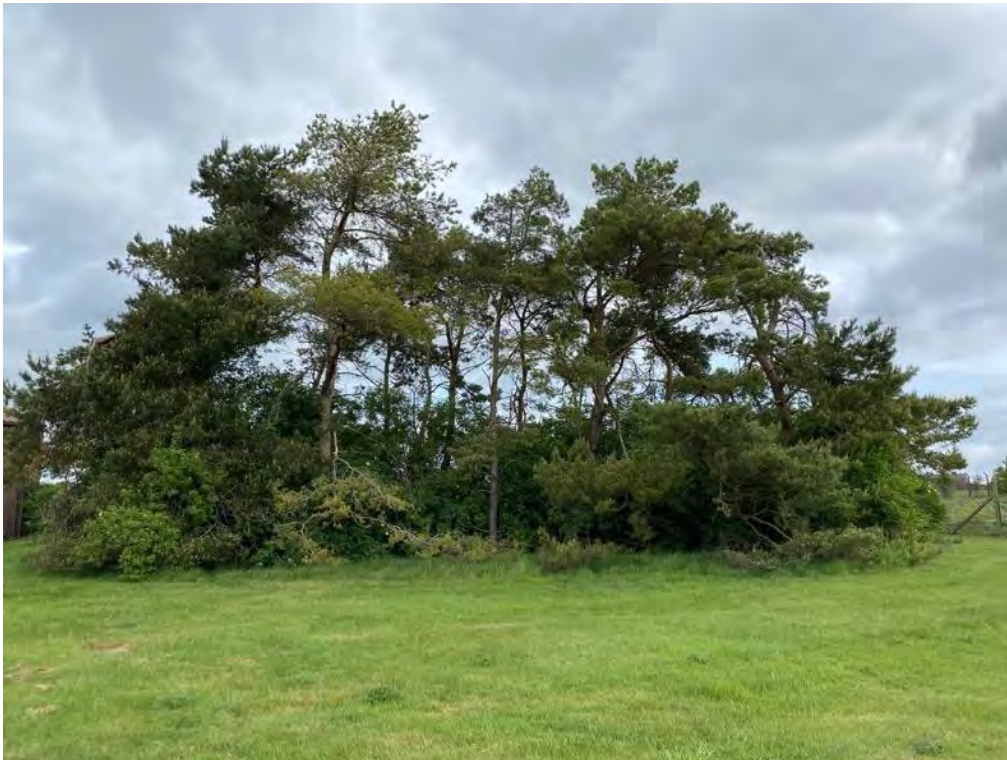
Photo 13: View north towards G1013.

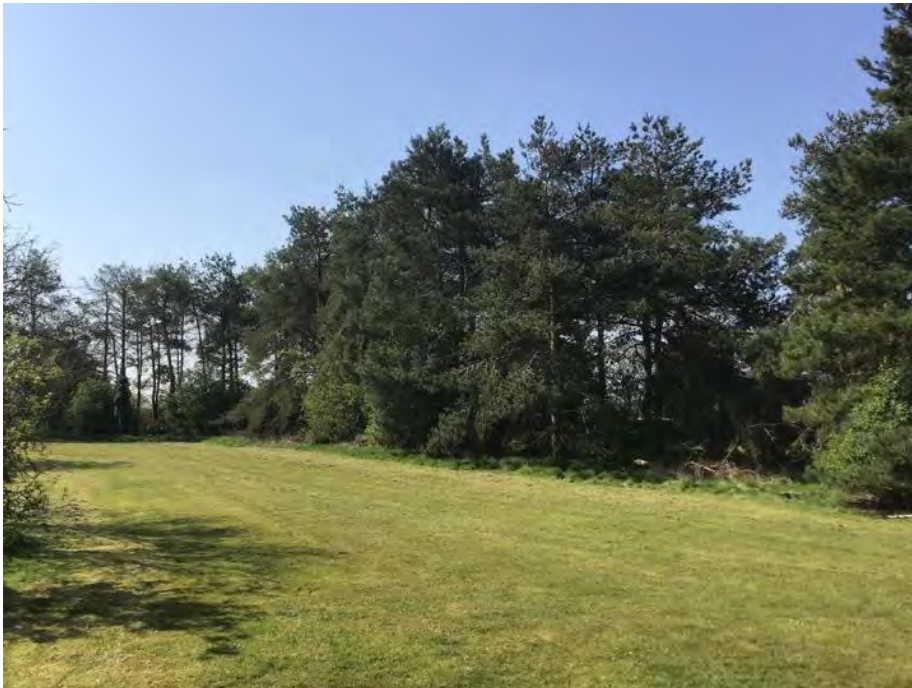
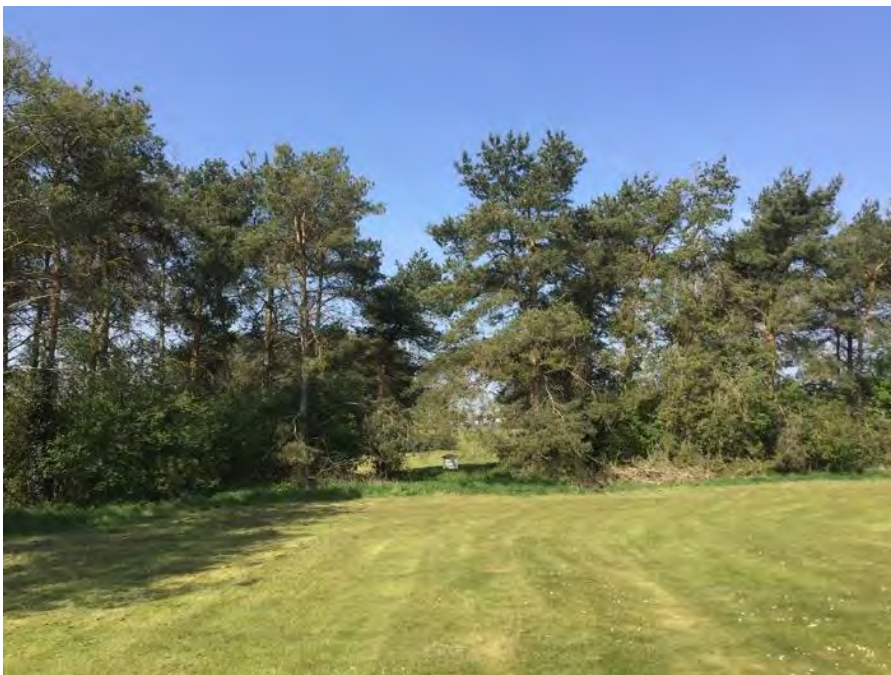
G1014 – C2: Photos 17 and 18

No trees within the group appear to be higher quality in their own right or appear to have characteristics that would significantly differentiate them from the rest of the group to warrant being surveyed as an individual. Several dead pine within the group.

They are assessed as low quality (Category C).

Photo 17: View north towards G1014.

Photo 18: view west towards G1014.
