# ARBORICULTURAL REPORT

**Sibford Park, Sibford Gower, OX15 5RY**

Arboricultural Impact Assessment  
Date: October 2022

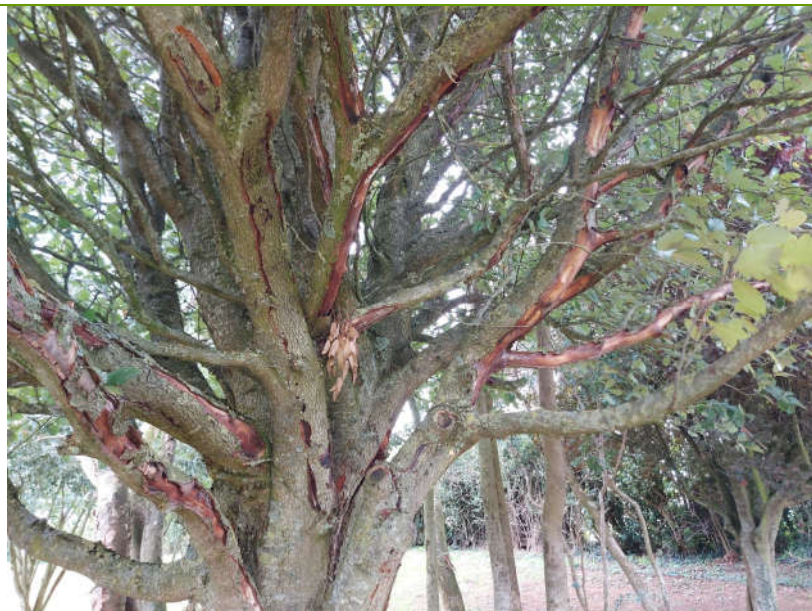
**P1. Extensive fire damage to the structural framework of the whitebeam within G1.**

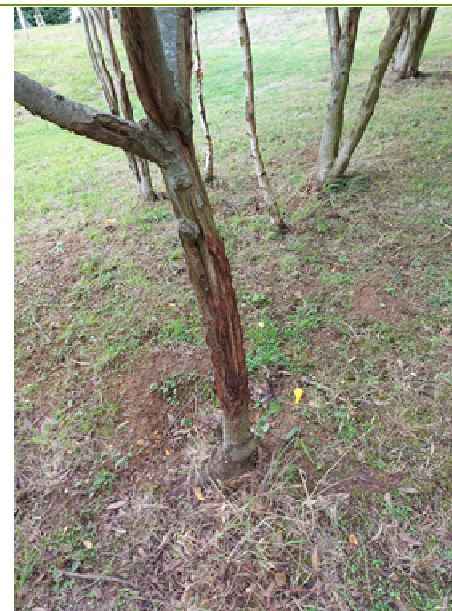
**P2. All of the goat willow stems within G1 have sustained significant grazing damage.**

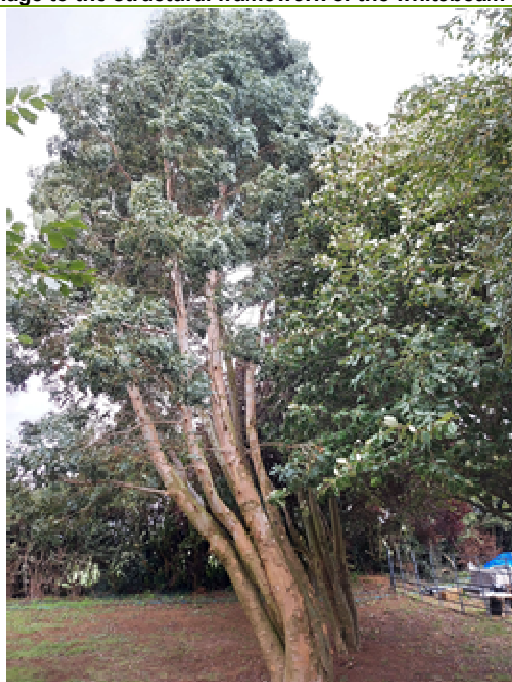
**P3. The poor structural form of the eucalyptus within G1 suggest limited SULE.**

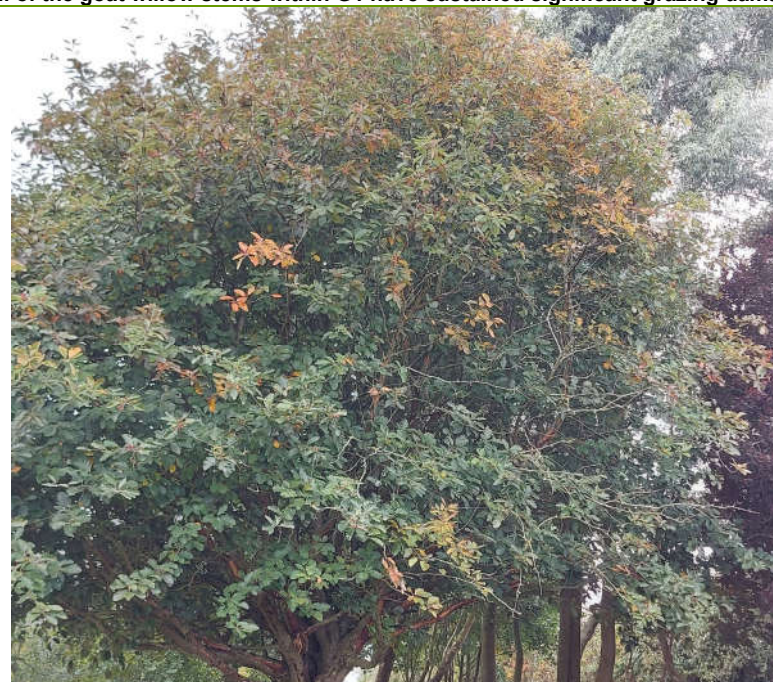
**P4. Dieback in the canopy of the whitebeam is further evidence of the fire damage.**

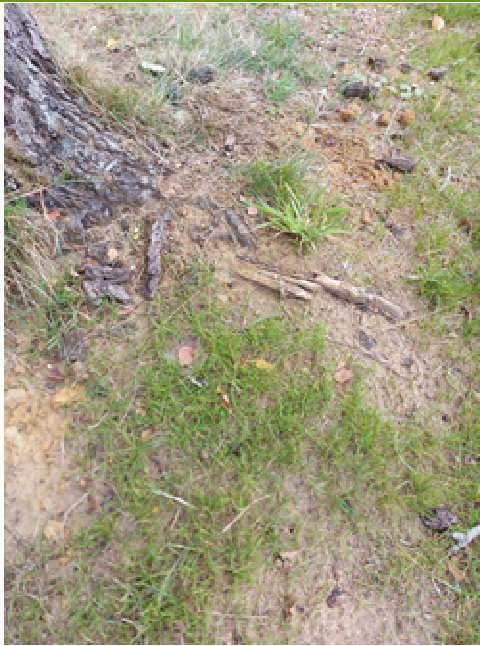
| No | Species | Age<br>Y SM<br>EM<br>M<br>LM<br>OM | Dbh<br>(mm<br>) | CS<br>N<br>S<br>E<br>W<br>(m) | H<br>CH<br>FB<br>(m) | Phys/<br>Struc | Condition notes and site<br>detail: | Prescription | RPA<br>(m/m2) | SULE<br>Yrs | BS<br>Cat:<br>A<br>B<br>C<br>U |
|---|---|---|---|---|---|---|---|---|---|---|---|
| T34 | Birch ( <i>Betula pendula</i> ) | M | 470 | 6.0<br>3.0<br>5.5<br>4.0 | 12.0<br>1.5<br>2.5<br>S | G<br>F | Lean to NE. Evidence of recent root damage. Recent trenching, ground level changes and compaction within RPA limiting SULE. Extent of root damage cannot be confirmed without exploratory airspade excavation. See photos P5 and P6 at appendix 3. | Removal proposed to facilitate extensive planting of high quality semi-mature tree and hedging as part of wider landscape proposals. | 5.7<br>102 | <20<br>Subject to extent of root damage. | B1 |

**P5.** Although evidence of root damage was limited around the base of T34, it suggests that the recent trenching and other groundworks were in close proximity to the stem.

- With the exception of T34, all higher category trees can be retained and appropriately protected in accordance with BS 5837/2012
- Whilst T34 currently appears healthy, it has recently been subject to significant negative impact associated with construction activity to the extent that its safe useful life expectancy (SULE) has been compromised and its removal and replacement is therefore considered appropriate to sustain and enhance the health, quality and longevity of the treescape

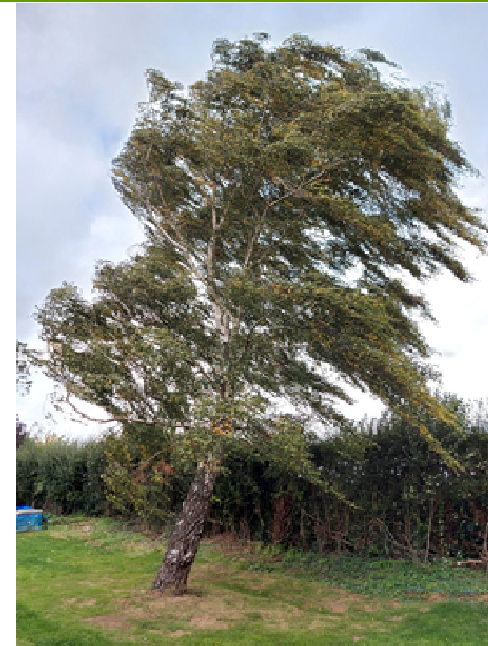
**P6.** The majority of the root damage has been sustained on the upwind side of T34. The tree already has a prominent lean and weighted canopy on the leeward (NE) aspect.

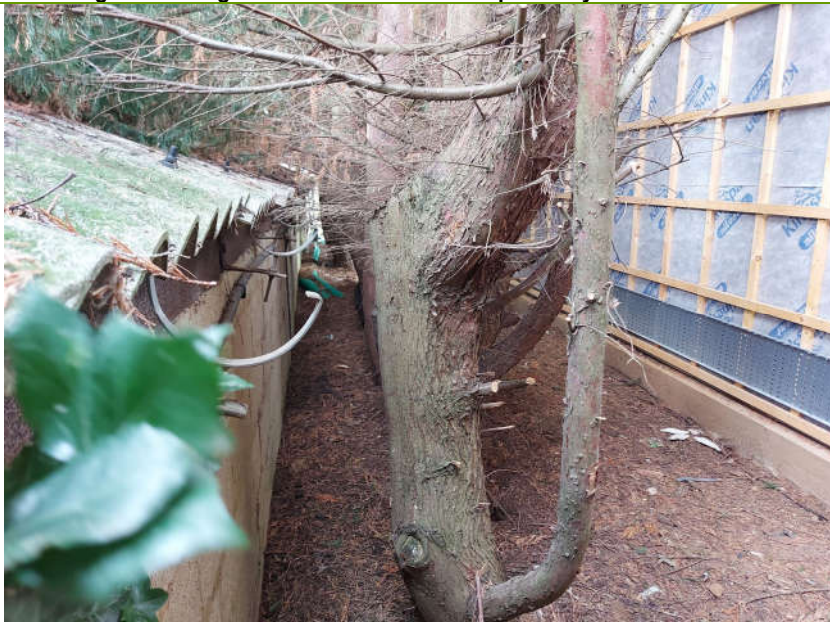
viable, or desirable and it is recommended for removal. See photos P7 and P8. Current landscape proposals include the planting of semi-mature, 4.5m high, formally pruned native yew hedging to create the formal setting and appropriate screening for the swimming pool that is the subject of this retrospective application. It is suggested that such planting is significantly more appropriate and beneficial than the current planting and will provide a positive contribution to the immediate landscape of the manor house and the wider landscape.

**P7.** Due to recent construction the Leyland Cypress hedge (H3) is now compromised by structures on both sides of the substantial line of stems. Retention is not viable.

| Tree (s) | Issue(s) | Constraint and recommended mitigation |
|---|---|---|
| T34, G1 and H3 | Pre commencement facilitation tree works | <p>H3 is recommended for removal for arboricultural reasons. The removal of T34 and a single cherry plum tree within G1 is required to facilitate the planting of a semi-mature 4.5m high yew hedge that is intended to border and screen the swimming pool garden area. It is recommended that all trees in G1 are removed to facilitate the creation of an arboretum between swimming pool garden and the tennis court. A detailed tree work schedule will be provided by the retained arboriculturist in advance of procurement of the tree work contract.</p> <p><b>Recommendations:</b></p> <ul style="list-style-type: none"> <li>• The retained arboriculturist will oversee the procurement and implementation of the tree work contract</li> <li>• A schedule of works will be provided by the retained arboriculturist and implemented by suitably qualified arborists in accordance with BS3998/2010 'Tree works – Recommendations'</li> <li>• Further generic guidance for tree works will be provided in the AMS.</li> </ul> |

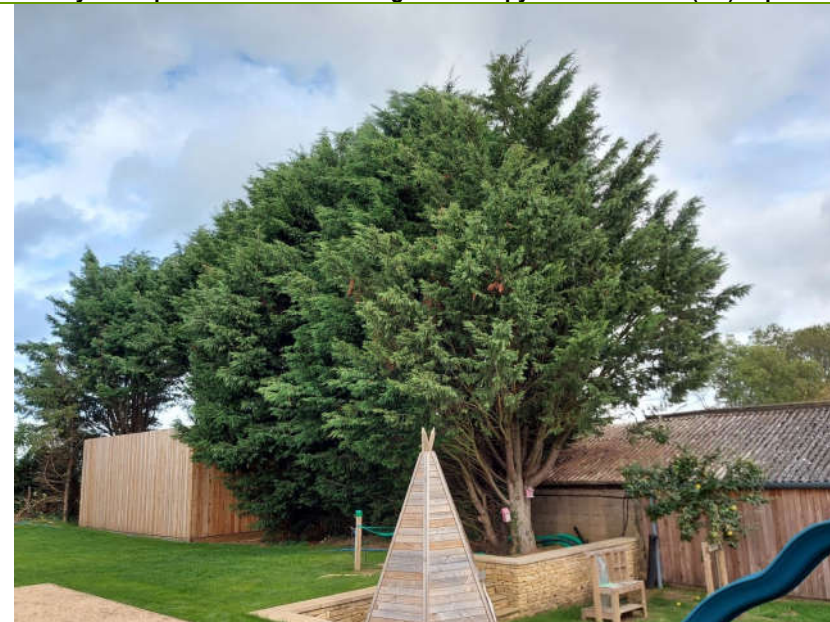
**P8.** Poor form, inappropriate past management and numerous compatibility issues associated with H3 mean that replacement planting is the only sustainable option.

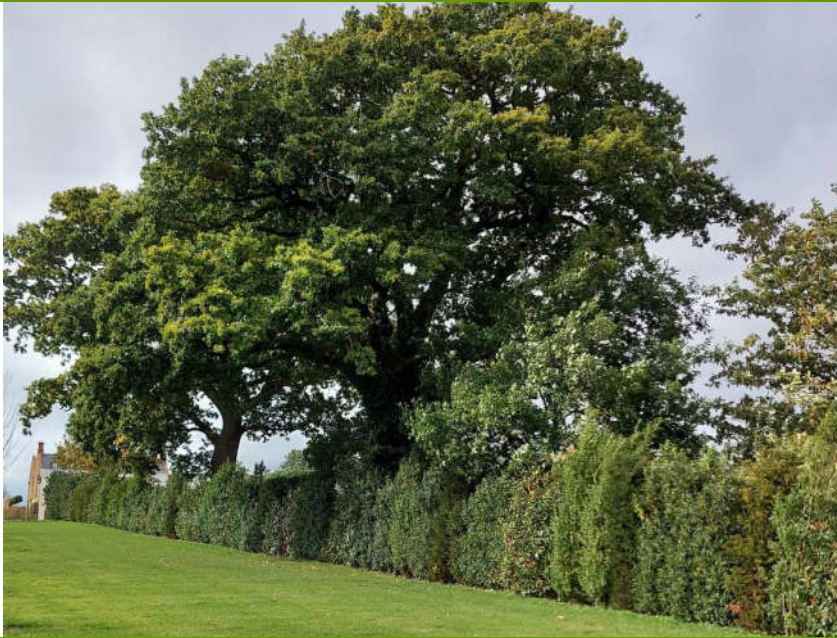
| No | Species | Age<br>Y SM<br>EM<br>M<br>LM<br>OM | Dbh<br>(mm<br>) | CS<br>N<br>S<br>E<br>W<br>(m) | H<br>CH<br>FB<br>(m) | Phys/<br>Struc | Condition notes and site<br>detail: | Prescription | RPA<br>(m/m2) | SULE<br>Yrs | BS<br>Cat:<br>A<br>B<br>C<br>U |
|---|---|---|---|---|---|---|---|---|---|---|---|
| G5 | Pedunculate Oak ( <i>Quercus robur</i> ) x5 | M | 1000<br>E | Av.<br>9.0<br>E | Av.<br>20<br>3.0<br>E | G<br>G | Neighbour's trees. Restricted access. The four mature trees are the subject of a TPO. Canopies overhang site boundary. Four mature trees and one semi-mature in group. 2 <sup>nd</sup> most easterly tree has recently failed – snapped @ 3.5m AGL. Remaining stem may categorise as a 'veteran' tree. Significant large dw in canopy of 2 <sup>nd</sup> most westerly tree. See photos P9 and P10 at appendix 3. | **Recommend crown clean of 2 <sup>nd</sup> most westerly tree. | 12.0 | >40 | A2 |

**P9. The mature TPO oak trees comprising G5 create an impressive feature in the otherwise open landscape.**

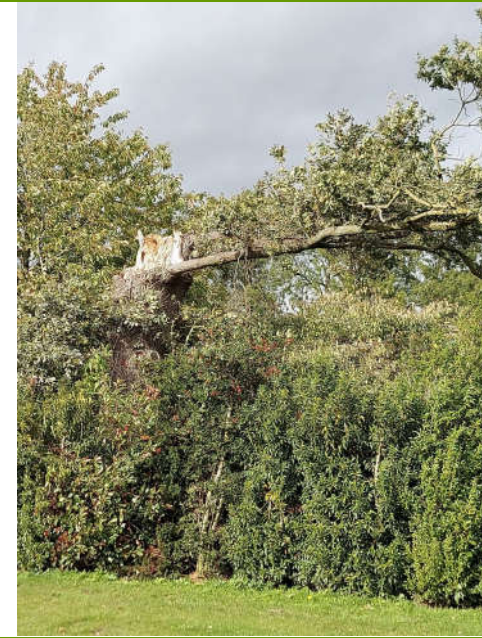
**P10. One of the mature oaks within G5 has recently failed.**
