**ARBORICULTURAL
IMPACT
ASSESSMENT
(OUTLINE)**

Banbury Logistics Park,
Banbury

May 2022

Barton Hyett Associates
Arboricultural Consultants

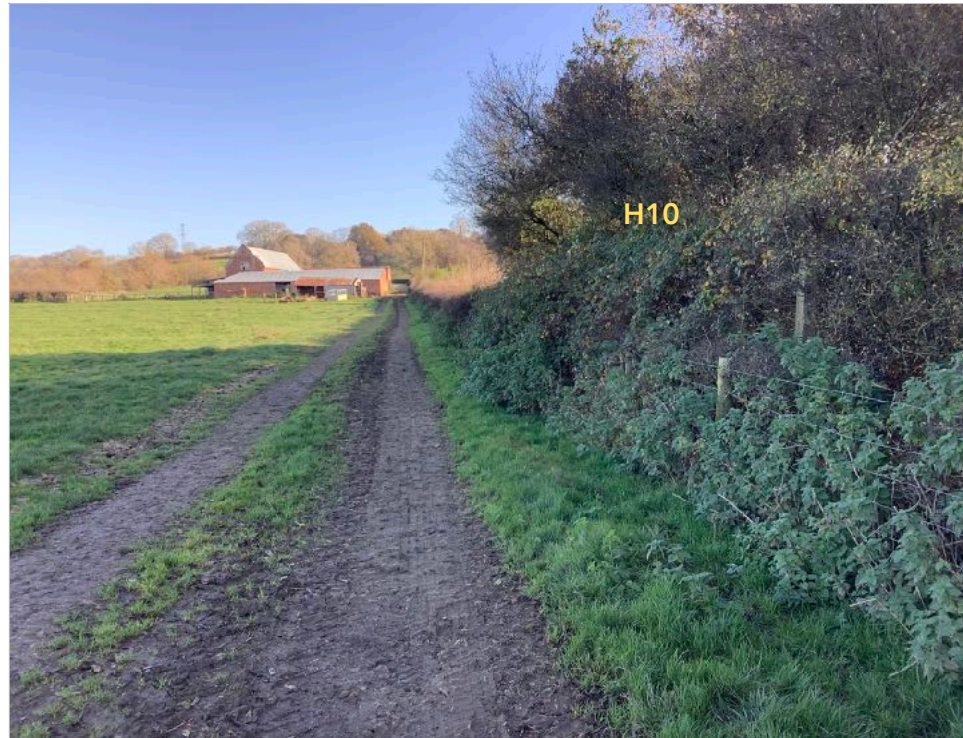
IMAGE 1: A view looking east along H10.

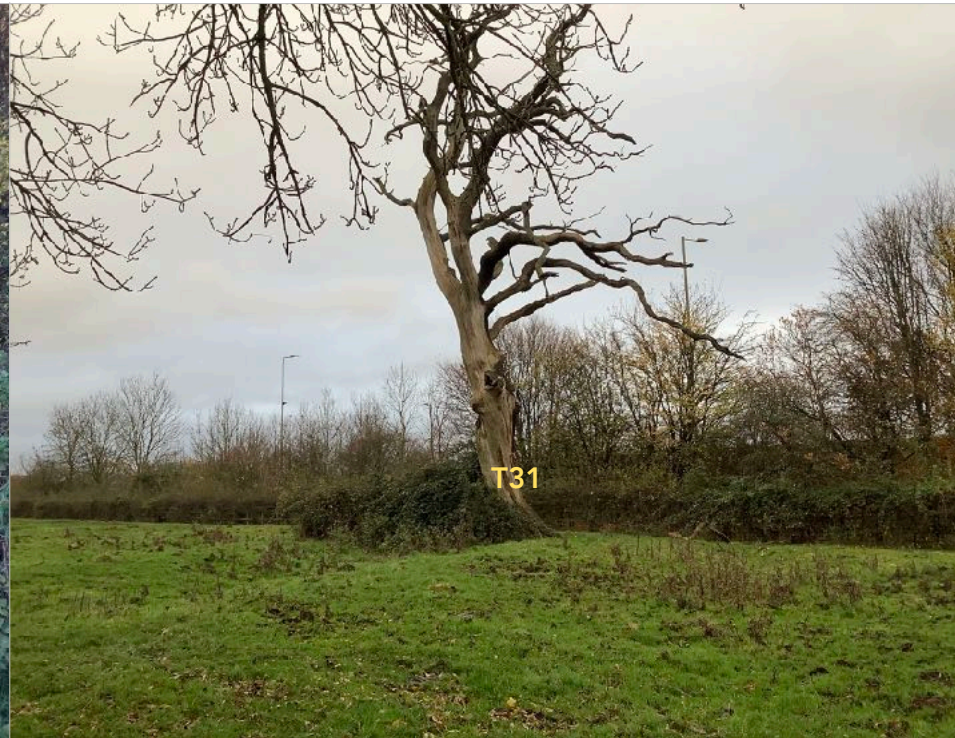
IMAGE 2: A view looking south-west at T31.

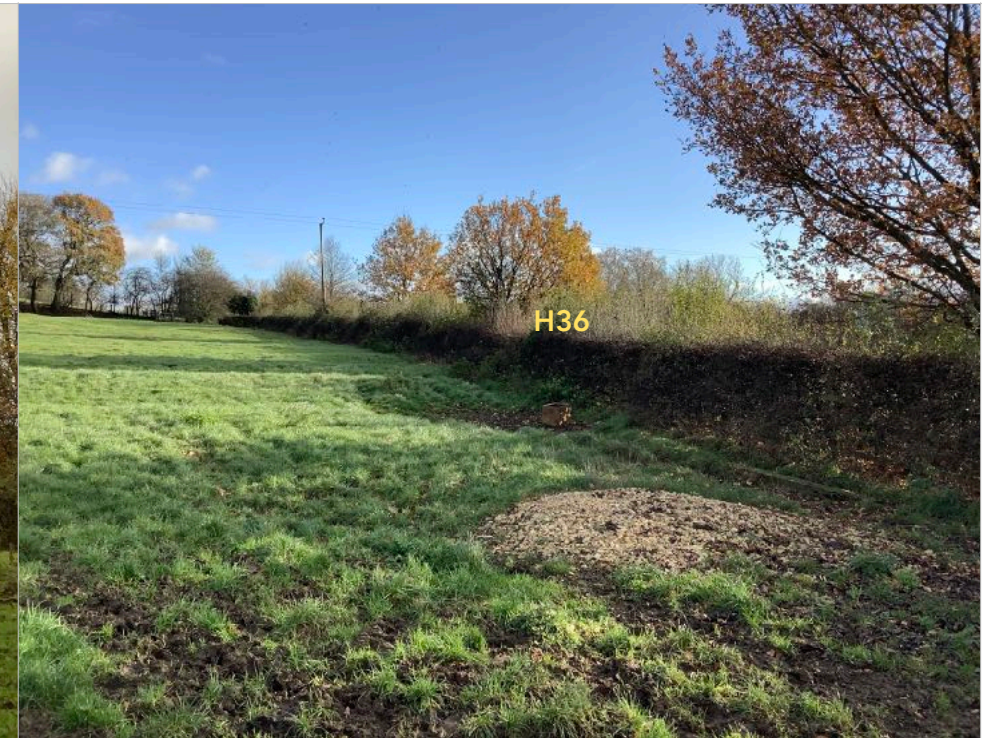
IMAGE 3: A view looking south-east along H36.

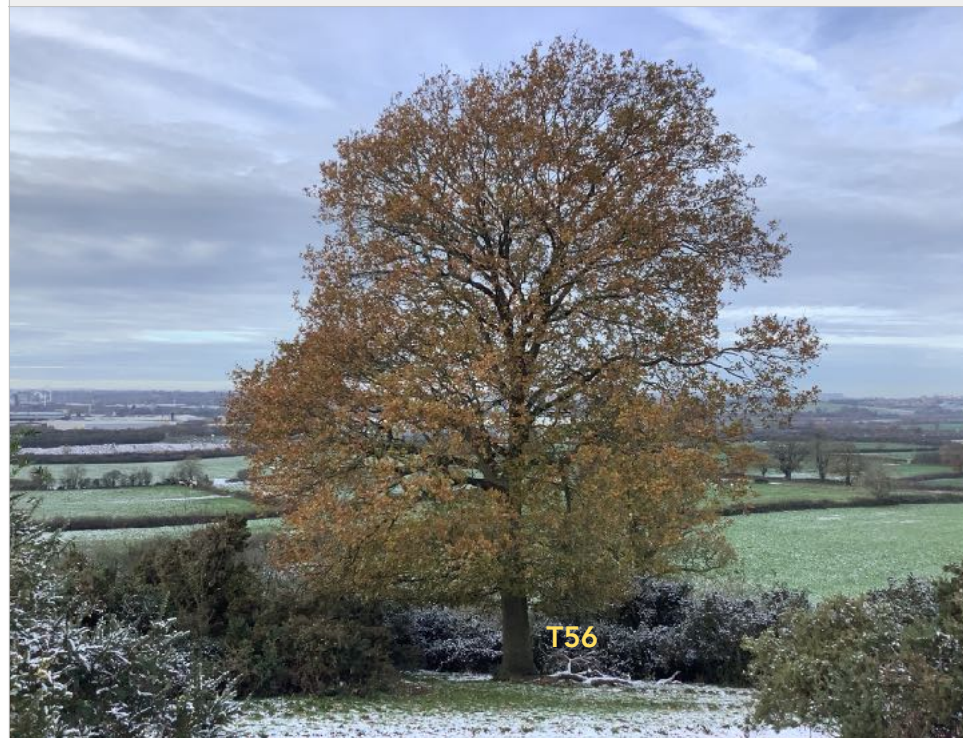
T56	Oak (English)	On	15.0	1	-	760.0	7-7-5-6	2.0	2.5	W	M	None	Within gorse thicket, good stem taper, historic storm damage to 2x lateral limbs	Good	Fair	40+	A1	9.1	261.0	-
T57	Ash (Common)	On	14.0	1	Yes	550.0	7-5-6-5	2.5	4.0	SW	EM	None	Hedgerow tree, main stem heavily swathed in ivy	Good	Fair	20+	B2	6.6	137.0	-
T58	Ash (Common)	On	16.0	1	Yes	850.0	7-10-6-8	2.5	4.5	N	M	None	Hedgerow tree, woodpecker activity visible in upper crown	Good	Good	20+	B2	10.2	327.0	-
T59	Oak (English)	On	15.0	1	Yes	1300.0	10-9-8-9	2.5	3.5	S	M	Ancient	Hedgerow tree, good form	Good	Good	40+	A2	15.0	707.0	19.5
T60	Oak (English)	On	15.0	1	-	900.0	7-6-7-8	2.0	3.0	N	M	None	Hedgerow tree, good stem taper	Good	Good	40+	A1	10.8	366.0	-

IMAGE 4: A view looking west at T56.

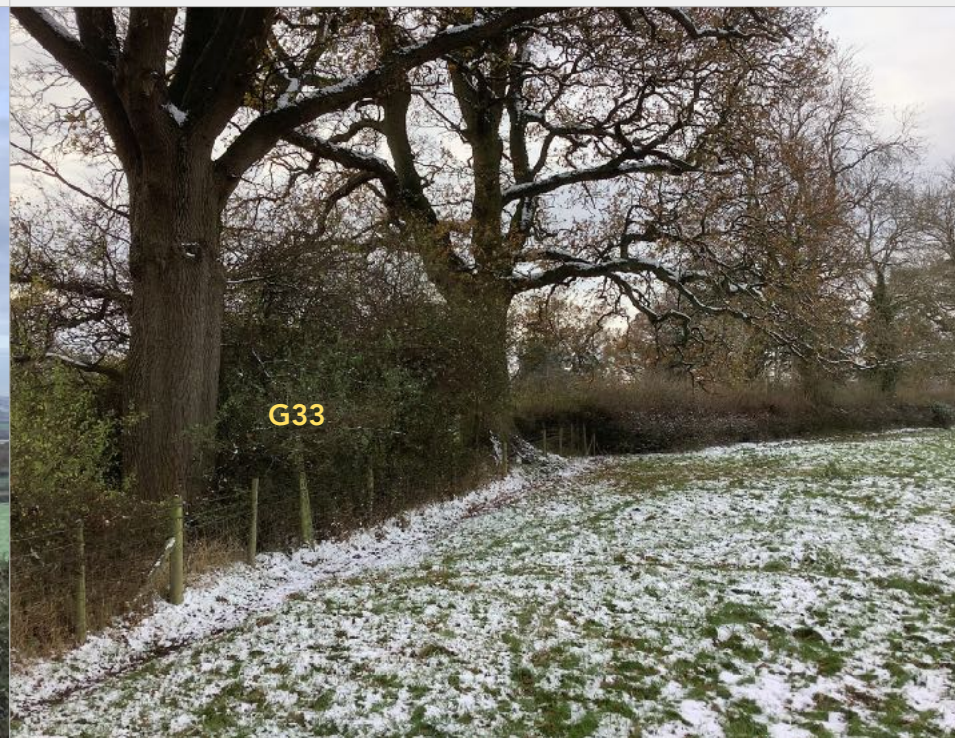
IMAGE 5: A view looking west along G33.

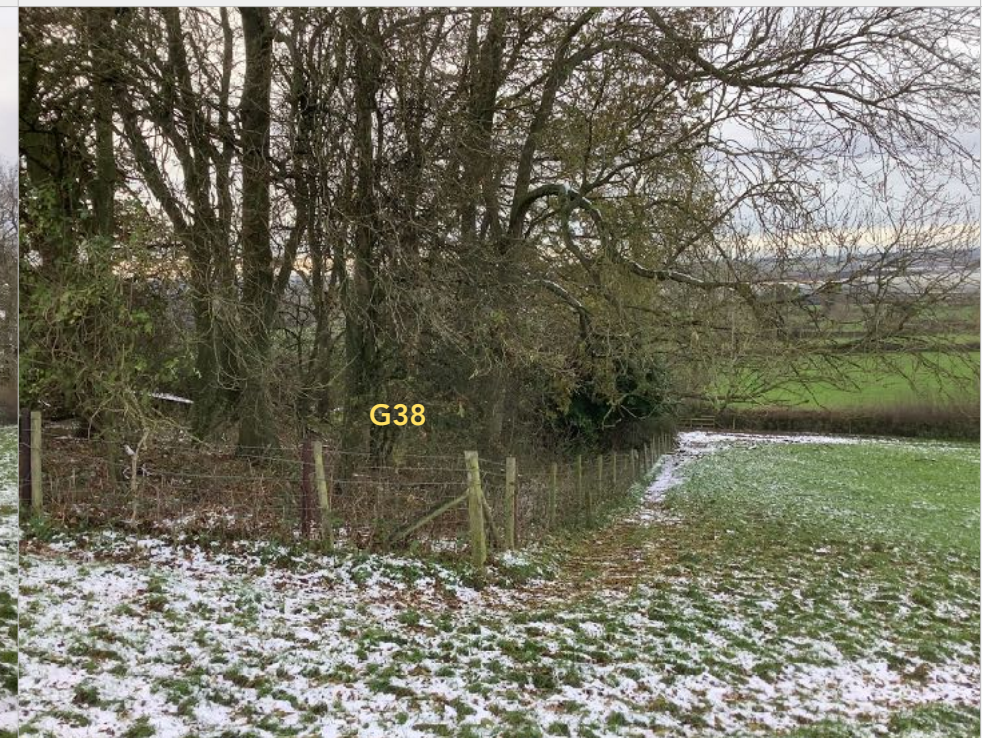
G38	Ash	On	18	2	Yes	1100	7.5	2.0	M	2x open grown trees on sloping part of site, tree to north dominates group	Good	Good	20+	A2	13.2	-
G39	Ash	On	12	2	Yes	500	5.5	2.0	M	2x ash hedgerow trees forming cohesive crown	Good	Fair	20+	B2	6.0	-
G40	Oak, hawthorn	On	5-15	12		1100	7.5	3.5	M	9x mature oak on boundary with 3x hawthorn, thorn is derelict sections of hedge, ivy cover to 5x oak, historic storm damage to central tree, good feature	Good	Fair	40+	A2	13.2	12.5
G41	Horse chestnut, elder	Off	9	6	Yes	900	6.0	2.0	M	2x horse chestnut with extensive decay throughout main stems, failed scaffold limbs, surrounding ground littered with debris, elder occurs as understory	Fair	Poor	<10	C2	10.8	-
G42	Ash, oak, elm, hawthorn, blackthorn, laurel	On	3-16	30	Yes	800	7.0	2.0	M	Copse at field edge, newly established laurel understory	Good	Fair	20	B2	9.6	-
G43	Ash, hawthorn, elder	On	14	11	Yes	800	7.0	2.5	M	4x ash hedgerow trees forming cohesive crown with derelict hedge beneath, stunted extension growth, staining to main stems indicates Inonotus hispidus brackets, historic storm damage	Fair	Fair	10+	C2	9.6	-

IMAGE 6: A view looking west along G38.
