Technical Note 03

Project: 1006638

Bat Ground Level Tree Appraisal

Land South West of Huscote Farm &
 East of Daventry Road, Banbury
 Bat Tree Plan

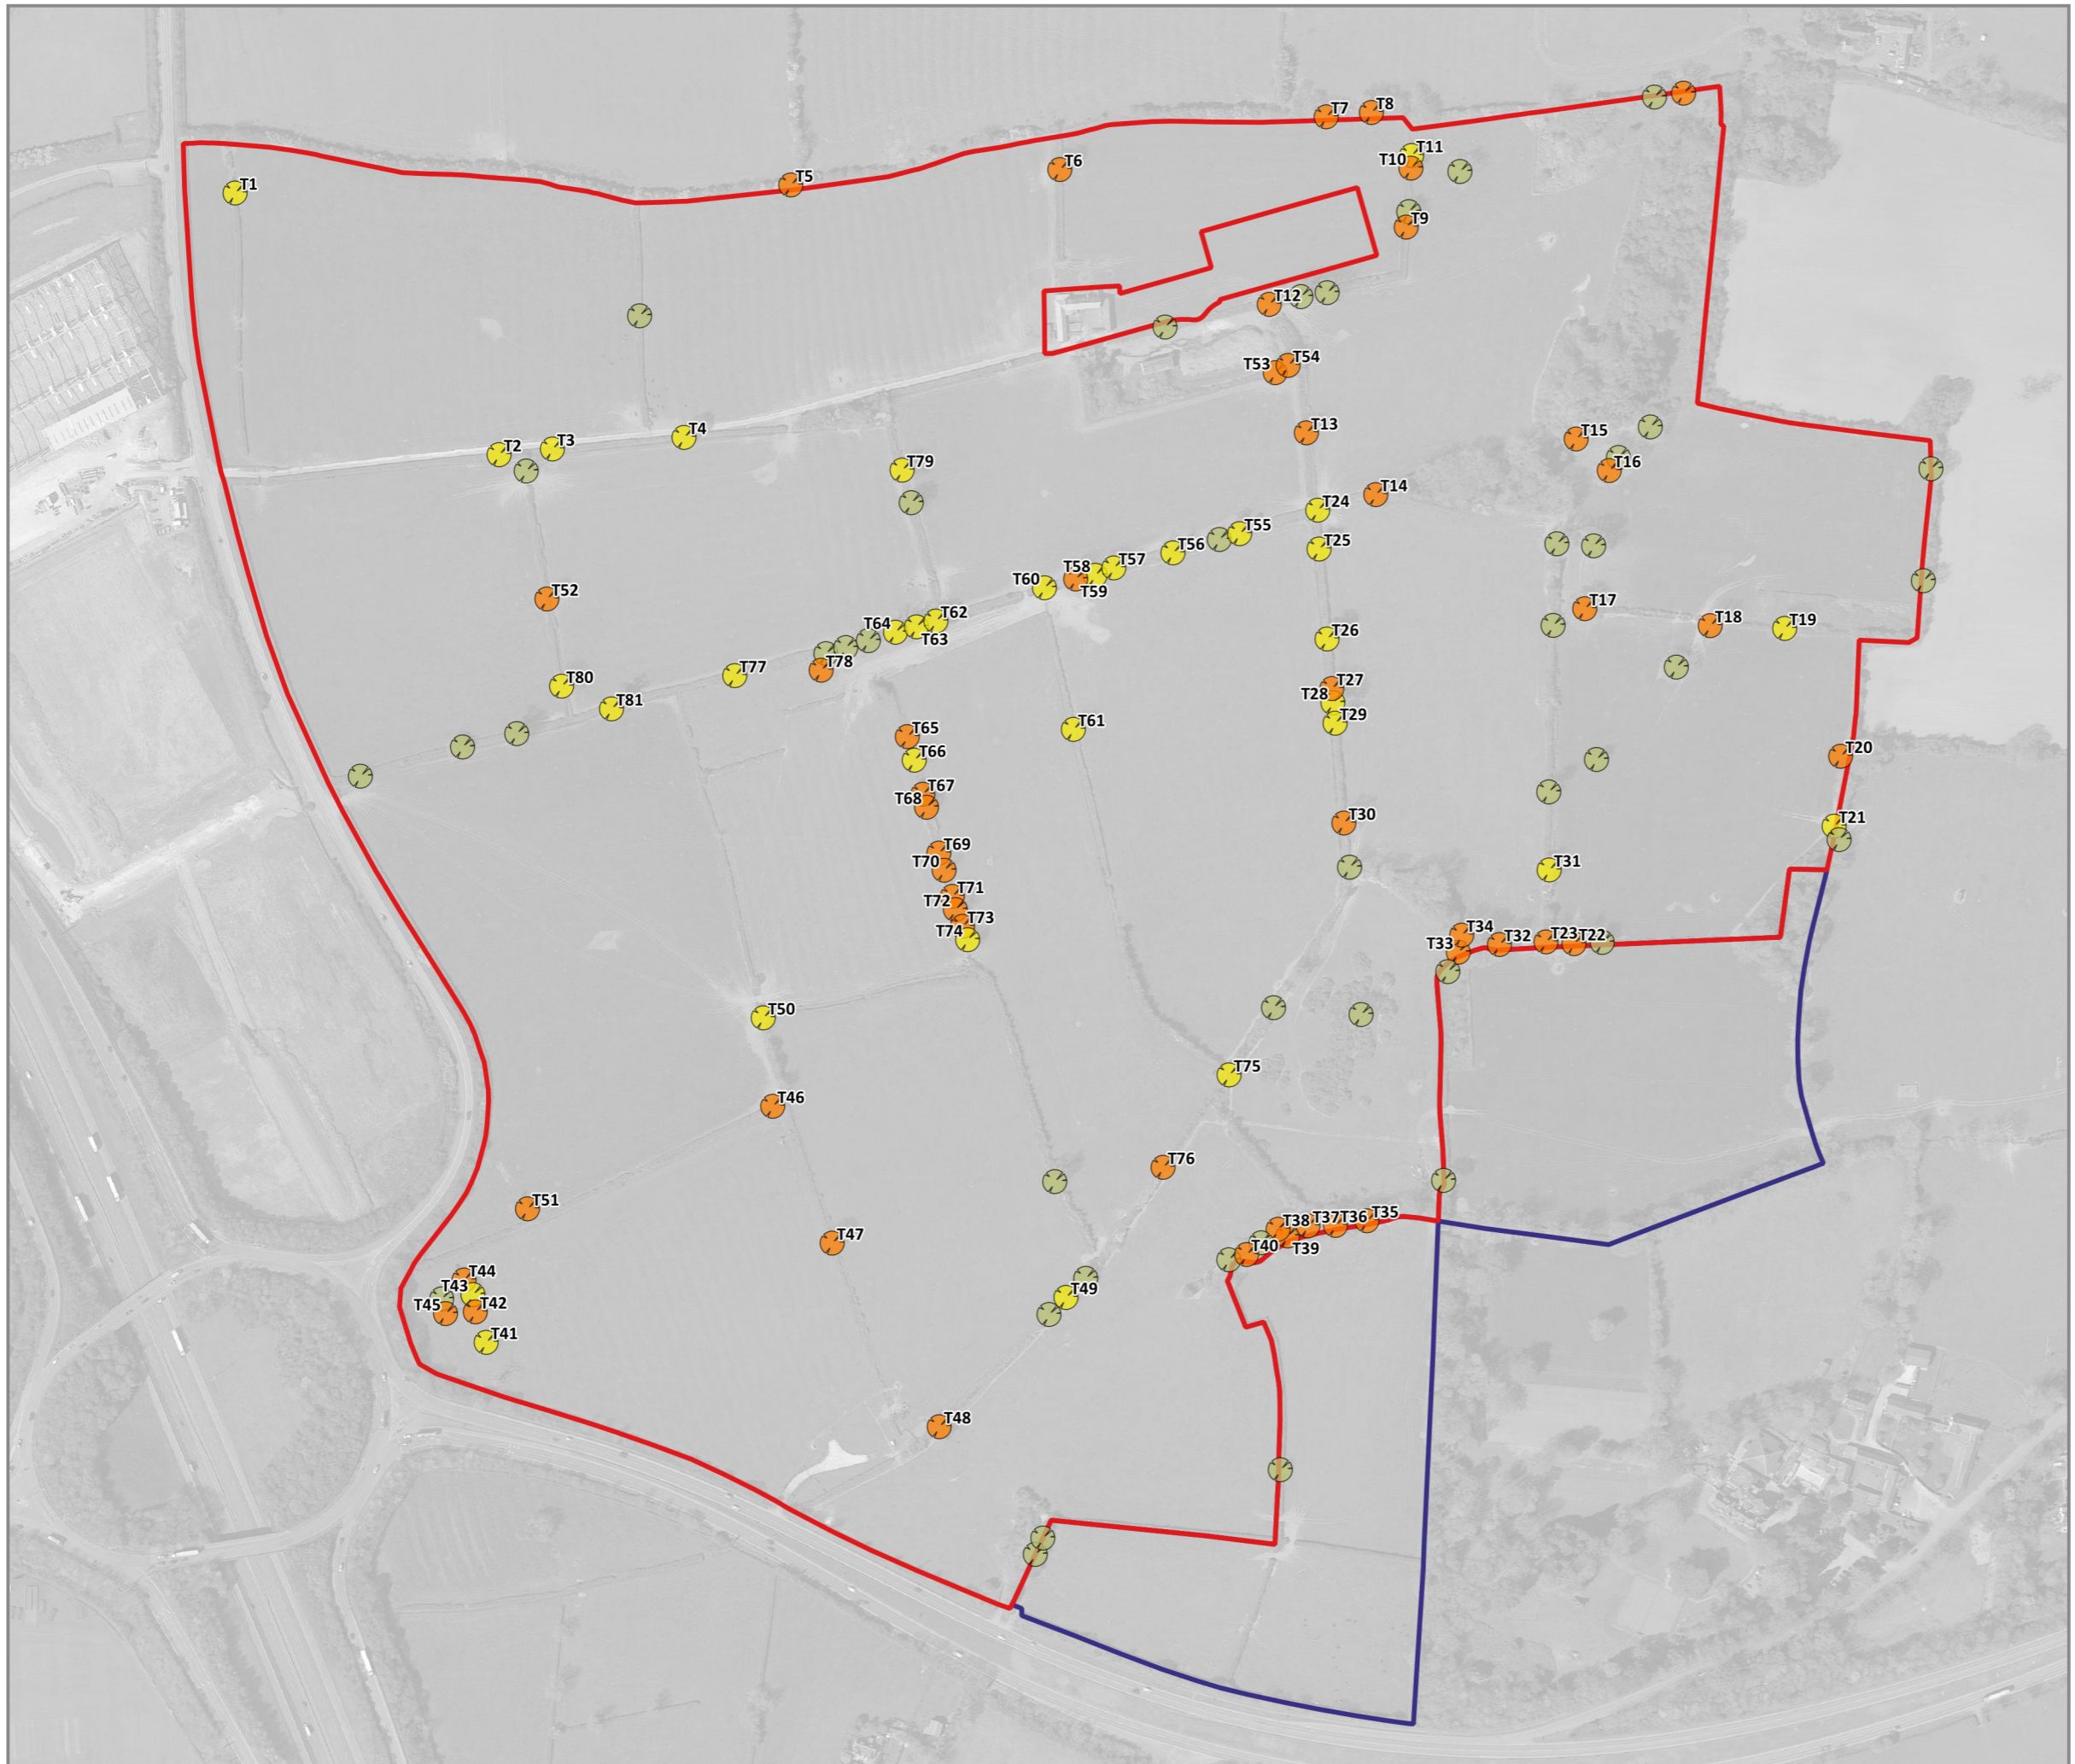
PROJECT	6638/BNG5
TITLE	C/JP
DRAWING NO.	December 2023
REV	
DATE

- 2.3.1 A substantial number of semi-mature and mature trees are present within the site. The results of the tree inspection work undertaken at the site are illustrated on Plan 6638/BNG5 and a summary of the individual trees identified to support features offering potential for use by roosting bats is set out in Table 2.1 below.

2.3.2 Overall, a total of 81 trees were identified to support features offering potential for use by roosting bats, of which 52 were recorded to offer moderate to high potential. No evidence for any use of the trees by bats was recorded during the ground level visual survey work.
