Symmetry Park, Bicester Phase 3

Phase 1 Desk Study

Doc ref: 22281-HYD-XX-XX-RP-GE-1003-S2-P01

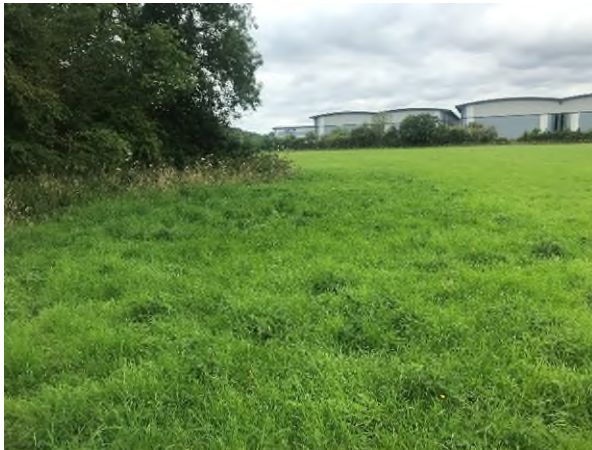
Figure 2.3: Photograph of general site overview from the centre of the site looking west

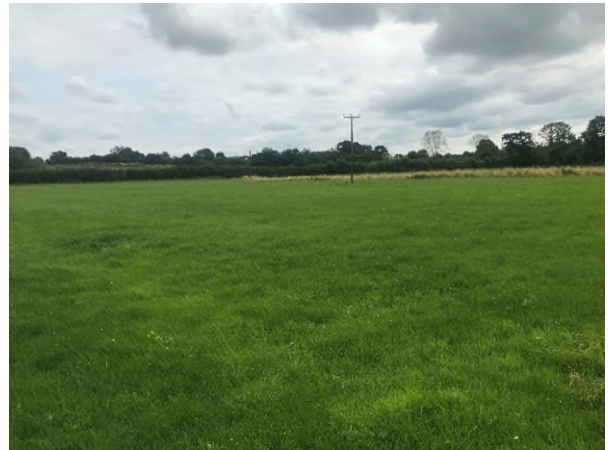
Figure 2.4: General site overview including overhead electricity pylon from the central west of the site looking southeast.

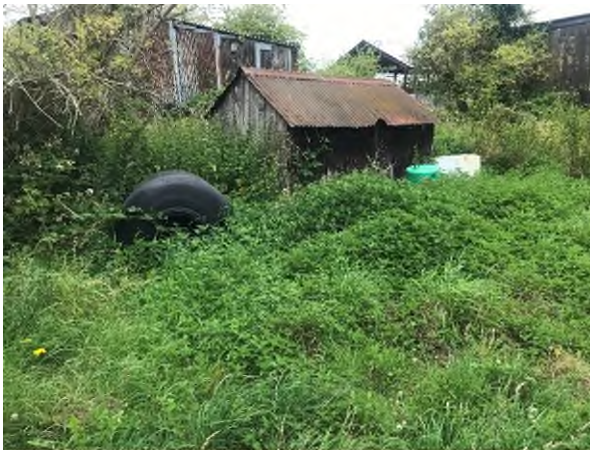
Present land use	The sites current land use is as an agricultural field, with no structures apart from a collection of disused farm buildings in the north-eastern corner. Many of the buildings are in disrepair. Probable asbestos cement sheeting and pipe were noted within structures as well as adjacent to the buildings amongst the vegetation surrounding the buildings. A number of canisters were noted including paints / lubricants / oils drums. Overhead electricity cables bisect through the centre of the site running from north-west to south-east with on-site field boundaries formed by fencing and open ditches. A wooded area is present in the southeast corner of the site.
Vegetation	The site is bordered by mature hedgerows and sporadic mature trees. An approximate 30m x 20m wooden area is present l the south-east corner of the site with mature trees sporadically present around the farmyard area.

Figure 2.5: Photograph of disused barn structures on site.

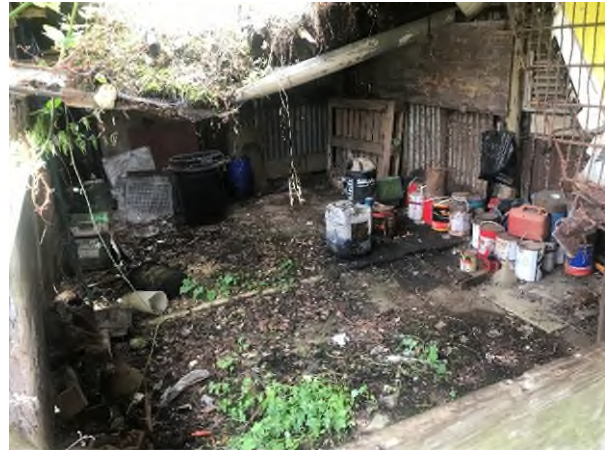
Figure 2.6: Photograph of various containers stored in the disused farm buildings on site.

During the site reconnaissance walkover, containerised storage for lubricants, oils and unknown chemicals were identified within the various the disused barn structures to the north-east corner of the site that could have, or be, leaking. As well as this, the Demolition Asbestos Survey Report

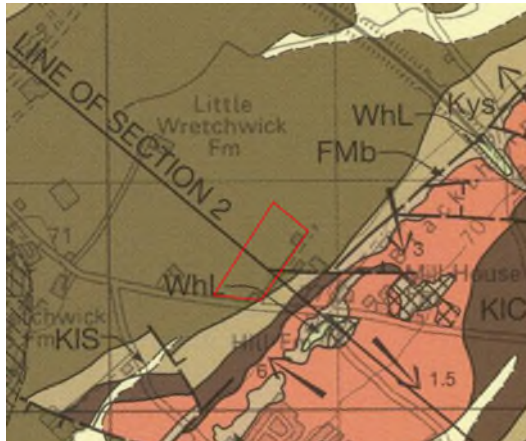
A normal fault is shown on BGS Sheet 219, approximately 200m south-east of the site. The fault trends north-east to south-west with a down-throw to the north-west. The normal fault has uplifted

Figure 2.9: Part of BGS Geological Sheet 219 showing faults to south-east of site.
(Reproduced with permission from British Geological Survey)
Contains British Geological Survey materials © UKRI 2024

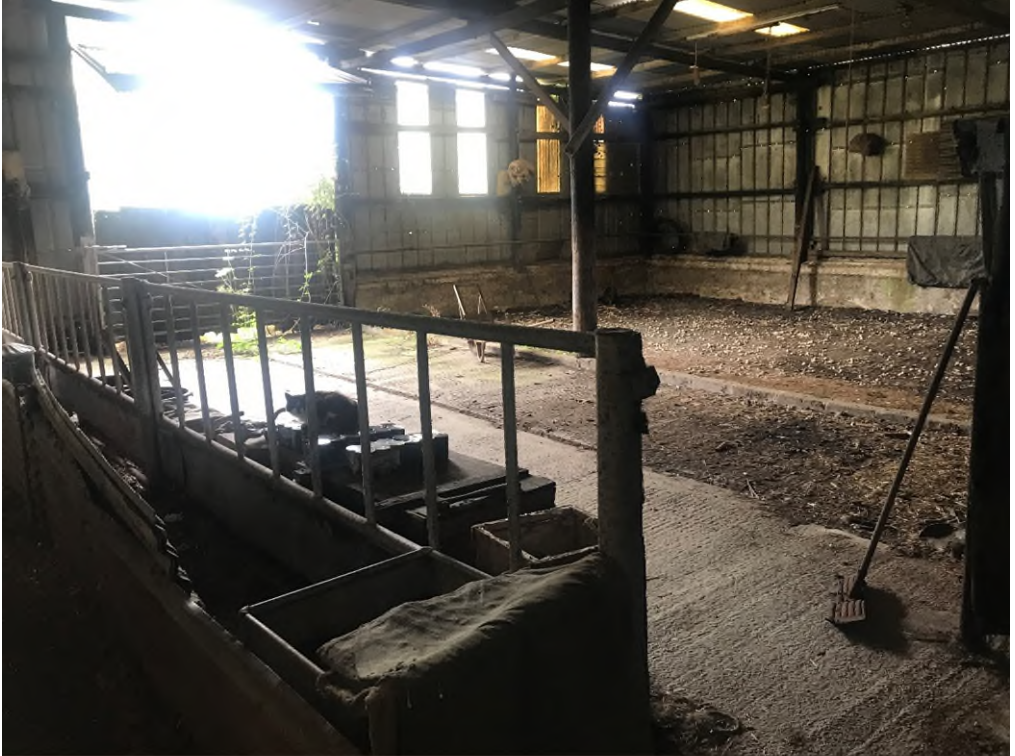
Photograph 17

Date: 24/07/2024	
Direction Photograph Taken: N/A	
Description: Internal main barn area.

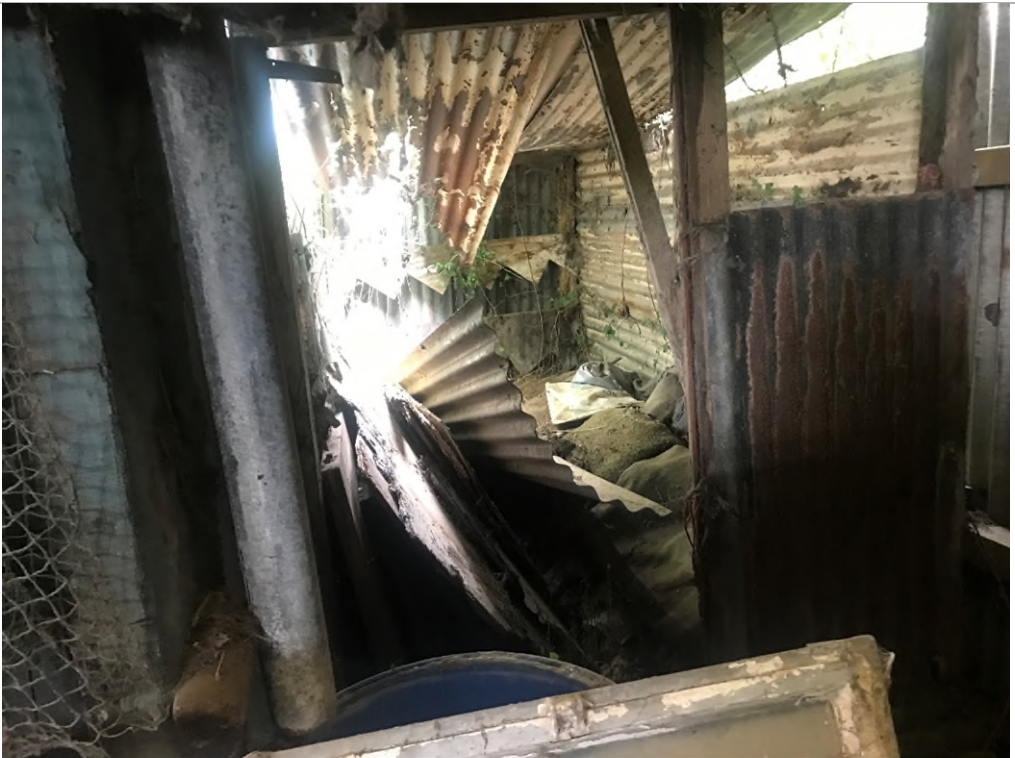
Photograph 18

Date: 24/07/2024	
Direction Photograph Taken: N/A	
Description: Roof collapse in main barn area (rear).

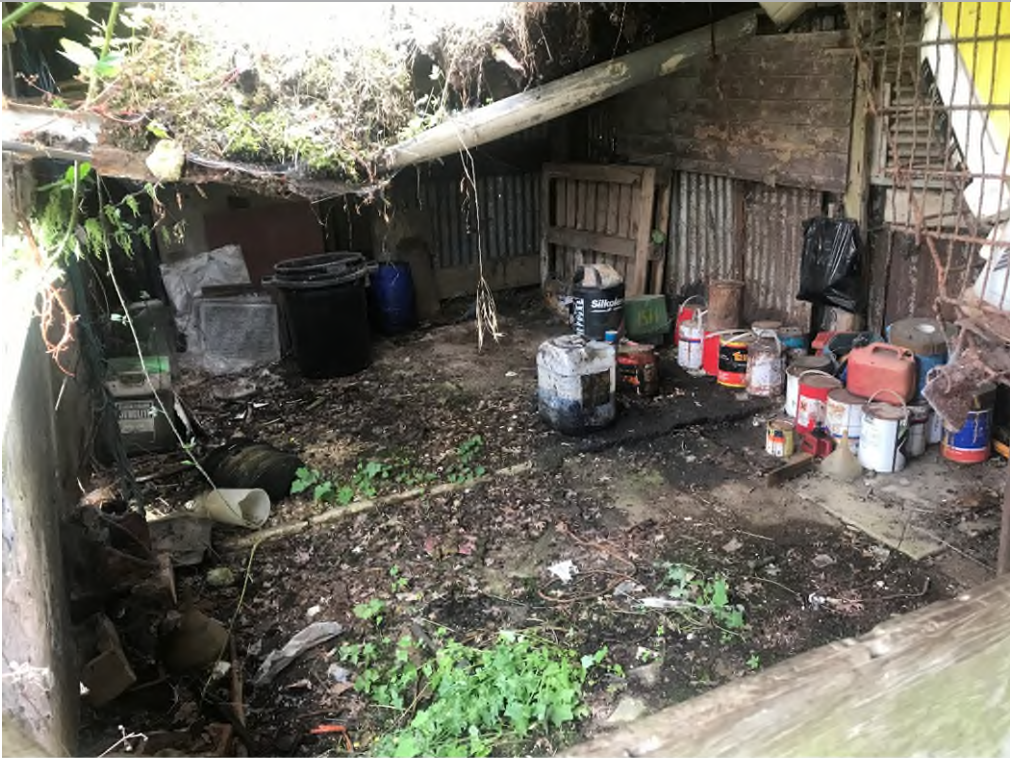
Photograph 19

Date: 24/07/2024	
Direction Photograph Taken: N/A	
Description: Various containers within small outhouses along eastern boundary.

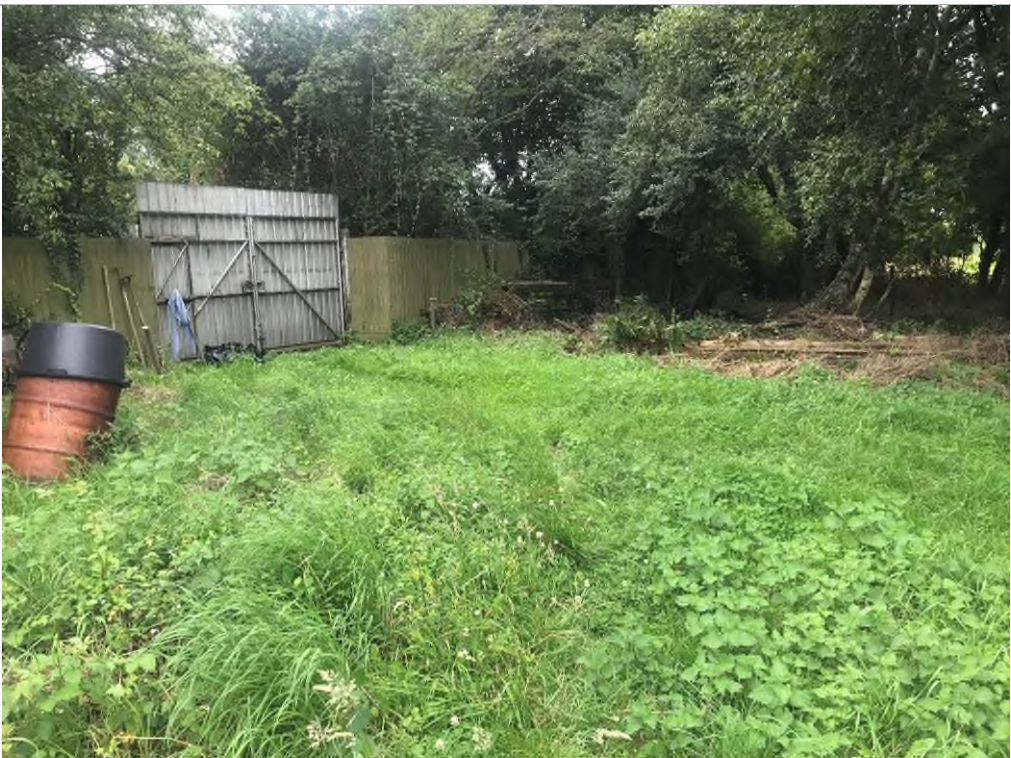
Photograph 20

Date: 24/07/2024	
Direction Photograph Taken: Southeast	
Description: Entrance to farm area.
