CLIENT
Tritax Symmetry Bicester 3 Ltd

PROJECT
Symmetry Park Bicester Phase 3

TITLE
Photo Location Plan

Appendix B Field reconnaissance photographs

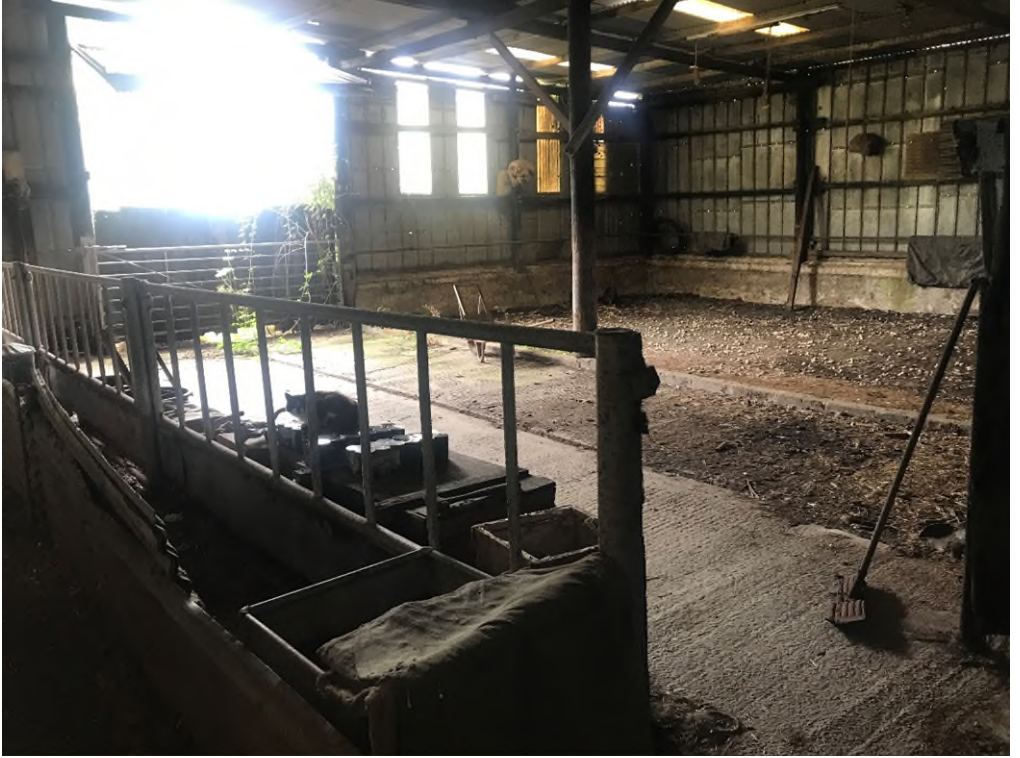
Photograph 17

Date: 24/07/2024	
Direction Photograph Taken: N/A	
Description: Internal main barn area.

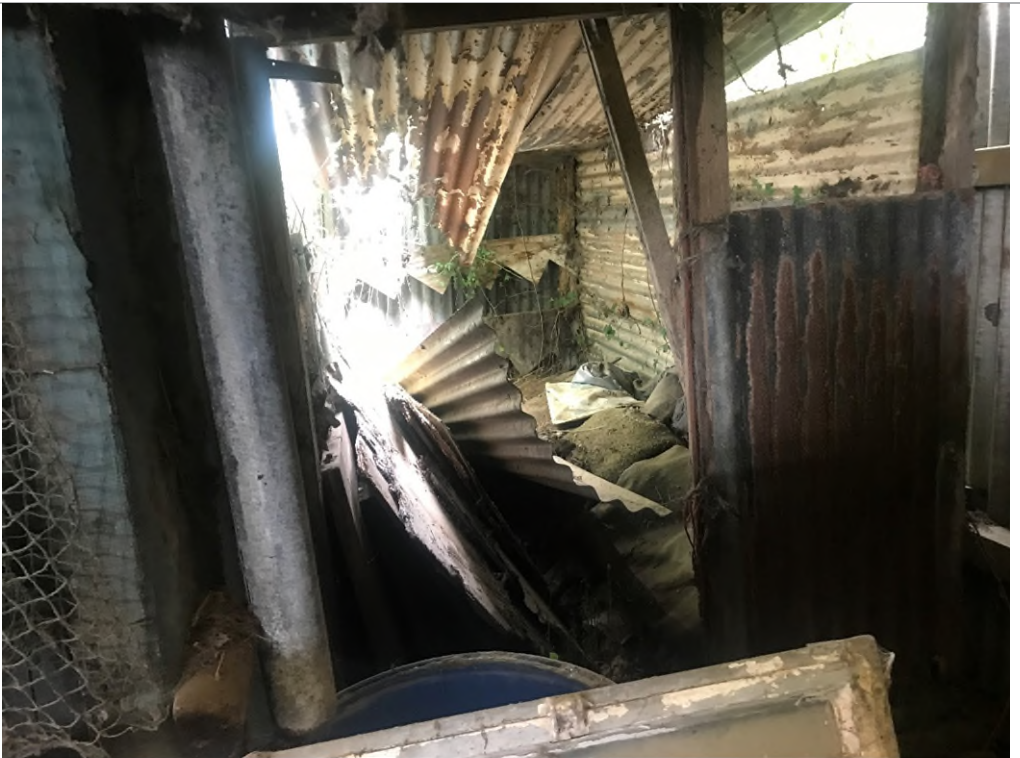
Photograph 18

Date: 24/07/2024	
Direction Photograph Taken: N/A	
Description: Roof collapse in main barn area (rear).

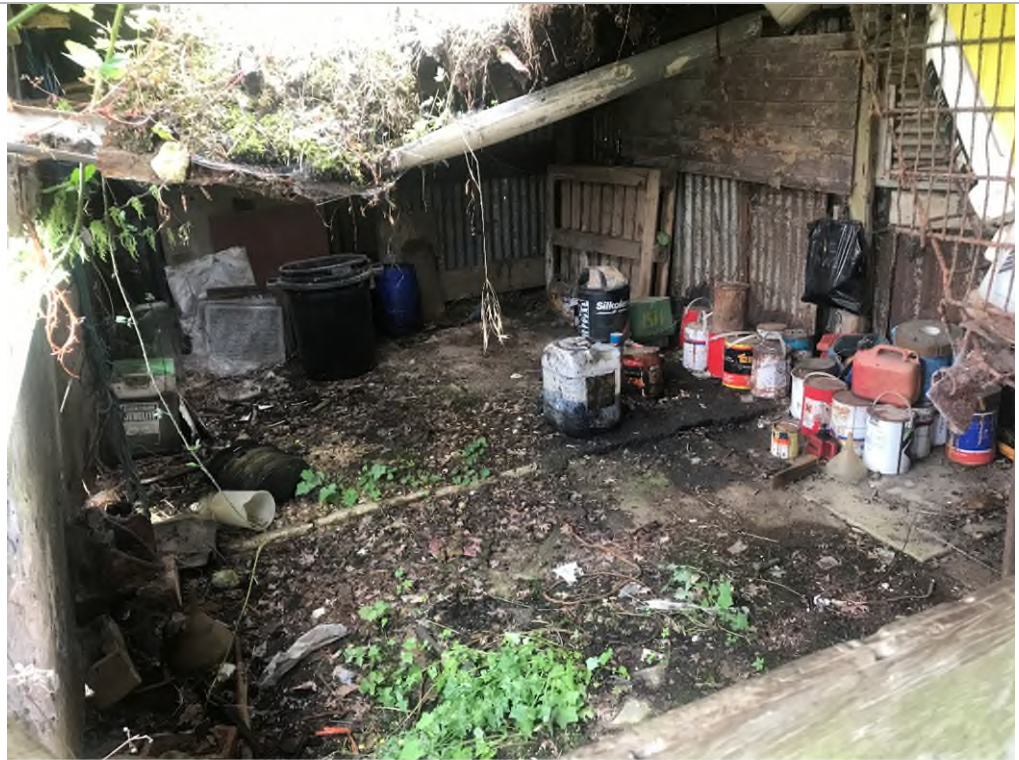
Photograph 19**Date:** 24/07/2024**Direction**
Photograph Taken:
N/A**Description:**
Various containers
within small
outhouses along
eastern boundary.

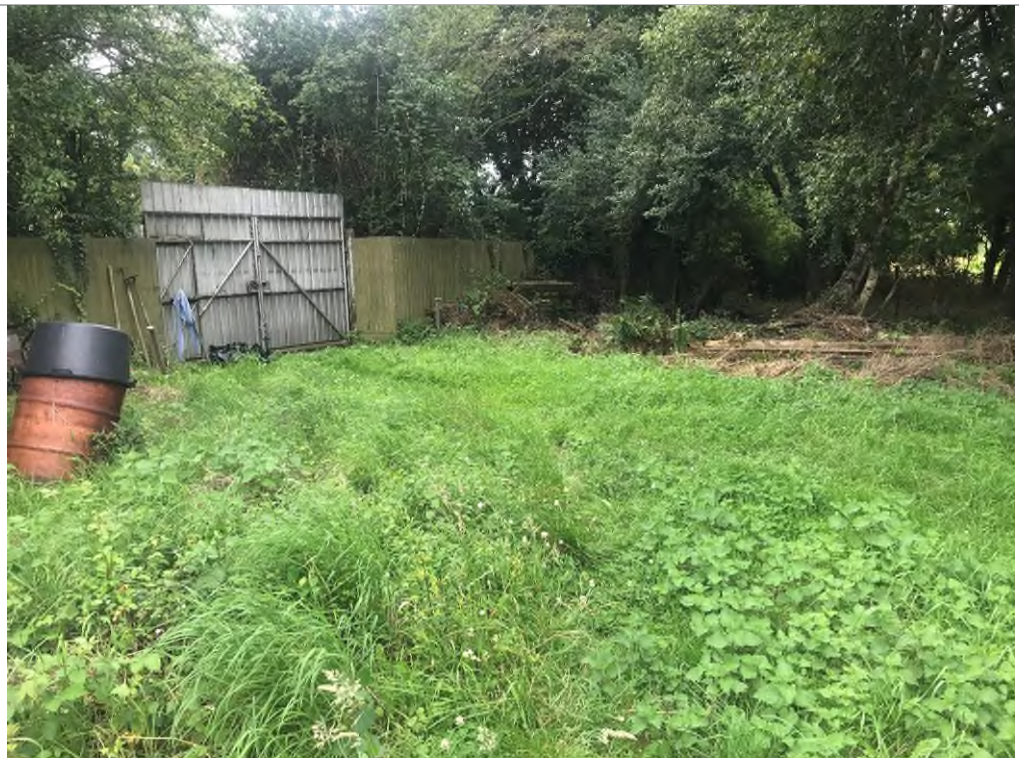
**Photograph 20****Date:** 24/07/2024**Direction**
Photograph Taken:
Southeast**Description:**
Entrance to farm
area.
