# Symmetry Park, Bicester Phase 3

## Phase 1 Desk Study

*For Tritax Symmetry Bicester 3 Ltd*

Doc ref: 22281-HYD-XX-XX-RP-GE-1003-S2-P01

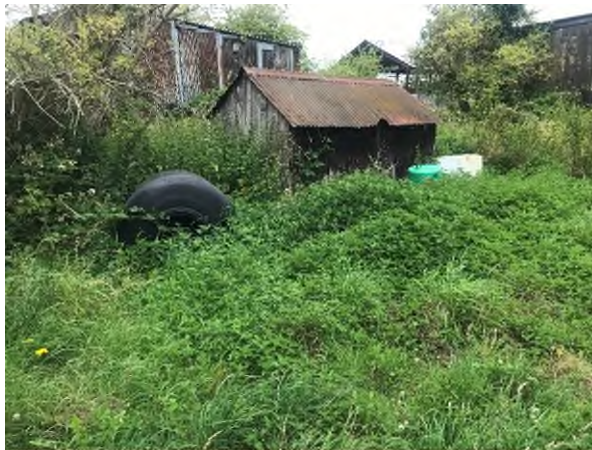
Present land use	The sites current land use is as an agricultural field, with no structures apart from a collection of disused farm buildings in the north-eastern corner. Many of the buildings are in disrepair. Probable asbestos cement sheeting and pipe were noted within structures as well as adjacent to the buildings amongst the vegetation surrounding the buildings. A number of canisters were noted including paints / lubricants / oils drums. Overhead electricity cables bisect through the centre of the site running from north-west to south-east with on-site field boundaries formed by fencing and open ditches. A wooded area is present in the southeast corner of the site.
Vegetation	The site is bordered by mature hedgerows and sporadic mature trees. An approximate 30m x 20m wooden area is present l the south-east corner of the site with mature trees sporadically present around the farmyard area.

Figure 2.5: Photograph of disused barn structures on site.

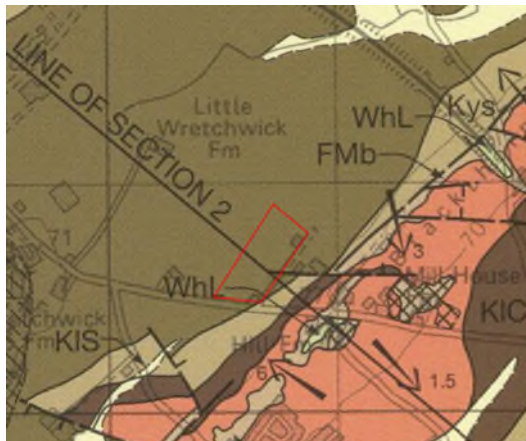
A normal fault is shown on BGS Sheet 219, approximately 200m south-east of the site. The fault trends north-east to south-west with a down-throw to the north-west. The normal fault has uplifted

the older geological units to the surface, south-east of the site. Numerous transverse faults are associated with the normal fault, which trend approximately south-east to north-west, as shown in Figure 2.9 and Figure 2.10. The transverse faults have caused lateral movement of geology to the north-west, therefore, there is a potential for the older sequence of geology (Kellaways Sand Member, Kellaways Clay Member and Cornbrash Formation) to be at, or near, the surface on the site.

Figure 2.9: Part of BGS Geological Sheet 219 showing faults to south-east of site.  
(Reproduced with permission from British Geological Survey)  
Contains British Geological Survey materials © UKRI 2024
