PROJECT: BARTLETT COTTAGE  
SIBFORD COWLEY, OX15 5RY

## 4.0 Proposed Works

### 4.01 Restoration Works - Roof Works & Chimneys

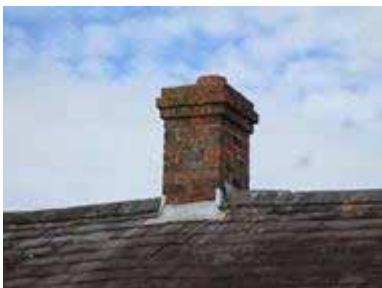
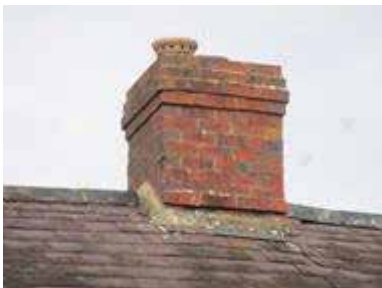
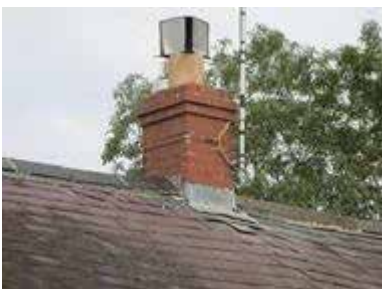
1 It was identified by the surveyor that there are light deterioration to the three chimney stacks.

Existing Chimney Stack - Left

Existing Chimney Stack - Central

Existing Chimney Stack - Right

The proposed restoration works includes the re-pointing of the brick mortar, redressing of lead flashing, replacement of cracked chimney pot works required to the existing chimney stacks

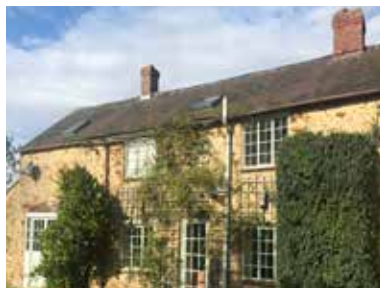
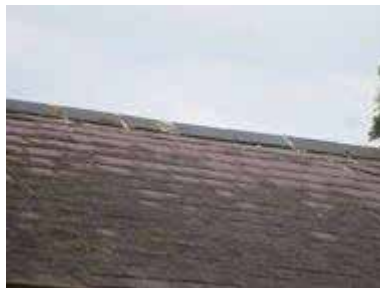
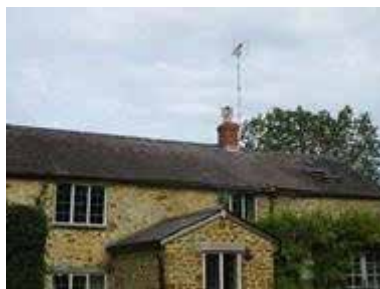
2 It was identified by the surveyor that there is undulation to the ridge tiles due to deterioration of the mortar pointing.

Existing roof ridge - left side

Existing roof ridge

Existing roof ridge - right side

The proposed restoration works includes the re-pointing and re-bedding of the ridge tiles.

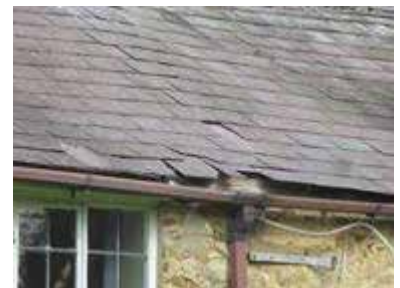
3 The existing roof is covered in slate tiles, there are slipped and damaged tiles.

Damaged and slipped slate tiles

The proposed restoration works includes the reinstatement of slipped tiles and replacement of damaged tiles with matching slate tiles.

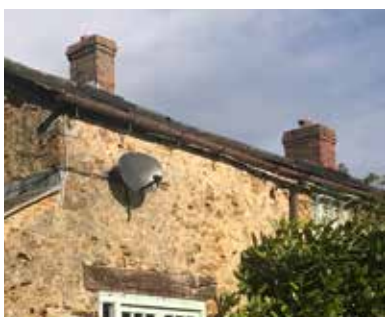
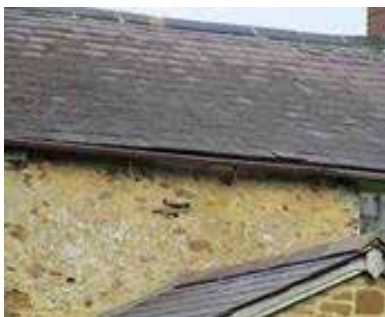
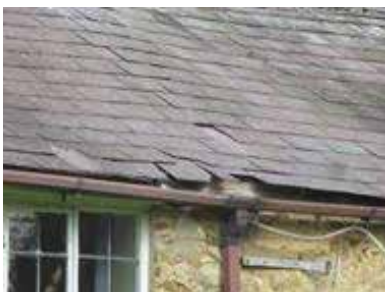
The existing gutters are mix of brown PVC and metal in a simple profile supported off metal brackets. Some of the gutters are in a poor state and pulling away and separated from the roof slate. Some of the existing timber fascias are in a poor state. The proposed restoration work is to replace all the existing with new conservation painted ( colour to match window frames ) metal gutter and down pipe system ( in a sympathetic “deep round” profile ). Existing fascias will be replaced with painted timber fascias. Other work include the incorporation of a felt support tray which will bridge the gap between the roof slates and the gutter to prevent ongoing saturation at the junction between the roof tile and adjacent building elements.

Existing Gutters

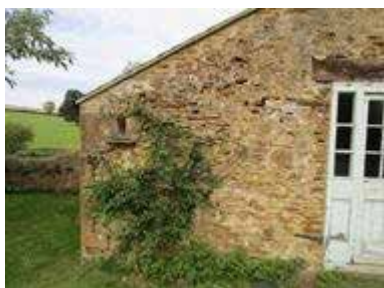
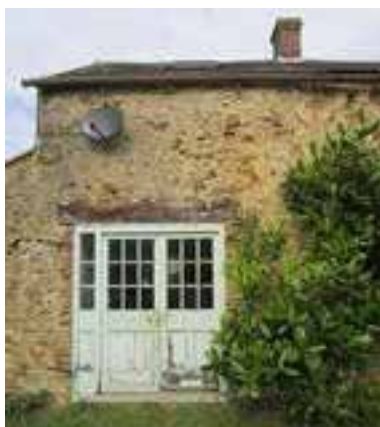
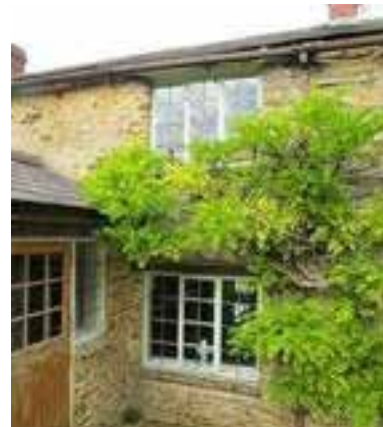
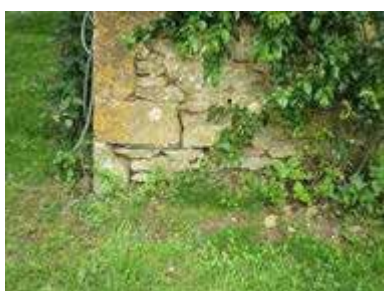
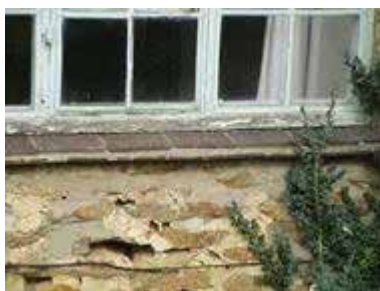
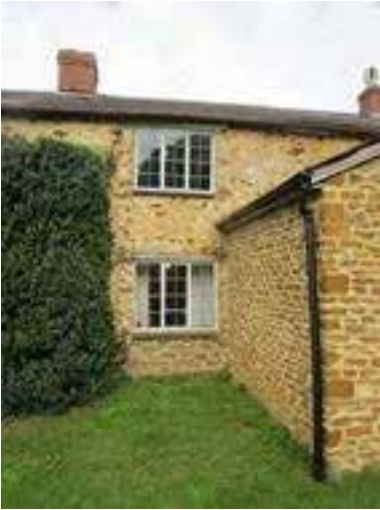
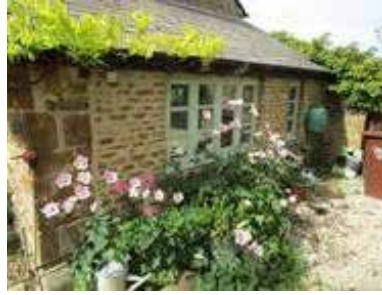
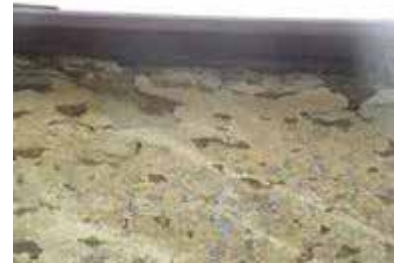
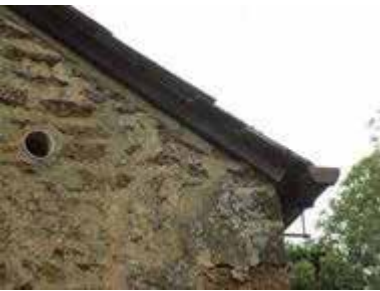
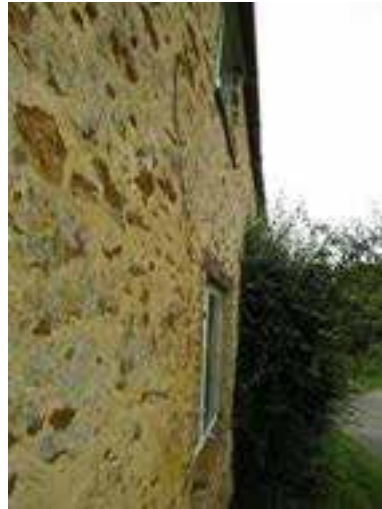
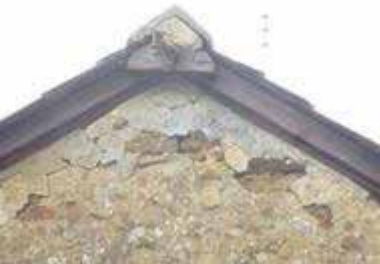
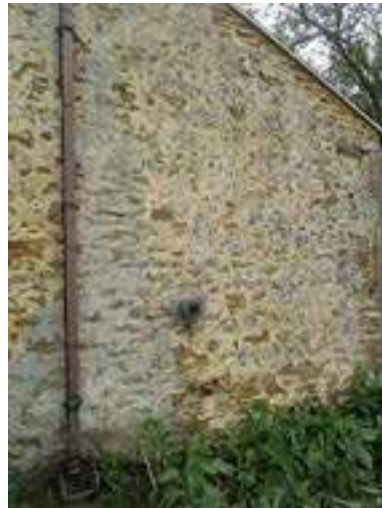
It was identified by the surveyor that there are significant erosion of and poorly applied mortar pointing to the south east elevation in various locations which includes but not exclusive to:

Stone wall outside of small single storey extension to the far left of property

Stone wall outside of "Games Room"

Stone wall right of entrance porch

Stone wall generally between central and left hand chimney stacks

Stone wall left of entrance porch

Stone wall of north west elevation - low level

Stone wall to garage

Stone wall of north east elevation - top right between rafters and sloped roof

Stone wall of north west elevation - right hand side of right hand chimney stack

Stone wall of north east elevation - gable

Stone wall of north west elevation - far right - wall to "garden room"

The proposed restoration works includes the re-pointing of the stone mortar using a lime based mortar by qualified and specialist stone mason.

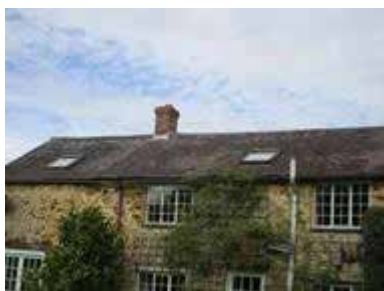
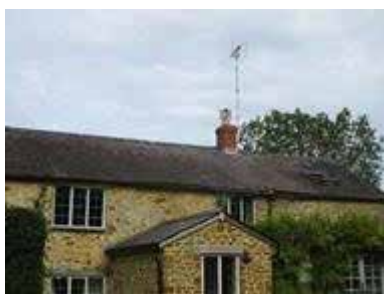
1 The existing 3nos roof lights are of some age, and the proposal is to replace them with new “conservation” roof lights ( double glazed ) to fit into the existing openings.

Existing South East Roof lights - left side

Existing South East Roof lights - right side

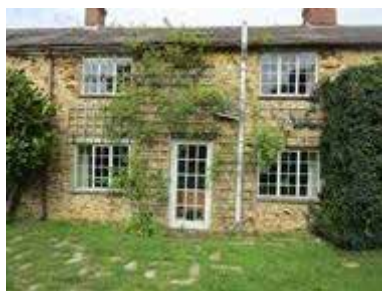
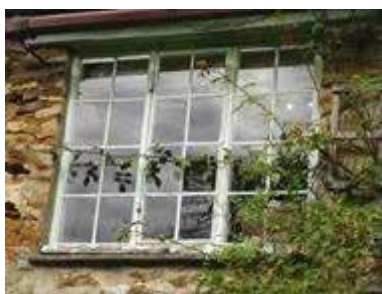
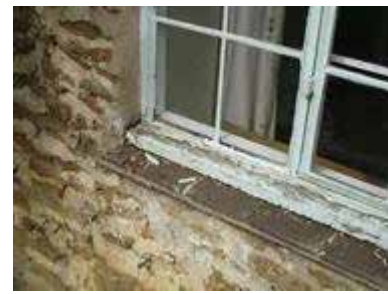
2 Inspection of the windows both at ground and first floor levels between the central stack and the left hand stack identified evidence of rot and decay. The windows have metal Crittall inserts which themselves were showing signs of corrosion particularly at cill level.

Existing South East 1st Fl Window -  
between central stack and left hand stack

Existing South East Windows - Crittall style

Existing South East 1st Fl Window - cill

The proposal is to replace with new double-glazed metal frame windows to match the existing with slim mullions and metal glazing bars, set in a fixed timber surround frame.

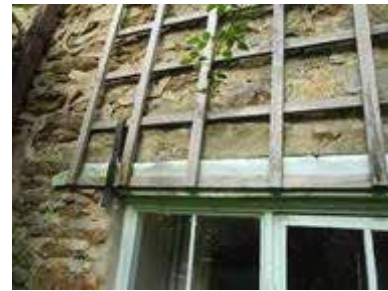
3 The lintel above the first floor left hand window has clearly suffered with decay in the past. The repair carried out previously appears basic.

Existing South East 1st Fl Window - lintel

The proposal is to replace the existing timber lintel with matching new timber lintel. A structural engineer will be appointed to size and proposed specification.

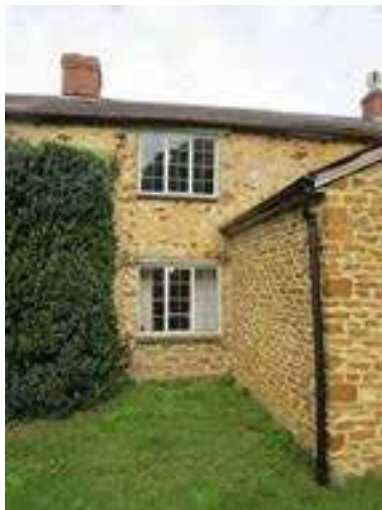
5 Timber windows to the left hand side of the entrance porch are in a substantially dilapidated state and will benefit from replacement. There is some cracking above the ground floor window to the left hand side of the entrance porch. The lintel above the first floor window to the left hand side of the entrance porch is in a dilapidated state. The proposal is to replace with new double-glazed metal frame windows to match the existing with slim mullions and metal glazing bars, set in a fixed timber surround frame. The proposal is to replace the existing timber lintels with matching new timber lintels. A structural engineer will be appointed to size and propose the specification.

Existing South East Windows - left of porch

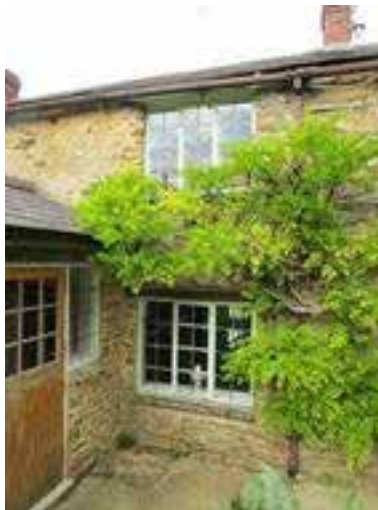
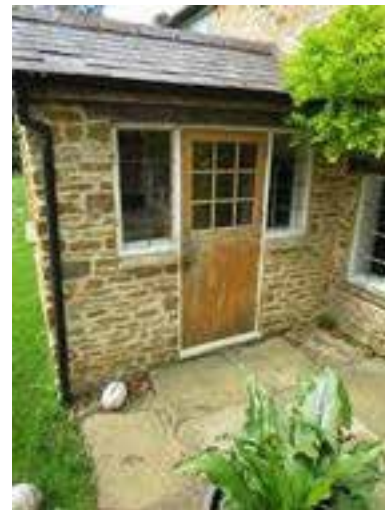
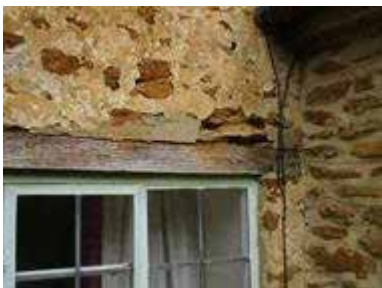
4 Timber windows to the right hand side of the entrance porch both at ground and first floor levels are in a dilapidated state. The proposal is to replace with new double-glazed metal frame windows to match the existing with slim mullions and metal glazing bars, set in a fixed timber surround frame.

Existing South East Windows - right of porch

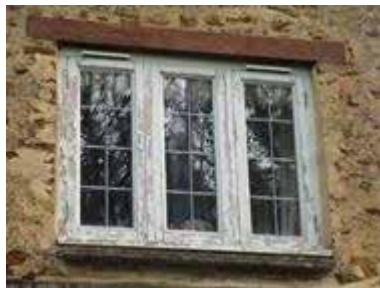
6 The timber window at first floor level is in a dilapidated state. The proposal is to replace with new double-glazed metal frame windows to match the existing with slim mullions and metal glazing bars, set in a fixed timber surround frame.

Existing South West Elevation - 1st fl window

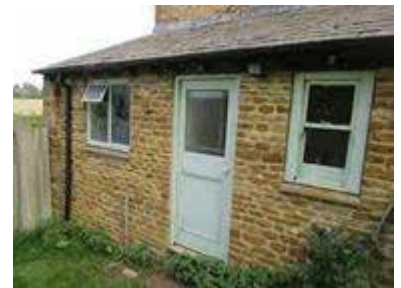
7 The ground floor windows are in a dilapidated state. The proposal is to replace with new double-glazed metal frame windows to match the existing with slim mullions and metal glazing bars, set in a fixed timber surround frame.

Existing South West Elevation - ground fl windows

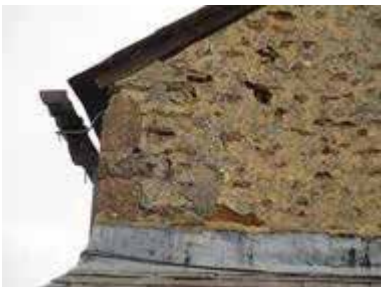
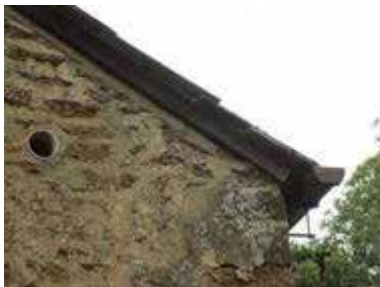
8 There is some slight cracking to the left and right hand sides of this elevation at the lowest point of the roof line most likely as result of light roof spread. As part of re-pointing works , crack stitching is proposed in order to tie the stone quoins to the main stone wall.

Existing South West Elevation - roof right

Existing South West Elevation - roof left

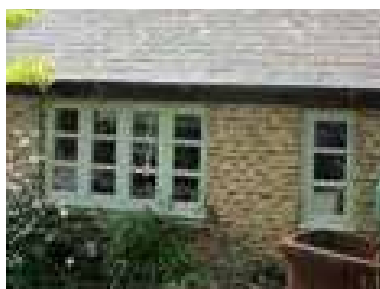
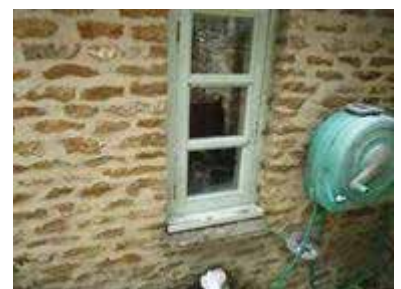
8 The windows are in a dilapidated state. The proposal is to replace with new double-glazed metal frame windows to match the existing with slim mullions and metal glazing bars, set in a fixed timber surround frame matching to existing.

Existing North East Elevation - windows

Existing North East Elevation - window left

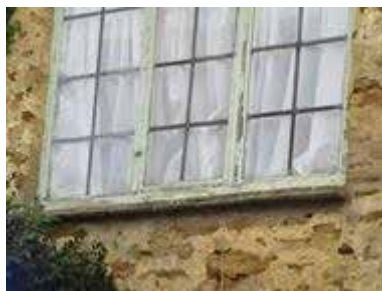
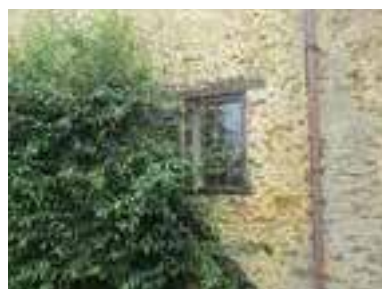
9 The timber window at ground and first floor level are in a dilapidated state. The proposal is to replace with new double-glazed metal frame windows to match the existing with slim mullions and metal glazing bars, set in a fixed timber surround frame.

Existing North West Elevation - general state of windows

Existing North West Elevation - far right window

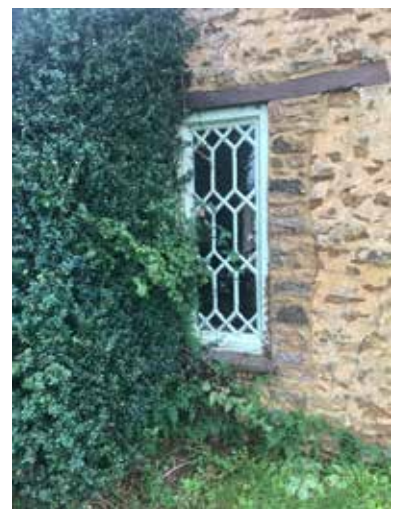
Existing North West Elevation - window with honeycomb glazing

11 The ground floor window with honeycomb glazing will be retained and refurbished.

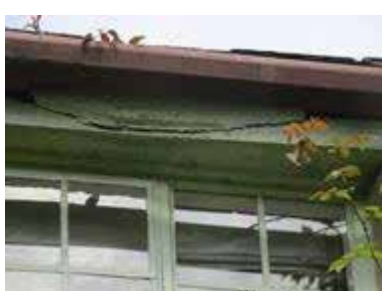
10 The lintels above the first floor windows have clearly suffered with some decay and deterioration over the life of the building however in large part they appear original and at this stage no failure is noted. However where more significant deterioration is noted particularly to the right hand side of this elevation.

Existing North West Elevation - 1st Fl Windows - lintels

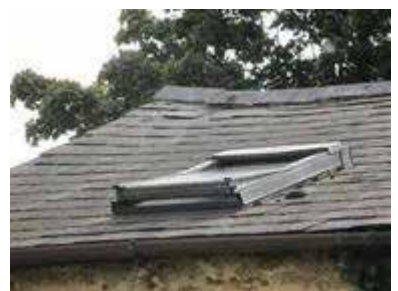
Existing North West Elevation - roof lights

12 The existing 2nos roof lights are of some age, and the proposal is to replace them with new "conservation" roof lights ( double glazed ) to fit into the existing openings.

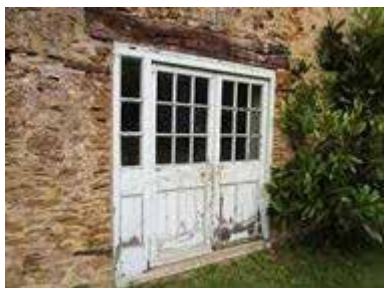
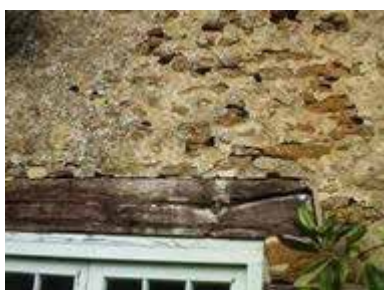
1 The existing pair of timber doors to the “games room” are in substantially dilapidated state. The timber lintel above the left hand doors is clearly of some significant age. It is showing signs of decay which is exacerbated as a result of the deterioration of pointing at the junction between the timber lintel and the stonework. There is some evidence of slight diagonal cracking to suggest some deflection as a result of the deterioration of the lintel.

Existing door to Games Room

Existing timber lintel to Games Room door

The proposal is to replace with new double-glazed metal frame doors to match the existing with slim mullions and metal glazing bars, set in a fixed timber surround frame. The existing timber lintel ( subject to further inspection by structural engineer ) to be maintained. The mortar pointing will be renewed to its perimeter and the timber treated with appropriate protective treatment.

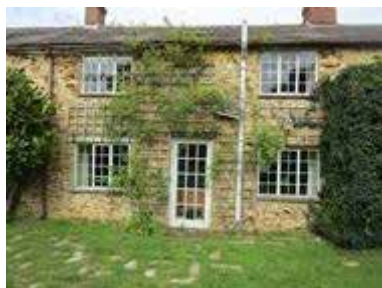
2 The pedestrian access door left of the central stack is in a dilapidated state.

Existing pedestrian access door left of central stack

The proposal is to replace with new double-glazed metal frame doors to match the existing with slim mullions and metal glazing bars, set in a fixed timber surround frame.

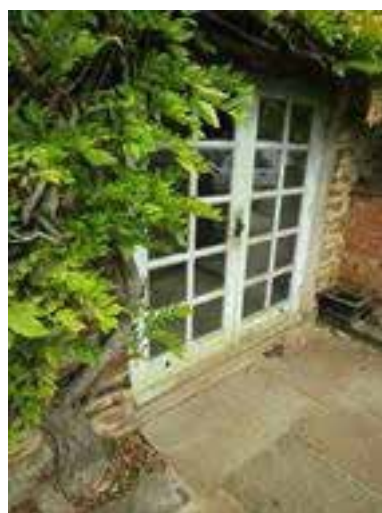
3 The existing double doors to the right hand side of this elevation are in a dilapidated state.

Existing double doors to right of this elevation

The proposal is to replace with new double-glazed metal frame doors to match the existing with slim mullions and metal glazing bars, set in a fixed timber surround frame.

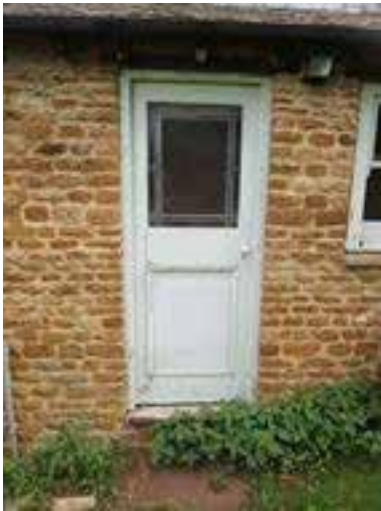
- 4 The pedestrian access door is in a dilapidated state.  
The proposal is to replace with new timber panel door with 2 stone external steps

Existing pedestrian access door

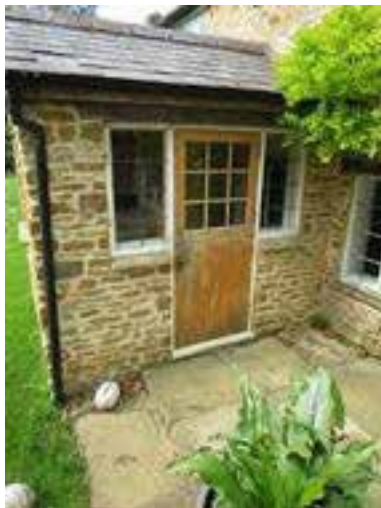
- 5 The existing “stable” style side entrance door is in a poor state.  
The proposal is to replace with new timber panelled door.

Existing “stable” style side entrance door

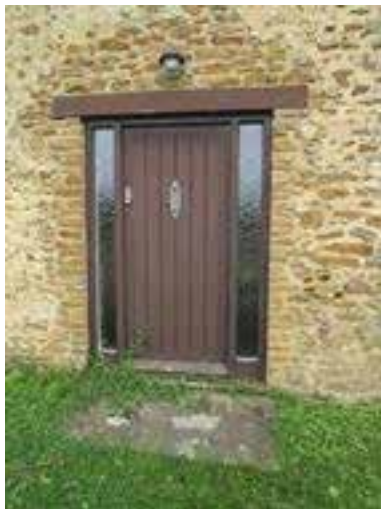
6 The existing main entrance is showing signs of deterioration. The proposal is to replace with new timber panelled door; style will be in keeping with the house

Existing main entrance door

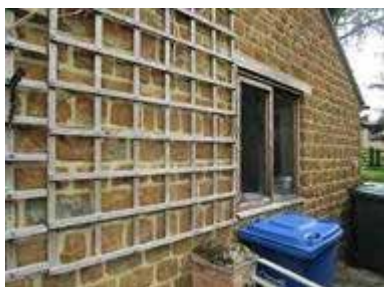
The existing south west facing window is in a dilapidated state. The proposal is to replace with new double-glazed metal frame window to match the existing with slim mullions and metal glazing bars, set in a fixed timber surround frame.

Existing south east facing window of garage
