**North Arms House, Wroxton – Schedule of Windows existing & proposed.**

In support of the application, the following schedule of existing and proposed window joinery is submitted.

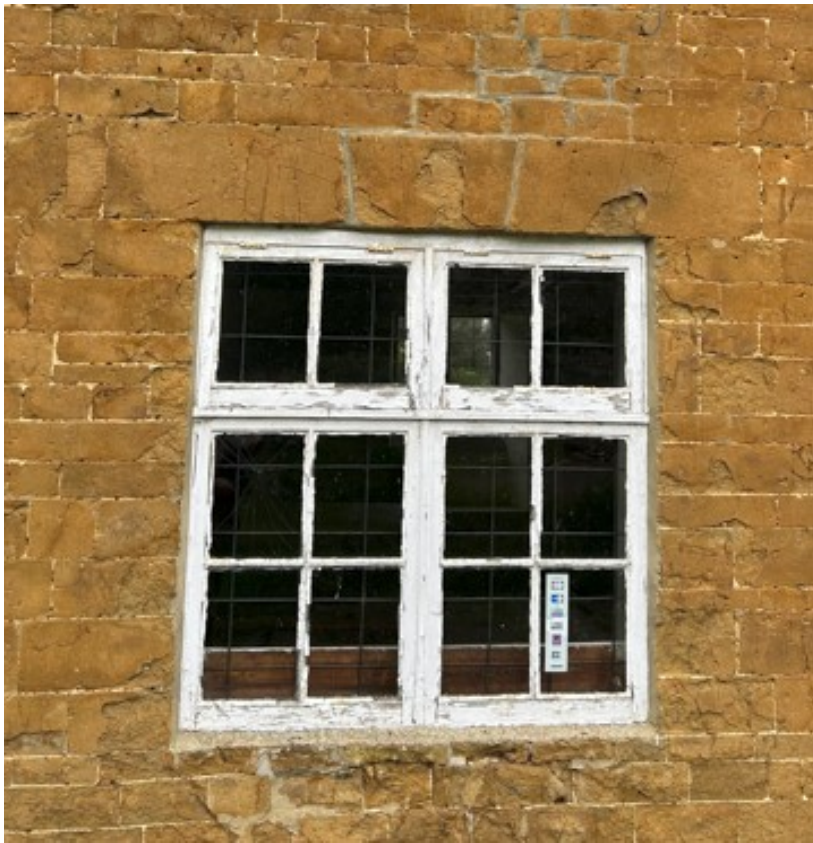
*Fig.2 – GFW 022*

Late C20 imitation mullioned and transomed window

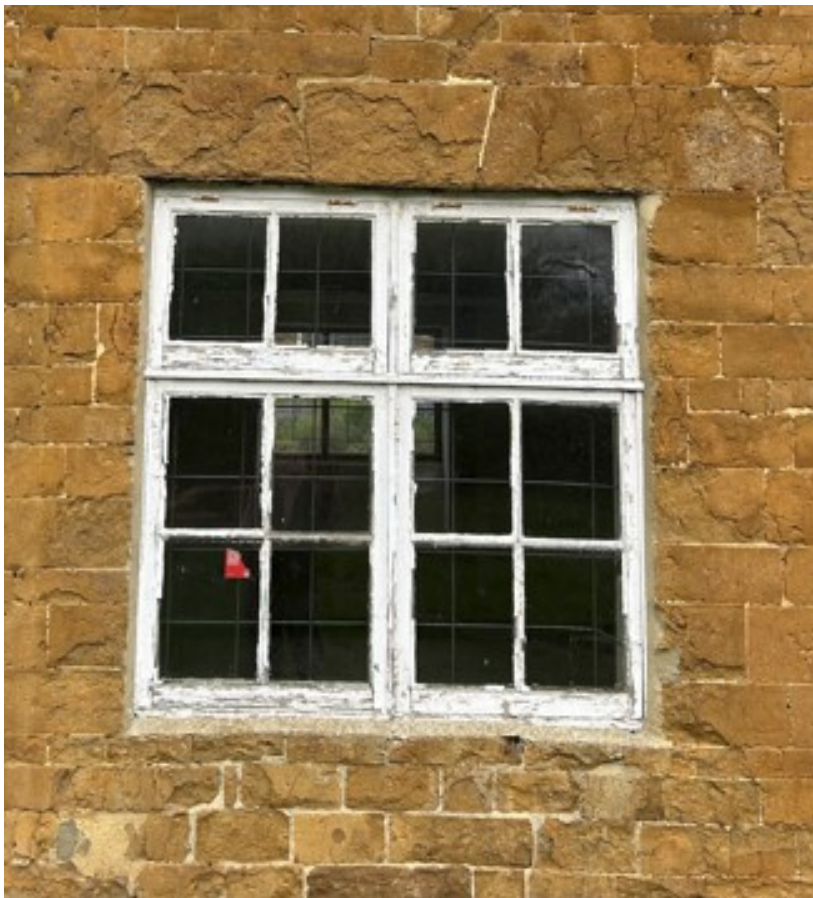
*Fig.3 – GFW 04*

Late C20 imitation mullioned and transomed window

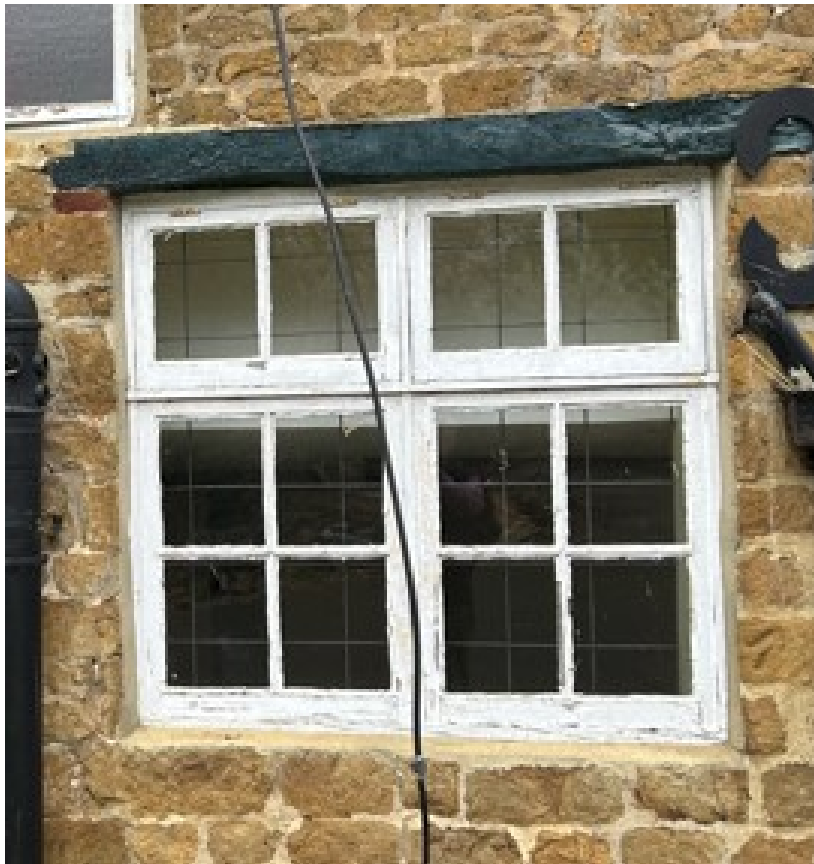
*Fig.5 – GFW 06*

C20 imitation mullioned and transomed window

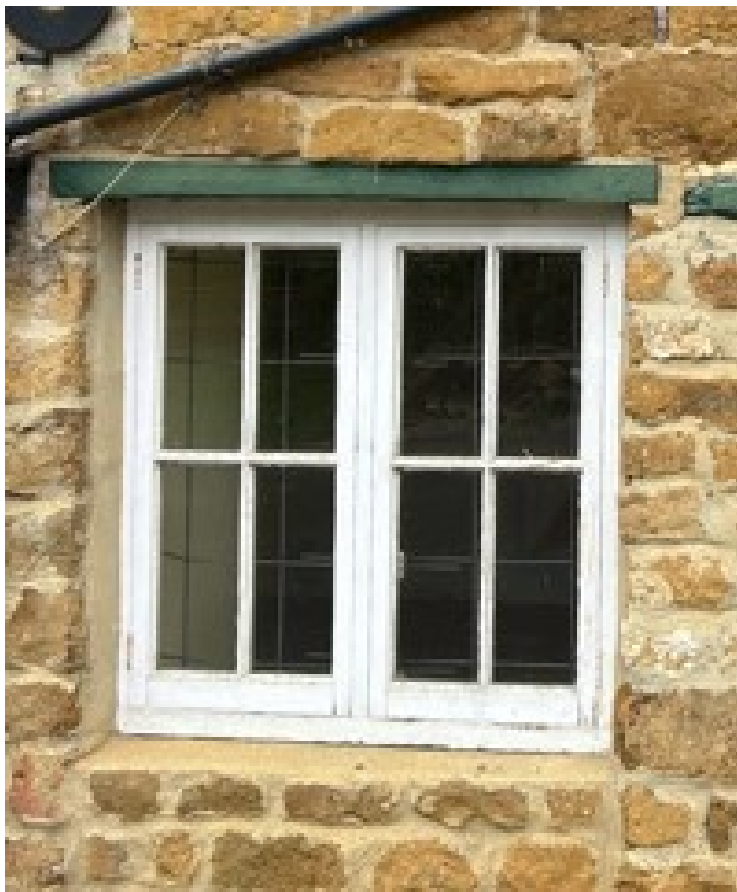
*Fig.6 - GFW 07*

C20 modern frame with machine routed "moulding" with curved radius mitres

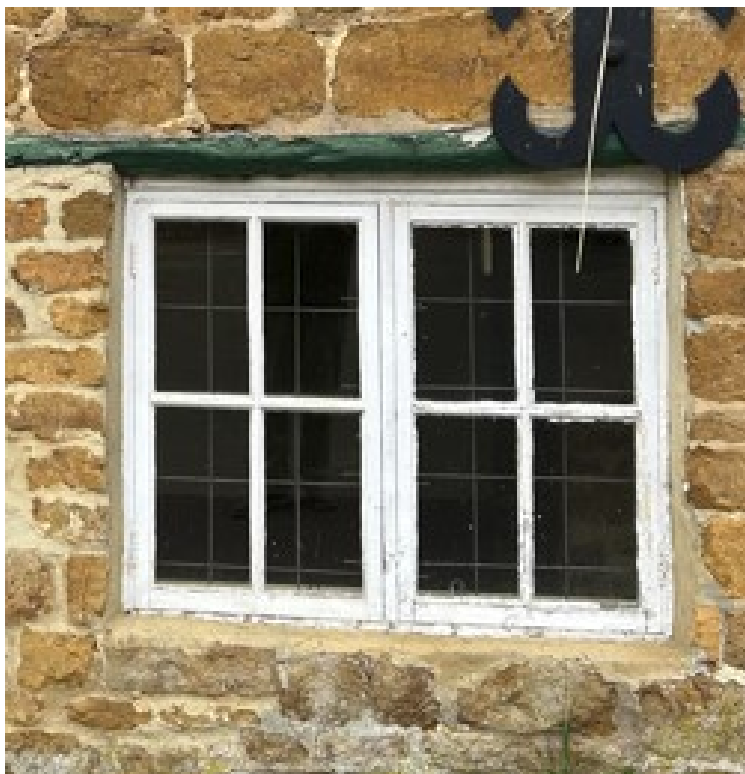
*Fig.7 - GFW 08*

C20 modern frame

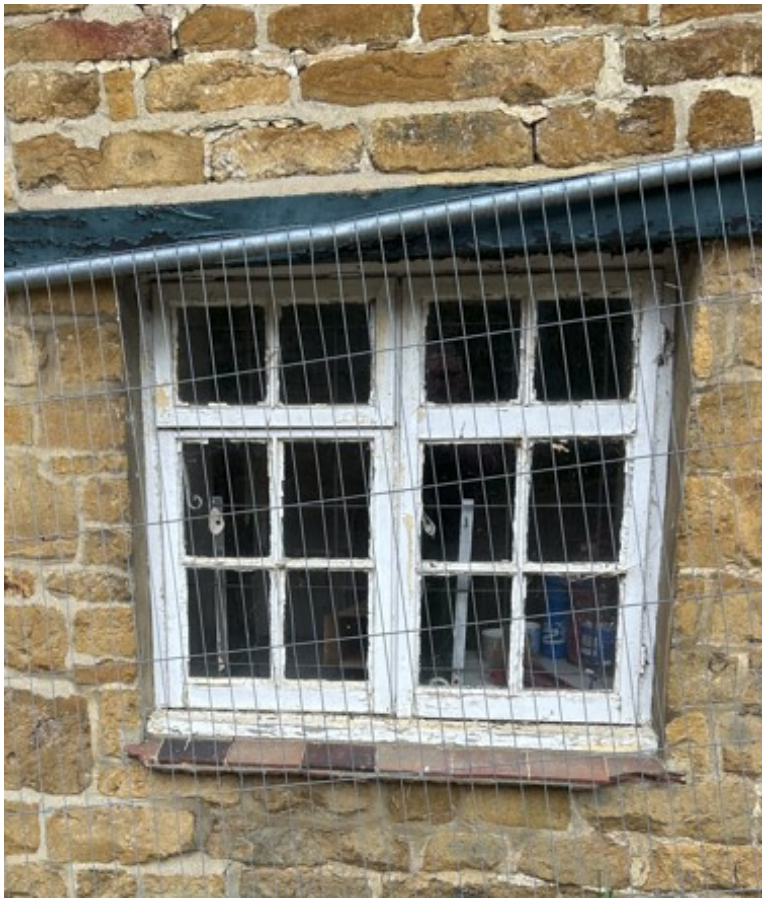
*Fig.8 - GFW 10*

Late C20 "cottage style" frame with storm proof rebates and asymmetric top hung vent

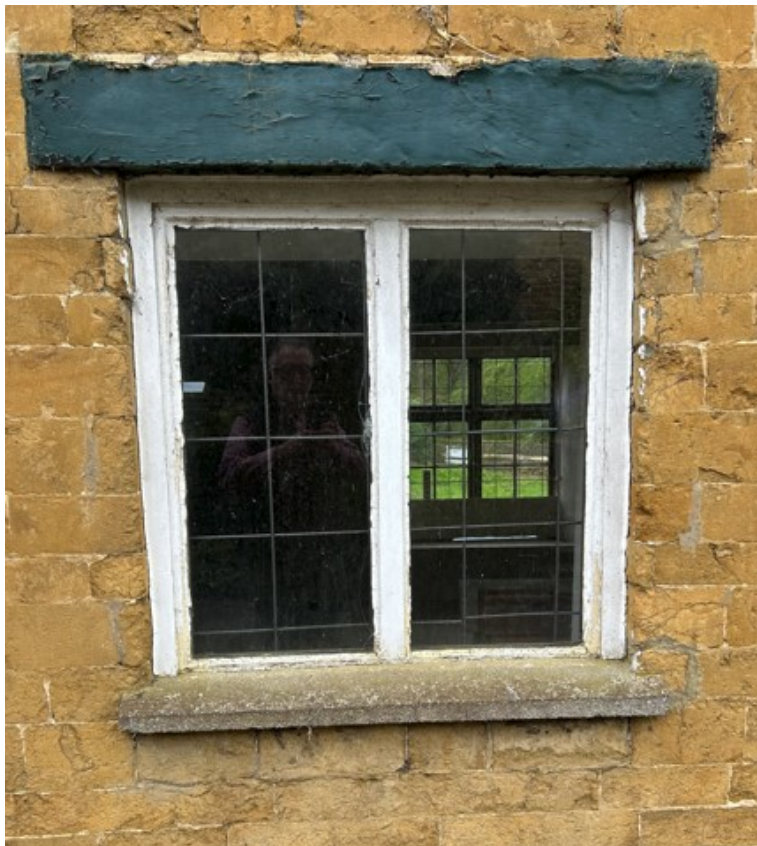
*Fig.13 - GFW 13*

C20 window opening cut into ashlar stonework with simple timber lintel and concrete cill. Side hung casements lost and direct glazed

Similarly existing windows GFW 13 and GFW 15 are direct glazed having lost original opening casements through time. These will be restored with additional horizontal glazing bars to complement the house windows throughout .

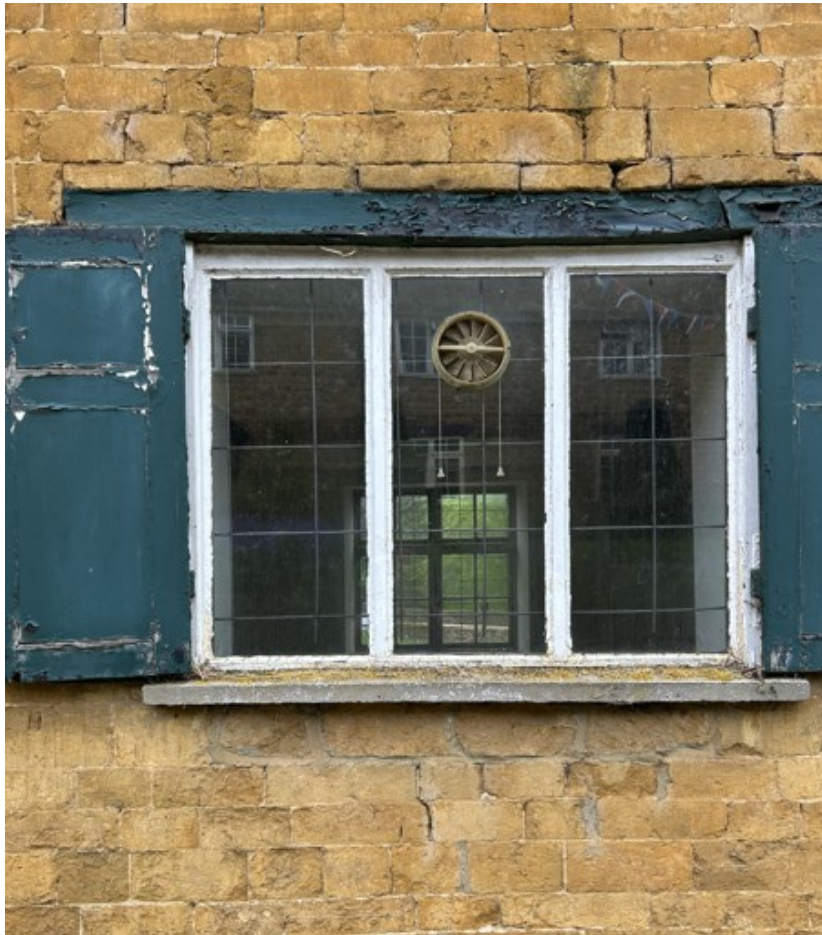
*Fig.14 - GFW 15*

C20 window opening cut into ashlar stonework with simple timber lintel and concrete cill. Side hung casements lost and direct glazed. Shutters added for privacy.

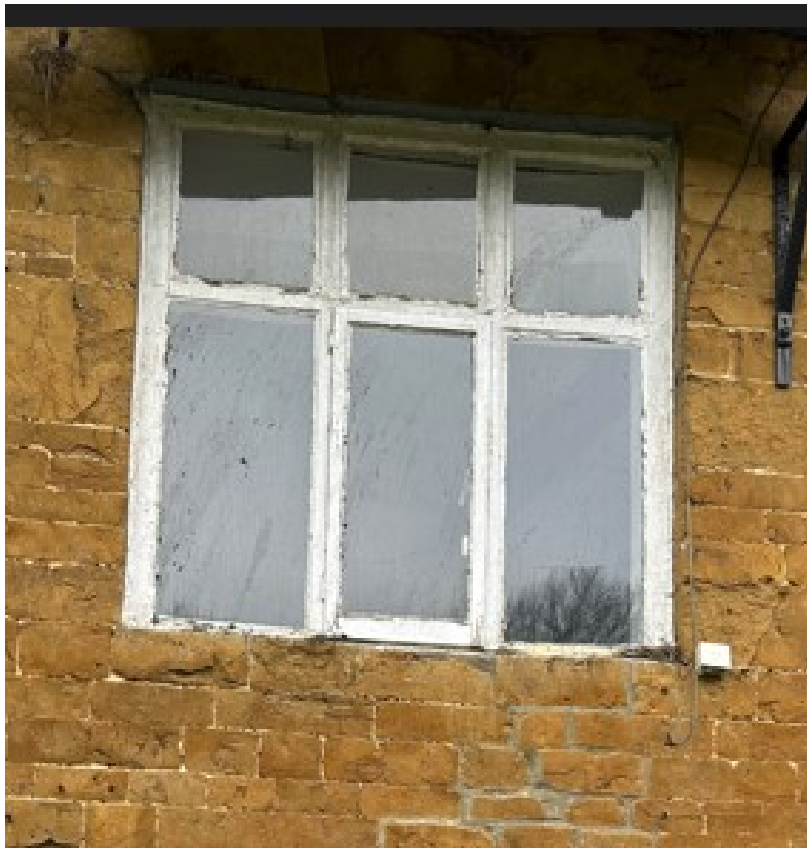
*Fig 15 - FFW 01*

C20 imitation mullioned and transomed window – side hung casements and top hung vents lost, and remaining frame direct glazed. Identical frames retaining opening casements evident at Raydon Hill House – *ref. Appendix*

Windows to be replaced would be entirely replicated with the exception of FF01; FF02 and Ff07 where the opportunity would be taken to restore opening side hung casements and top hung vents to improve ventilation.

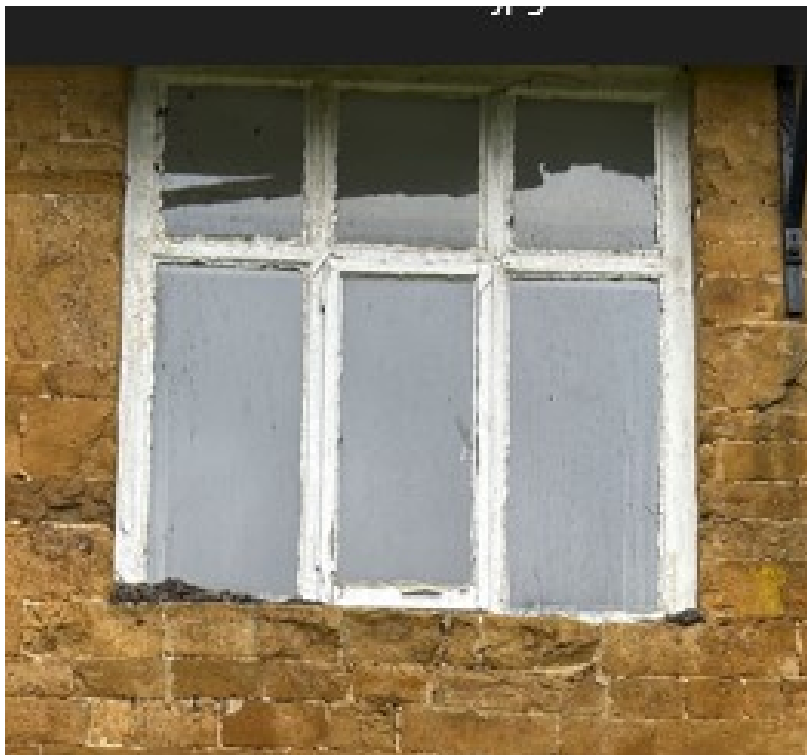
*Fig.16 - FFW 02*

C20 imitation mullioned and transomed window – side hung casements and top hung vents lost, and remaining frame direct glazed. Identical frames retaining opening casements evident at Raydon Hill House – *ref. Appendix*

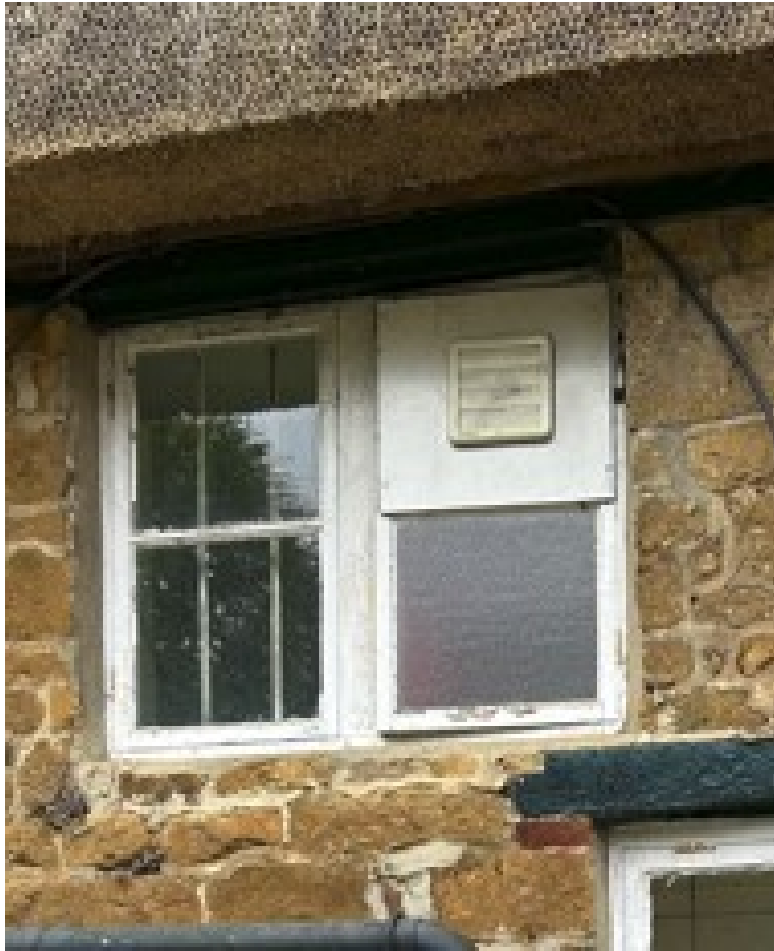
**Fig.17 - FFW 03**

C20 window altered with introduction of centre mullion to receive modern bathroom partition

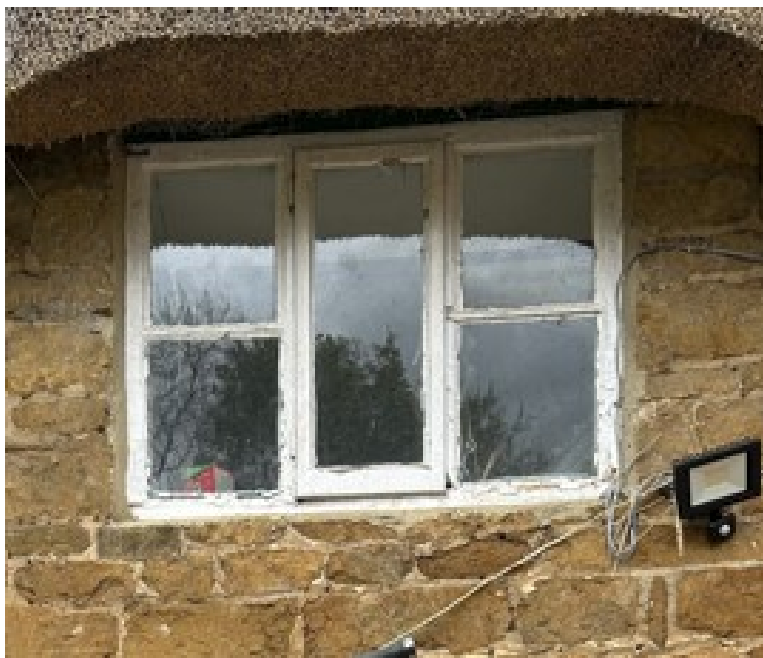
**Fig 18 - FFW 04**

C20 window altered with introduction of modern centre side hung casement

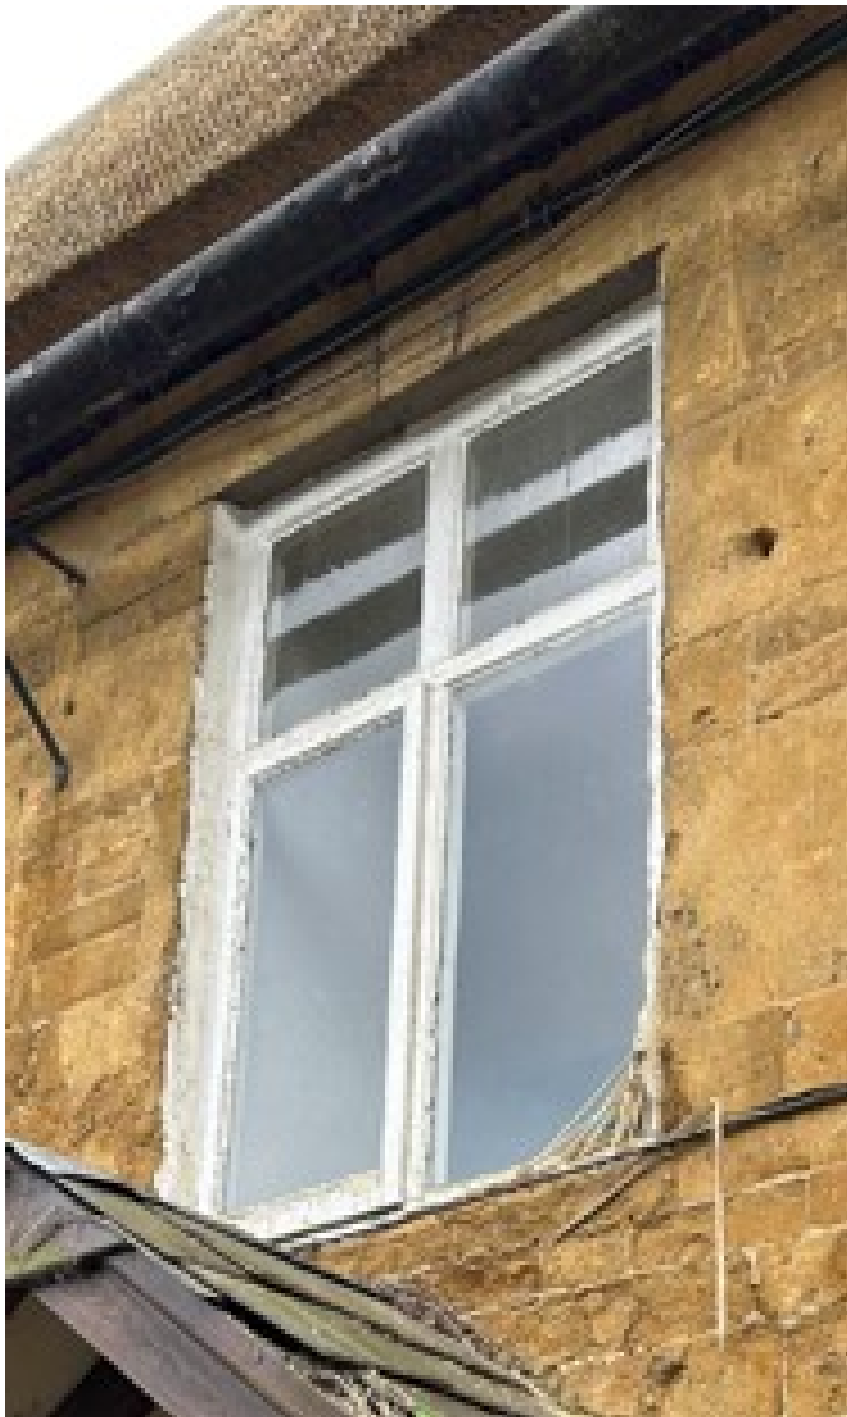
*Fig. 19 - FFW 07*

C20 imitation mullioned and transomed window – side hung casement and top hung vents lost, and remaining frame direct glazed. Identical frames evident at Raydon Hill House – *ref. Appendix*
