Arboricultural Statement

Portway Bridleway, Upper Heyford

On behalf Heyford Park Estates Ltd

11th June 2018

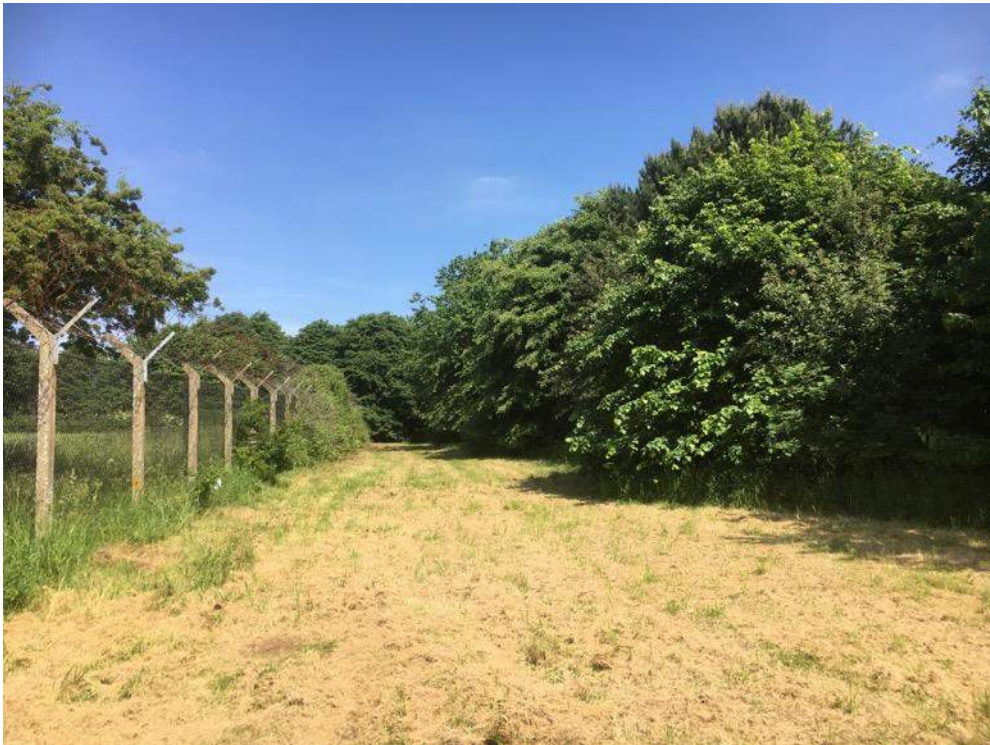
Photoview 1: View looking east towards G1024 in the background. To the right of frame is G1023 and left of frame existing chain-link fence to be replaced with 1.5m wooden post and rail.

- 6.7 In terms of removal of existing structures, it is noted that the existing chain-link fence to the north of G1023 is to be removed and replaced with wooden post and rail fence. However, this is located away from retained trees.

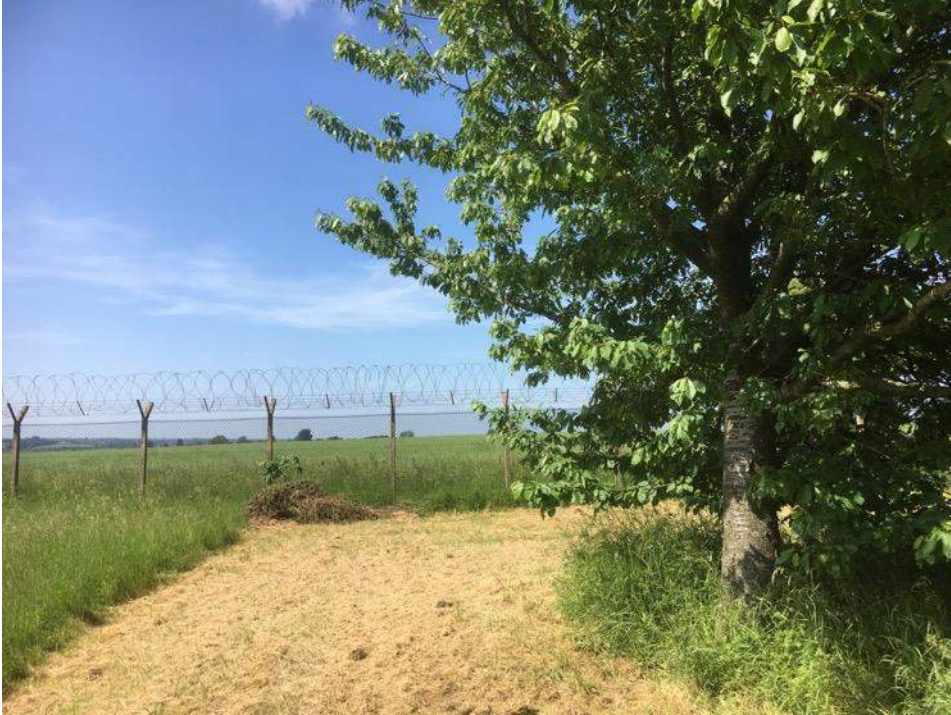
Photoview 2: View looking north towards the existing chain-link perimeter fence with the western edge of G1023 to right of frame.

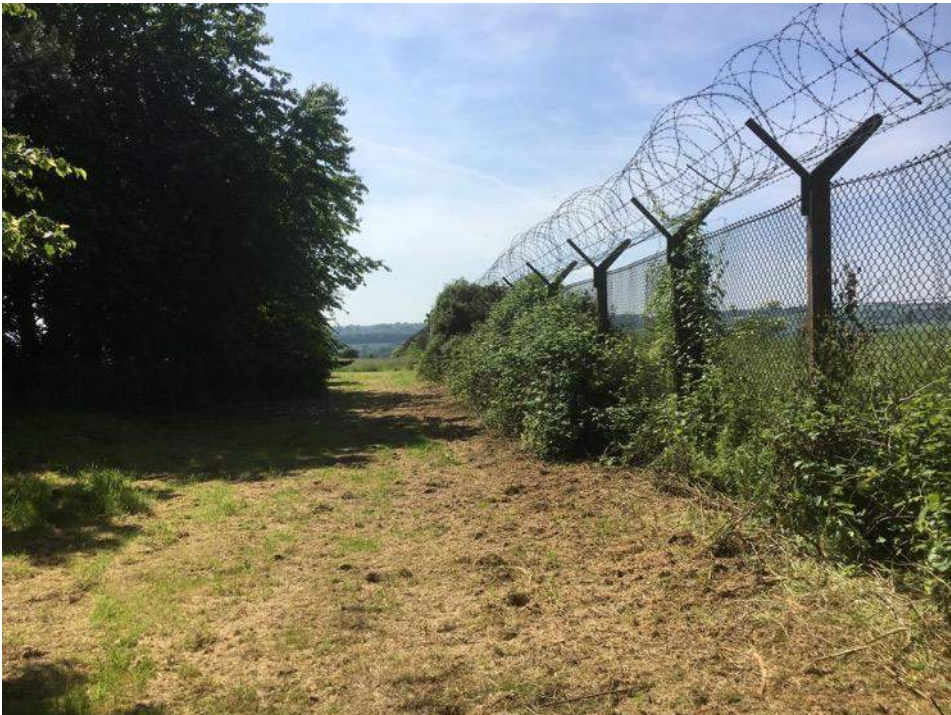
Photoview 3: View looking west along the chain-link perimeter fence with G1023 to the left of frame.

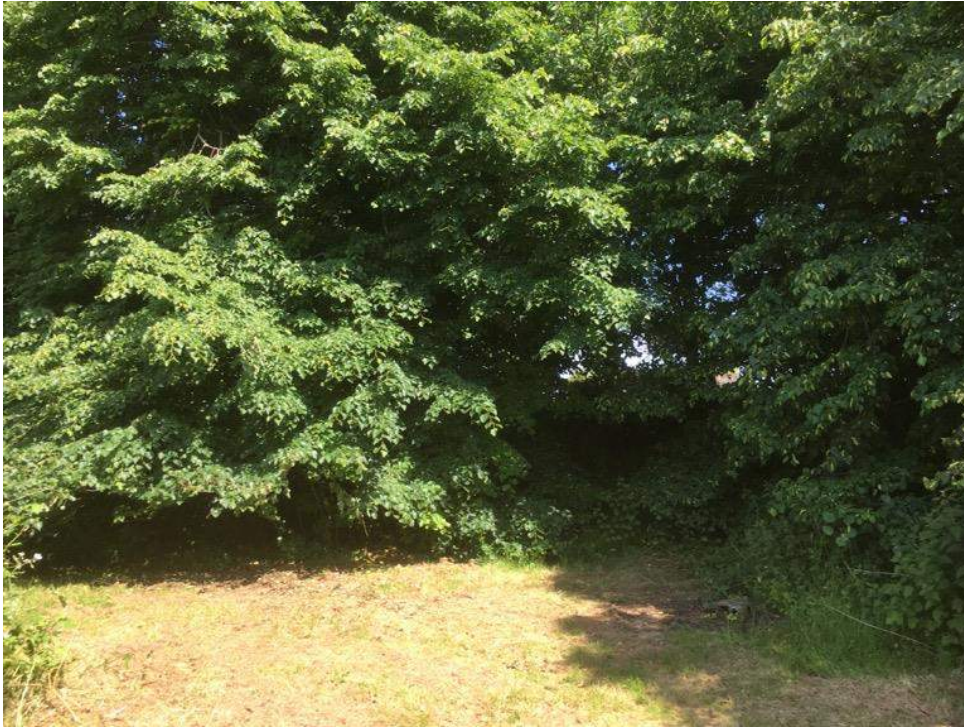
Photoview 4: View looking east towards G1024 where the new southern chain-link fence alignment and access to the earth embankment is proposed.

- 6.12 The proposed new chain-link fence is shown to cut through G1024 in two locations. This is to enable public access to the top of the embankment, which is immediately to the east of the canopy spread of G1024, to allow public views across the flying fields. The alignment of the fencing through G1024 is likely to require a small number of stems to be removed and canopy pruning to enable construction and clearance of fencing (see Photoview 5) Given the nature of proposals there is flexibility to align the fencing around existing trees and avoid stem removal as far as possible.

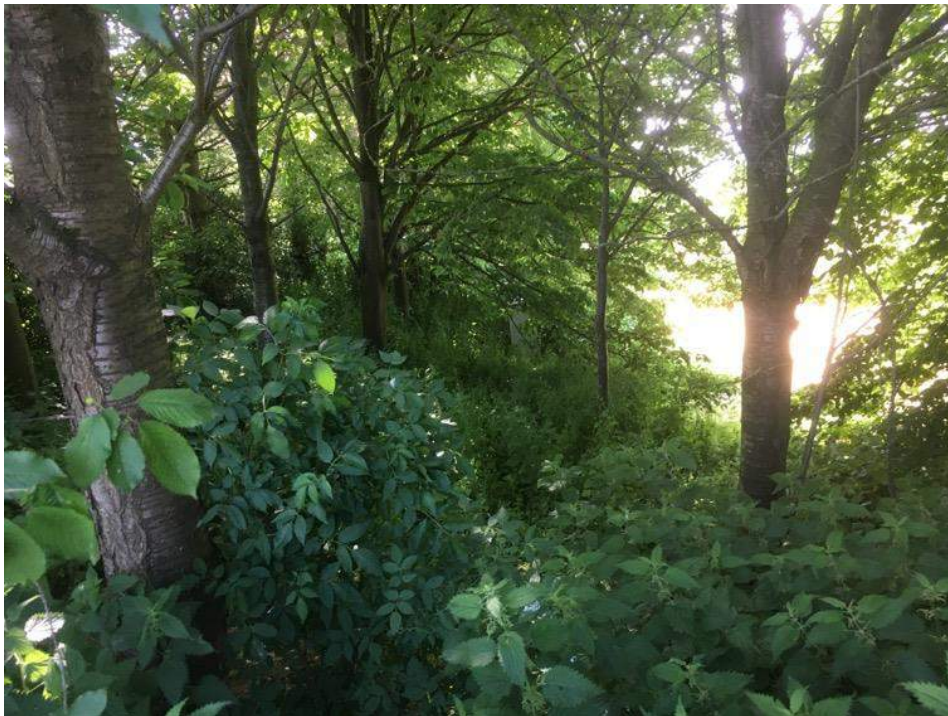
Photoview 5: View looking west from the earth embankment along the proposed alignment of the southern chain-link fence within G1024 towards the location of viewpoint 4 outside of the group beyond.

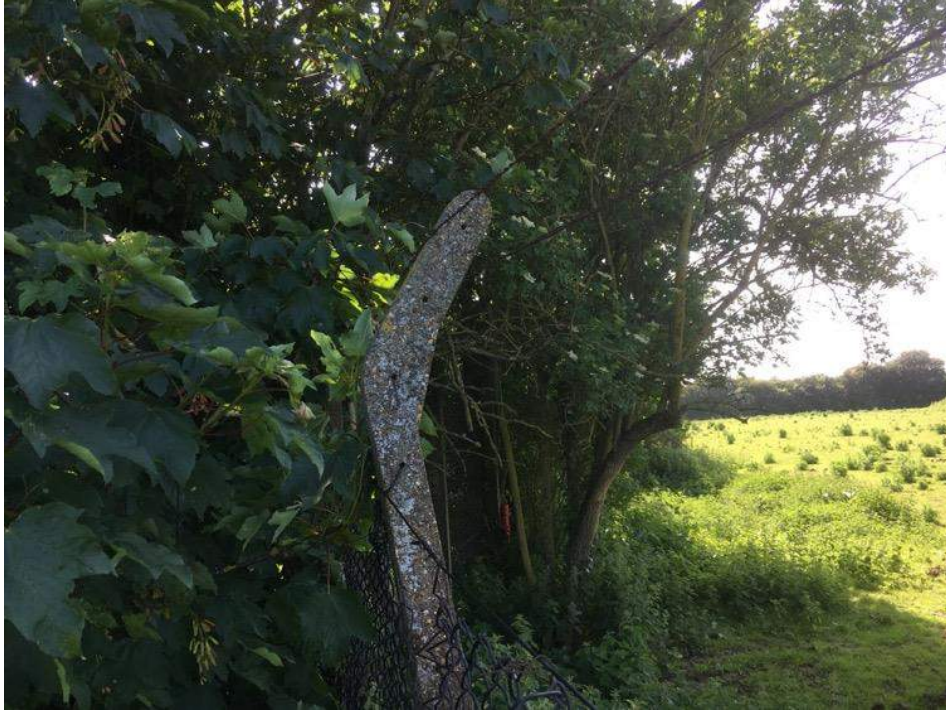
Photoview 6: View looking west from the eastern side of H1018 towards the elder bush growing in front of the proposed connection to the existing bridleway at the southern part of the site.

- 6.14 In order to connect the proposed bridleway with the existing bridleway to the south of the site a section of the existing chain-link fencing on the north side of H1018 will need

to be removed. In addition, existing elder stems to the front of the existing fencing (see photoview 6) will require removal.

- Lateral reduction to G1023 on its northern and western side to allow for chain-link fencing to be installed with at least 0.5m of clearance.
 - Elder stems to be removed from the frontage of H1018 where the proposed bridleway will connect with the existing. Overhanging branches from neighbouring trees to be pruned to ensure clearance.

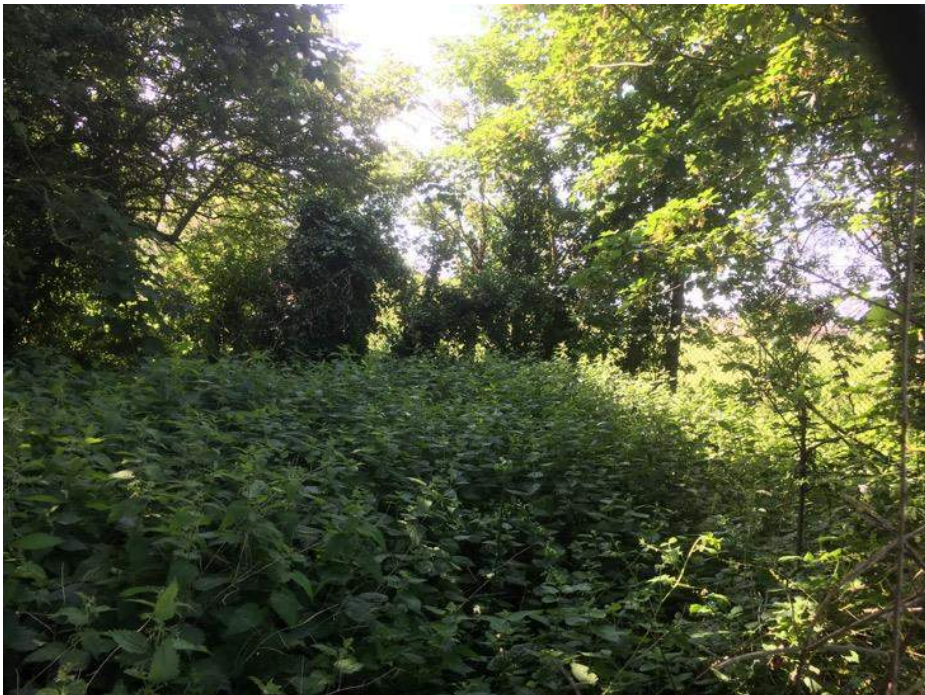
Photoview 7: View looking north west within H1018. The proposed bridleway connection point can be seen in the lighter area to the right of frame.

- 6.15 As shown in photoview 7 trees within H1018 are located on the boundaries of the bridleway and existing chain-link fencing. There is a multi-stemmed sycamore shown in photoview 8 on the eastern aide of H1018. The proposed new chain-link fencing is to connect with existing fencing in this location. It is likely some lower canopy pruning could be required as part of the construction process, however the tree would not need to be removed.

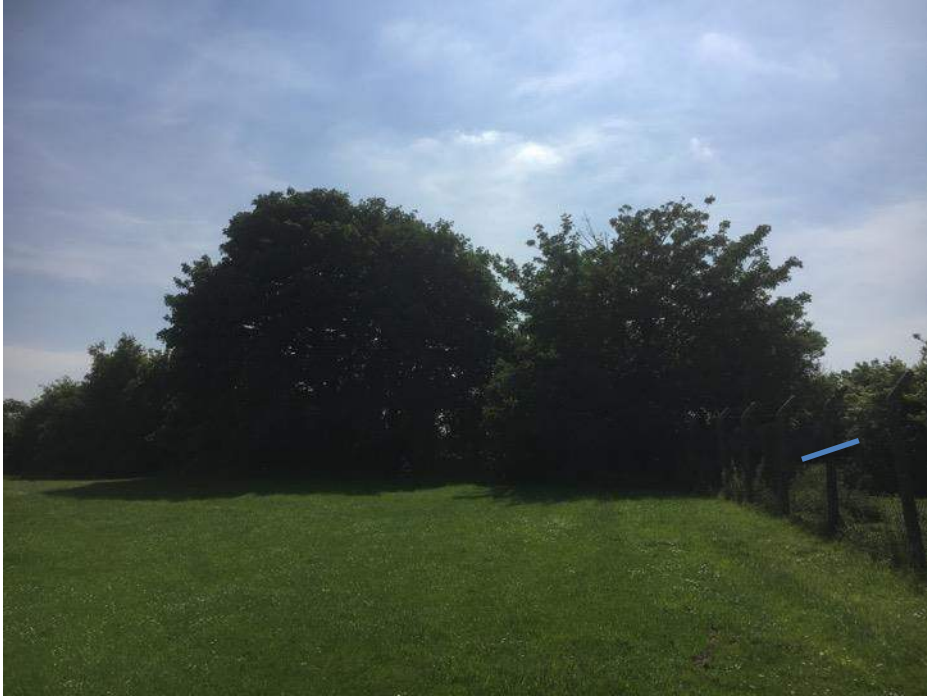
Photoview 8: View looking south west towards the eastern edge of the northern end of H1018. The tree visible to the right of frame is an early/mature to mature sycamore growing along the existing chain-link fence line. The proposed connection to the existing bridleway will come in just west of the northern side of this tree, indicated by the blue line.
