TREE SURVEY REPORT AND TREE SURVEY PLAN

THE FORMER PRIMARY SCHOOL SITE.

Heyford Park Tree Survey and Constraints Plan

Drawing Ref: **D.0345_02-A**
Client : **Dorchester Group**

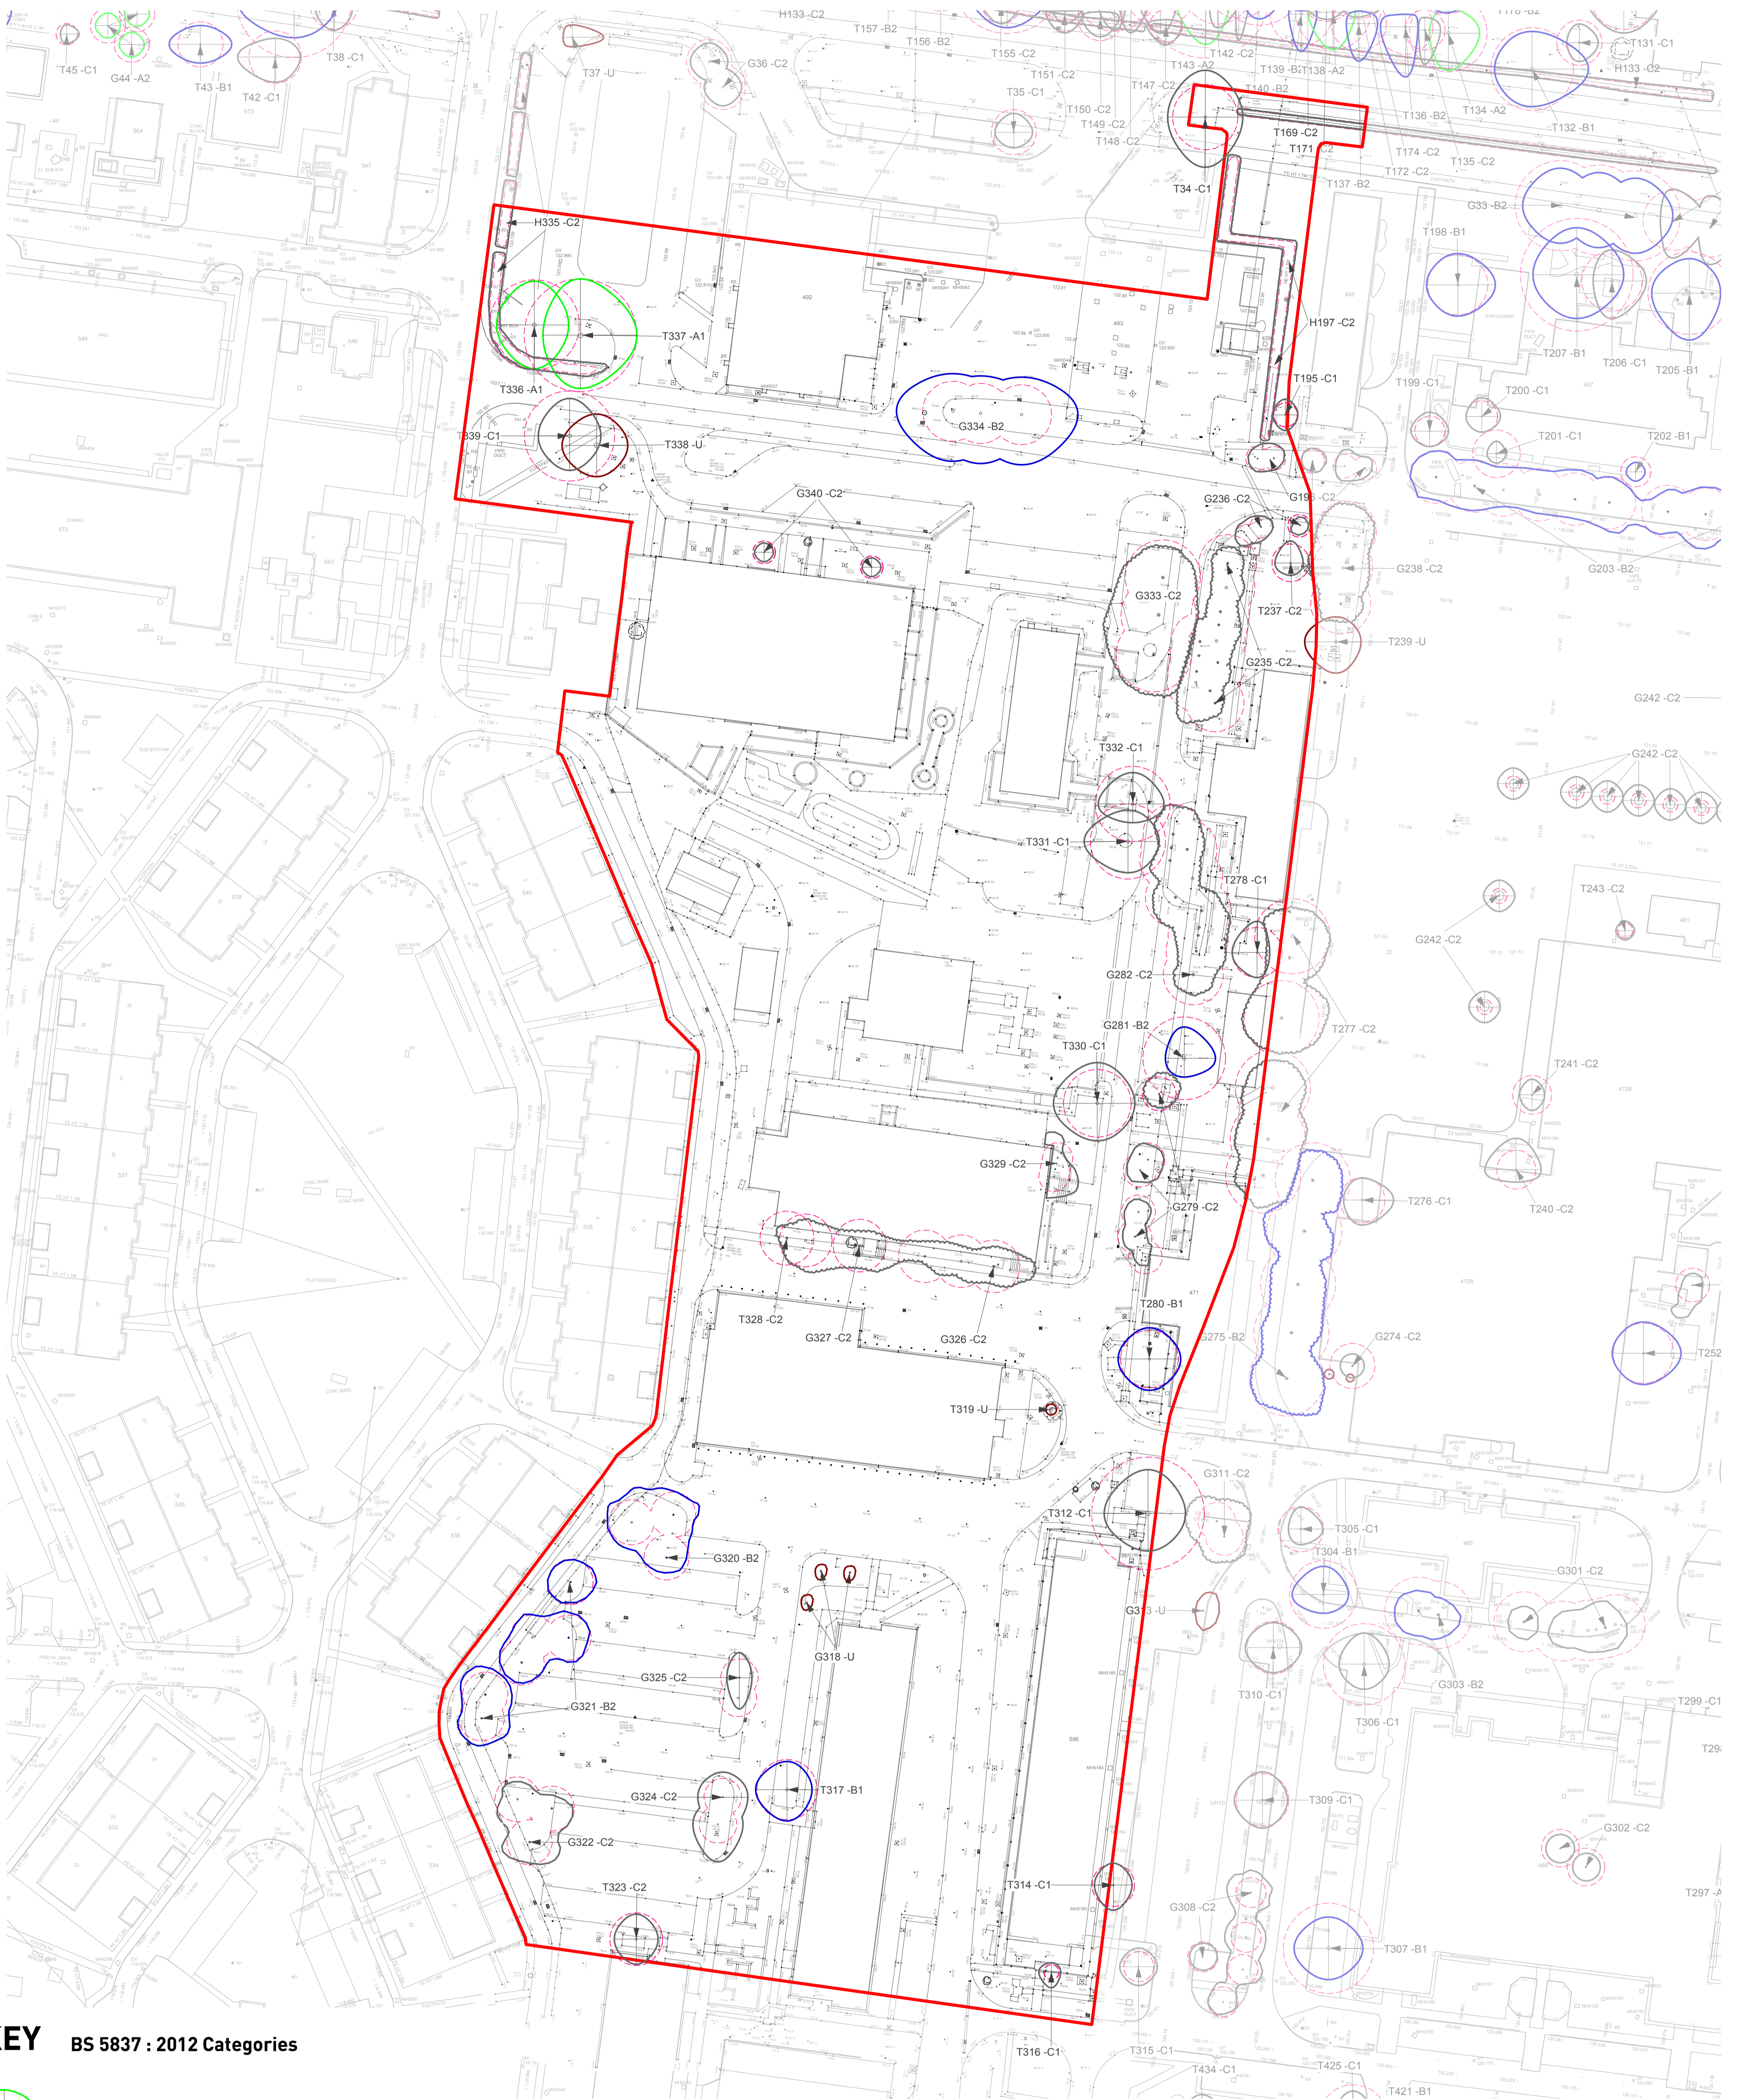
TREE SURVEY PLAN

8.7 The colour-coded categorisation of tree quality is also shown on the Tree Survey Plan.

- 9.5 The proposals for the site should be designed with a view to accommodating the preliminary tree constraints that are illustrated on the Tree Survey Plan. A Project Arboriculturist should be responsible for input into the on-going review of the detailed layout and design as these details come forward.
