Our ref: 8854_lt.003

RE: Proposed footpath/cycleway, Bladon Roundabout: Arboricultural Summary

ENCLOSURE A: TREE CONSTRAINTS PLAN (8854 TCP 01 REV D)

ENCLOSURE C: TREE PROTECTION PLAN (8854 TPP 06)

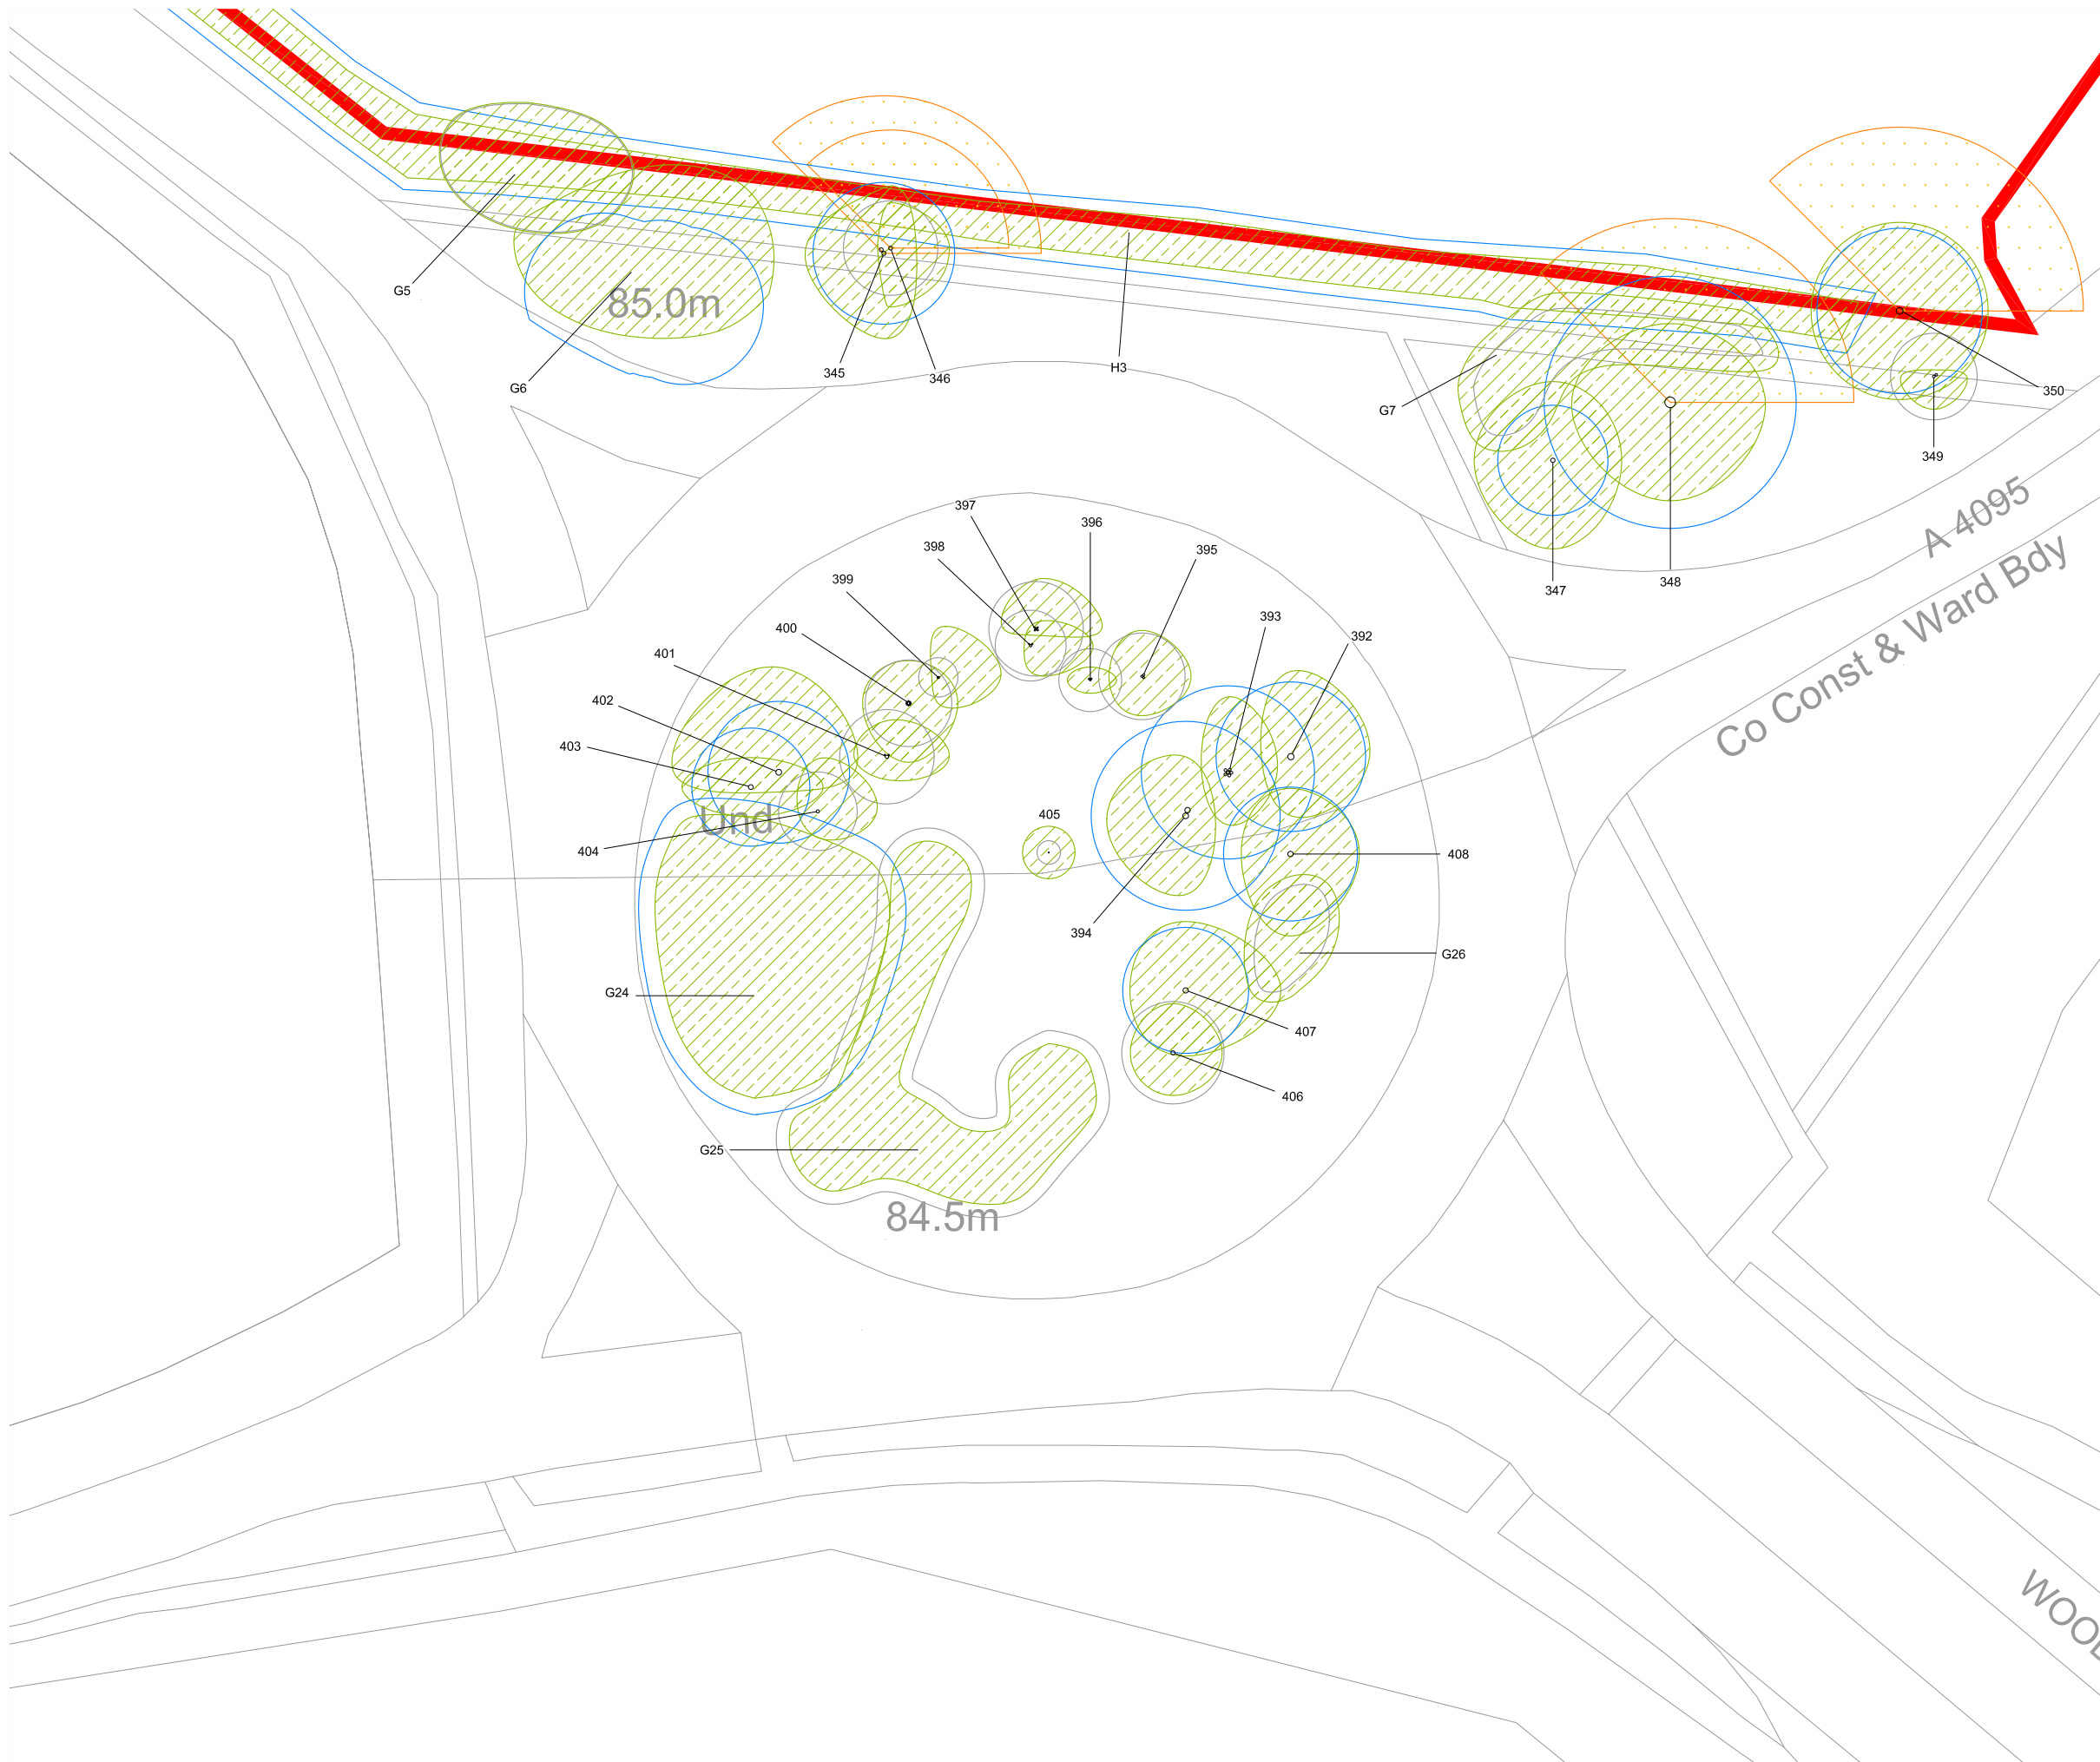
The proposals incur the removal of 4 no. trees in order to implement the proposed route, due to being located within the footpath itself, or at a distance where the level of incursion within the root protection area is considered to outweigh any current amenity potential. This assessment including tree removals is illustrated in Enclosure C, and will be restricted to T345 Common Ash (Category B), T346 Scots Pine (Category C), T399 Spindle (Category C) and T405 Norway Maple (Category C).

Tree removals comprise trees with generally limited individual significance, and their loss, including T345, is considered acceptable subject to mitigation submitted as part of the main site application which includes woodland planting to the north of the roundabout and retention of more established specimens throughout the local vicinity.

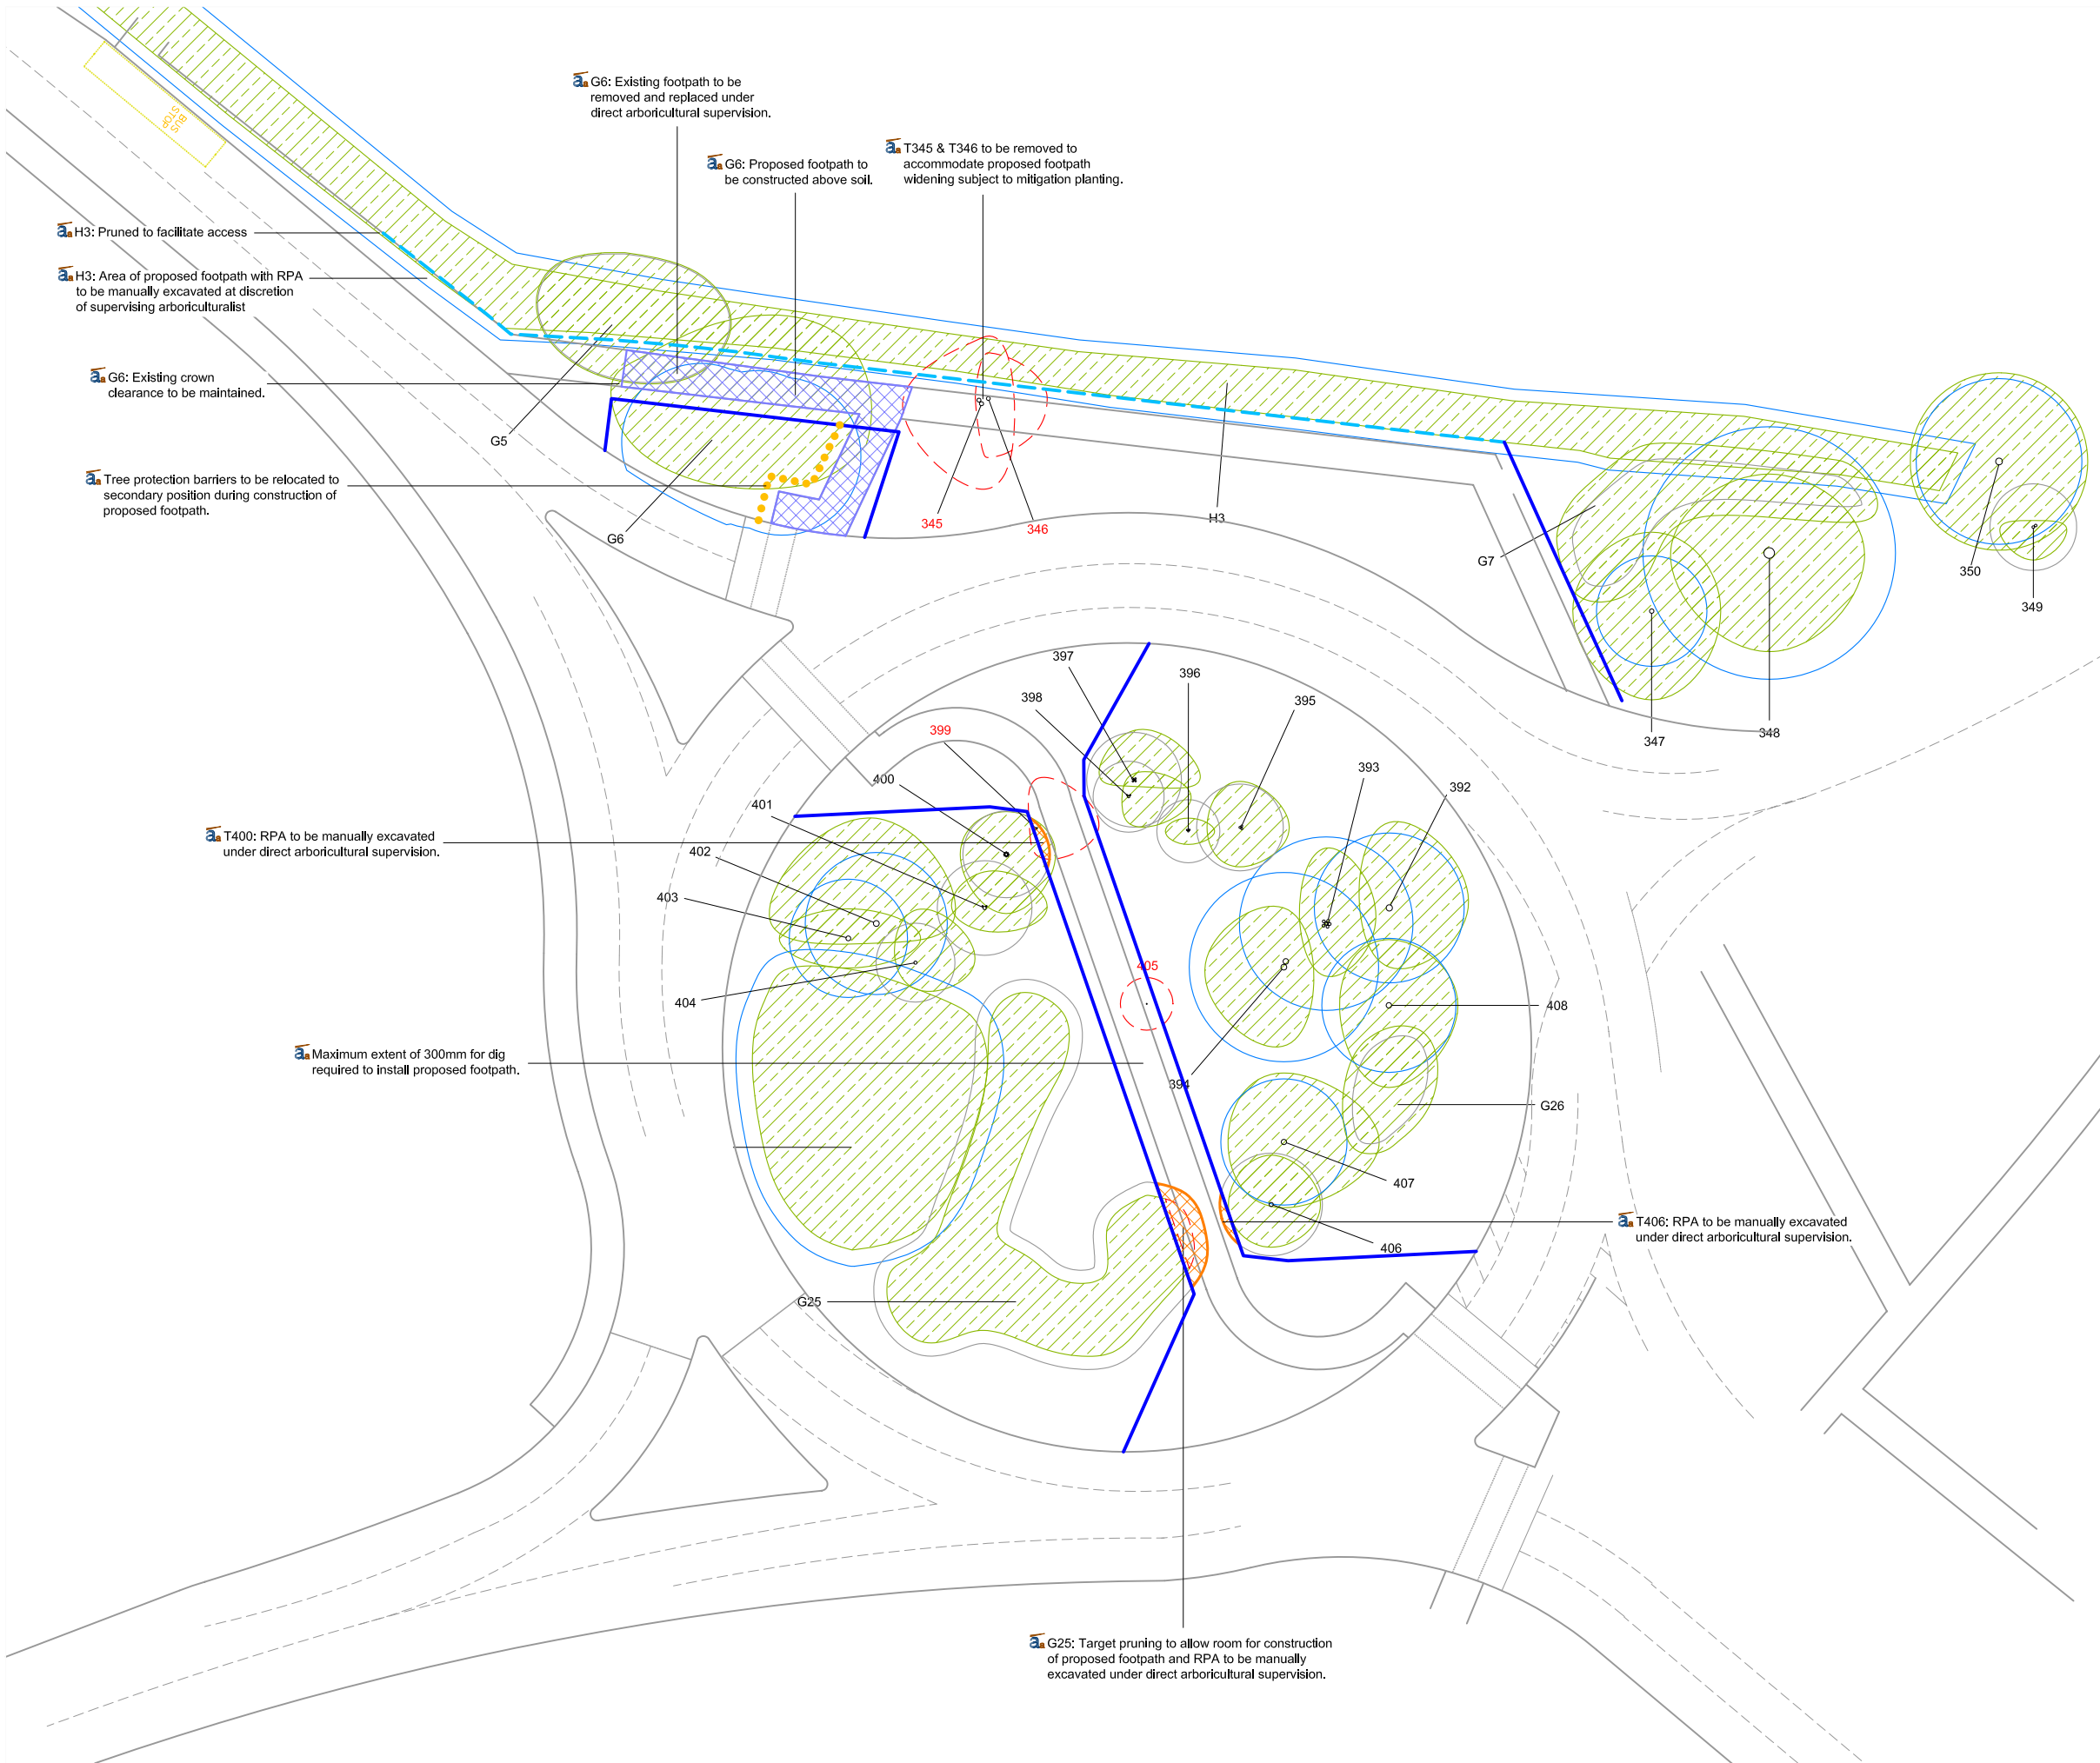
The existing topography of the roundabout has levels that go from 84.8m AOD to 86.2m AOD (a difference of 1.4 metres). It is known that the footpath should have a gradient of no more than 1 in 20, meaning some digging into the ground will be necessary, but it should not be more than 30cm. This depth would not have any adverse impact on the existing trees to be retained subject to adopting the safeguards illustrated in Enclosure C.

In order that the proposals can be implemented without incurring harm to the retained trees, it will be necessary to employ safeguards detailed within the enclosed Tree Protection Plan (refer to Enclosure C: Drawing Number 8854 TPP 06 Bladon Roundabout). This includes:

- Identification of tree removals;
- Target pruning of tree nos. G25 and H3 to allow for working room;

- Siting of tree protection barriers including secondary positioning of barriers around G6 during footpath reconfiguration;
- Works requiring direct arboricultural supervision e.g. manual removal of hard surface and above soil surfacing within the root protection area of G6 and manual excavation within root protection areas of T400, T406, G25 and H3.
