STATION ROAD, HOOK NORTON

TREE SURVEY REPORT and ARBORICULTURAL IMPACT ASSESSMENT

HDA ref: 723.3 Issue 2 October 2014

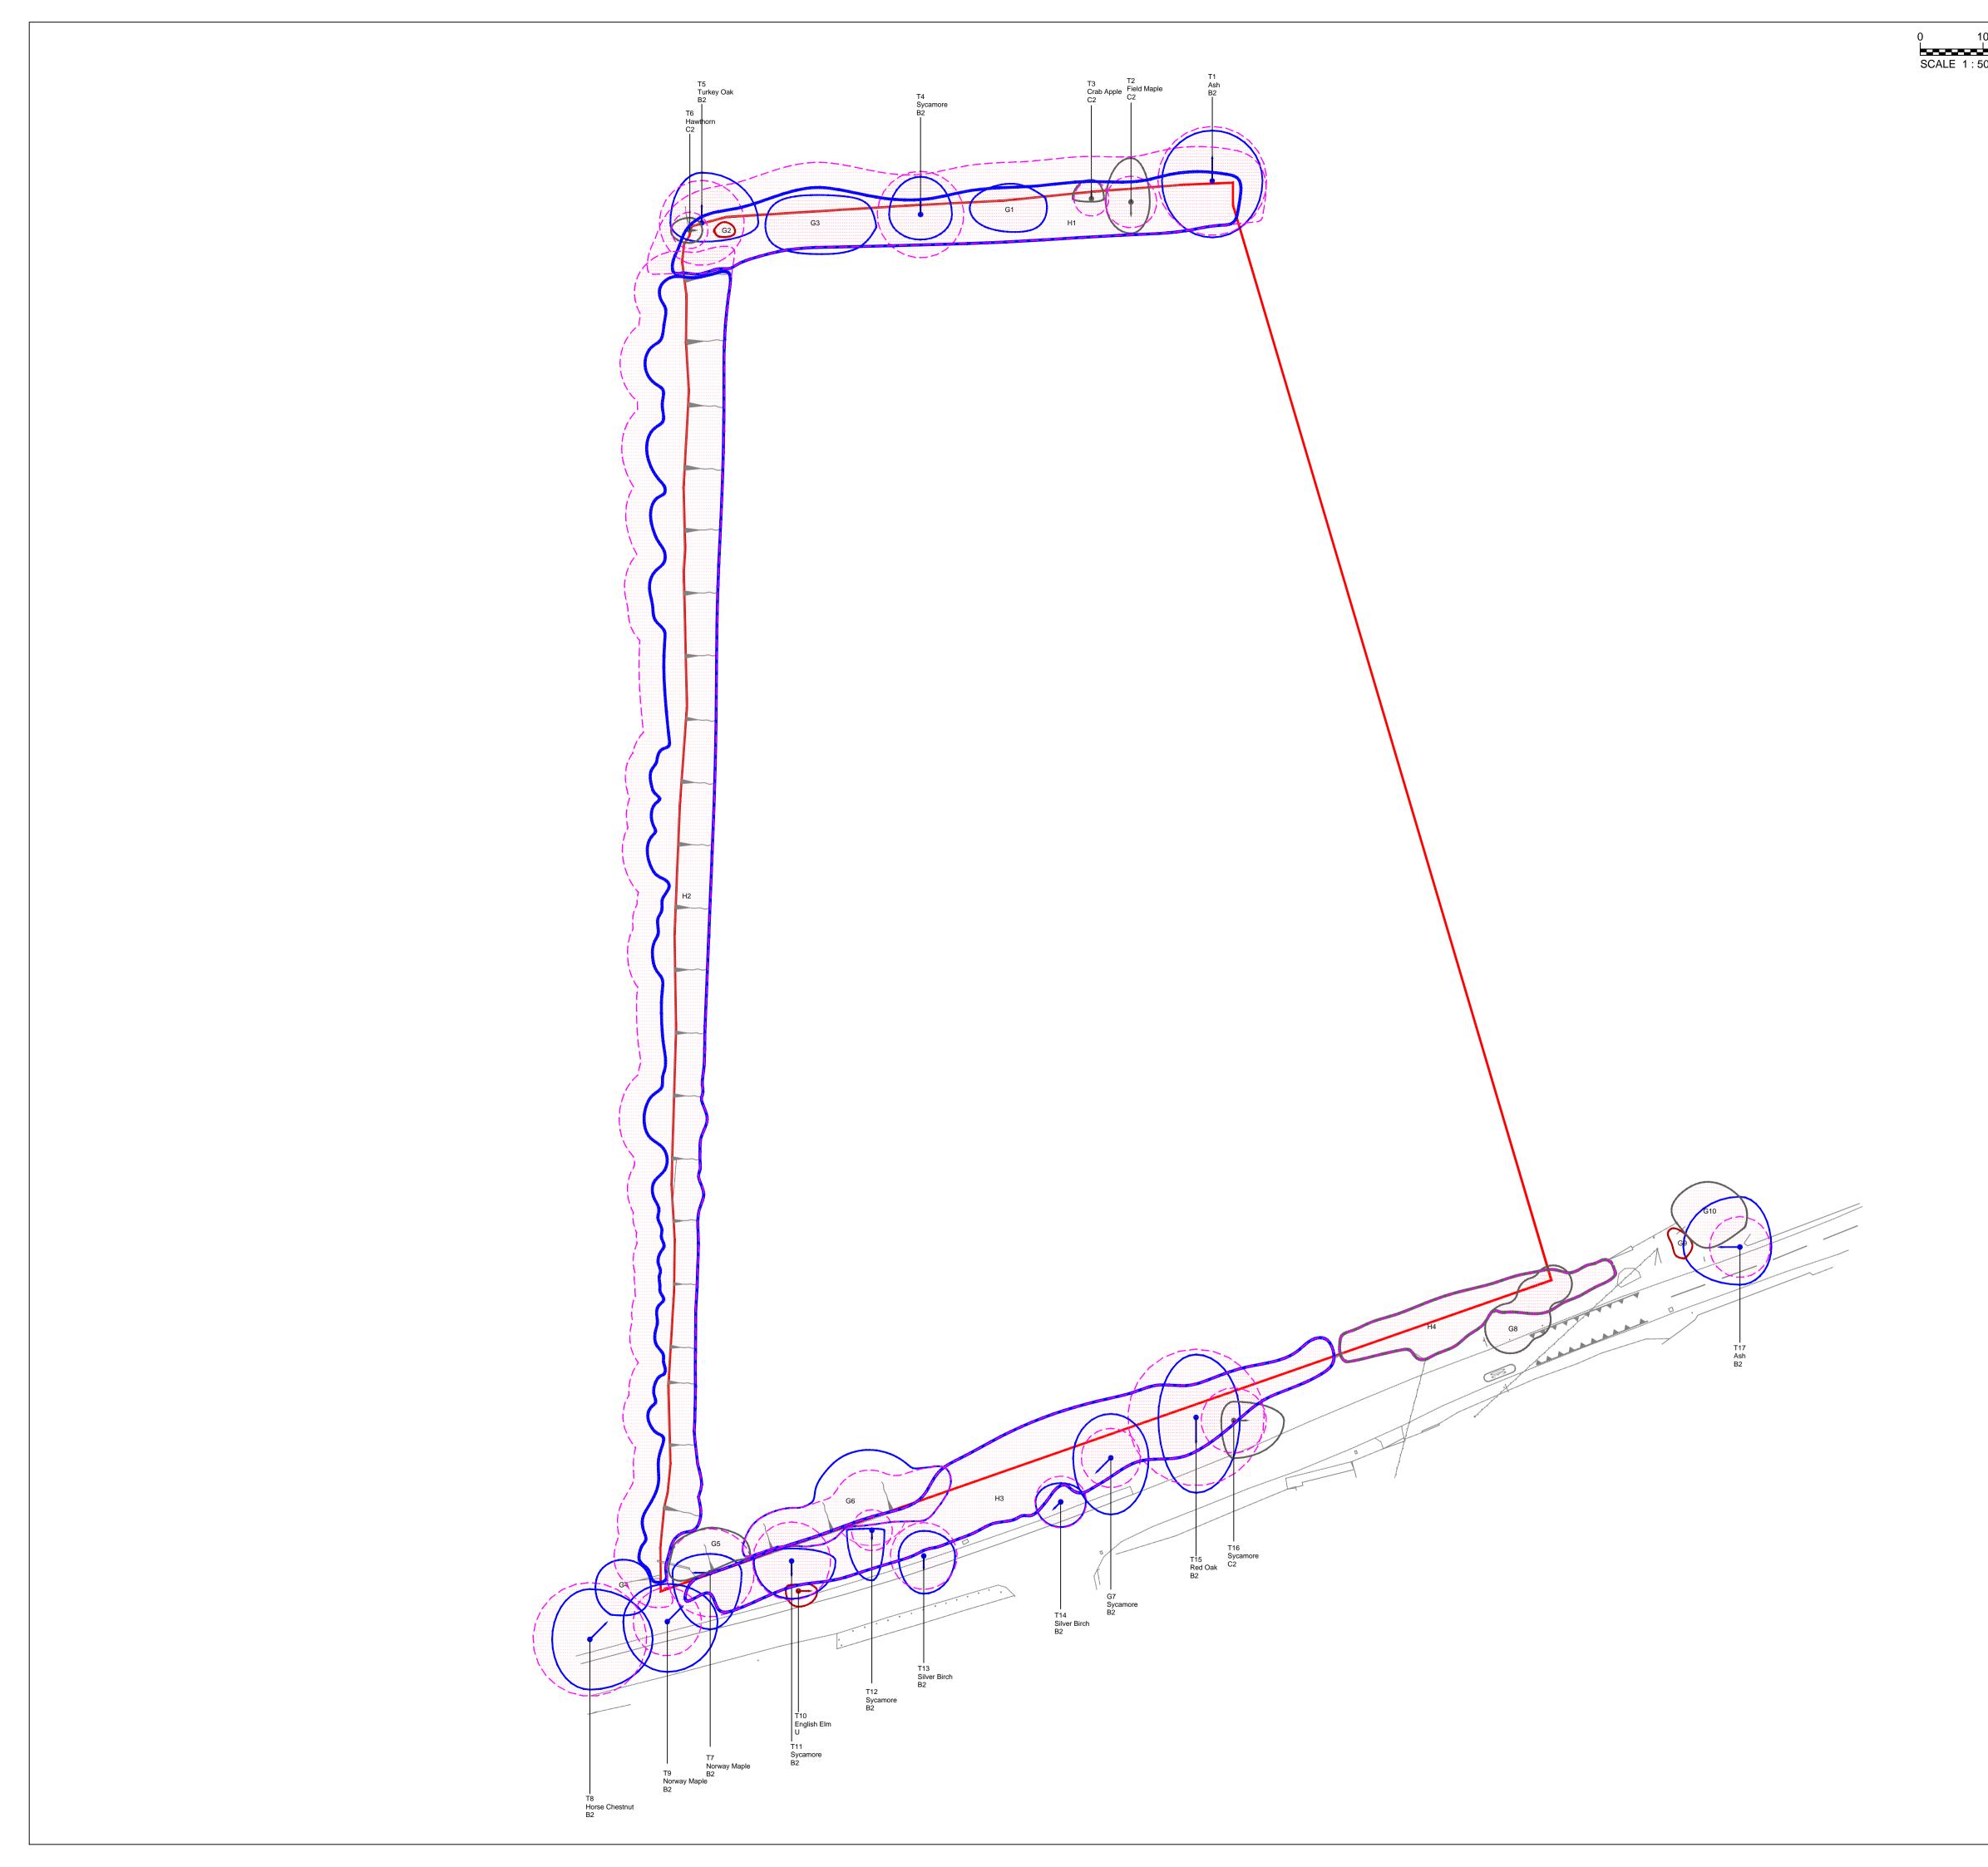
- 4.1.6 Tree locations are shown on the Tree Survey Plan provided in Appendix A and a description of all trees located within the site is given in the Tree Data Schedule provided in Appendix B.

4.1.7 The Root Protection Area (RPA) of individual trees and groups is shown in Appendix A. The RPA of trees along the northern and western boundary of the site has been off-set to take account of the significant change in ground level caused by the quarrying which would have restricted root growth. In addition to this the site's subsequent use for arable farming would also have inhibited root growth.

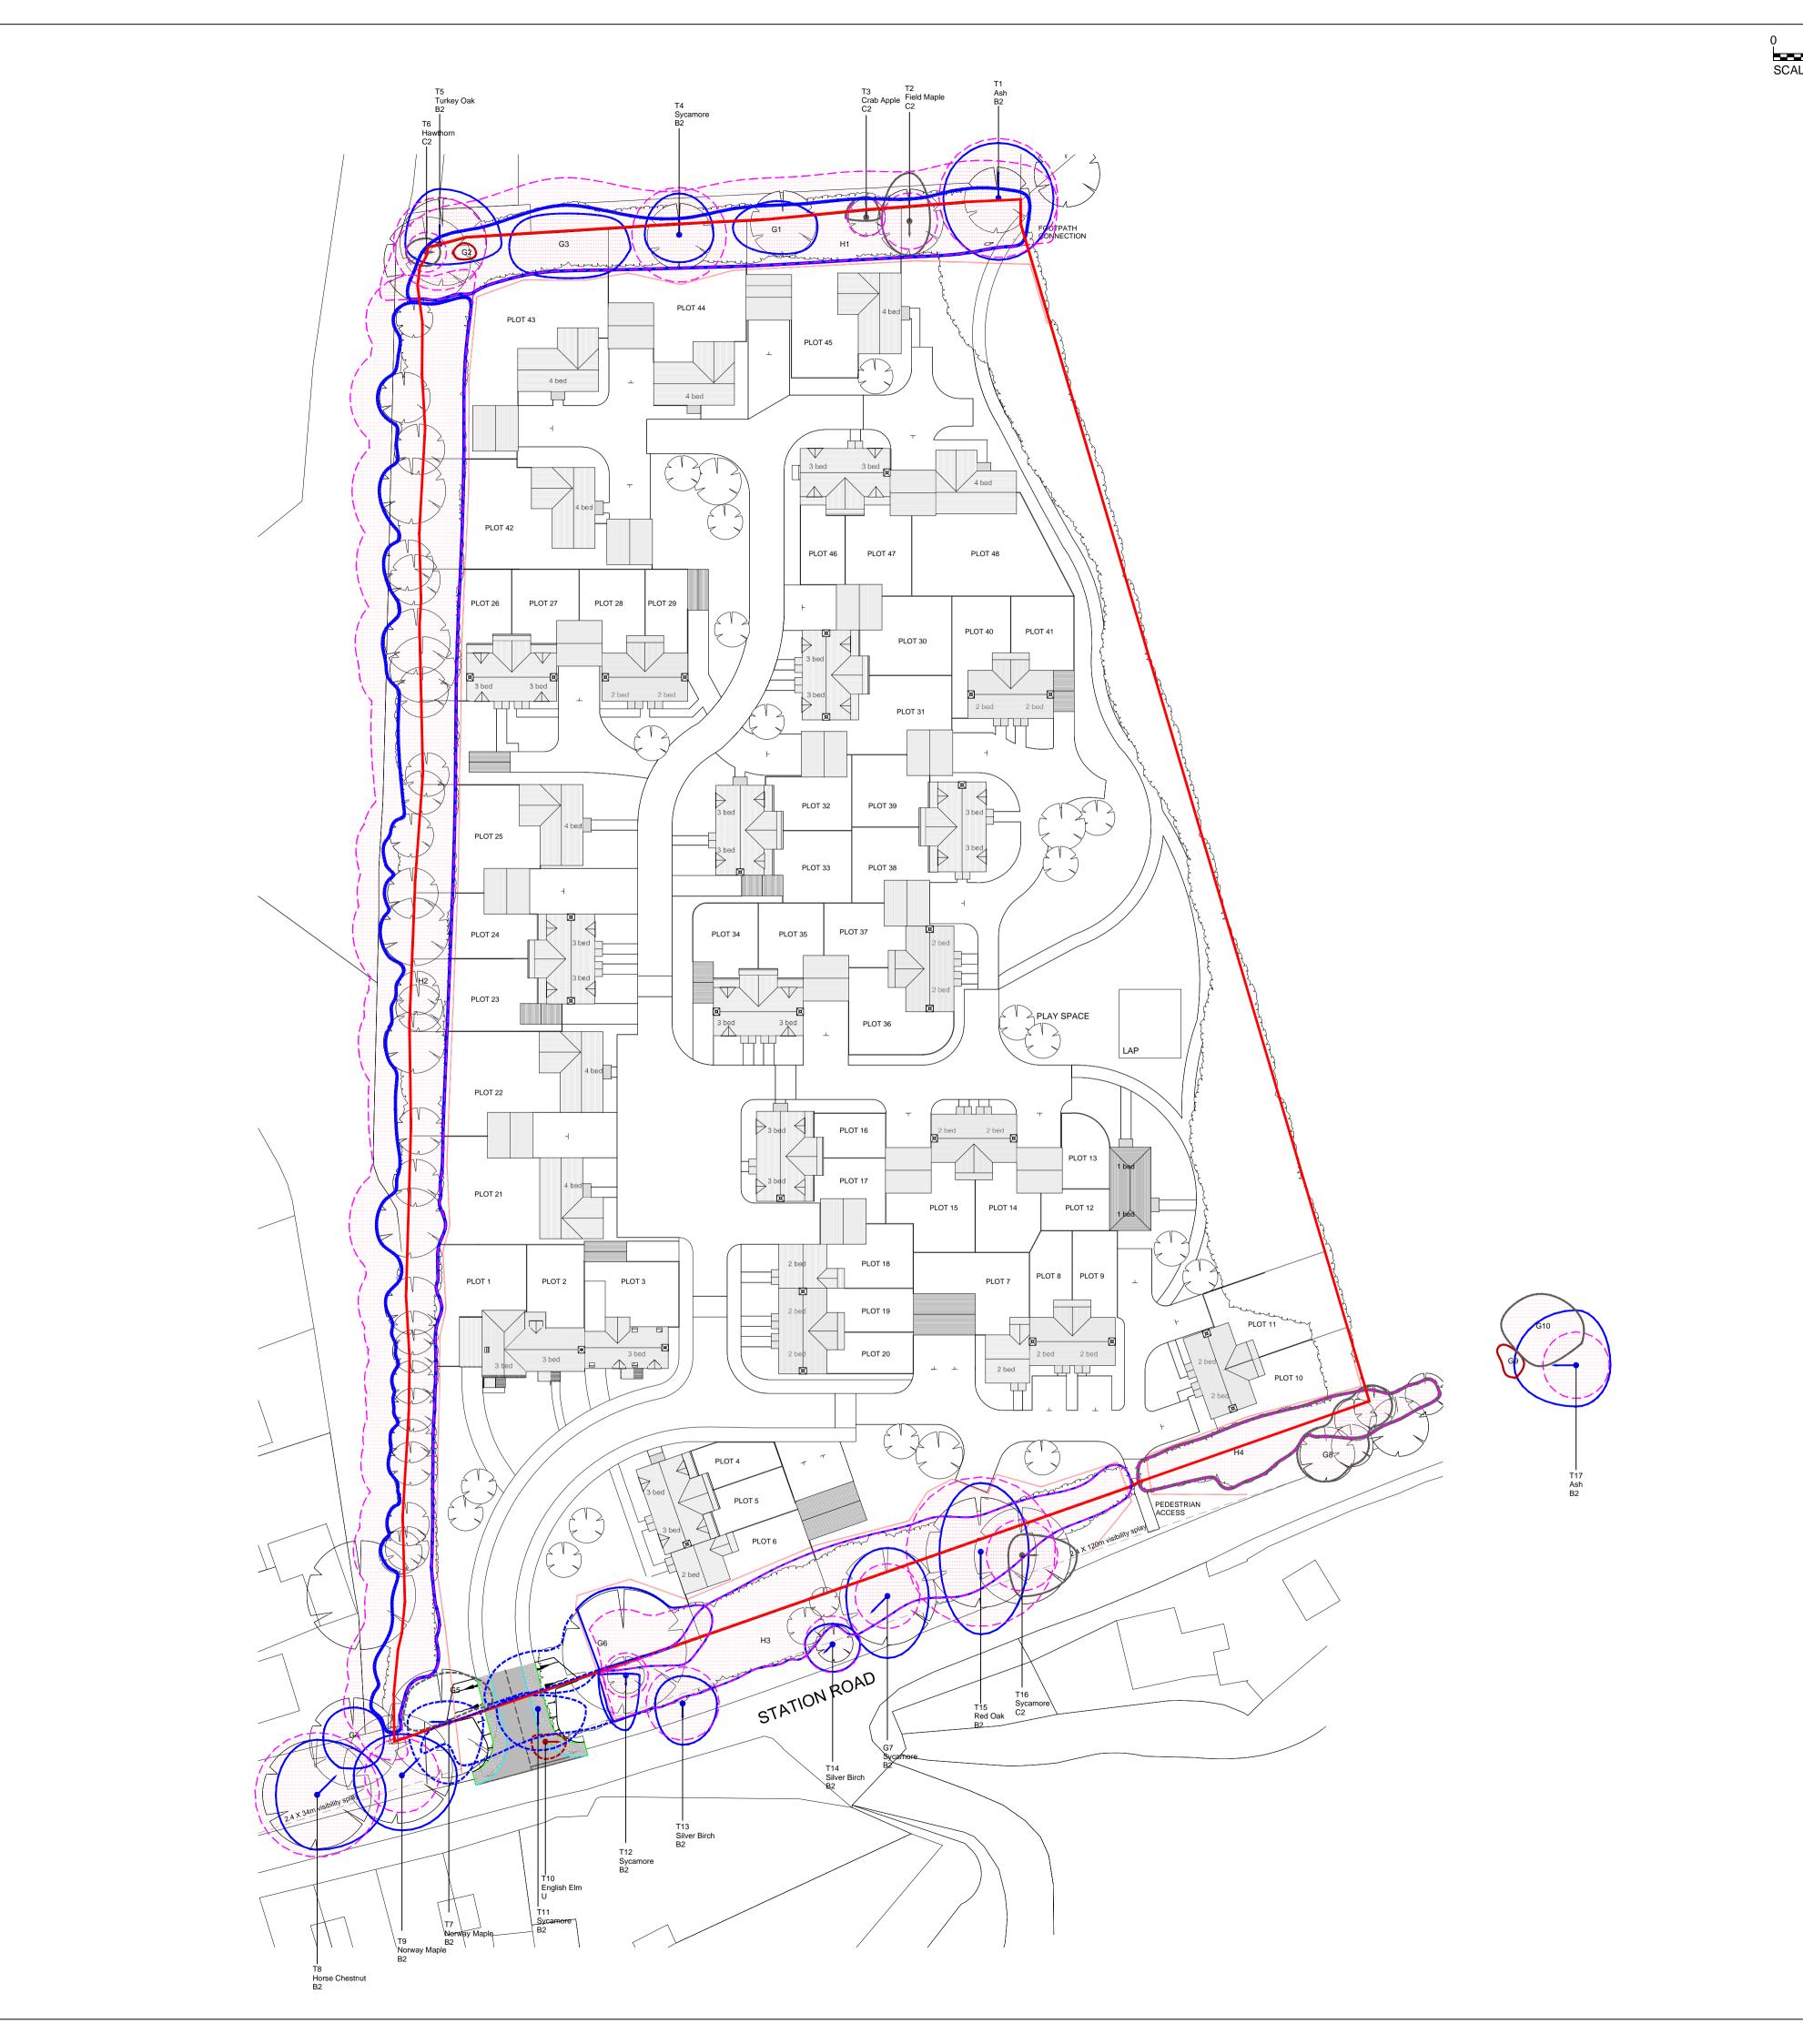
- 5.2.1 The trees to be removed are illustrated on the Tree Protection Plan (Appendix D). A summary of the trees to be removed (in addition to those listed for removal in Table 2) is shown in Table 3 below.
- 5.2.2 Trees to be removed in order to facilitate the proposed development as currently shown on the illustrative masterplan include four Category B trees (including part of a hedge), one Category C group and one Category U tree.
- 5.2.3 It should, however, be noted that the detail design of the proposed access has not been prepared at this stage and the detailed design should be reviewed at a suitable stage to determine whether there are additional tree losses in this area due to the change in ground levels between the existing road and the development site.

- 5.3.2 Tree works required to facilitate the proposed site access are limited to the removal of five trees (G5, G6, T7, T10 and T11) and a 25m section of H3. The precise extent of tree removal is not known as the individual trees within G5 and G6 were not picked up in the topographical survey and it may be possible to retain some trees within these groups, however, the trees are predominantly self-set Sycamore which are generally of a lower category grading when assessed as individuals.
