Gladman Developments Ltd

**Land to the West of White Post Road, Banbury**

**Arboricultural Assessment**

April 2016

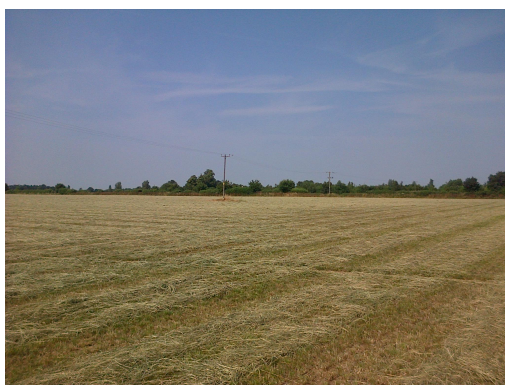
**Photograph 1: A view of typical tree cover around the boundaries of the arable fields**

- 3.4 The majority of the tree stock surveyed was situated within the hedgerows that surrounded the field parcels. From an arboricultural perspective the trees were insignificant due to their young and semi-mature proportions. T3 was a mature English holly *Ilex aquifolium* that was situated within H7 hedgerow between one of the arable fields and the amenity grassland. The tree was in a good overall condition with a dense canopy (typical for the species type), that was tidy in appearance with no major defects. The tree was considered as having a moderate arboricultural value and was regarded as retention category B.

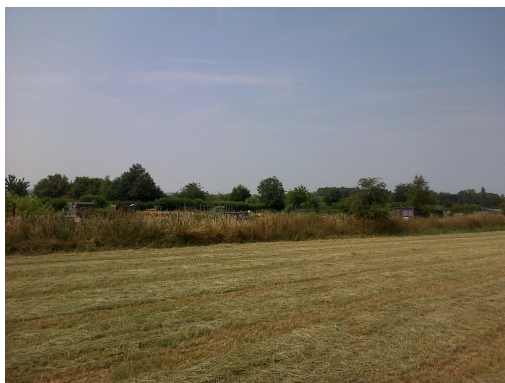
**Photograph 2: Trees associated with the edge of the allotment**

- 3.5 There were several trees bordering the allotment area that were young to semi-mature and of a mixture of different species; (refer to Appendix A Tree Schedule). They were sparsely distributed and of small dimensions hence were therefore considered to have only a low arboricultural value.

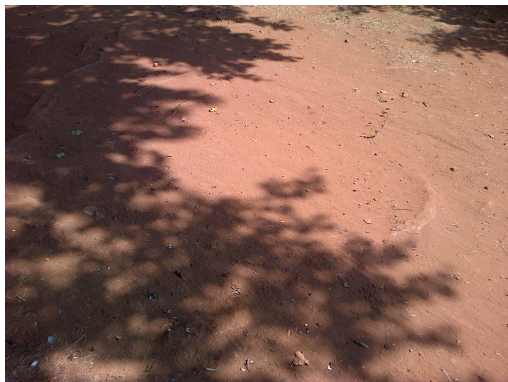
**Photograph 3: Exposed and damaged roots**

- 3.8 All of the trees within the field parcel had suffered from soil poaching with some specimens having some exposed and damage roots resulting from vehicular access to the field. From visual observations those trees that had suffered most were TG17 that comprised of two common lime, T14 copper beech, T15 common beech, and T16 common lime, which were all close to the access gate into the amenity grassland. Direct damage to some of the rooting area was evident although limited to the surfacing material however the damage had only exposed a relatively small proportion of the total root plate and as the trees appeared to be generally in a fair or good overall condition they seemed not to have been adversely affected by damaged parts. It should however be taken into account over the long-term that if the continual use of vehicles accessing the field is to occur it is more likely to cause decline to the trees overall health, as the soil in the rooting area housing the roots will become permanently compacted, and this is likely to reduce the availability of nutrients and water vital to long term good health and survival.

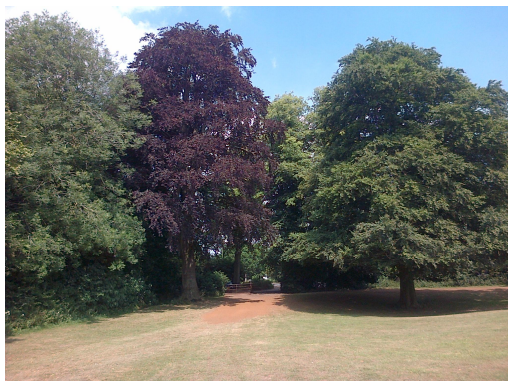
**Photograph 4: Beech trees situated within amenity grassland**

- 3.12 Located within the field parcel were T14 copper beech and T15 common beech that individually and collectively added high aesthetic value to the locality, and were regarded therefore as retention category A accordingly. As mentioned in paragraph 3.9 both trees had also suffered from soil poaching and exposure to some of the roots caused by vehicles using the gated access point. Both trees contained both minor and major deadwood. T15 contained major deadwood within the lower half of the crown with some dead branches up to 5m long. Stubs were present on both trees from past pruning operations. The overall ground clearance of T15's canopy was 3m.

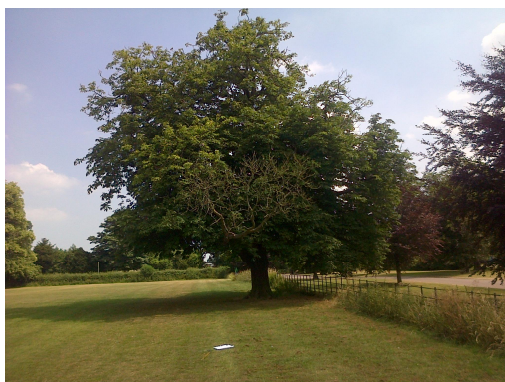
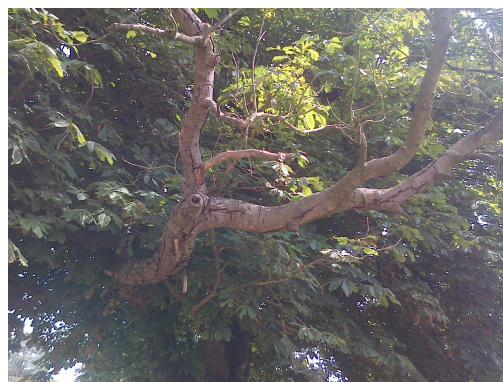
- T8 showed a degree of recovery from infection by Bleeding Canker identified in the previous survey. However, due to the progressive nature of this condition the specimen, if retained should be monitored for further changes in its condition on a regular basis and appropriate action for rectification of any deterioration in its condition applied accordingly.

**Photograph 5: T8 horse chestnut with dieback    Photograph 6: 7m long dead branch on T8**

- 3.14 T8 was an over-mature horse chestnut *Aesculus hippocastanum* that was previously in visibly poor physiological condition exhibiting major dieback throughout the canopy. Major deadwood was visible and included a 7m long branch in the western side of the crown. Exposed wounds and bark necrosis was also visible and particularly prevalent on the lowest 2m of the stem. A 5m

vertical large split to a primary limb was also visible that formed a potential “hazard beam”, the nature of which would have a higher likelihood of branch failure. Soil poaching had also occurred near the roots of the tree close to the stem that had resulted in minor root exposure. Visible during the observation of T8 were a number of black spots present on some of the dead branches. This is a potential indicator of Bleeding Canker of Horse Chestnut *Pseudomonas syringae* pv. *Aesculi*, a pathogen which can lead to the eventual demise of the condition of the tree and ultimately death. T8 had a low canopy in places with just 1 - 2m ground clearance.

- 4.12 Only one tree would need to be removed. T8 was an over-mature horse chestnut, which is afforded statutory protection through a Tree Preservation Order however, the tree was assessed as being in a slightly poorer physiological condition than normal for what would be expected for a tree of such an age. There was major deadwood present within the canopy and indications of infection from the disease; Bleeding Canker of Horse Chestnut, a disease that has the potential to eventually cause the death of a tree in most cases where it occurs. Despite it's category B grade in its current condition the tree was considered as offering a lower overall arboricultural value due to the current compromised structural health and more importantly for having a much reduced life expectancy due to the presence and nature of the disease affecting it.

- 6.5 T8, an over-mature horse chestnut subject of a Tree Preservation Order, was assessed as being in a poor physiological condition. The tree displayed symptoms of the often fatal disease; Bleeding Canker of Horse Chestnut. For this reasons it would seem reasonable to remove the tree to facilitate the development and seek a replacement specimen as part of the landscaping proposals, in favour of retaining the higher quality category A specimen T7 to its north west as there would be scope to consider moving the indicative position of the main access road to the south in order to avoid the rooting constraint of the specimen. If the tree was removed as part of the facilitation of the layout, the status of the Tree Preservation Order would be overridden and the manner of a replacement would need to be agreed with the LPA.

- 4.14 The suggested approach, involving the removal of T8 in order to achieve this should not raise objection on arboricultural grounds especially considering the trees limited future prospects and that it can be replaced close by within the open space provision being proposed.

- 4.15 If approval is given to the development and T8 is removed to facilitate the consented layout, the status of the Tree Preservation Order would be overridden but, the manner of its replacement would need to be agreed with the LPA.
