Gladman Developments Ltd

Land to the West of White Post Road, Banbury

Arboricultural Assessment

April 2016

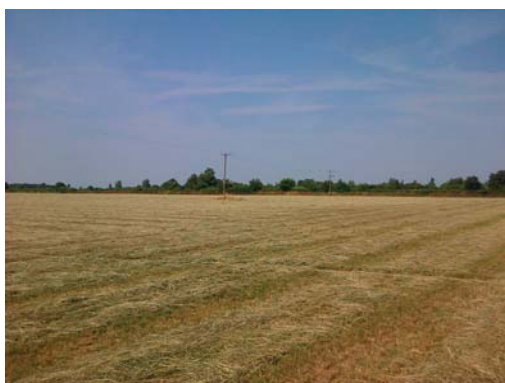
Photograph 1: A view of typical tree cover around the boundaries of the arable fields

- 3.4 The majority of the tree stock surveyed was situated within the hedgerows that surrounded the field parcels. From an arboricultural perspective the trees were insignificant due to their young and semi-mature proportions. T3 was a mature English holly *Ilex aquifolium* that was situated within H7 hedgerow between one of the arable fields and the amenity grassland. The tree was in a good overall condition with a dense canopy (typical for the species type), that was tidy in appearance with no major defects. The tree was considered as having a moderate arboricultural value and was regarded as retention category B.

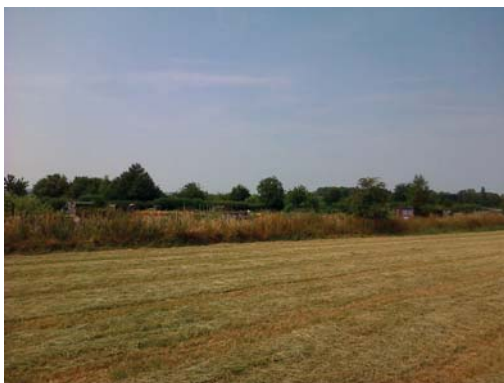
Photograph 2: Trees associated with the edge of the allotment

- 3.5 There were several trees bordering the allotment area that were young to semi-mature and of a mixture of different species; (refer to Appendix A Tree Schedule). They were sparsely distributed and of small dimensions hence were therefore considered to have only a low arboricultural value.

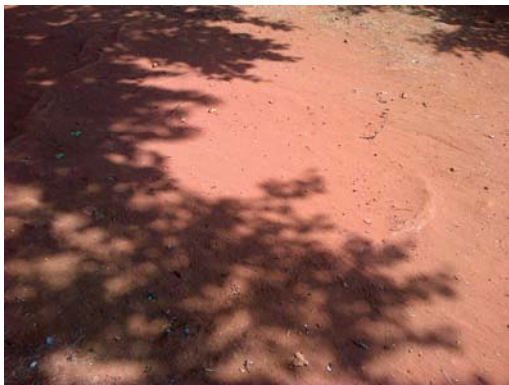
Photograph 3: Exposed and damaged roots

- 3.8 All of the trees within the field parcel had suffered from soil poaching with some specimens having some exposed and damage roots resulting from vehicular access to the field. From visual observations those trees that had suffered most were TG17 that comprised of two common lime, T14 copper beech, T15 common beech, and T16 common lime, which were all close to the access gate into the amenity grassland. Direct damage to some of the rooting area was evident although limited to the surfacing material however the damage had only exposed a relatively small proportion of the total root plate and as the trees appeared to be generally in a fair or good overall condition they seemed not to have been adversely affected by damaged parts. It should however be taken into account over the long-term that if the continual use of vehicles accessing the field is to occur it is more likely to cause decline to the trees overall health, as the soil in the rooting area housing the roots will become permanently compacted, and this is likely to reduce the availability of nutrients and water vital to long term good health and survival.

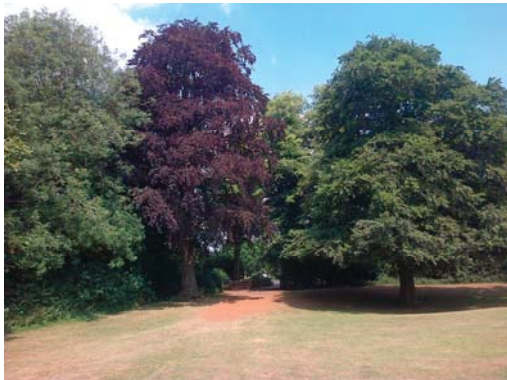
Photograph 4: Beech trees situated within amenity grassland

- 3.12 Located within the field parcel were T14 copper beech and T15 common beech that individually and collectively added high aesthetic value to the locality, and were regarded therefore as retention category A accordingly. As mentioned in paragraph 3.9 both trees had also suffered from soil poaching and exposure to some of the roots caused by vehicles using the gated access point. Both trees contained both minor and major deadwood. T15 contained major deadwood within the lower half of the crown with some dead branches up to 5m long. Stubs were present on both trees from past pruning operations. The overall ground clearance of T15's canopy was 3m.

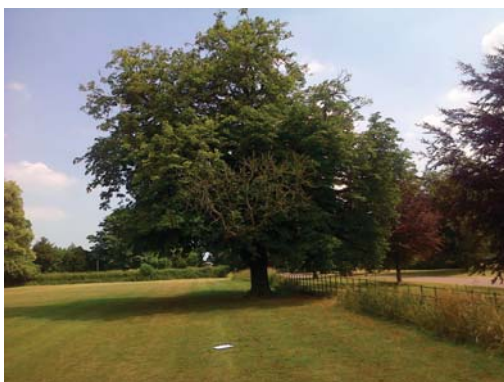
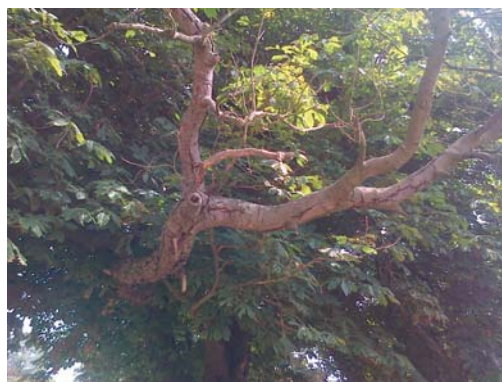
- T8 showed a degree of recovery from infection by Bleeding Canker identified in the previous survey. However, due to the progressive nature of this condition the specimen, if retained should be monitored for further changes in its condition on a regular basis and appropriate action for rectification of any deterioration in its condition applied accordingly.
- T24 similarly showed improved signs of health to previously and was considered suitable for retention albeit would need to be subjected to remedial tree surgery to address some of the defective crown material, should approval be given to the development, due to its proximity to areas frequented by the public in the interests of safety.

Photograph 5: T8 horse chestnut with dieback Photograph 6: 7m long dead branch on T8

- 3.14 T8 was an over-mature horse chestnut *Aesculus hippocastanum* that was previously in visibly poor physiological condition exhibiting major dieback throughout the canopy. Major deadwood was visible and included a 7m long branch in the western side of the crown. Exposed wounds and bark necrosis was also visible and particularly prevalent on the lowest 2m of the stem. A 5m

vertical large split to a primary limb was also visible that formed a potential “hazard beam”, the nature of which would have a higher likelihood of branch failure. Soil poaching had also occurred near the roots of the tree close to the stem that had resulted in minor root exposure. Visible during the observation of T8 were a number of black spots present on some of the dead branches. This is a potential indicator of Bleeding Canker of Horse Chestnut *Pseudomonas syringae* pv. *Aesculi*, a pathogen which can lead to the eventual demise of the condition of the tree and ultimately death. T8 had a low canopy in places with just 1 - 2m ground clearance.

- 4.12 Only one tree would need to be removed. T8 was an over-mature horse chestnut, which is afforded statutory protection through a Tree Preservation Order however, the tree was assessed as being in a slightly poorer physiological condition than normal for what would be expected for a tree of such an age. There was major deadwood present within the canopy and indications of infection from the disease; Bleeding Canker of Horse Chestnut, a disease that has the potential to eventually cause the death of a tree in most cases where it occurs. Despite it's category B grade in its current condition the tree was considered as offering a lower overall arboricultural value due to the current compromised structural health and more importantly for having a much reduced life expectancy due to the presence and nature of the disease affecting it.

- 4.14 The suggested approach, involving the removal of T8 in order to achieve this should not raise objection on arboricultural grounds especially considering the trees limited future prospects and that it can be replaced close by within the open space provision being proposed.
