Gladman Developments Ltd

Land to the West of White Post Road, Banbury

Arboricultural Assessment

April 2016

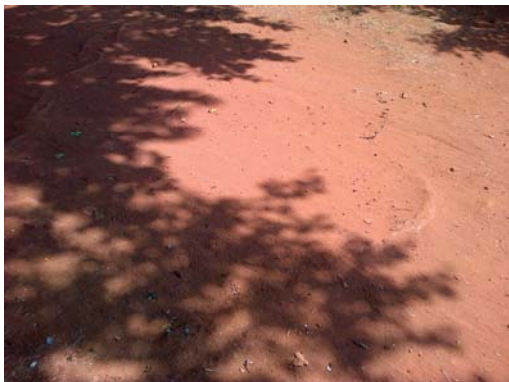
Photograph 3: Exposed and damaged roots

- 3.8 All of the trees within the field parcel had suffered from soil poaching with some specimens having some exposed and damage roots resulting from vehicular access to the field. From visual observations those trees that had suffered most were TG17 that comprised of two common lime, T14 copper beech, T15 common beech, and T16 common lime, which were all close to the access gate into the amenity grassland. Direct damage to some of the rooting area was evident although limited to the surfacing material however the damage had only exposed a relatively small proportion of the total root plate and as the trees appeared to be generally in a fair or good overall condition they seemed not to have been adversely affected by damaged parts. It should however be taken into account over the long-term that if the continual use of vehicles accessing the field is to occur it is more likely to cause decline to the trees overall health, as the soil in the rooting area housing the roots will become permanently compacted, and this is likely to reduce the availability of nutrients and water vital to long term good health and survival.
