Gladman Developments Ltd

Land to the West of White Post Road, Banbury

Arboricultural Assessment

July 2015

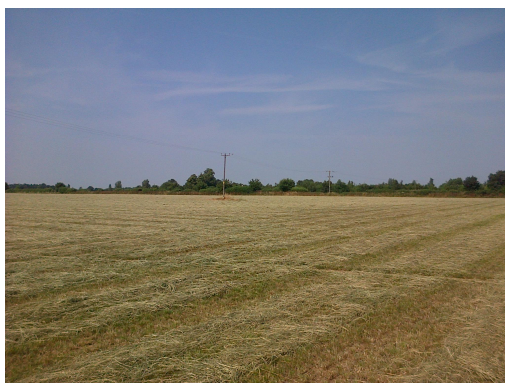
Photograph 1: A view of typical tree cover around the boundaries of the arable fields

3.4 The majority of the tree stock surveyed was situated within the hedgerows that surrounded the field parcels. From an arboricultural perspective the trees were insignificant due to their young and semi-mature proportions. T3 was a mature English holly *Ilex aquifolium* that was situated within H7 hedgerow between one of the arable fields and the amenity grassland. The tree was in a good overall condition with a dense canopy (typical for the species type), that was tidy in appearance with no major defects. The tree was considered as having a moderate arboricultural value and was regarded as retention category B.
