## PRELIMINARY BAT ROOST ASSESSMENT

**Yew Tree House,  
Main Street, Sibford Gower,  
Oxfordshire OX15 5RT**

**Report Reference  
C1565-1**

**18<sup>th</sup> December 2015**

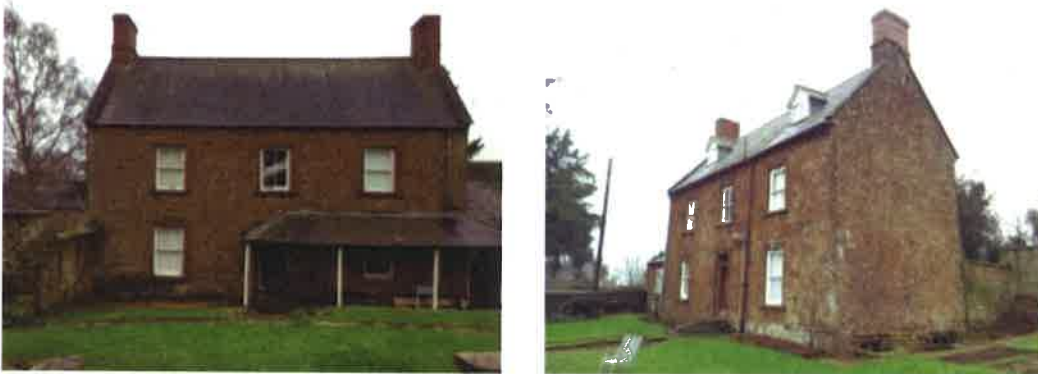
Yew Tree House is a three-storey Georgian building (c. 1750) with a cellar, small single-storey extension on the west gable wall and an adjoining outbuilding (Plates 1 and 4).

*Plates 1 and 2. Yew tree House: north elevation showing the main house and canopy from the rear garden (left), and south-east corner showing the east gable wall with cellar windows just visible (right); the single-storey extension is proposed on the east gable wall (right).*

The rear (north) elevation of the house supports an open canopy with a slate-covered unlined roof; this might present opportunities for cover, prior to re-entry or after emergence, if bats were roosting within the building.

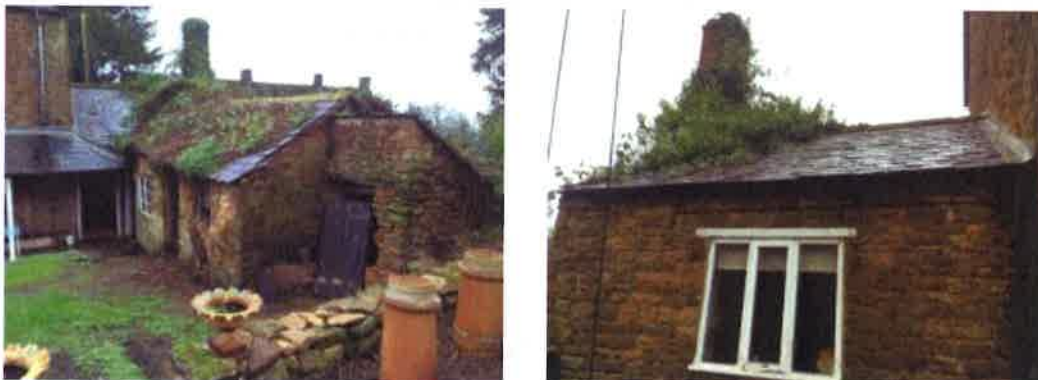
The outbuilding adjoining the west extension contains two rooms, each supporting a doorway, with old, poorly fitting wood-panelled doors, and a single window; only one of the windows is fully glazed (Plate 3).

The outbuilding is partially covered in dense ivy, which extends along the length of the roof onto the west extension; this has been cut back recently to reveal extensive damage to the stonework, roof slates and one of the windows; there is extensive ingress of ivy into the two roof spaces.

There is a small extension, with a single-pitched corrugated metal roof, on the northern end of the outbuilding, understood to be a former privy. The stonework is badly damaged, with areas of crumbling stone and mortar, and the extension has an open doorway; the wood-panelled door is present but off its hinges (Plate 3).

*Plates 3 and 4. Outbuilding and western extension to the main house; showing the single-storey outbuilding and ivy-covered chimney of the extension from the rear garden (left) and western extension from the south elevation of the dwelling (right).*

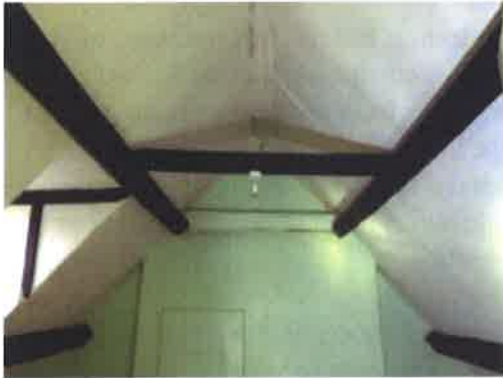
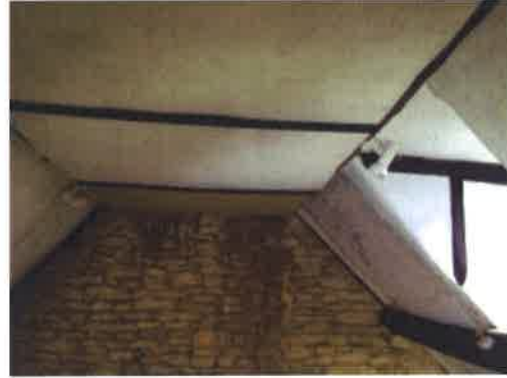
There are no enclosed roof voids within the main house. The third floor is built into the roof space with the west room ceiling extending up to the roof apex (Plate 5). The east room has a false ceiling extending between two of the roof timbers, with a small cavity above (Plate 6), but it is understood that the cavity has been filled with insulation material; consequently, there are limited roosting opportunities for roof-void dwelling bat species within the main house. There may be spaces between the roof slates and ceiling boards, if accessible from the outside, that are suitable for crevice-dwelling bat species (although see Section 4.3.1).

*Plates 5 and 6. Third storey interior within the main house; showing the west room (left) and east room (right); the east room has a false ceiling, installed at the level of the purlins, with a small void above understood to contain thick insulation material.*

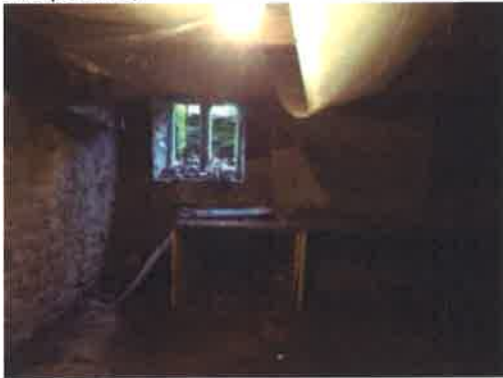
*Plate 7: Cellar beneath house*

The cellar is cool but relatively well-lit from the unglazed east-facing window (Plate 7). The stone walling of the cellar contains only minor cracks while the ceiling is currently covered with suspended polythene; consequently, although bats would be able to access the cellar relatively easily, there are few roosting opportunities for crevice or void-dwelling bats.

The cellar of the main house is easily accessible to bats but has few features, such as gaps, cracks or crevices, that would be suitable for roosting bats; the cellar ceiling is also covered with polythene, which would deter bats from resting or roosting in this area. The single cellar room is relatively well-lit from the unglazed window and exposed to draughts; consequently, it is considered that the cellar is unlikely to support roosting bats, and thus there is a very low likelihood of Impacts arising as a result of the construction of the proposed extension.

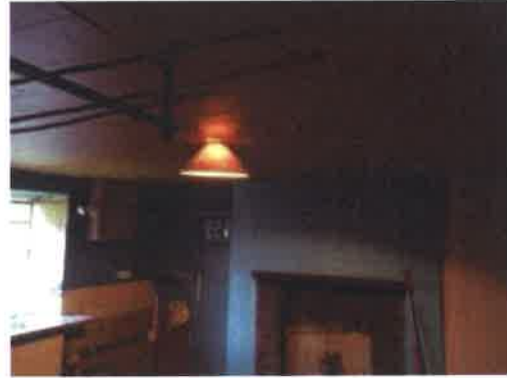
*Plate 8: Interior of western extension*

The single room comprising the west extension contains a wood-panelled ceiling, above which is a small roof void (Plate 8); there is no human access into the void, and thus it was not accessible on the day of the survey. The void has some potential to support roosting bats if accessible from the exterior, although part of the roof and chimney are covered with dense ivy.

The enclosed roof void of the west extension was not accessible for internal inspection, and thus the presence of a bat roost in this area cannot be entirely ruled out; however, the relatively well-sealed nature of the slates, extensive covering of ivy on part of the roof and chimney, with probable ingress of ivy into the roof void, and lack of evidence of bats on any external gaps, makes the presence of a bat roost in this void less likely.

- Renovation works which involve incursions into the non-accessible roof void, and/or removal of roof materials above the roof void on the west extension, should be supervised by a licenced bat ecologist. Dismantling of the roof structure in other areas should be undertaken in a sensitive manner, including careful removal of all roof coverings, ridge tiles and slates, and any roof linings, if present.

- Prior to the commencement of renovation works on the roof of the west extension, a licensed bat ecologist will inspect the roof void internally and externally to look for any roosting bats or signs of roosting bats, so far as it is safe to do so. Should any roosting bats be found in locations where they are deemed to be vulnerable to disturbance or harm all work must cease immediately and an application to Natural England for an EPS licence may be required.

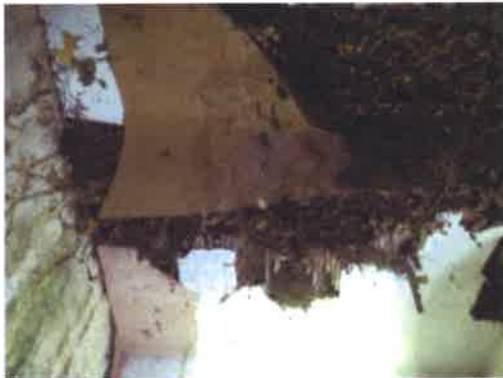
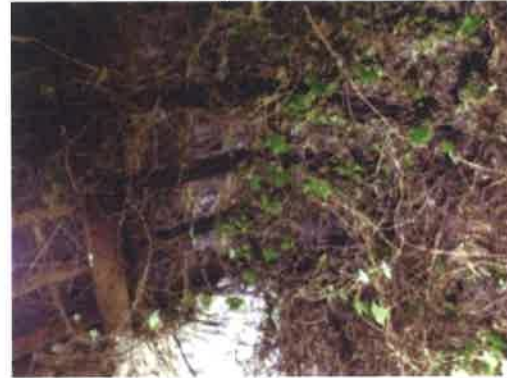
The outbuilding has two unconnected roof spaces. The south room contains a lath and plaster ceiling; this has several large holes through which can be seen extensive ivy growth within the void above; the roof is unlined (Plate 9). The north room is open from the floor to the unlined roof, which has several large holes; the timbers and tile batons support dense ivy growth (Plate 10).

*Plates 9 and 10: Interior areas of outbuilding; showing extensive ivy ingress into the south (left) and north (right) roof spaces.*

The damaged roof of the outbuilding is less suitable for roosting bats due to conditions of light, exposure and clutter (from extensive ivy ingress). It is considered that there is a low likelihood of bats roosting within this building.
