Chancel Cottage

PLANNING AND DESIGN AND ACCESS STATEMENT

5th September 2014

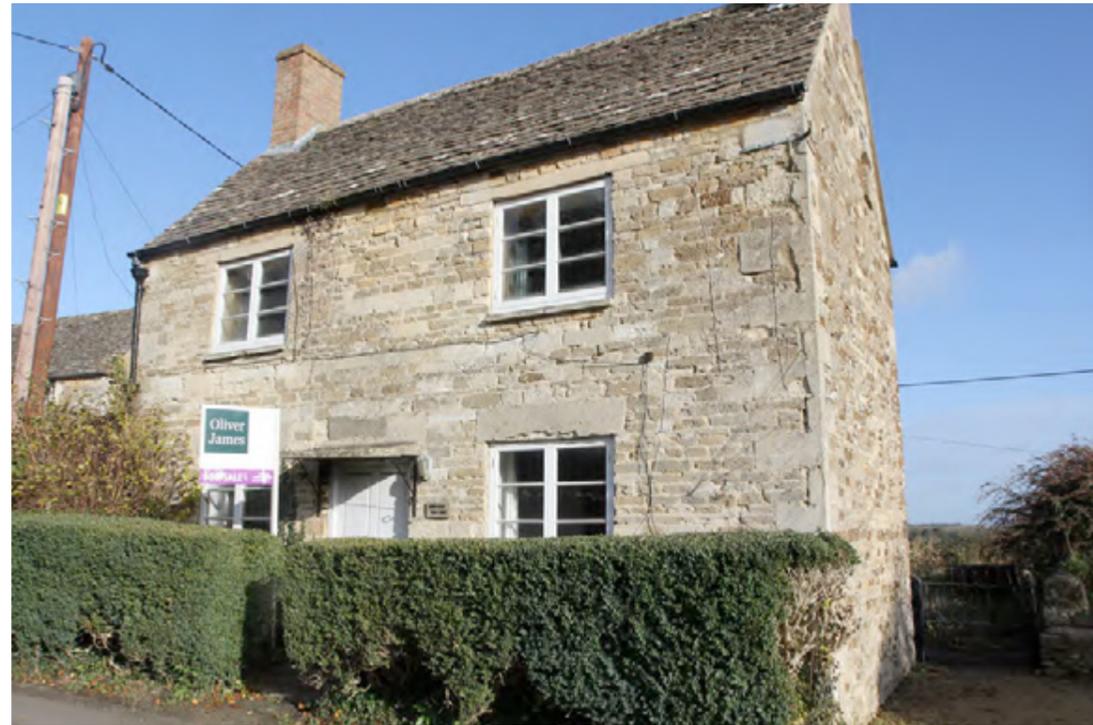
The wall is coursed limestone with ashlar dressing, which is affected by ivy and vegetation growing either side of the doorway and causing damp internally. There are many open joints to the wall, particularly beneath and between the windows and beneath the eaves. The overhaul of the stonework and repointing is required. There is rot occurring to the lower rail to the door and to the weatherboard.

There has been outward movement to roof, which has caused the eaves to bow. The addition of restraint to the roof is required. The quoin stones on the south side are affected by some movement to the outer face of the wall to the east gable.

There is some slippage to the slates beneath the ridge and around the chimneys and recovering is required. Both end stacks are in brick with a lead lining. There are open joints around the lining from the west slope to the chimney to the east, clearly repairs are required. There are several missing small bricks to this chimney and slates missing under the flashing. Overhaul and repointing is required to the stack.

Fig.15 - Front facade

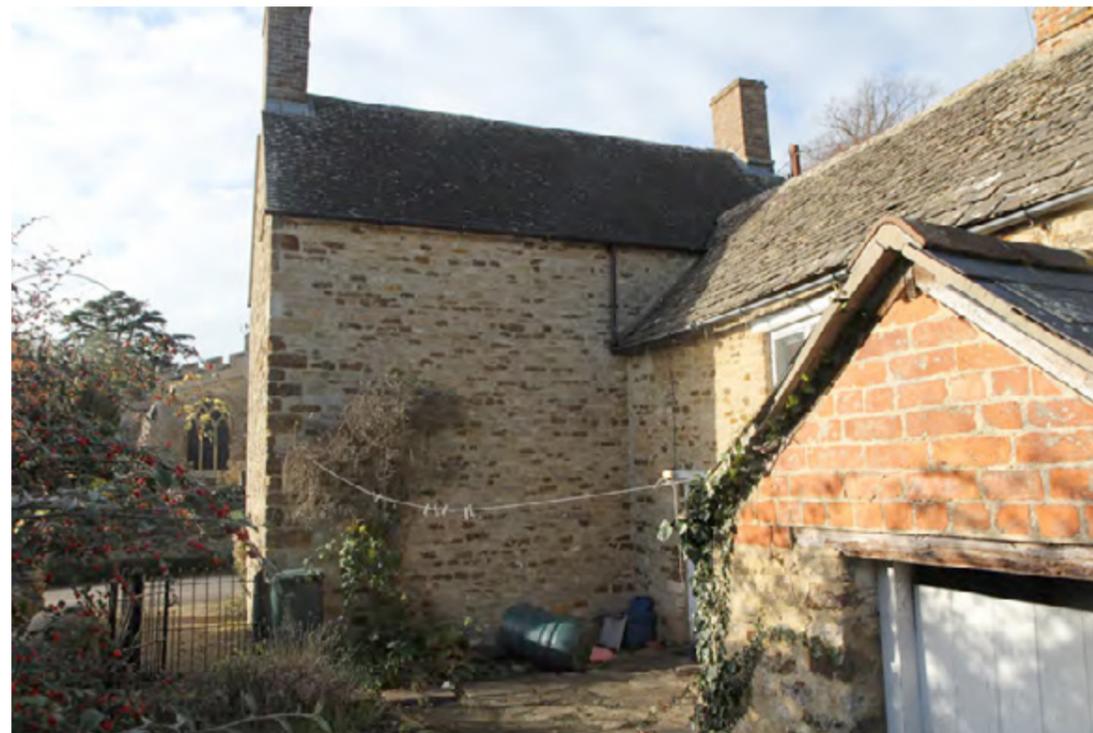
Fig.17 - East elevation to front section

The roof drainage is formed with a fascia and plastic gutter and downpipe, which discharges into the gutter extending along the outbuilding. As noted previously, there is brickwork cracking to the chimney to the south and general repair is required together with the replacement of the flashing. Attention is required to the flashing to the chimney to the west.

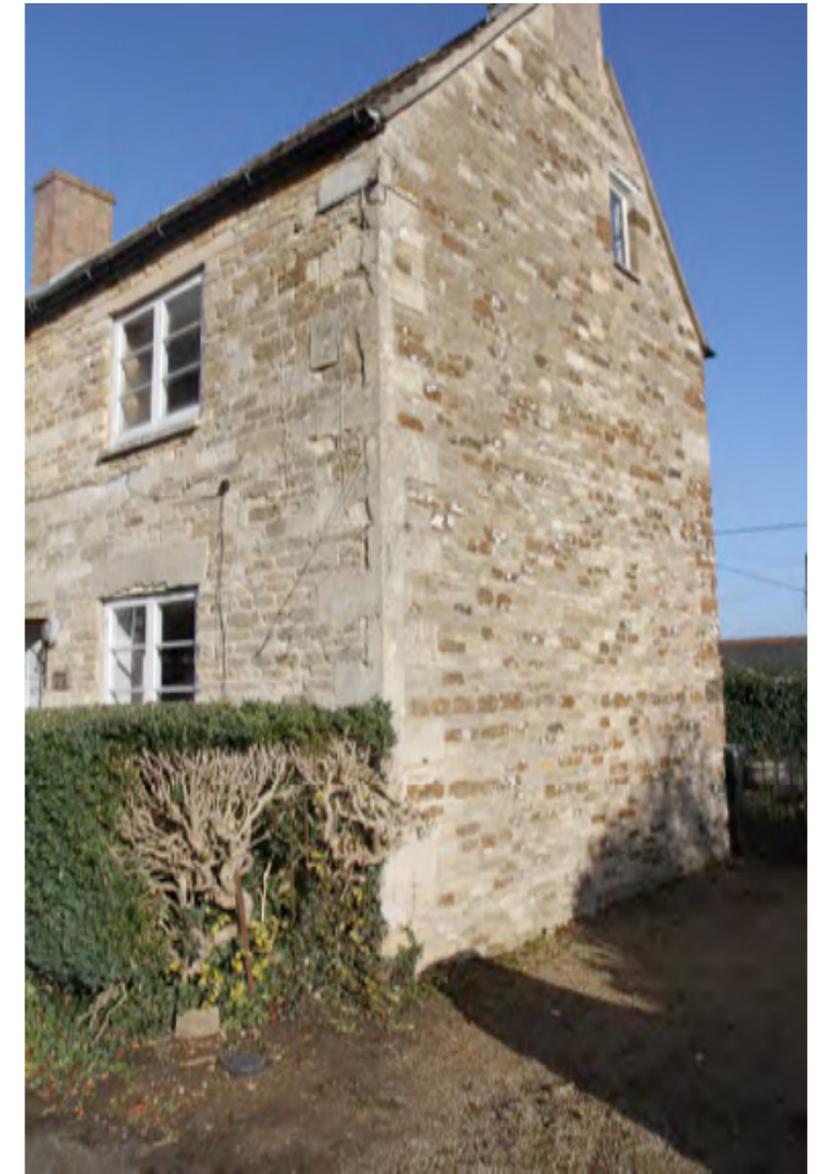
The south gable to the main range is in limestone rubble and ironstone, there are open joints to the corner to the west and at ground level, which require urgent repointing.

At high level there is the single light metal window, general overhaul of this is required together with re-puttying. The cement dubbing has broken away allowing the mortar to ingress behind the flashing, which is causing the damp internally.

Fig.16 - South gable

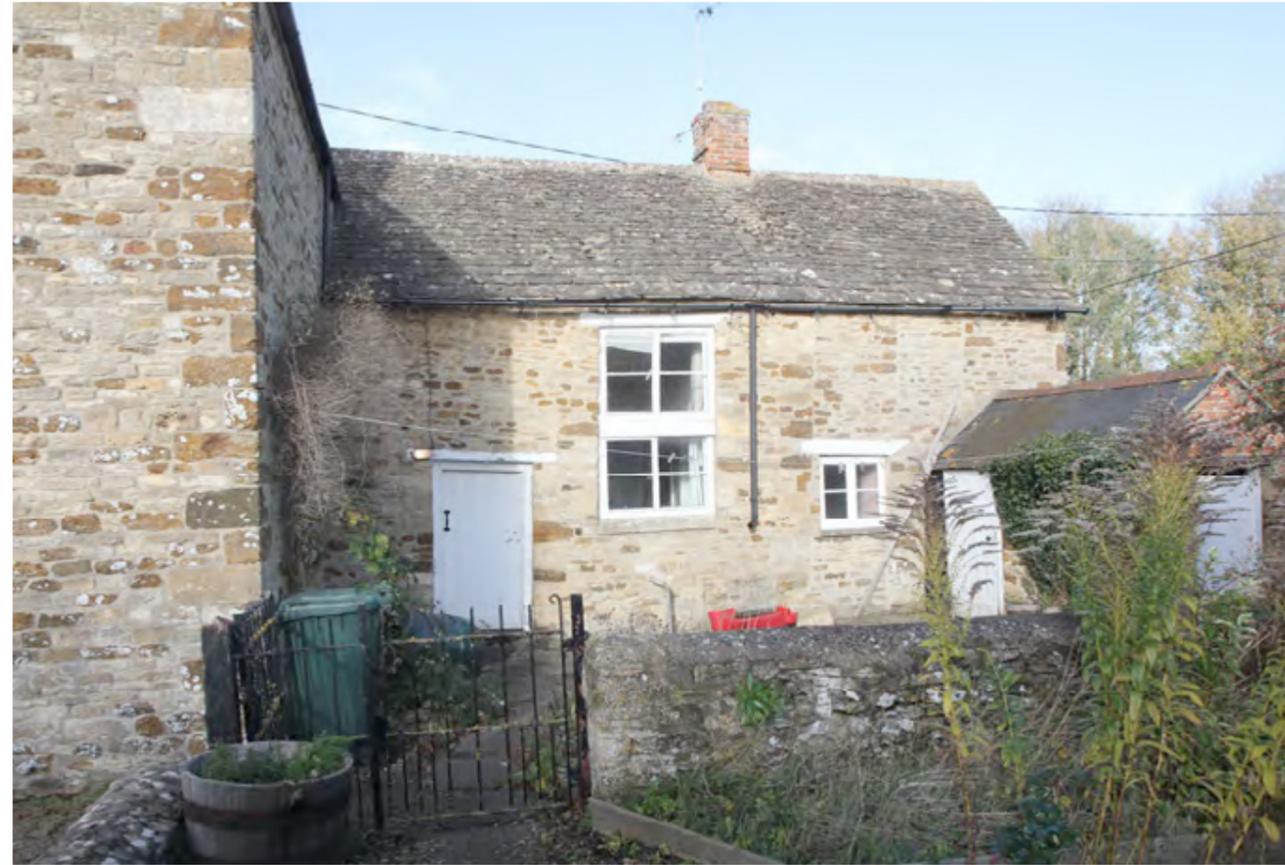
The elevation is a mixture of limestone and ironstone, which has been flush pointed and requires overhaul and repointing. There has been outward pressure from the roof causing movement cracks to the main building and beneath eaves. The movement has occurred to the centre of the wall where the window has distorted. There is also damage to the stonework to the junction with the gable wall to the bathroom section. The main building has been repointed in a hard cement mortar, which is coming away. The general tying in and repointing is required along with an investigation made into the ground conditions in this area to assess the cause of a substantial bow to the wall.

Fig.18 - South elevation to rear wing

The boarded entrance door is in poor condition. There has been some rot to the lower members of the frame, which has been replaced in the past. Overhaul, repair and redecoration is required.

Past repairs to the kitchen window, that have been pieced into the cill, are decaying. Over the replacement metal opening light is a timber lintol, to which there is settlement. The general overhaul and repair is required.

There is a plastic gutter on rise and fall brackets which used to discharge into a now removed rainwater pipe. Improvement of the drainage system here is urgently required.

The roof is formed in stone slates in diminishing courses, which is in poor condition; recovering is required. To the ridge there is a brick chimney to which the brickwork is spalling and the pointing is poor. The general overhaul of this is required.

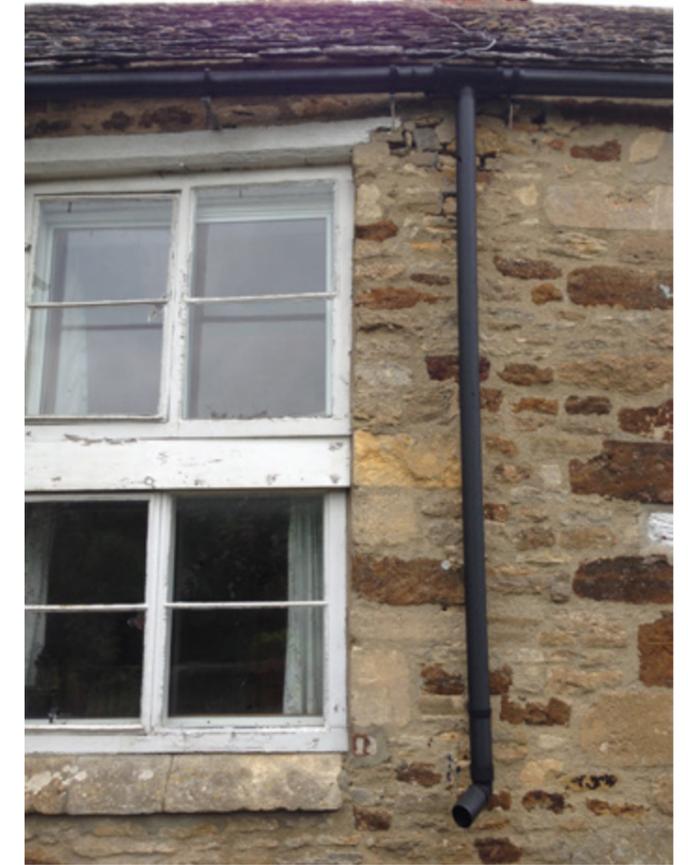
Fig.19 - Stonework condition

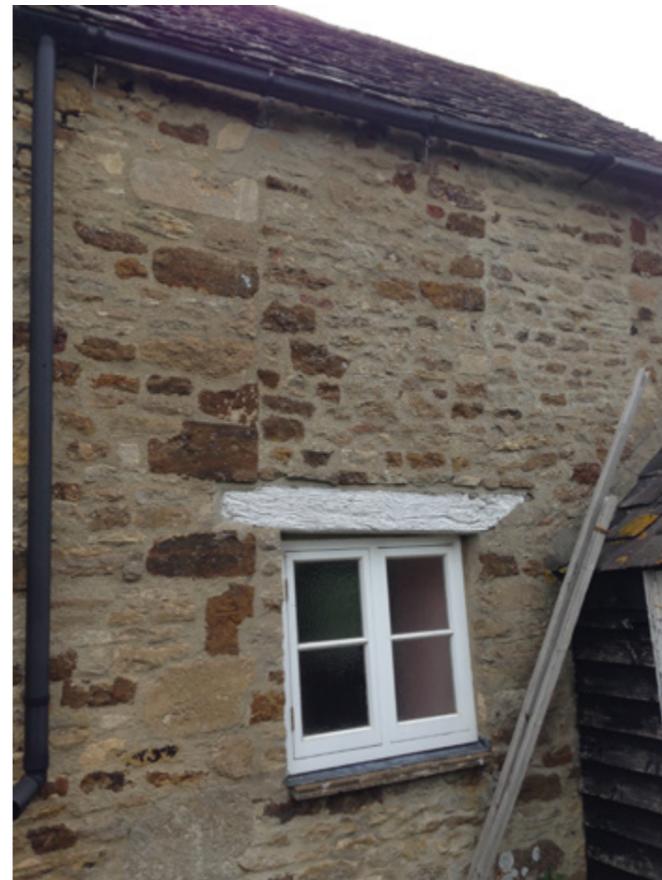
Toward the east of the south elevation is a clear line between the stonework (fig.20) that suggests the wall may have been either rebuilt or is a later addition.

Fig.20 - Line down stonework

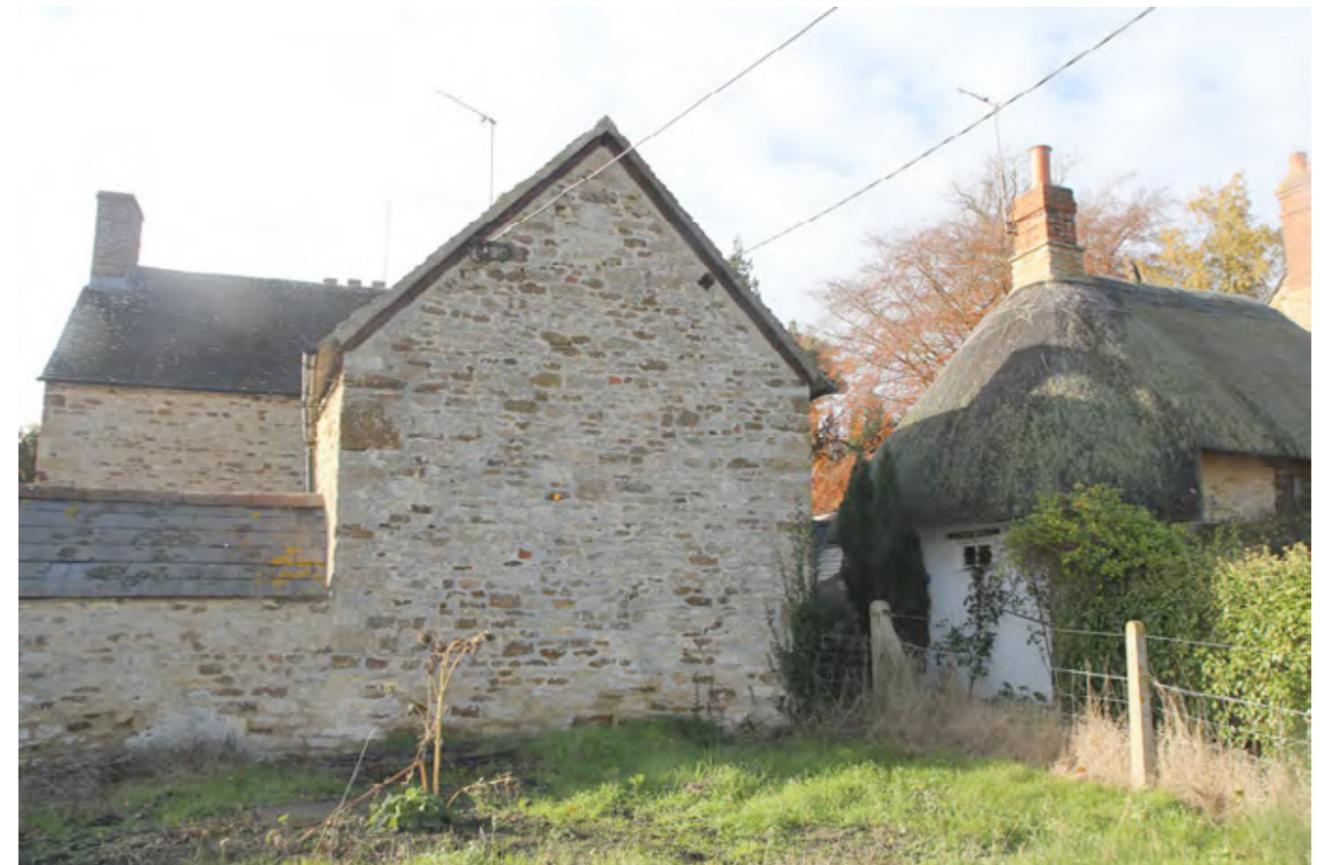
Fig.21 - East gable

The stone gable has considerable opening joints and movement cracks which extend down the centre of the wall to both corners. General repointing is required and overhaul to the gable complete and local replacement of stonework. The incoming electrical mains is fixed to the purlin end, which is clearly not helping the condition of the movement of the gable.

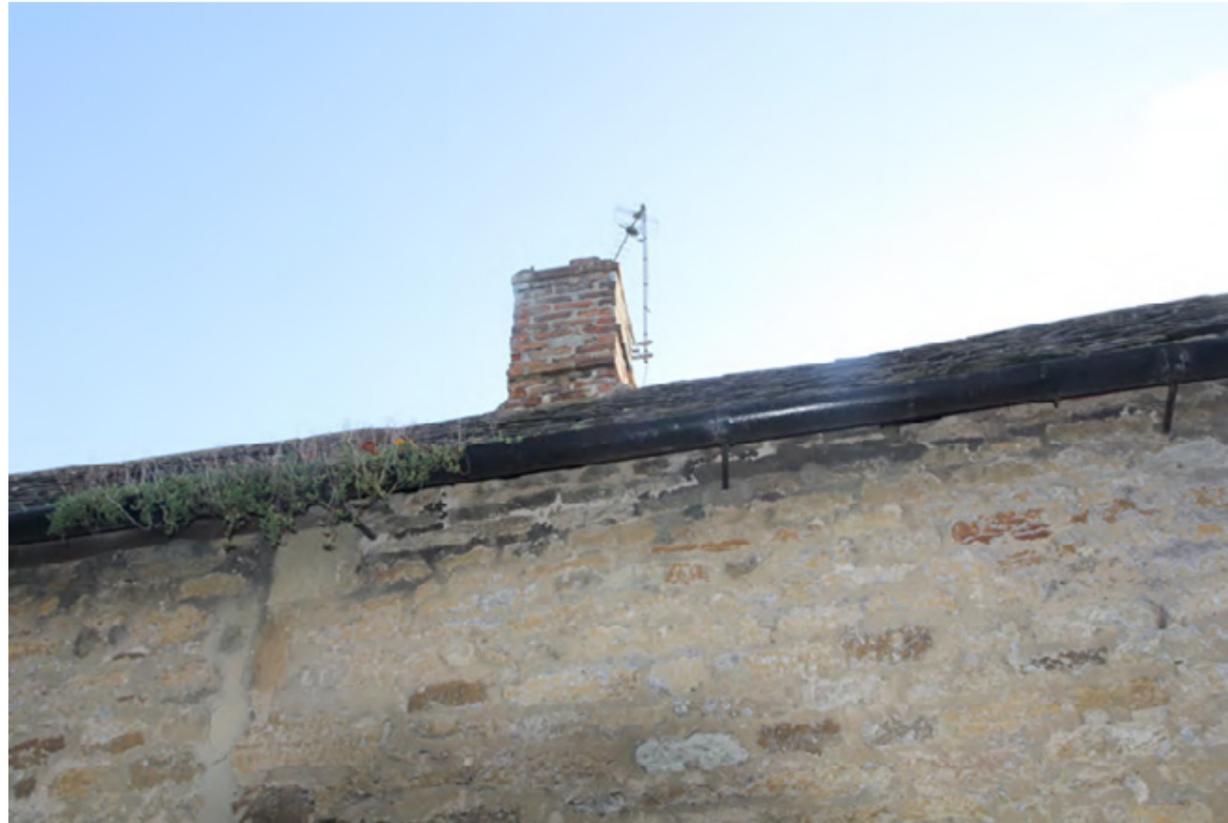
There are movement cracks evident to the bathroom, the general making good and repointing is required. Overhaul and redecoration is required to the timber 2-light casement window and the timber lintol, which is affected by furniture beetle. To the kitchen section again general repointing is required. There is an open joint, which has been pointed in a hard cement mortar between the extension and the main gable; this requires repointing. There is an aluminium gutter on rise and fall brackets, which is blocked, the general cleaning out of this is urgently required. The roof is in stone slates, which are in poor condition, and the general recovering is required. As noted previously, the chimney stack is in poor condition and the overhaul and replacement of brickwork generally is required.

Fig.22 - North elevation to rear wing - joint between the extension

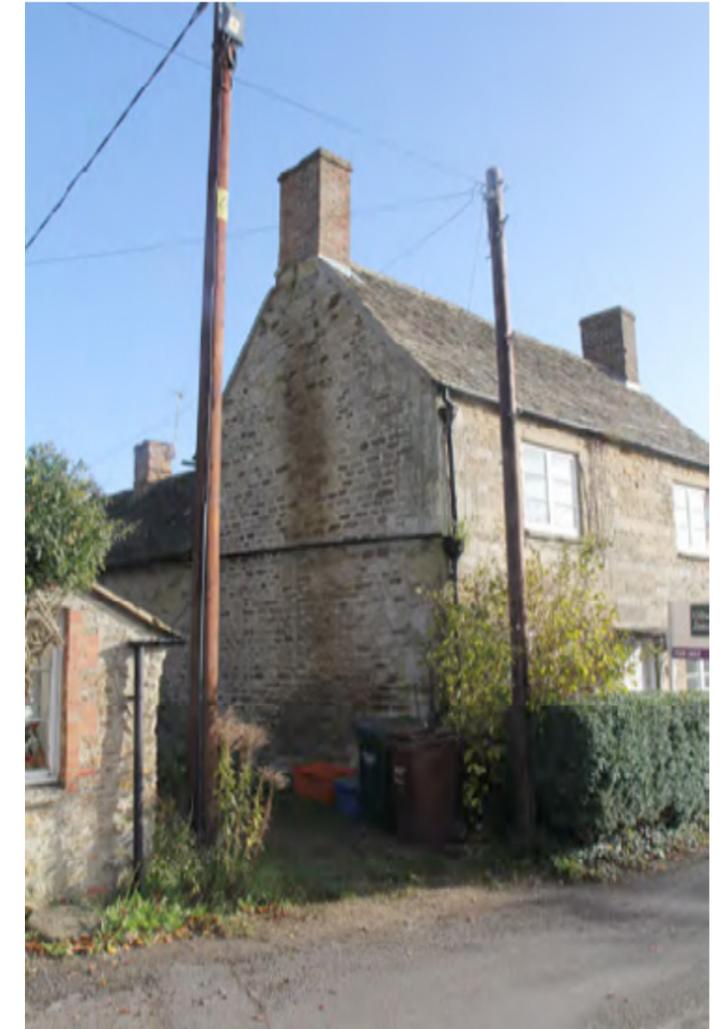
There has been some movement to the stone here, particularly to the corner to the west. The general repointing here is required together with the removal of vegetation. The chimney stack has decayed stonework beneath the brick chimney stack, replacement of this and general repointing is required to an area of approximately 30 sq metres. Extending across the elevation is the aluminium gutter, which discharges into the copper grating to the front elevation. The replacement of this is required in conjunction with improvement of the system

Fig.23 - North gable front section

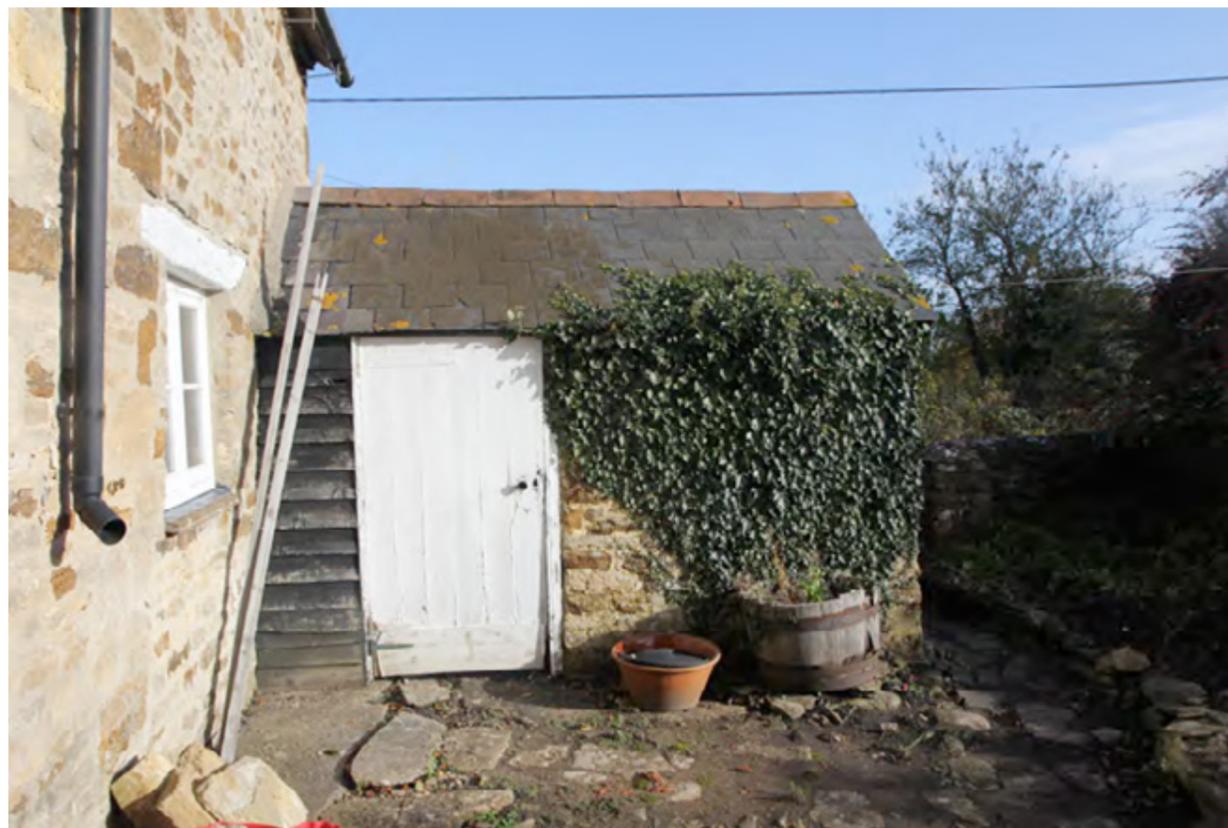
The store are a mix of timber boarding, brick, and stone; and in generally poor condition. Repointing is required as well as the addition of a gutter and replacement of timber lintols. Our proposed works seek to remove the stores and reuse the stone in the new extension.

Fig.24 - Stores

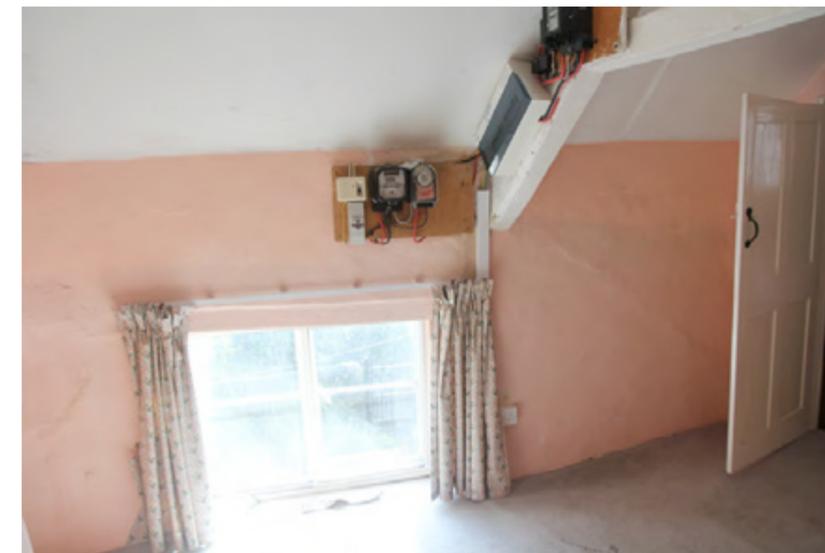
The system is generally poorly installed, with surface mounted wiring that is untidy and detracts from the building.

Fig.26 - Bedroom 2 - electrical incoming mains and distribution boards

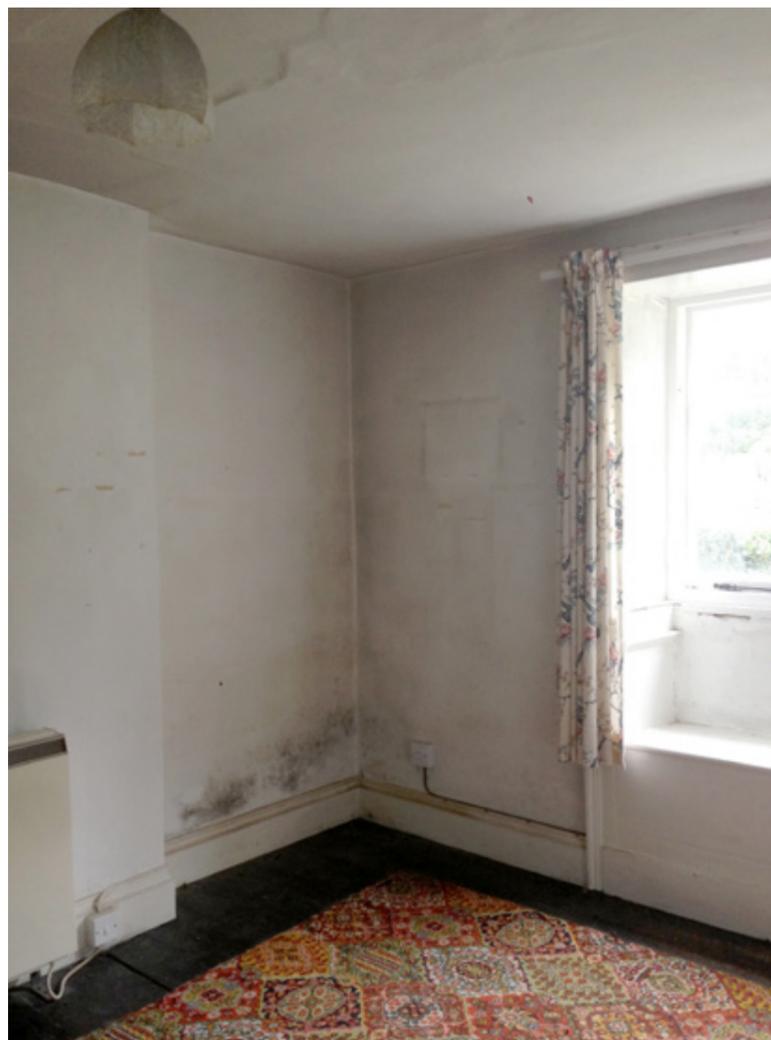
The ground floor suffers from the same problems as the first: Chiefly, high levels of damp, poor quality recent decorations, and movement to walls caused by the outward thrust.

Fig.27 - Dining room - damp

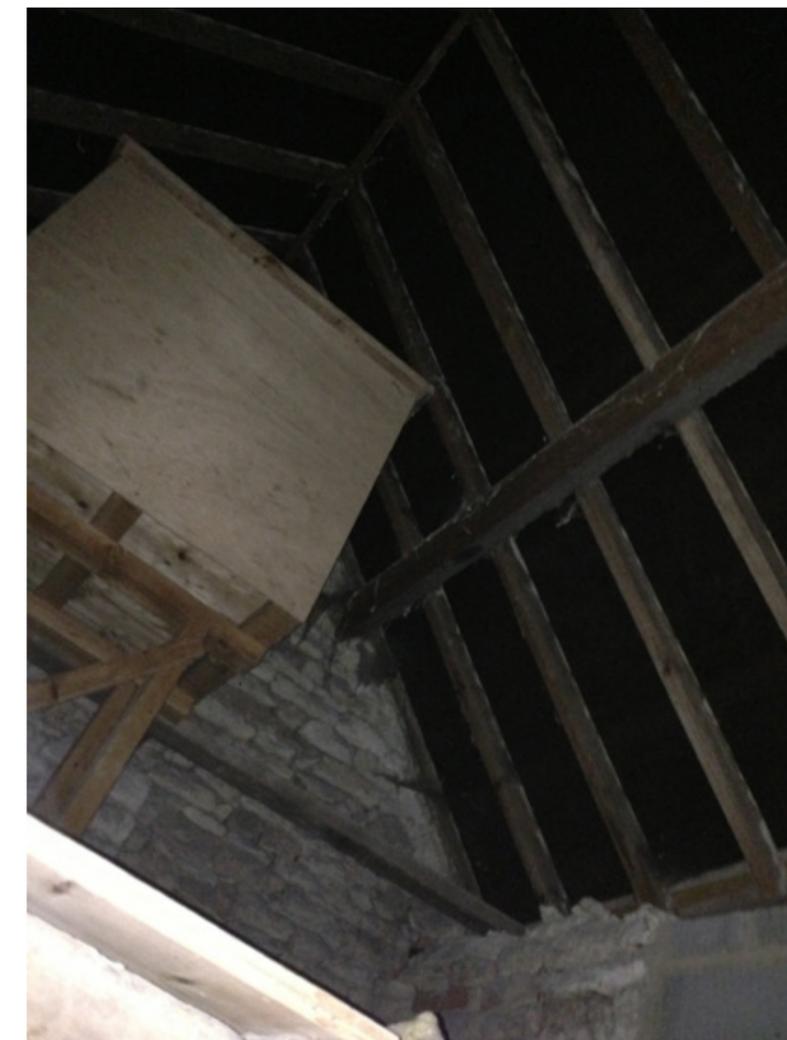
There are newer looking joists and rafters in the roof space above the bathroom that houses the water tank, again this indicates that the eastern end of the building may have been partially rebuilt or be a later addition.

Fig.28 - Bathroom roof space
