Document Title:	Arboricultural Implications Assessment
Document Author:	Matthew Harmsworth, tech.arbor.a, DipRS, RPQ-s
Project Manager:	Matthew Harmsworth
Project Title	BS5837 tree survey @ Cemex / Grundon, Hingham Way, Banbury

Report no: 15_5837_08_03

**Arboricultural implications assessment to BS 5837 of trees at:
Land Adjacent to Higham Way, Banbury, OXON.**

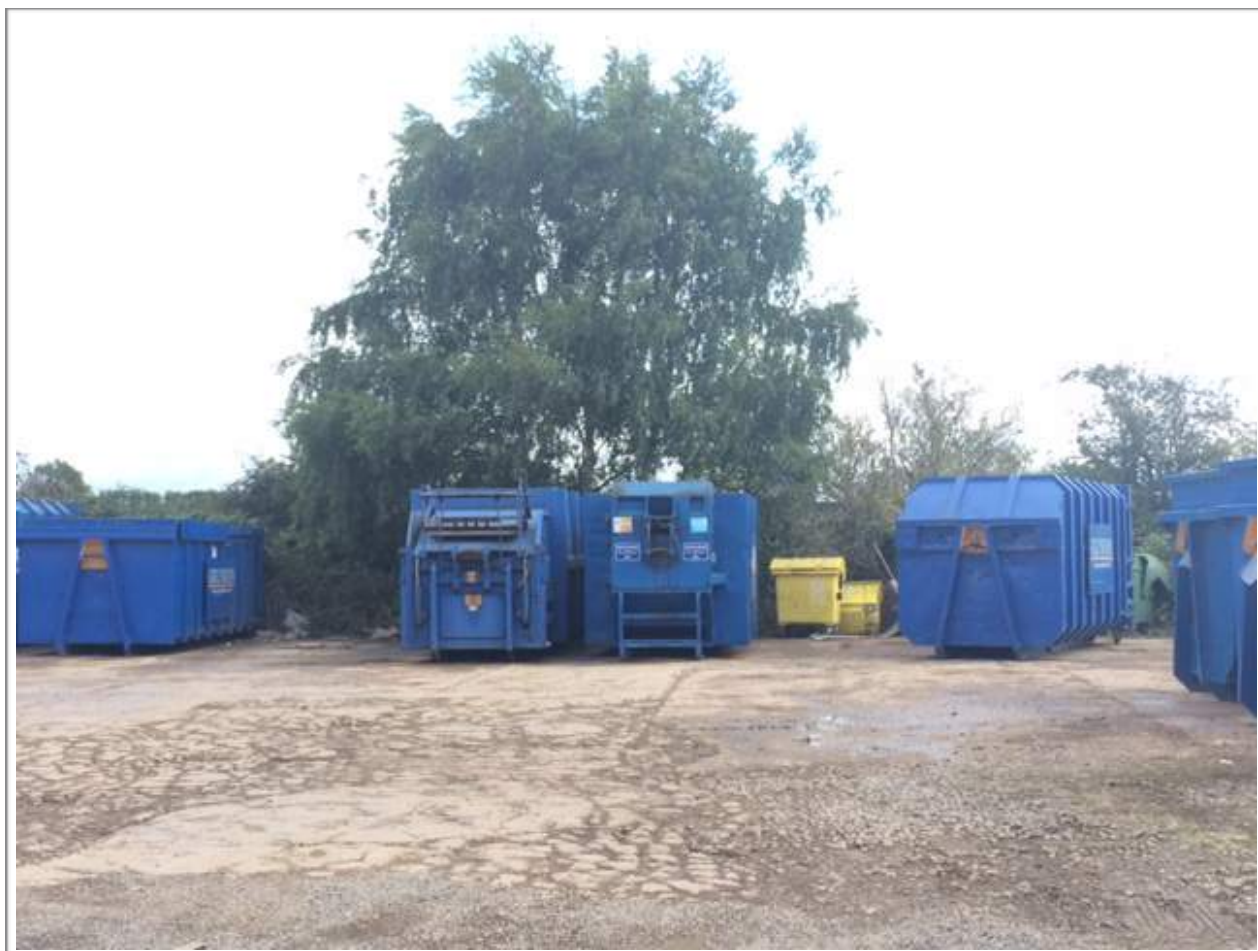
Photographic plate showing the group of silver birches that form G4 on the eastern boundary

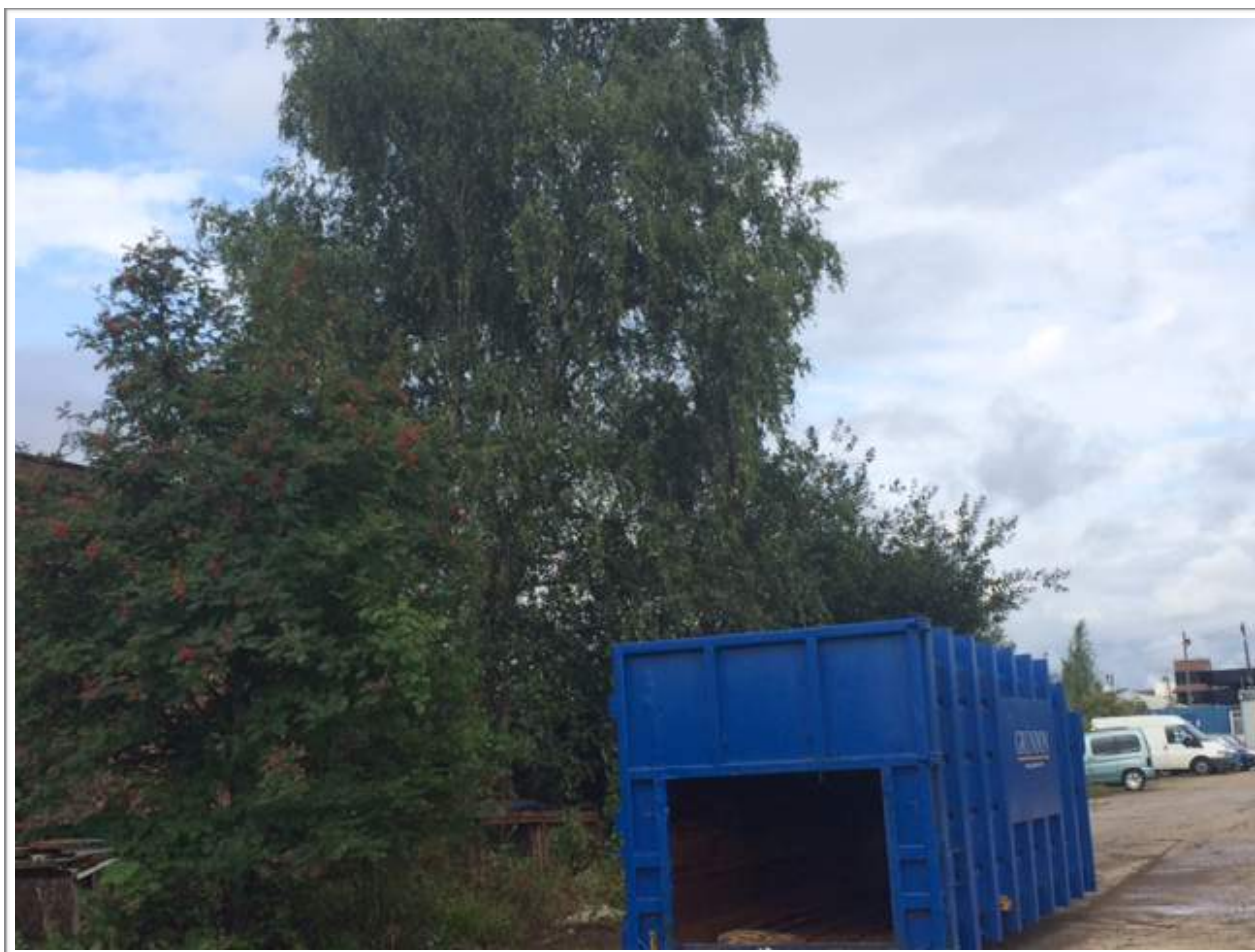
Photographic plate showing tree T1 with T2 in the background

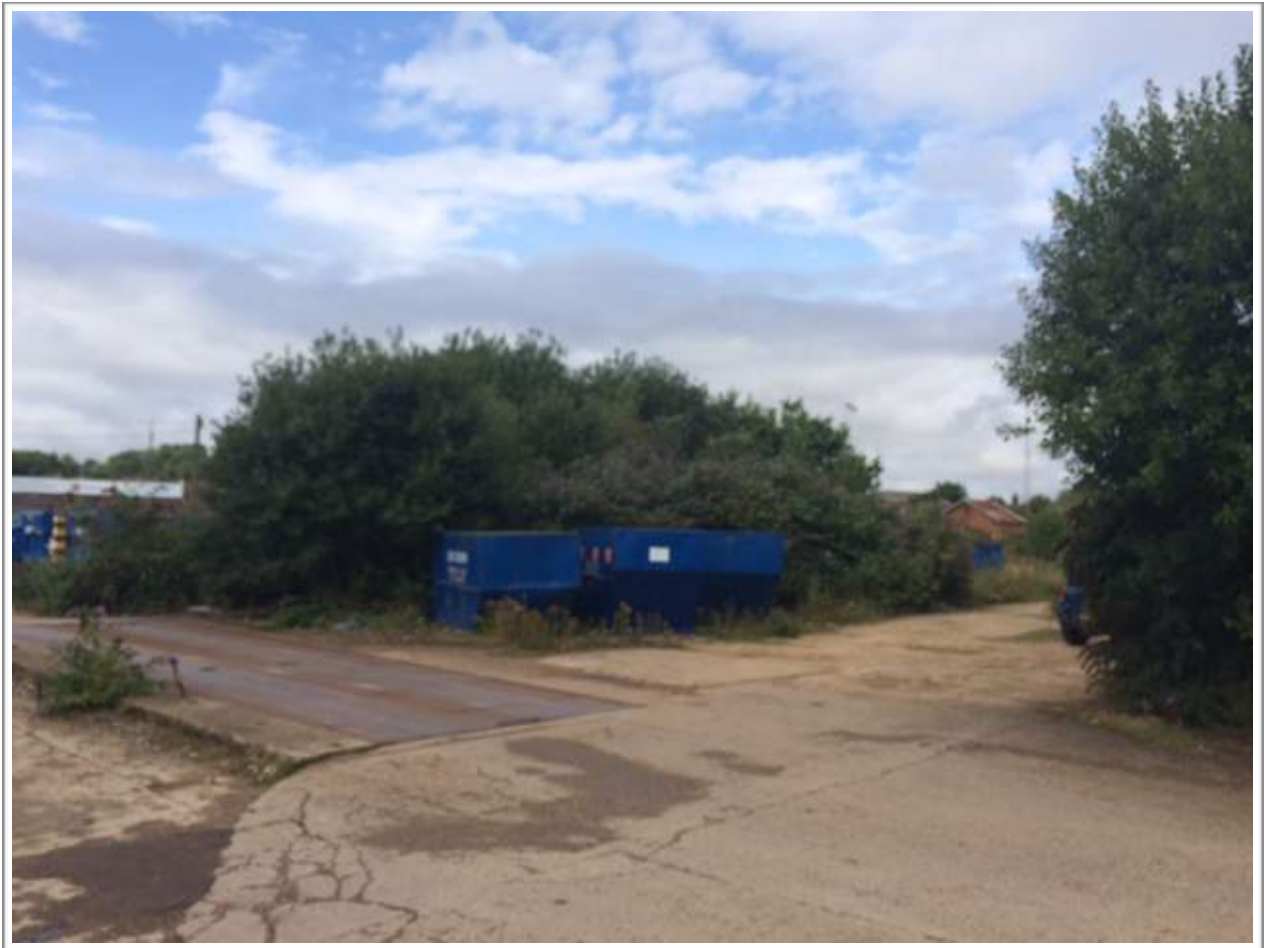
- 5.1 Full details of suggested pruning works and removals are located within the appended arboricultural data tables.
- 5.2 The site currently used by CEMEX and Grundon is populated by low quality self-set regeneration that has come about through a lack of maintenance since the site was abandoned from railway use.

Photographic plate showing typical self-set scrub that occupies the site
