**St. George's Catholic Church,  
Round Close Road, Adderbury, Oxfordshire**

**Protected Species Survey Report**

**November 2015**

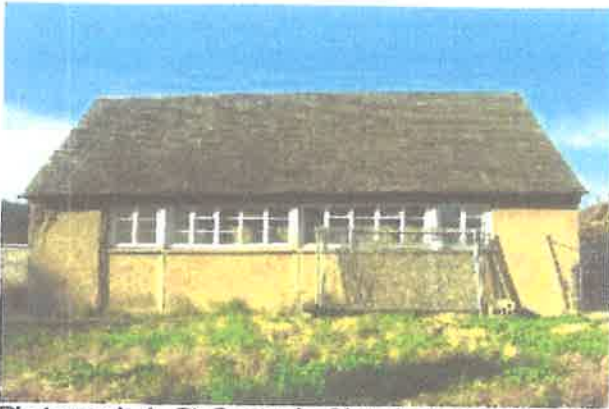
St. George's Catholic Church is thought to date from the mid-20<sup>th</sup> Century and is of a very simple construction. It is a rectangular, single-storey building with external walls of pebble-dash render. The roof is pitched and has a covering of wooden shingles.

Photograph 1. St George's Church viewed from the east.

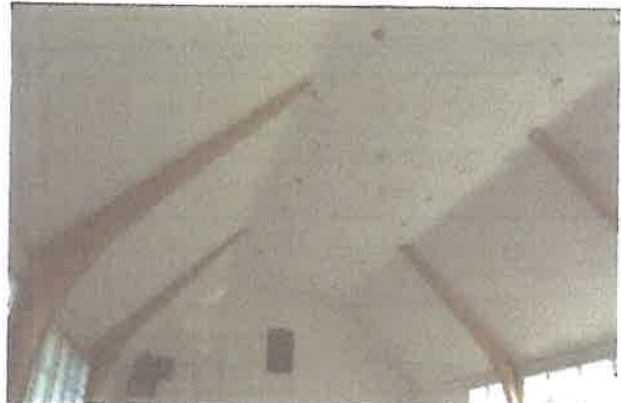
The interior of the building comprises a large room with a smaller room to the rear (south). Both rooms are plastered throughout and there are no loft spaces. Above each room is a small apex void which appears to be no more than 50cm in height. Wooden bargeboards are fixed to the gable ends of the building and wide sloping wooden soffit boards have been fitted at the eaves along the eastern and western elevations. A shallow concrete alcove is present within the northern elevation of the building, above a porch which has a flat roof of concrete.

Photograph 2. The interior space of the church.

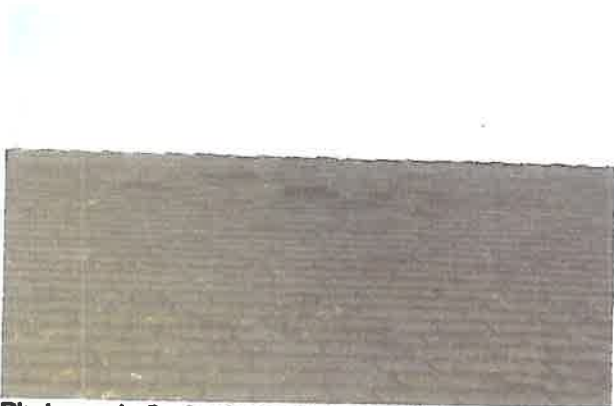
The building is in a good state of repair, with no cracks or gaps observed within the exterior render. The wooden bargeboards are tight fitting. The sloping soffit boards fitted to the eaves on either side of the building are also tight fitting. A number of wooden shingles have become very warped, but these do not appear to create any potential shelter for bats within the fabric of the roof.

Photograph 3. A photograph showing some of the lifted wooden shingles.

Demolition works should proceed in a careful and controlled manner. Contractors should be briefed with regard to the fact that individual bats can often exploit very small crevices as roost sites (such as gaps in beneath wooden shingles and beneath wooden soffits) and that bats can move between roost sites on a regular basis.

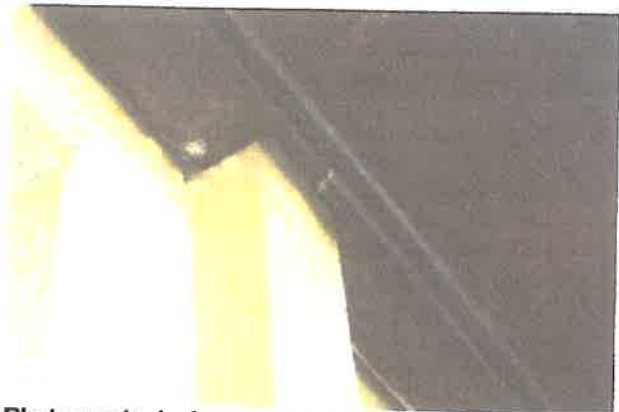
Photograph 4. A gap at the eaves of the western elevation.

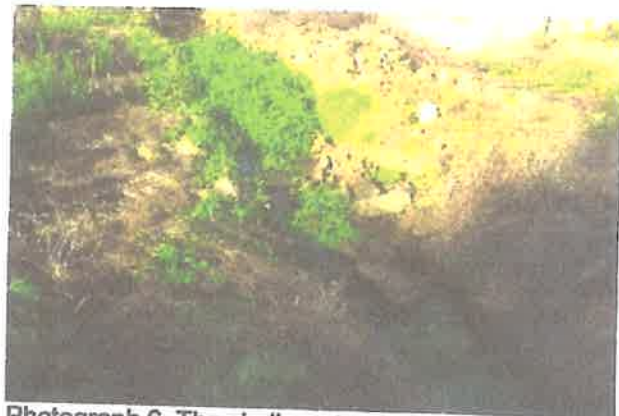
A small stream is present to the southern side of the site. It flows above ground for a short section of its length (approximately 10m) before being culverted beneath adjacent properties. The stream appears to have good water quality and is of 20cm depth at its deepest point, with a bed of rubble and soil. The only aquatic vegetation found within the stream is fool's watercress *Apium nodiflorum*. The banks are shallow and the watercourse has an approximate width of 80cm.

The stream is considered to be an important ecological feature within the context of the site. This is due to the fact that the stream provides habitat for aquatic plants and aquatic invertebrates. The stream is not suitable habitat for otters *Lutra lutra* or water voles *Arvicola amphibius*.

Photograph 6. The shallow stream.

During works to culvert the stream it should be protected from run-off and pollution in accordance with the Pollution Prevention Guidelines from the Environment Agency.
