**St. George's Catholic Church,
Round Close Road, Adderbury, Oxfordshire**

Protected Species Survey Report

November 2015

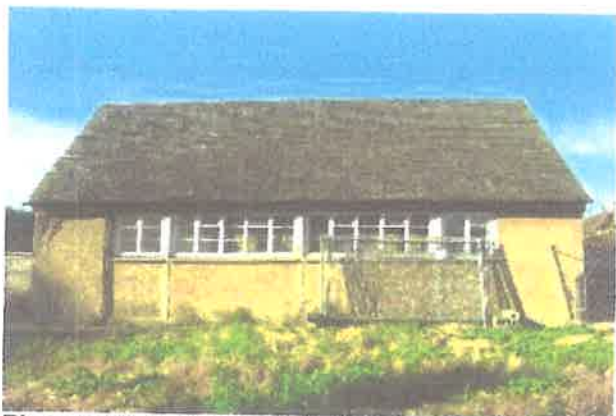
St. George's Catholic Church is thought to date from the mid-20th Century and is of a very simple construction. It is a rectangular, single-storey building with external walls of pebble-dash render. The roof is pitched and has a covering of wooden shingles.

Photograph 1. St George's Church viewed from the east.

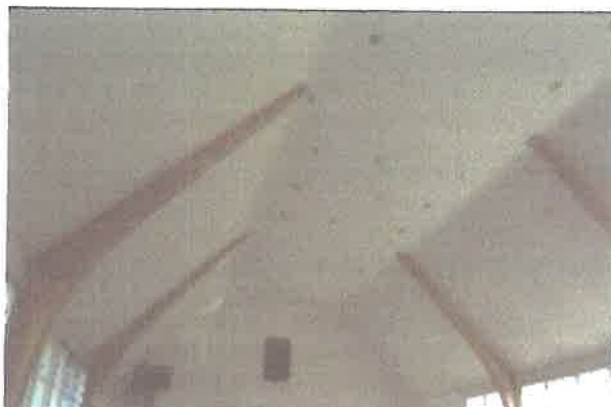
The interior of the building comprises a large room with a smaller room to the rear (south). Both rooms are plastered throughout and there are no loft spaces. Above each room is a small apex void which appears to be no more than 50cm in height. Wooden bargeboards are fixed to the gable ends of the building and wide sloping wooden soffit boards have been fitted at the eaves along the eastern and western elevations. A shallow concrete alcove is present within the northern elevation of the building, above a porch which has a flat roof of concrete.

Photograph 2. The interior space of the church.

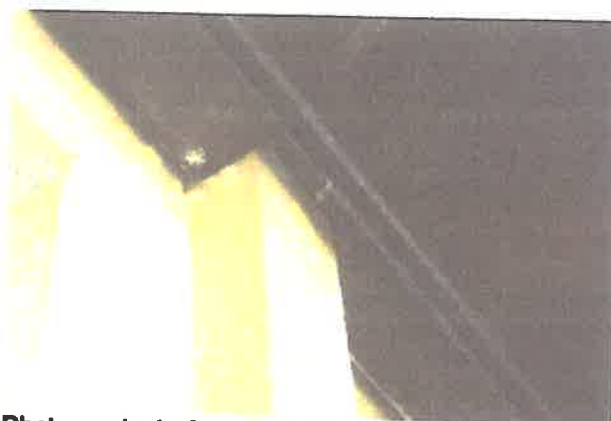
Photograph 4. A gap at the eaves of the western elevation.

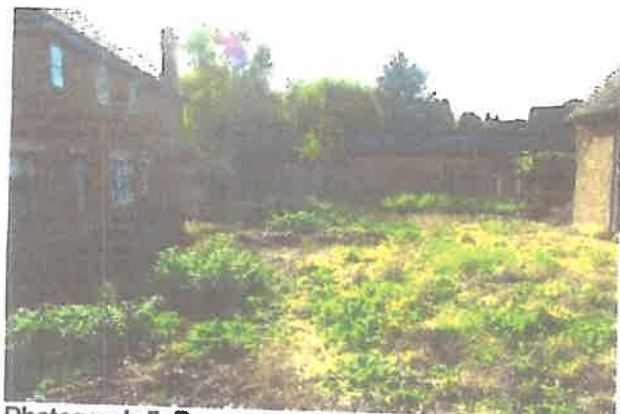
The land surrounding the church comprises an area of bare ground with sparse ruderal vegetation. Species include willowherb *Epilobium* spp., spurge *Euphorbia* sp., herb Robert *Geranium robertianum*, ivy *Hedera helix*, dandelion *Taraxacum officinale*, field speedwell *Veronica persica*, fat hen *Chenopodium album*, stinging nettle *Urtica dioica*, sow thistle *Sonchus* sp., cut-leaved crane's-bill *Geranium dissectum*, dove's-foot crane's-bill *Geranium molle* and wood avens *Geum urbanum*.

The ruderal vegetation is typical of disturbed, urban habitats and waste ground and is of negligible ecological value.

Photograph 5. Bare ground and ruderal vegetation.

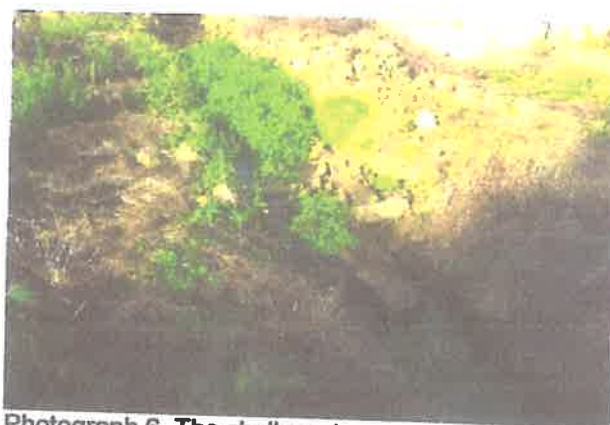
A small stream is present to the southern side of the site. It flows above ground for a short section of its length (approximately 10m) before being culverted beneath adjacent properties. The stream appears to have good water quality and is of 20cm depth at its deepest point, with a bed of rubble and soil. The only aquatic vegetation found within the stream is fool's watercress *Apium nodiflorum*. The banks are shallow and the watercourse has an approximate width of 80cm.

The stream is considered to be an important ecological feature within the context of the site. This is due to the fact that the stream provides habitat for aquatic plants and aquatic invertebrates. The stream is not suitable habitat for otters *Lutra lutra* or water voles *Arvicola amphibius*.

Photograph 6. The shallow stream.

During works to culvert the stream it should be protected from run-off and pollution in accordance with the Pollution Prevention Guidelines from the Environment Agency.
