# Preliminary Arboricultural Impact Assessment

Bicester Airfield, Skimmingdish Lane, Bicester,  
OX26 5HA

Ridge & Partners LLP

Address	Bicester Airfield, Skimmingdish Lane, Bicester, OX26 5HA		
Client	Ridge & Partners LLP	Client Ref	
ES Ref	D0807161029	Consultant	Jonnie Setterfield BSc (Hons)
Report Date	11 August 2016	Quality Checked	Karen Carr
Technical Arboriculture Approved John Graham PhD BSc

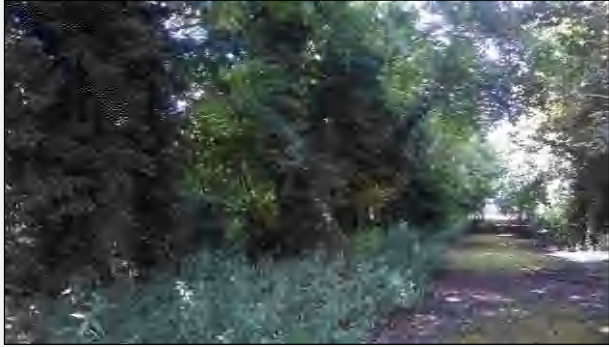
Tree No.	Species	DBH	No of Stems	Ht (m)	N	E	S	W	BS Cat	Age Class	Life Expect	Cr Ht (m)	Observation	Recommendations	RPA (m2)
W1	Mixed Species woodland mainly comprising of Ash, Elm, Acer sp and Prunus sp with other understory species.	0.25	M/s	12	2	2	2	2	C2	Early-Mature	10_19	1	Woodland boundary trees, between airfield and highway. No significant recent crown management. Dutch elm disease present. 3rd party offsite trees, unable to fully inspect. Offsite boundary trees with overhanging branches.	No Works.	20
TG1	Ash, Elm, Elder and Hawthorn.	0.2	M/s	6	3	3	3	3	C2	Early-Mature	10_19	0.5	Poor form, shape and condition. Unable to inspect due to restricted access. Offsite boundary tree with overhanging branches. Hedgerow standard tree. Self-set, pioneer tree. Dead Elms	Cut back to boundary line, and remove all dead elm trees.	13
TG2	Ash, Sycamore, Elm, Elder and Hawthorn.	0.2	M/s	6	3	3	3	3	C2	Early-Mature	10_19	0.5	Poor form, shape and condition. Unable to inspect due to restricted access. Offsite boundary tree with overhanging branches. Hedgerow standard tree. Self-set, pioneer tree. Dead Elms	Cut back to boundary line, and remove all dead elm trees.	13
