Claydon Marina

Follow-up report – Revision 3

858429

RSK

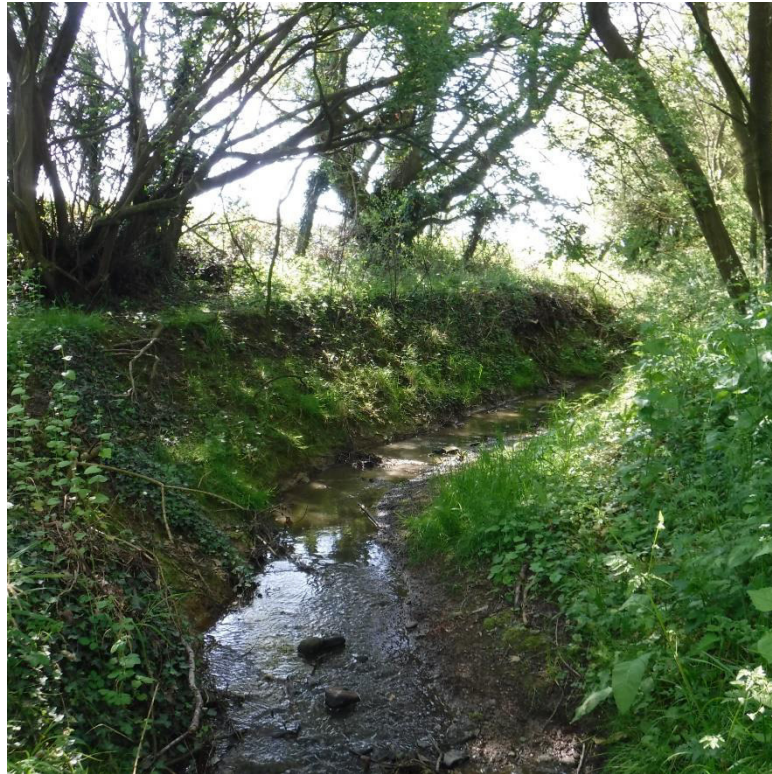
The channel downstream of the culvert is similar to the upstream channel with shallow areas of slow flowing glide or no perceptible flow. Short sections of shallow run or riffle were noted, particularly alongside depositional features such as side or point bars. Several CWD dams were present creating short impoundments of deeper (c.20 cm) glide. The development includes plans for a small headwall within this section (outfall from the proposed clubhouse sewage treatment plant) approximately 250 m downstream of the culvert. The habitat around the proposed headwall location is a mixture of shallow glide and shallow run (<10 cm depth) over a mixed substrate of clay and silted pebble and gravel. The proposed headwall location is on the RHB which is tall, steep and vegetated (Figure.2).

Figure 2 – Facing upstream looking at the approximate proposed headwall location

- Headwall installation – disturbance to the banks and bed of the brook should be minimised as much as practicable. Having an ecological clerk of works (ECoW) on site during headwall installation would be advisable to assess the exact placement locations for protected species (such as water vole & white-clawed crayfish) and provide advice to minimise disturbance to the watercourse.

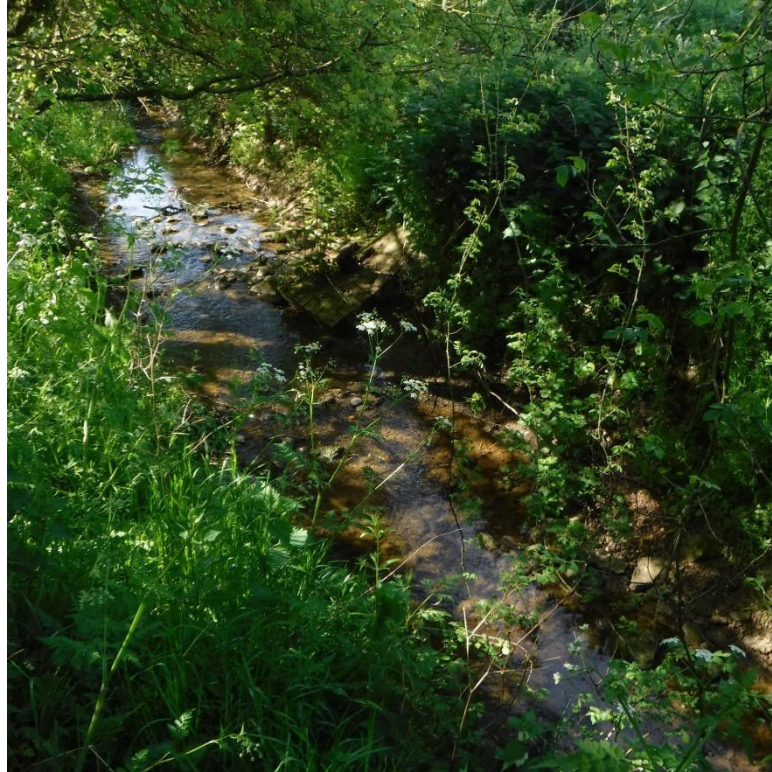
A short distance downstream of the proposed headwall location the channel has been historically re-aligned for c.400 m, presumably during construction of the now defunct railway, of which little visible evidence still exists except for old fencing. Access is poor along much of this reach being inhibited by dense riparian vegetation. Sufficient gaps existed to permit a survey to be undertaken. Habitat does not vary significantly in this reach from that present upstream being predominantly a mix of shallow glide and very shallow run over a mix of clay and silted pebble / gravel substrates (Figure.3).

Figure 3 - Shallow run habitat within historic straightened section

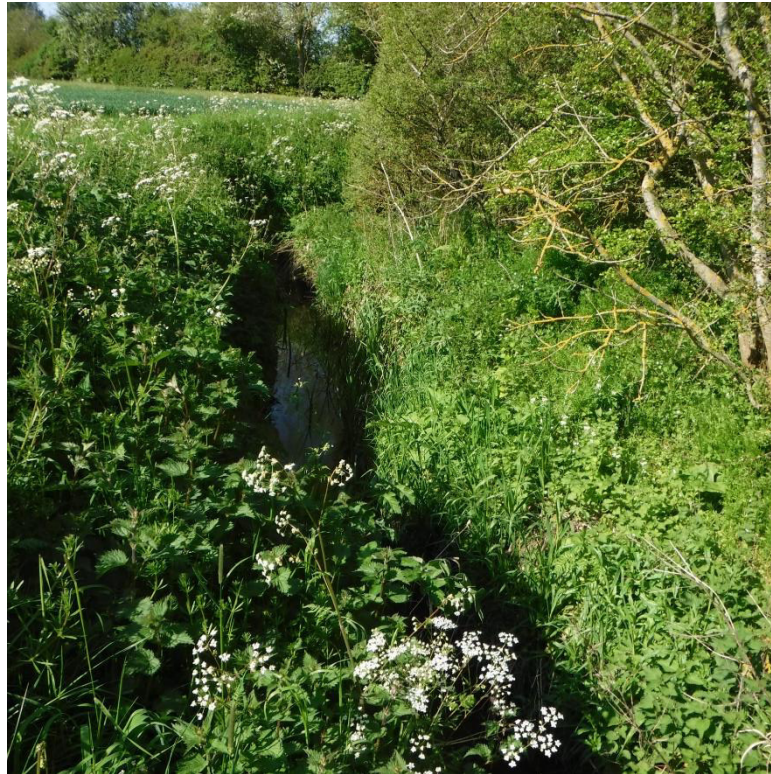
As the brook exits the culvert it flows through an over-deepened section with the RHB being particularly steep and overgrown (Figure 4). Flows are sluggish throughout this section mainly comprising shallow glide (c.10 – 30 cm depth). This section represents the first part of the survey reach outside of wooded areas and as such shading is significantly reduced allowing emergent macrophyte species to grow within the channel. This section may provide potential water vole (*Arvicola amphibious*) habitat.

Figure 4 - Facing upstream - over-deepened section with glide habitat
