Arboricultural Report& Method Statement

Muddle Barn Farm, Sibford Gower Oxfordshire, OX15 5RY.

August 2018

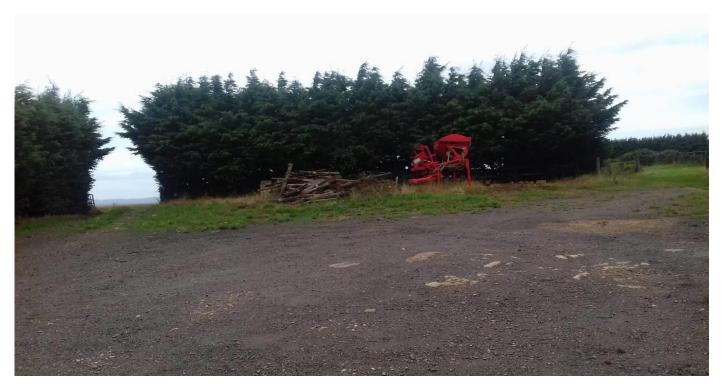
1/ G1 – Leyland Cypress

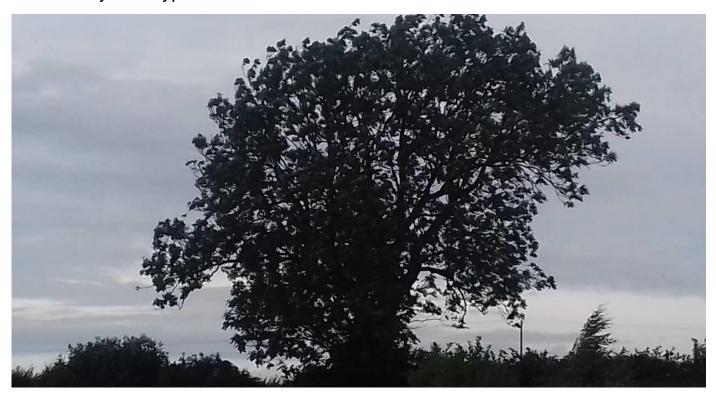
- ➤ Two mature ash trees (T2 & T19). Both are hedgerow trees which were not fully accessible. The latter is in poor condition with limited life expectancy.

2/ T2 - Ash

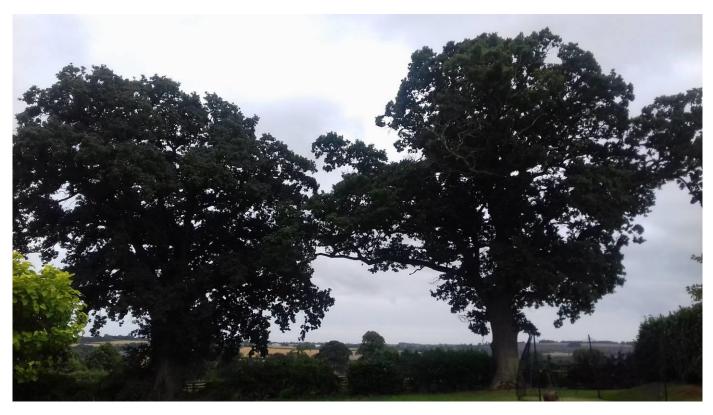
T12	English Oak (Quercus robur)	16	1030	7	8	8	8	4w	4	М	40+	Moderate basal damage north, several occluding pruning wounds on main stem, moderate sized deadwood throughout crown. Crown lift to 4.5m if using drive for access.	A1	12.30
T13	English Oak (Quercus robur)	17	1030	6	9	7	6	4	4	М	40+	No significant features. Crown lift to 4.5m if using drive for access.	A1	12.30
T14	English Oak (Quercus robur)	4	210	3	3	3	3	2	2	SM	40+	Small suppressed tree. Crown lift t0 4.5m if using drive for access.	C1	2.40

3/ Off-Site Oaks T13 & T12

- 4.18. **Remedial Tree Works:** Trees T12 T16 should undergo crown lifting to 4.5m before any large vehicles are brought onto site.
- 4.19. **Use of Herbicides**; No herbicide use is planned.

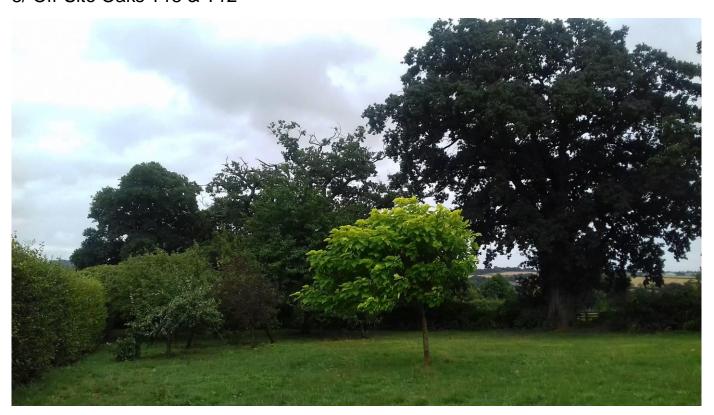
4/ Off-Site Oaks T16 & T14
