# ARBORICULTURAL REPORT, IMPACT ASSESSMENT AND METHOD STATEMENT

# Muddle Barn Farm, Sibford Gower, Oxfordshire OX15 5RY.

**Date:** 02/09/18

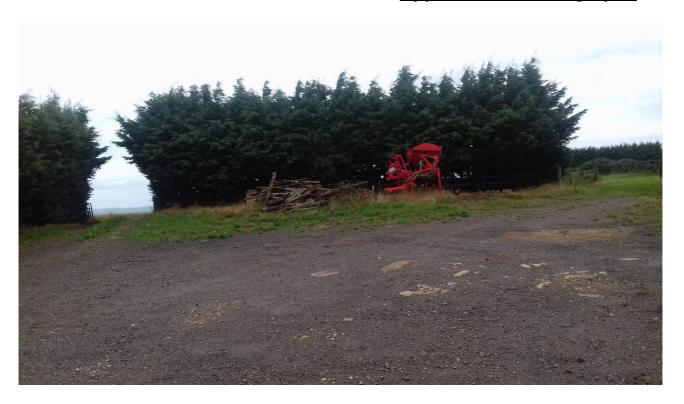
1/G1 - Leyland Cypress

- ➤ Several groups of close planted early mature Leyland cypress trees (G1 & G6 G10). It is assumed these were planted for screening purposes. They are out of keeping with the local landscape and are of little arboricultural merit.

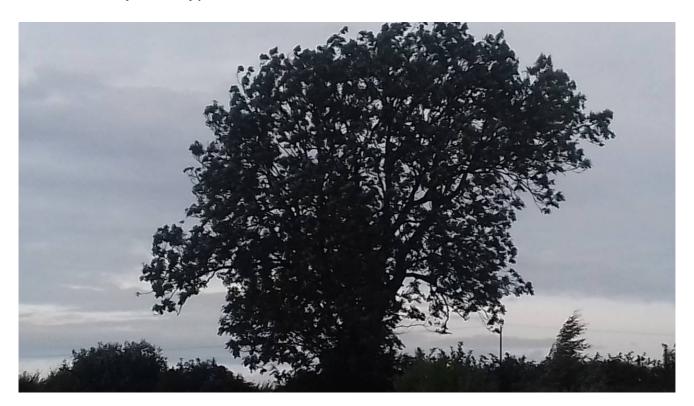
2/ T2 - Ash

- ➤ Two mature ash trees (T2 & T19). Both are hedgerow trees which were not fully accessible. The latter is in poor condition with limited life expectancy.

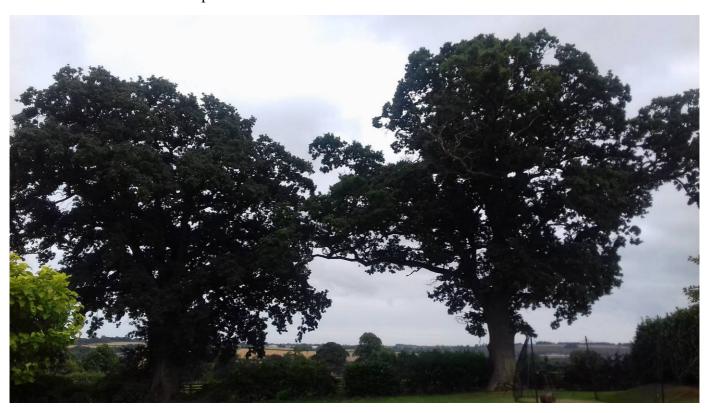
3/ Off-Site Oaks T13 & T12

T12	English Oak ( <i>Quercus robur</i> )	16	1030	7	8	8	8	4w	4	M	40+	Moderate basal damage north, several occluding pruning wounds on main stem, moderate sized deadwood throughout crown. Crown lift to 4.5m if using drive for access.	A1	12.30
T13	English Oak ( <i>Quercus robur</i> )	17	1030	6	9	7	6	4	4	М	40+	No significant features. Crown lift to 4.5m if using drive for access.	A1	12.30
T14	English Oak ( <i>Quercus robur</i> )	4	210	3	3	3	3	2	2	SM	40+	Small suppressed tree. Crown lift t0 4.5m if using drive for access.	C1	2.40

13.1 Trees T12 – T16 should undergo crown lifting to 4.5m before any large vehicles are brought onto site.
