The Old Malthouse St. John's Road Banbury Oxfordshire NGR: SP 454 400

A Heritage Impact Assessment of Proposed Development

July 2017 **Mercian Heritage Series No.1126**

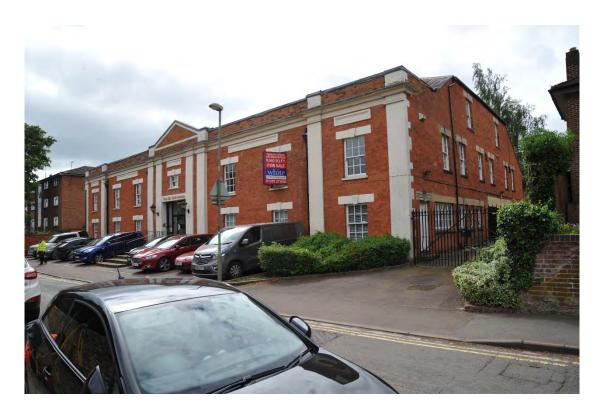
At the wall head is a simple painted stone entablature and above that, a solid brick parapet. This is, oddly, made of cruder bricks than the rest of the wall beneath. It was capped by a painted stone coping – as shown on the older aerial photographs – but it is unclear how much of that survives beneath the modern lean or zinc overhang that now tops the parapet.

The tall and glazed central doorway and main entrance, and the stepped approach to it, have obviously been modernised in the recent past. Above is a small window with modern balanced sash; the brickwork beneath its sill has been disturbed and made good.

Pl.2: The front, or north, elevation from the north-west.

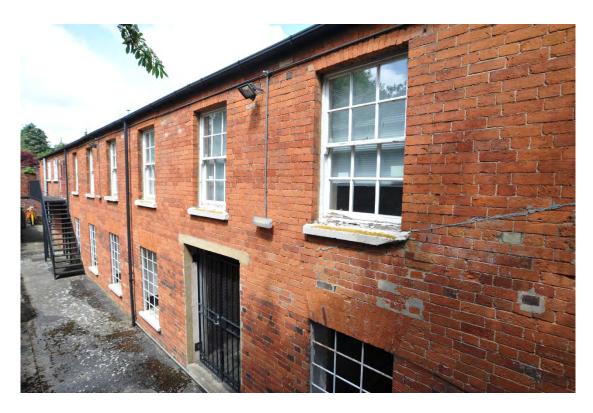
The two left-hand windows at ground-floor level have higher sills than the others; the one at the very left-hand end could be a primary opening of this shape and size. The one next to it has been altered; the present window does not quite fit beneath an original flat-arched brick head. It appears that an original window was replaced by a doorway – and then that was blocked and replaced by the present window.

The glazing of all the windows has been replaced. There are modern horned sashes in most of the first-floor windows and some mof the ground-floorm ones have iron barred openings to match.

Pl.4: The rear elevation from the south-east.

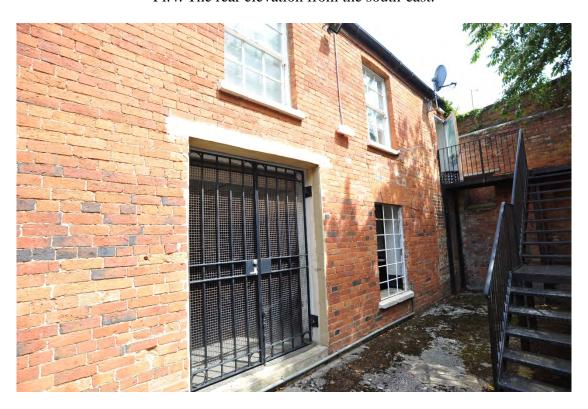
Pl.5: The eastern end of the rear elevation.

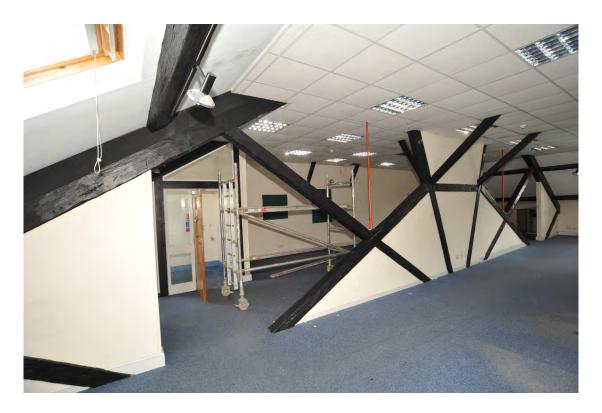
The jointing of the roof timbers seems to be of simple shouldered mortice and tenons with no indication of pegging. The joints are, however, mostly hidden by modern steel reinforcing plates presumably added in the recent past.

Pl.9: The exposed section of the westernmost truss, viewed from the second floor.

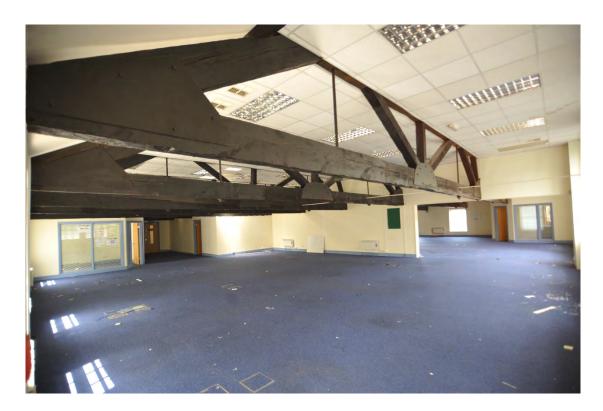
Pl.10: Some of the trusses visible at first-floor level; the tie-beams are in two sections.

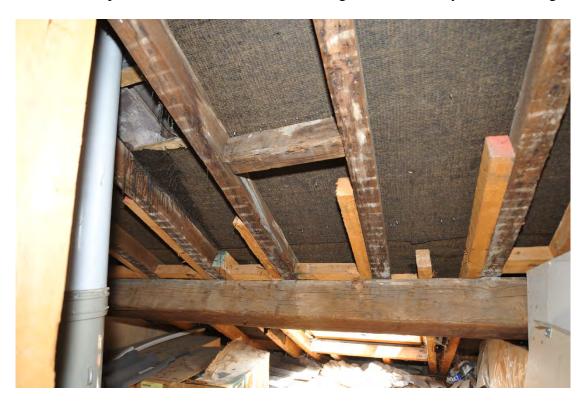
There is evidence in some original rafters to show that they were once covered by lathand-plaster; this, coupled with the existence of the roof lights, clearly indicates that the first floor was either open to the roof or, more likely, that there was a loft throughout the building.

Pl.12: Evidence of lath-and-plaster in the roof spece as well as trimmers between rafters and recently inserted rafters.

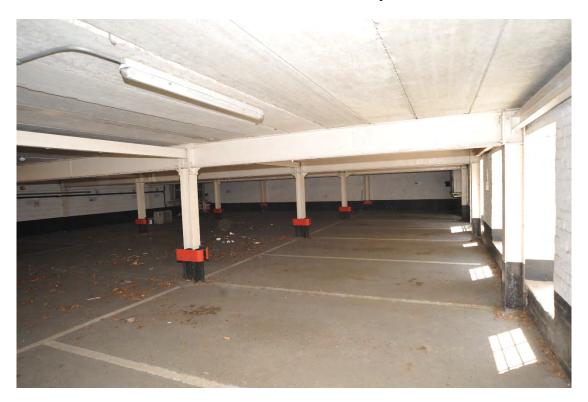
Pl.14: The bulk of the ground floor of the building is a covered car park; note the RSJ stanchions and concrete first floor, presumably dating to the engineering works phase.

The replacement of an original internal first floor and its replacement with a concrete floor on RSJ stanchion and girder support probably occurred in the mid-20th century when the building was converted into an engineering works.

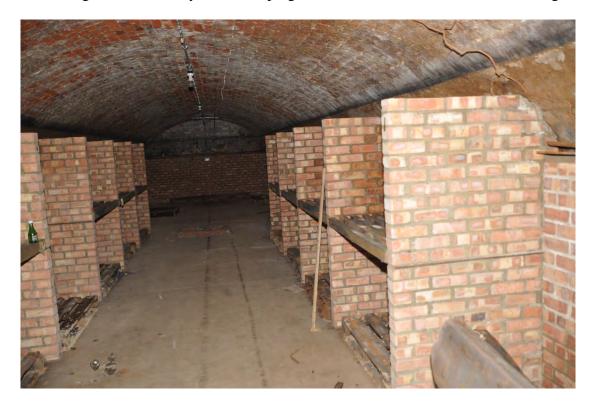
Pl.19: Below the terrace; the brick walls of the shelving is quite modern.
