Himley Village, Bicester

Desk Study

Countryside Properties PLC

Doc ref: 16153-HYD-XX-XX-GE-DS-1001-S2-P01

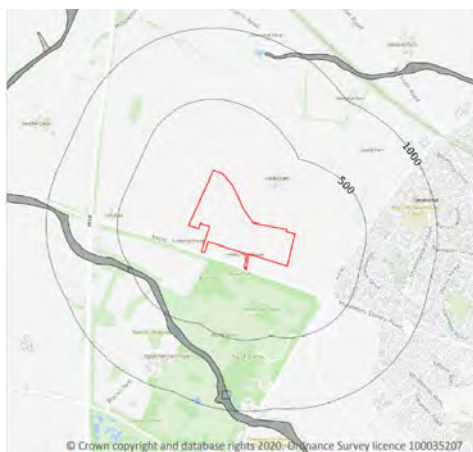
Figure 2.7: Superficial deposits. (Reproduced with permission from Groundsure)

Ref. for Figures	Location	Stratigraphic Name	Description
Superficial Deposits (Figure 2.7)			
None recorded.			
Solid Geology (Figure 2.8)			
1 (shown as pink on Figure 2.8)	On site.	Cornbrash Formation	Medium to fine grained limestones with intense bioturbation and poorly bedded. Bluish grey weathering to olive or yellowish brown. Beds of weathered clay encountered in the Hydrock investigation.
2 (shown as dark yellow on Figure 2.8)	On site underlying the Cornbrash Formation. Outcropping, to the south west and north.	Forest Marble Formation	Greenish grey calcareous mudstone with banks and channels infilled with variable cross bedded limestones. Beds of weathered greenish grey clay encountered in the Hydrock investigation.

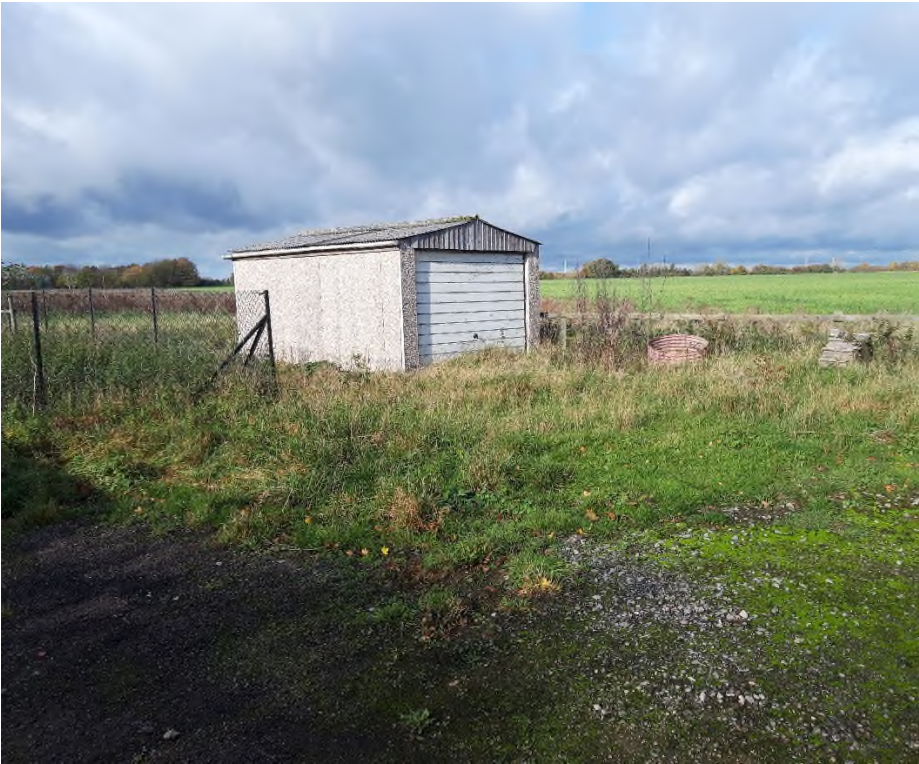
<p>Desk Study Photograph 3</p>

<p>Date: 03/11/20</p>	
<p>Direction Photograph Taken: North west from southern east of western field.</p>	
<p>Description: Garage with a probable asbestos cement roof. Located off site, immediately west.</p>

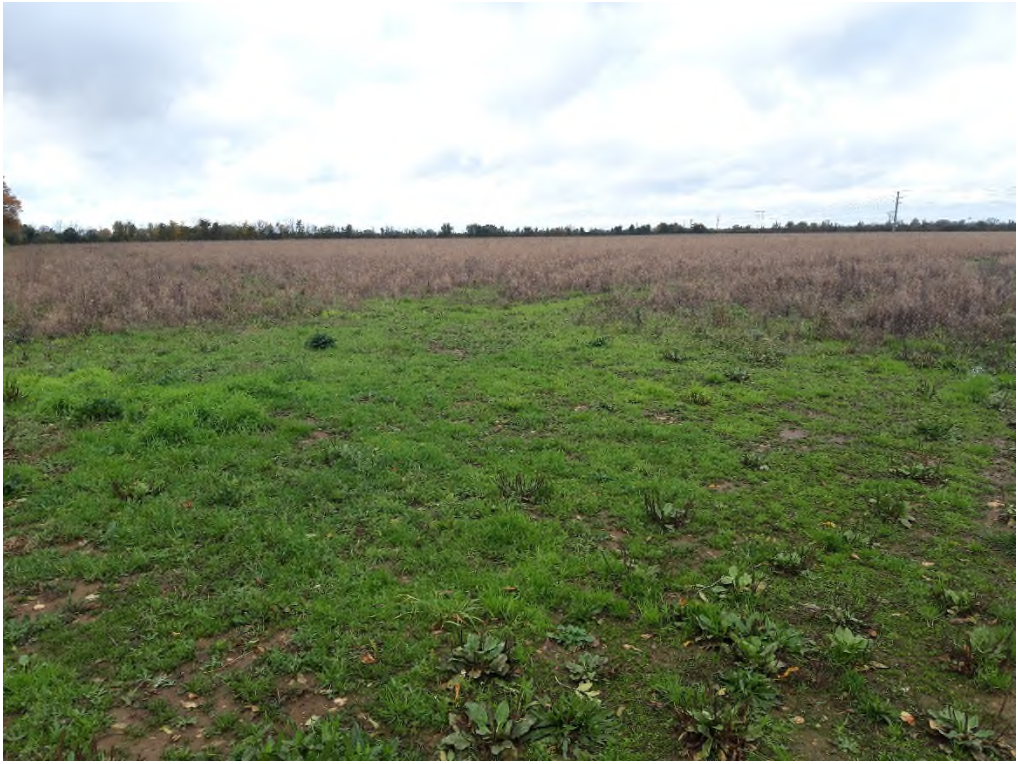
<p>Desk Study Photograph 9</p>

<p>Date: 03/11/20</p>	
<p>Direction Photograph Taken: North west from the south east of the eastern field.</p>	
<p>Description: Agricultural field forming the eastern field of the site.</p>
