P3 Eco (Bicester) Ltd & A2 Dominion Group Ltd
NW Bicester Eco Development
Geotechnical Interpretative Report - Masterplan Site

Geotechnical Interpretative Report - Masterplan Site

Report No 2507-UA001881-UP33R-01

Date February 2011

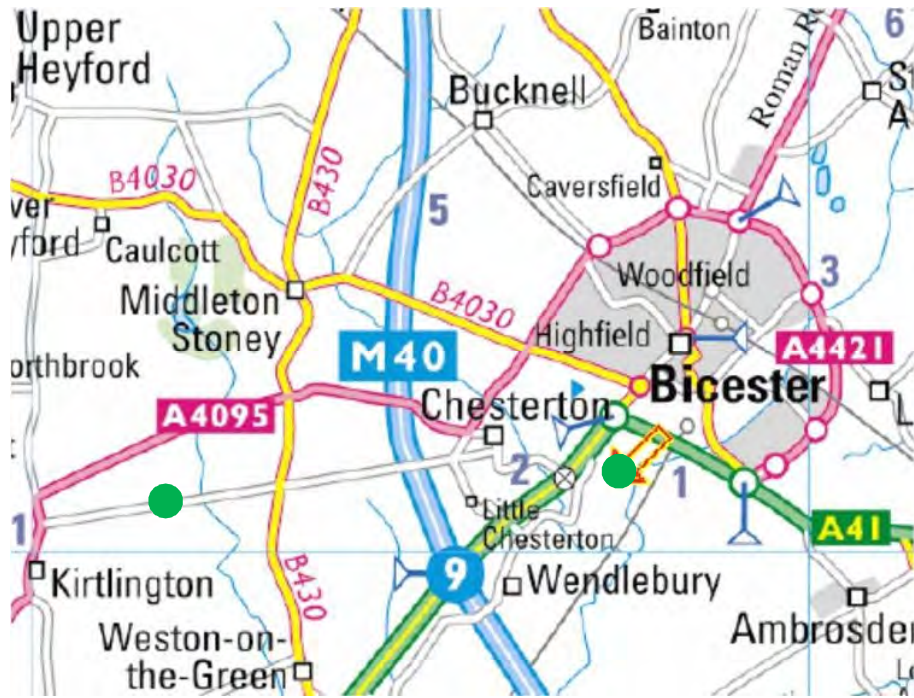
Figure 4.2 – EA Water Quality Monitoring Locations (approximate)

KEY: ● EA Groundwater Quality Monitoring Location

Parameter	UKDWS	Minimum	Maximum	Number of Tests
Nitrate (mg NO ₃ /l)	11.3	Less than 0.9	7.2	40
Bentazone (µl)	500	Less than detected	0.00754	9
m-p xylene (µl)	500	Less than 0.2	0.59	10
ethyl benzene (µl)	300	Less than 0.1	0.12	10

Note: Bentazone water quality standard available is for surface water quality only and relates to the WFD; xylene and ethylbenzene drinking water quality standards shown are for WHO as no specific UK drinking water standard are available. Results are from Wendlebury Chicken Farm and Kirklington Park Farm, located 2 km S of the Site boundary and 4.5 km W of the Site respectively. These are EA monitoring boreholes installed within the Great Oolite aquifer.
