Himley Village, Bicester

Ground Investigation Report

Countryside Properties PLC

Doc ref: 16153-HYD-XX-XX-GE-RP-1002-P1-S2

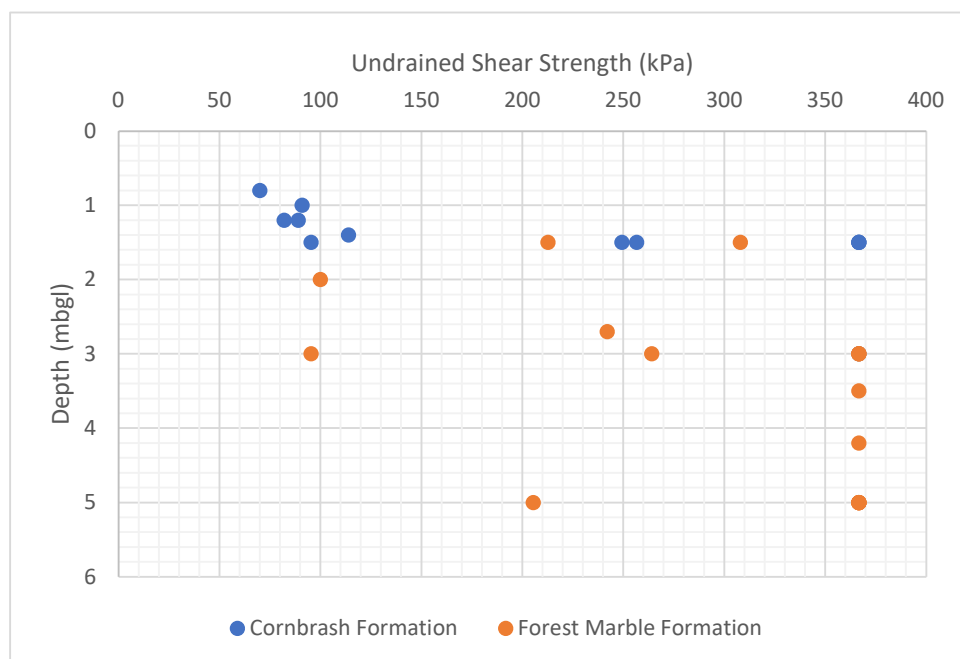
Figure 5.1: Undrained shear strength of clay soils versus depth summary

As shown by Figure 5.1, the strength profile of the Cornbrash Formation indicates typical undrained shear strengths of 70 – 90kPa around 1.00mbgl, sharply rising to in excess of 250kPa as depth increases and primarily due to a decrease in the degree of weathering and the presence of limestone bands.

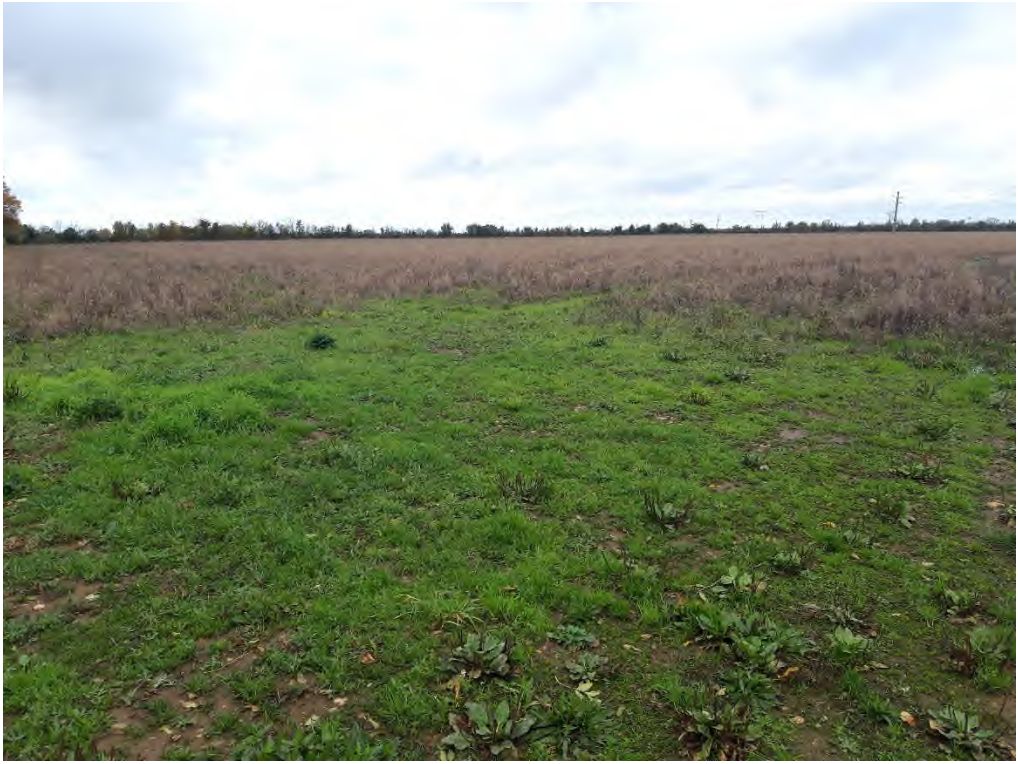
<p>Desk Study Photograph 9</p>

<p>Date: 03/11/20</p>	
<p>Direction Photograph Taken: North west from the south east of the eastern field.</p>	
<p>Description: Agricultural field forming the eastern field of the site.</p>
