4.0 PRELIMINARY CONTAMINATION ASSESSMENT

5.0 PRELIMINARY GEOTECHNICAL ASSESSMENT

PROJECT:
Land West of Bloxham Road,
Banbury, Oxfordshire

TITLE:
Site Observations

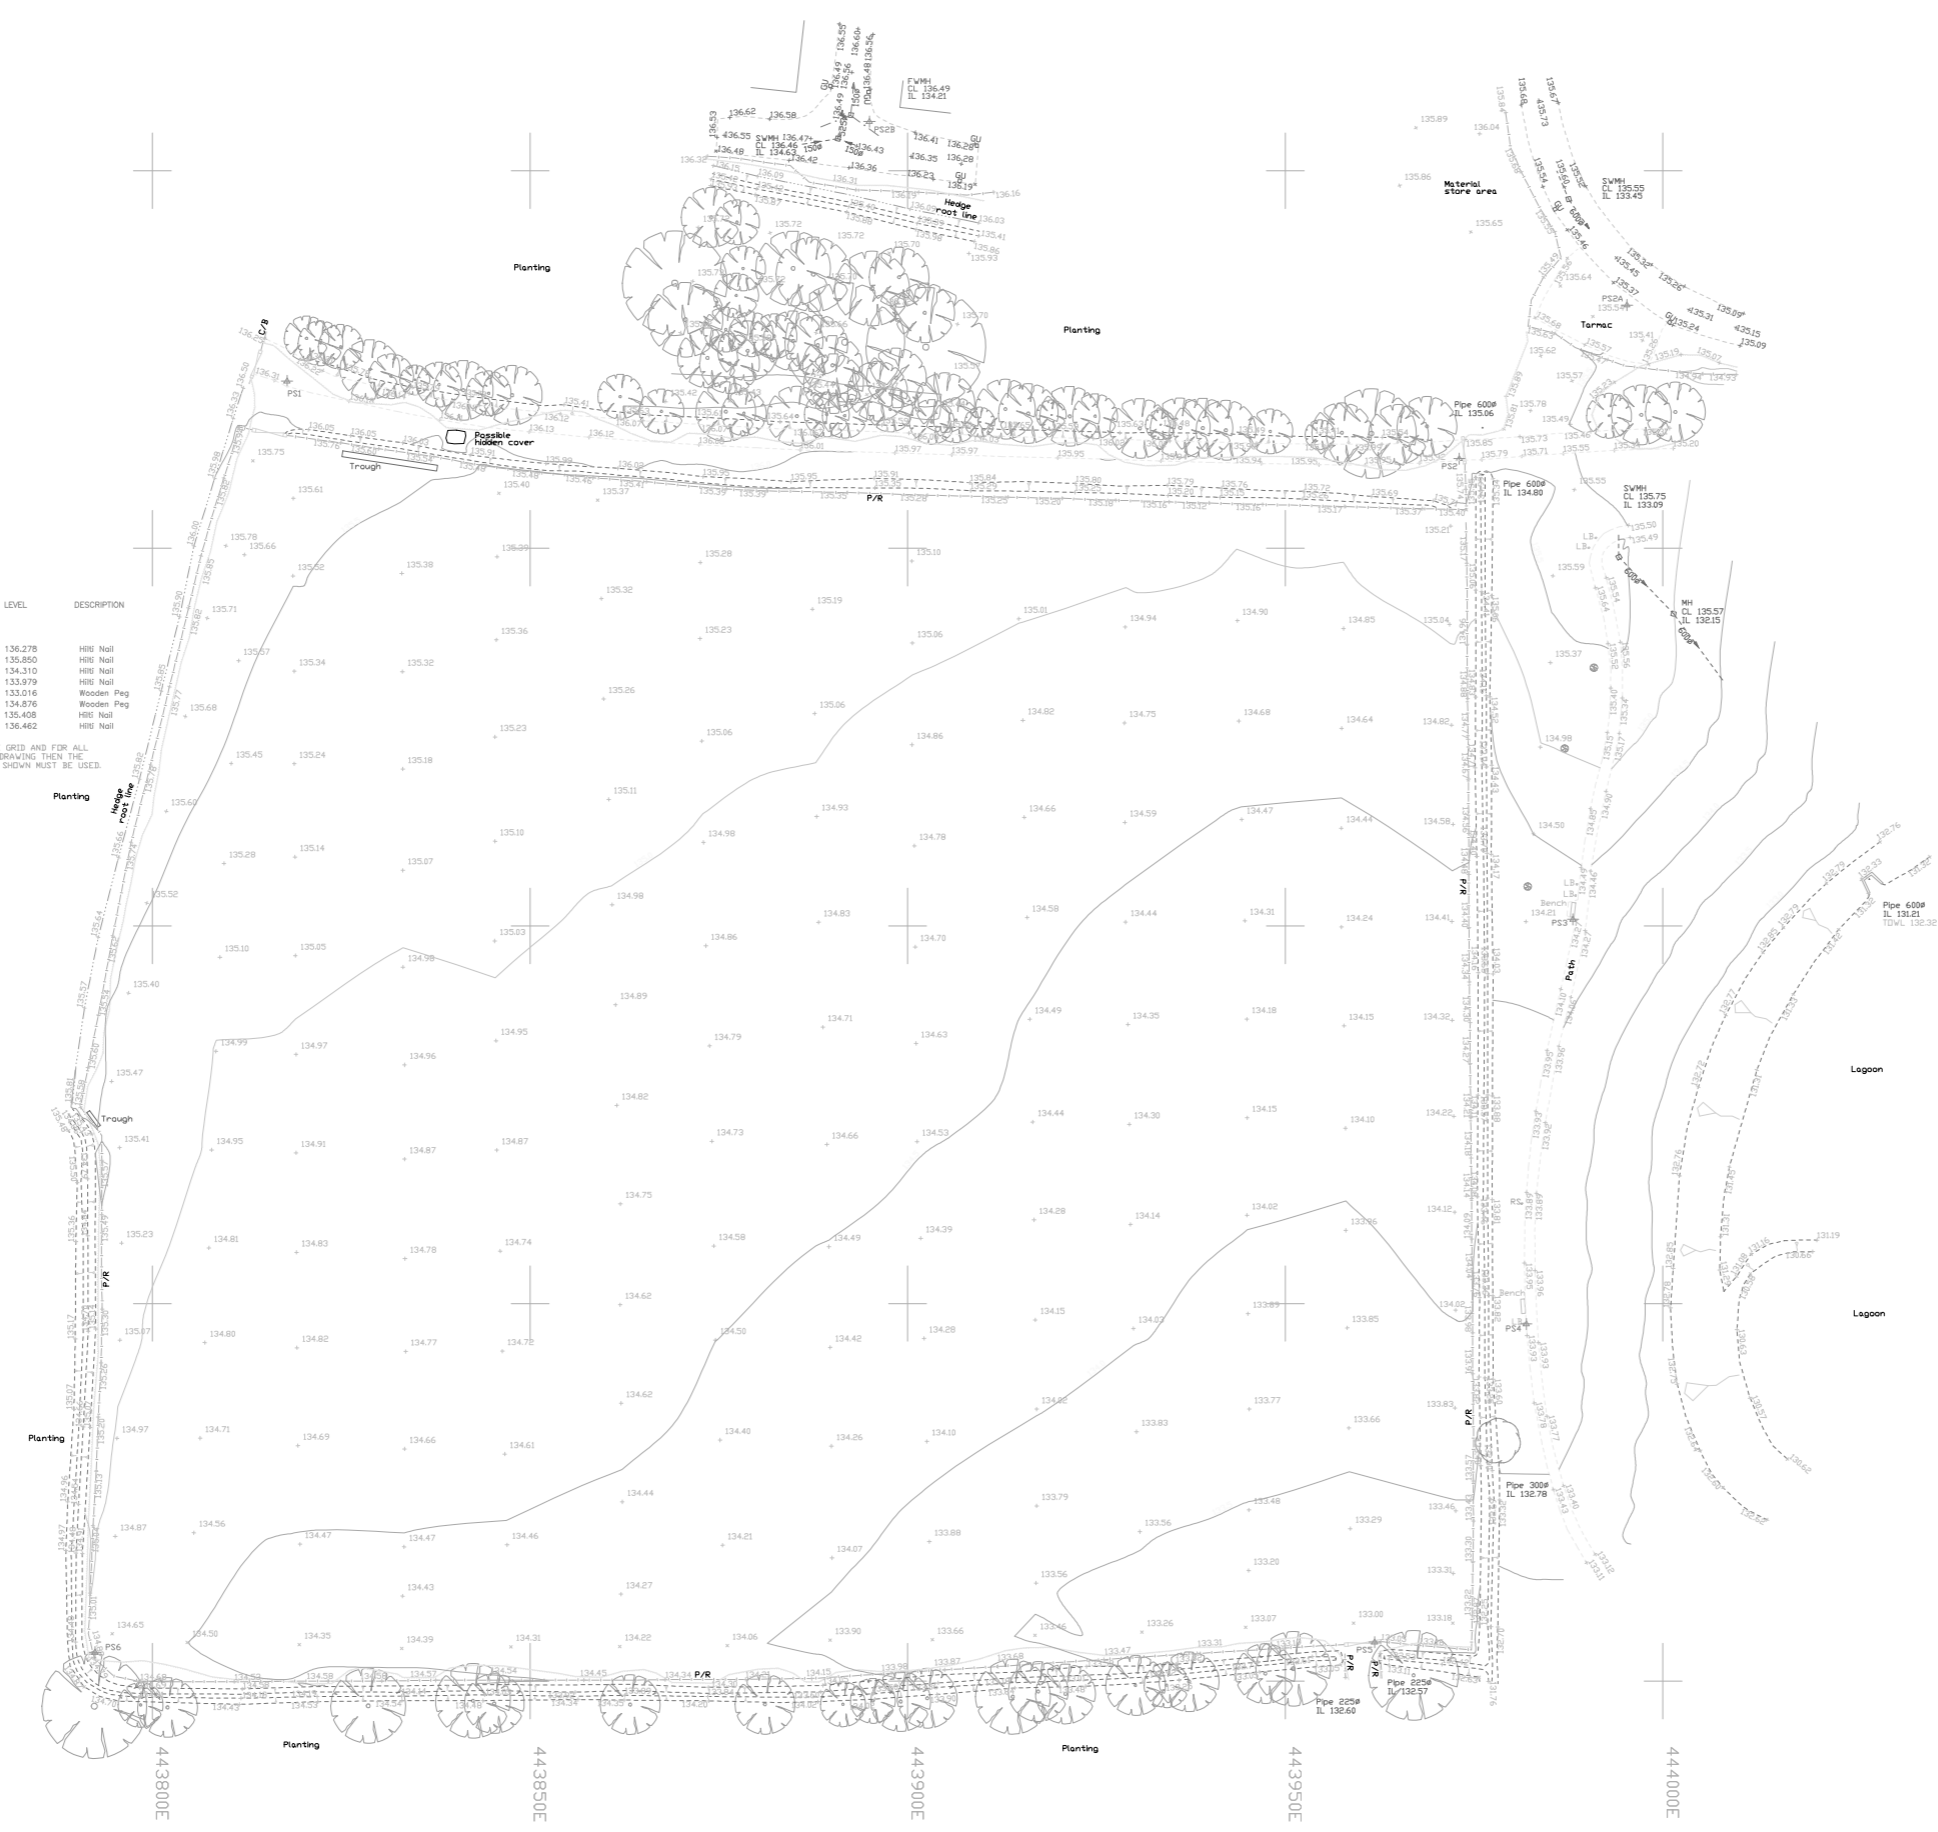
Project Title: **Topographical Survey Sheet 1 of 1**

STATION	EASTINGS	NORTHINGS	LEVEL	DESCRIPTION
PS1	443817.818	238772.140	136.278	H/W Nail
PS2	443973.040	238761.871	135.800	H/W Nail
PS3	443988.080	238700.879	134.310	H/W Nail
PS4	443981.904	238647.306	133.979	H/W Nail
PS5	443961.822	238601.171	133.016	Wooden Peg
PS6	443792.398	238603.834	134.876	Wooden Peg
PS2A	443995.230	238782.210	135.408	H/W Nail
PS2B	443894.935	238800.805	136.462	H/W Nail

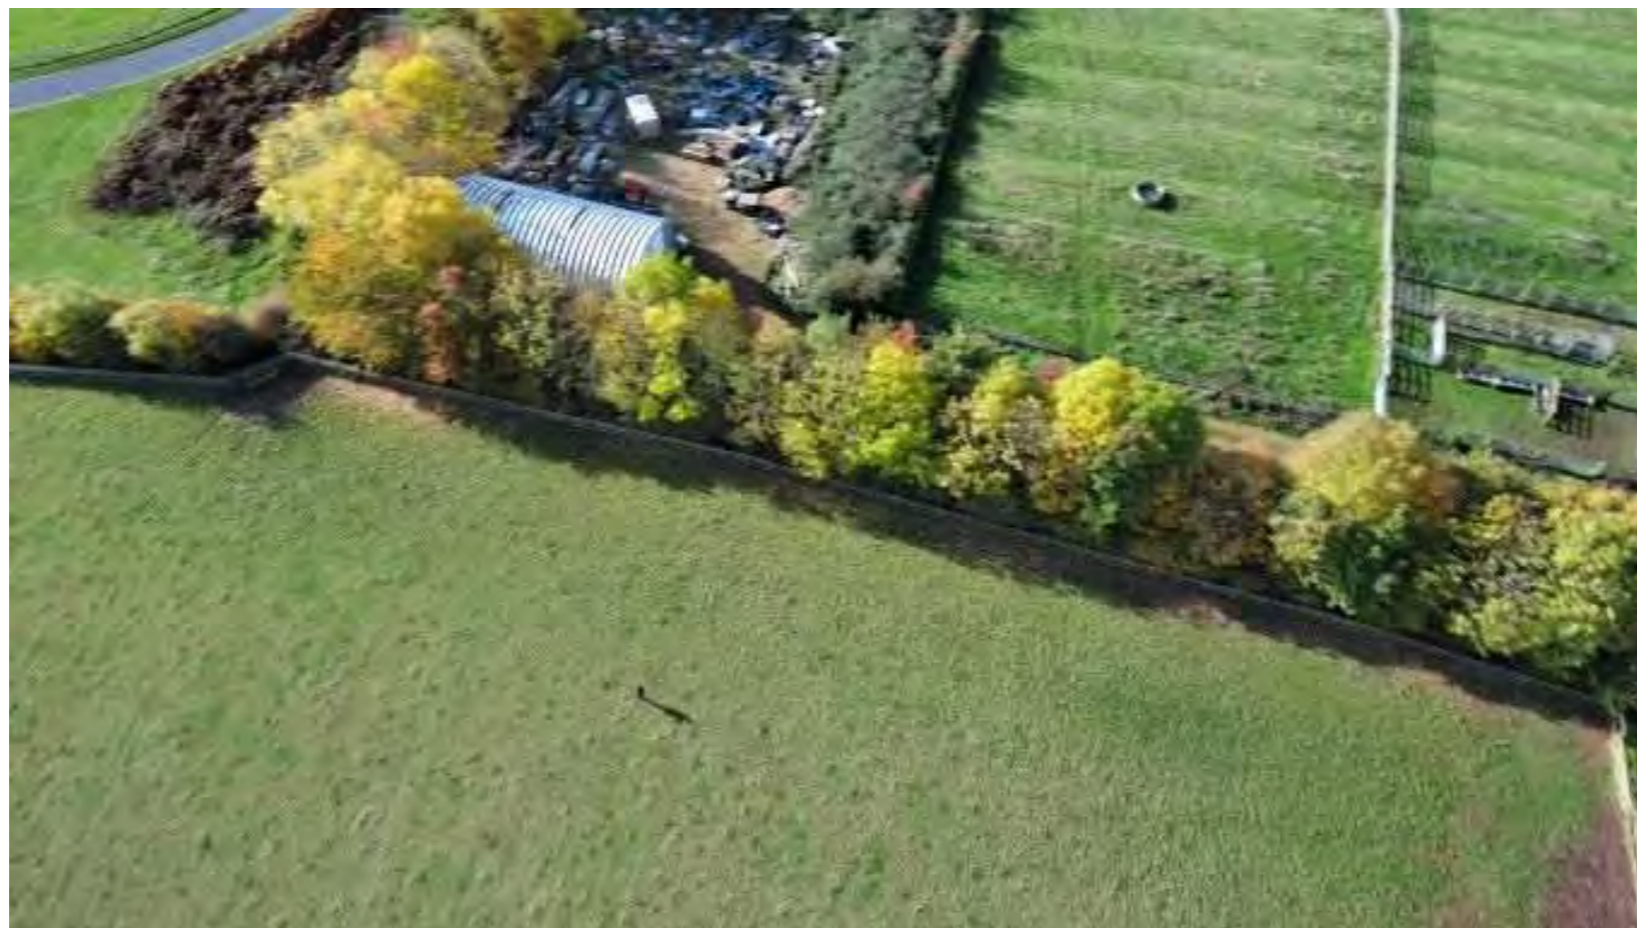
Aerial view of the site, towards the western field boundary. Shows the metal agricultural building adjacent to the boundary.

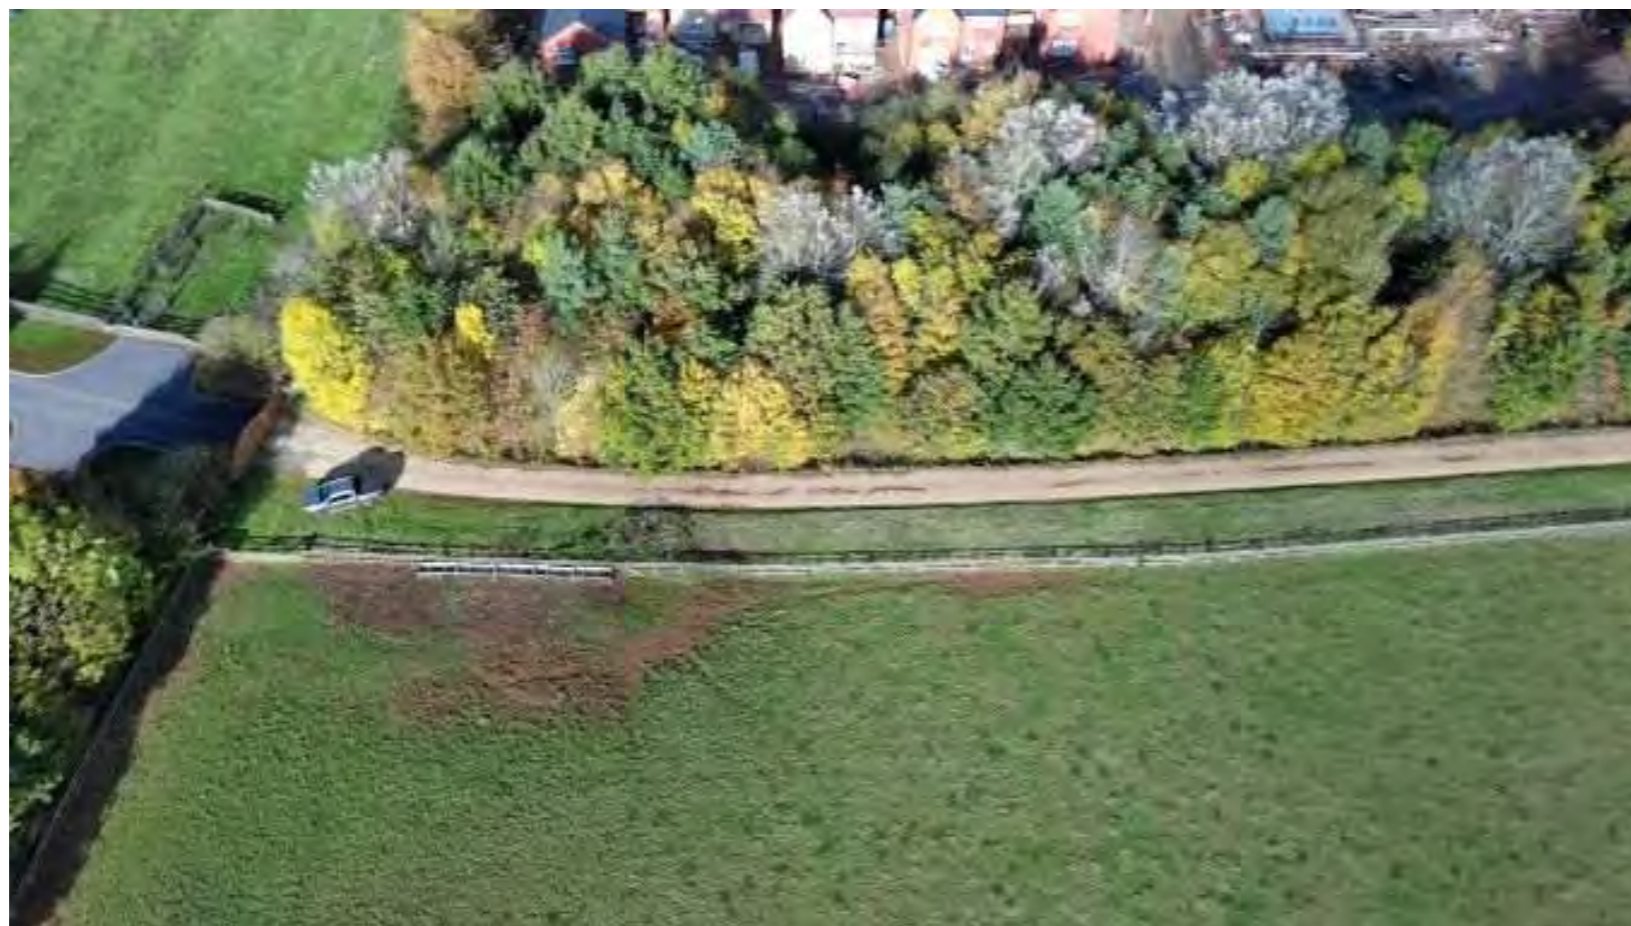
Aerial view of the site, towards the northern field boundary. Shows the farm track, the woodland and the new development beyond.

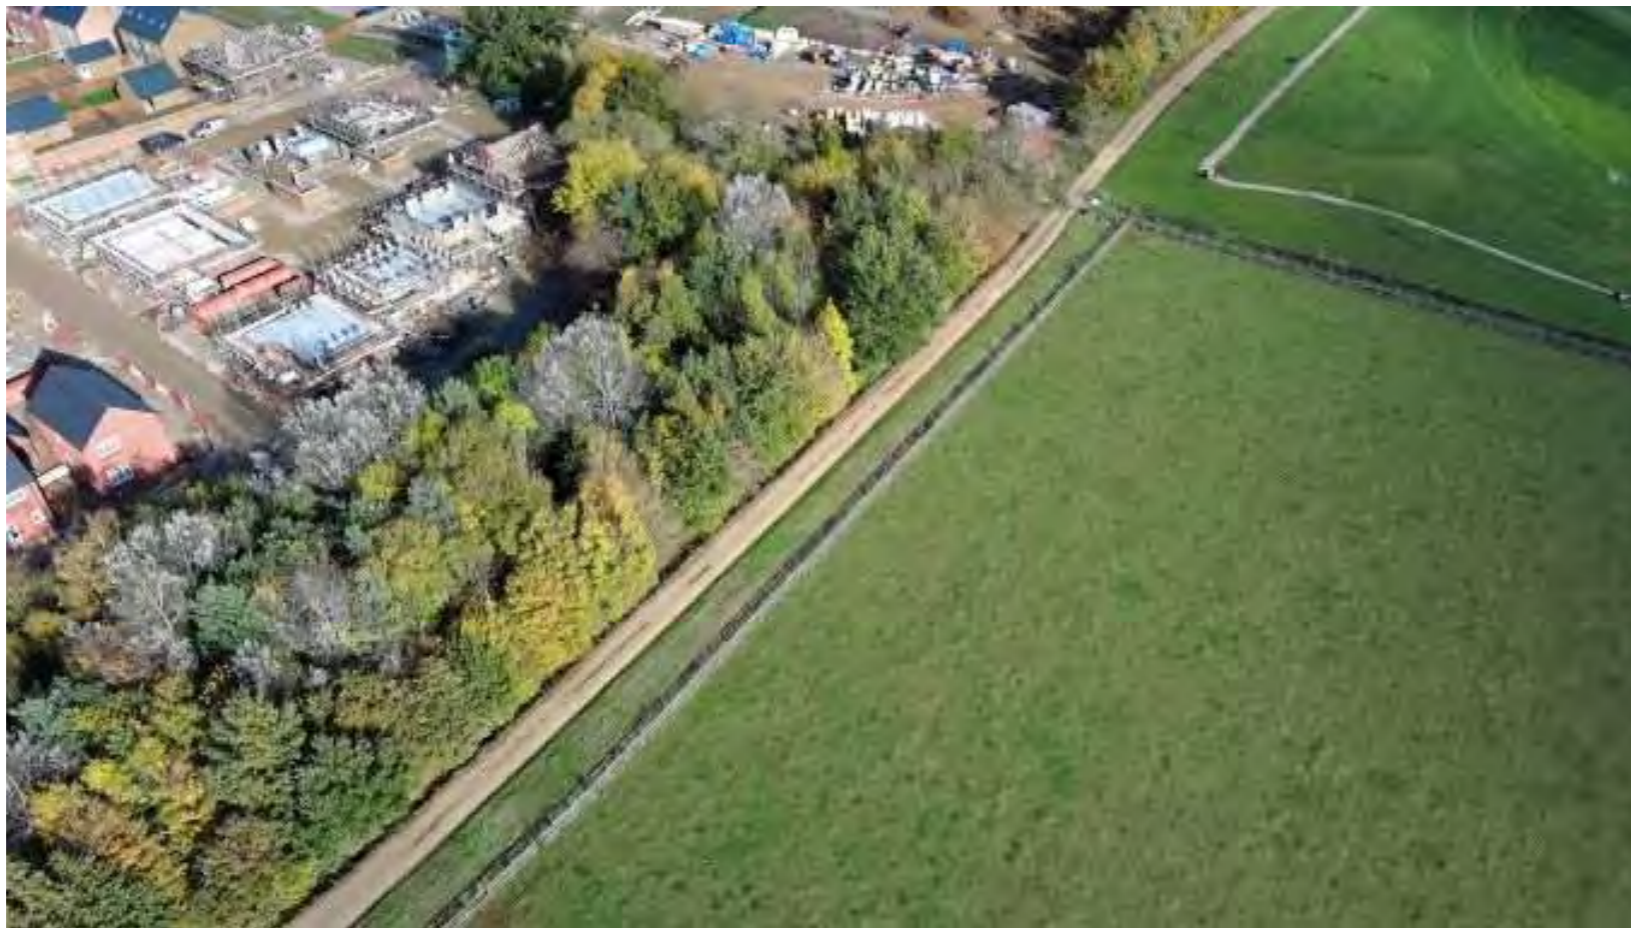
Aerial view of the site, towards the north eastern corner of the site. Shows the track, woodland and the adjacent development.

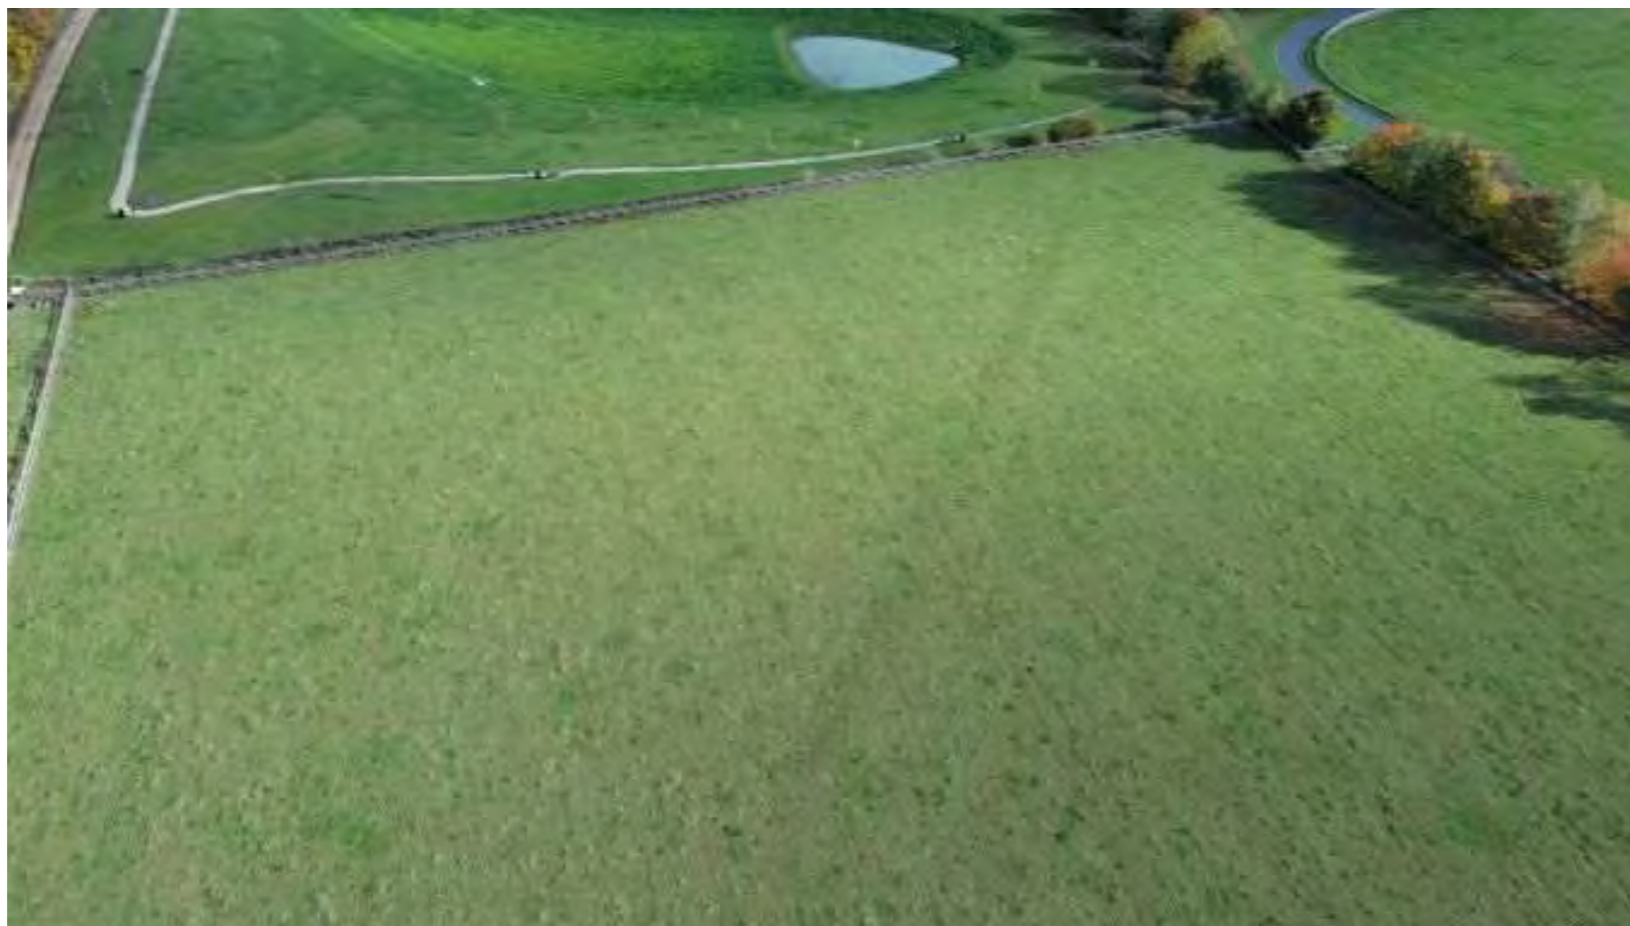
Aerial view of the site, towards the eastern field boundary. Shows the drainage lagoon beyond the timber fence boundary.

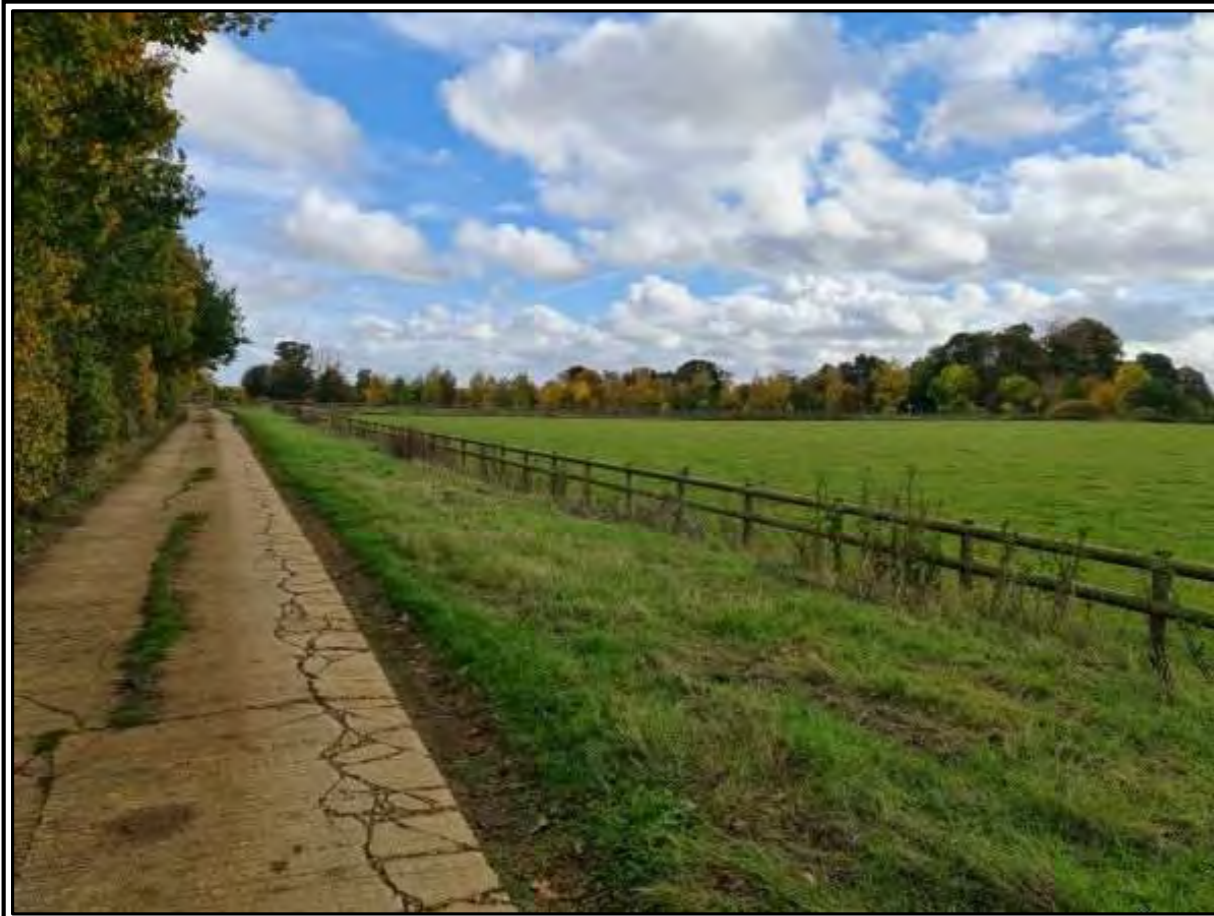
View from the western end of the track, looking to the east and towards the access gate to the south of Crouch Cottages, Bloxham Road.

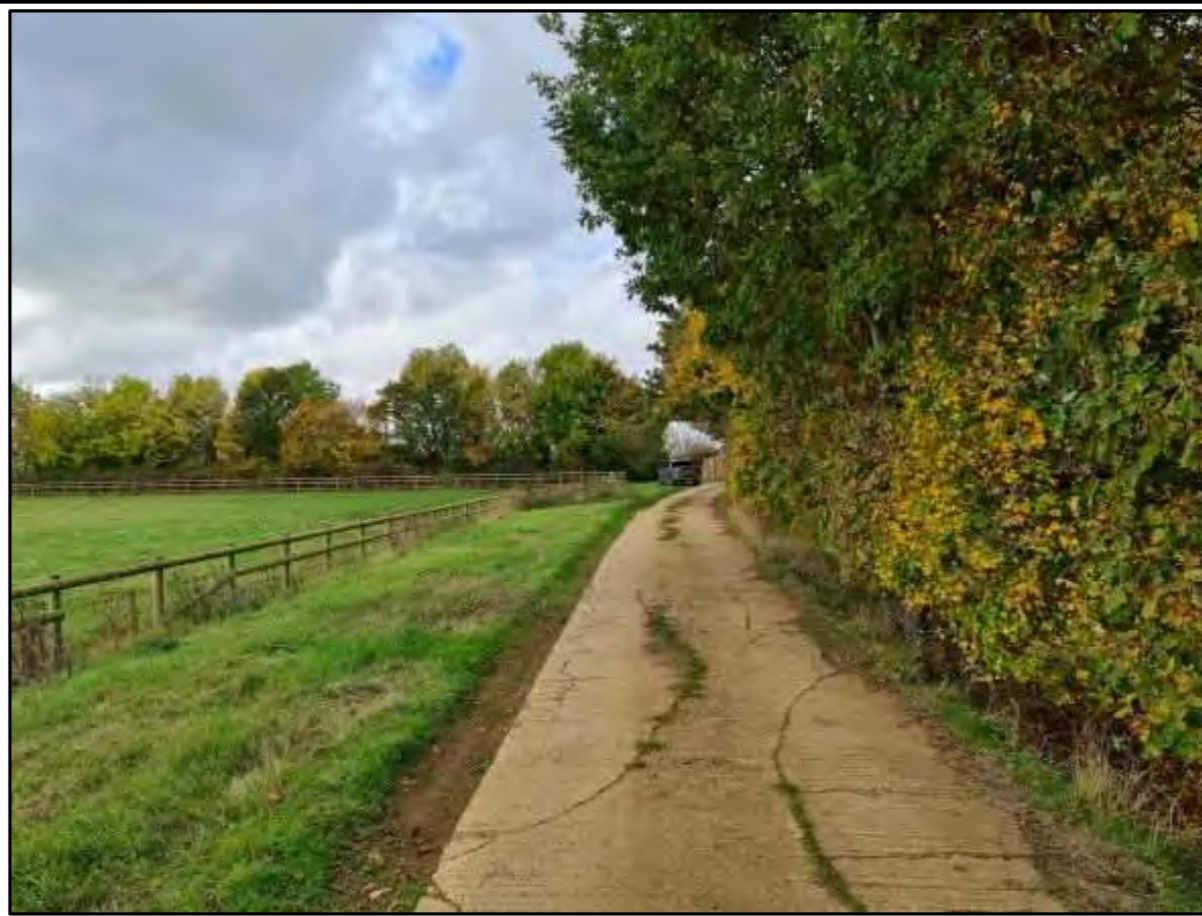
View from the access gate at the eastern end of the track, looking to the west and towards one of the access gates to Crouch Farm.

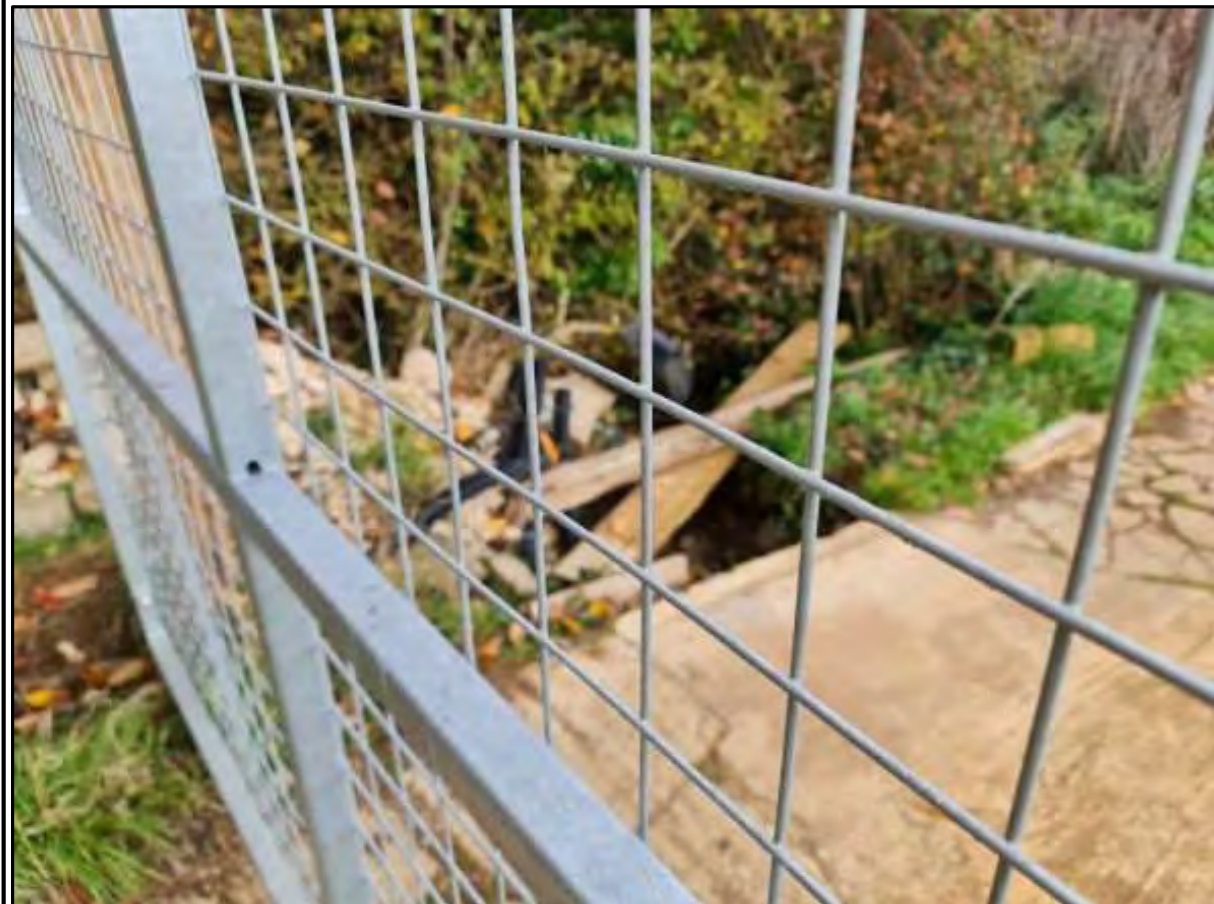
View through the access gate towards the ditches along the eastern boundary – the ditch was dry and may have been culverted or diverted.

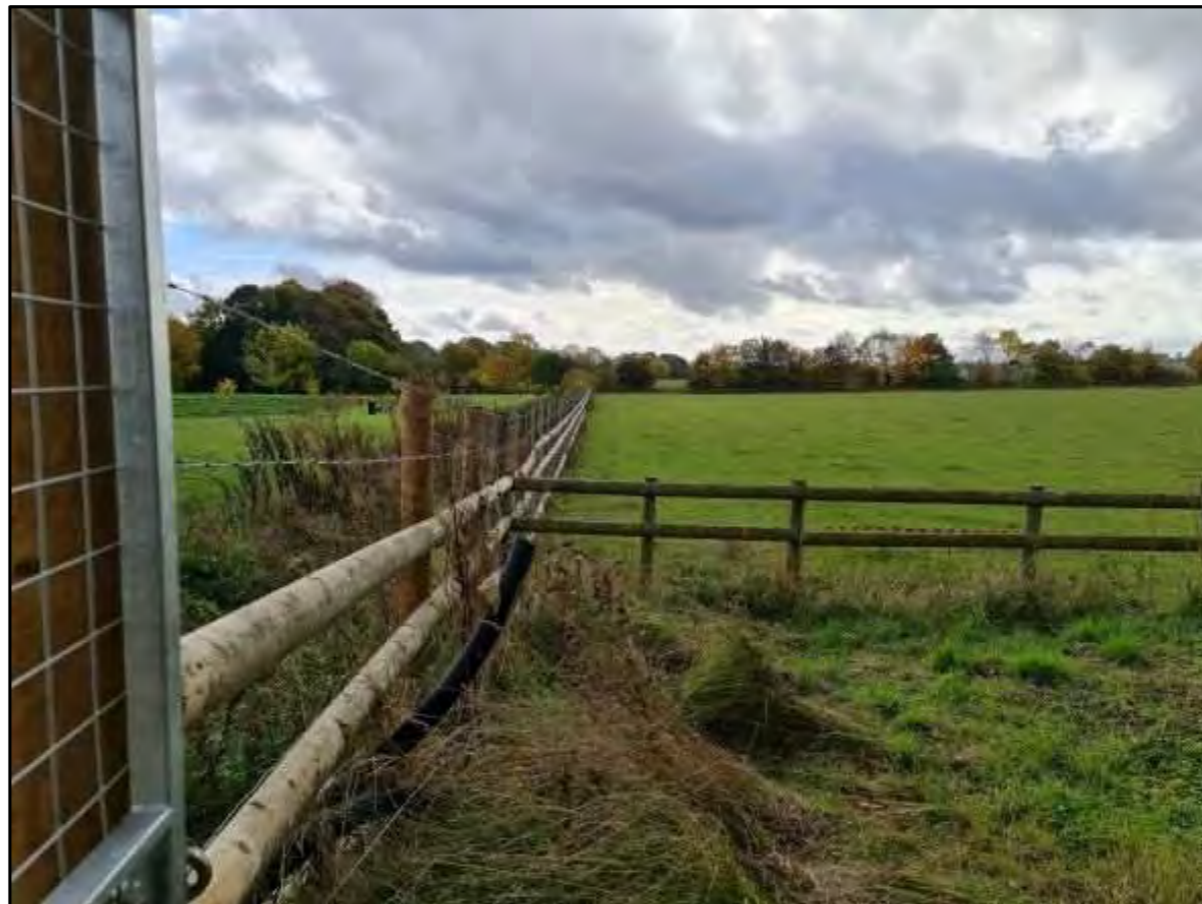
View from the access gate at the eastern end of the track, looking to the south, along the eastern site boundary.

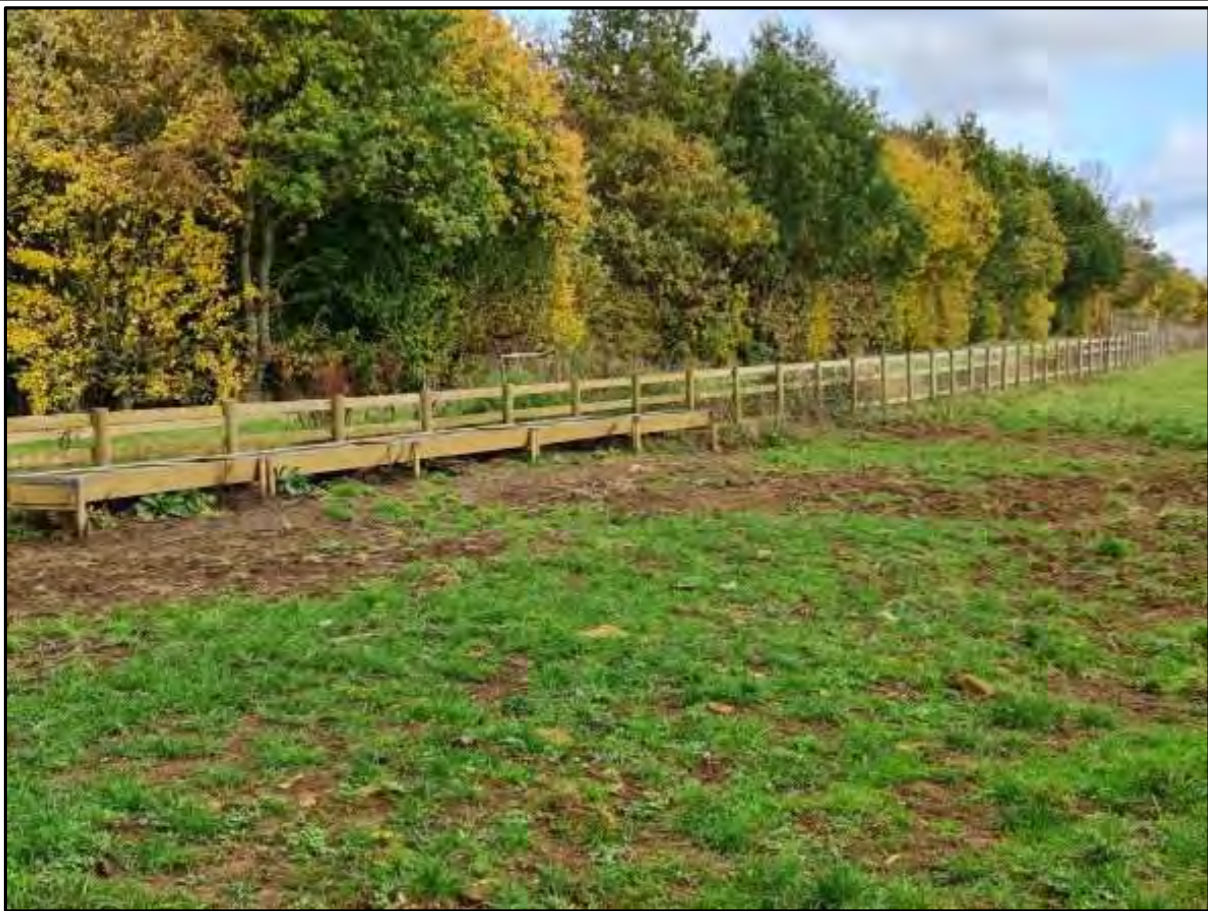
View from the north western corner of the field and towards the north east, shows the animal troughs, the track and woodland to the rear.

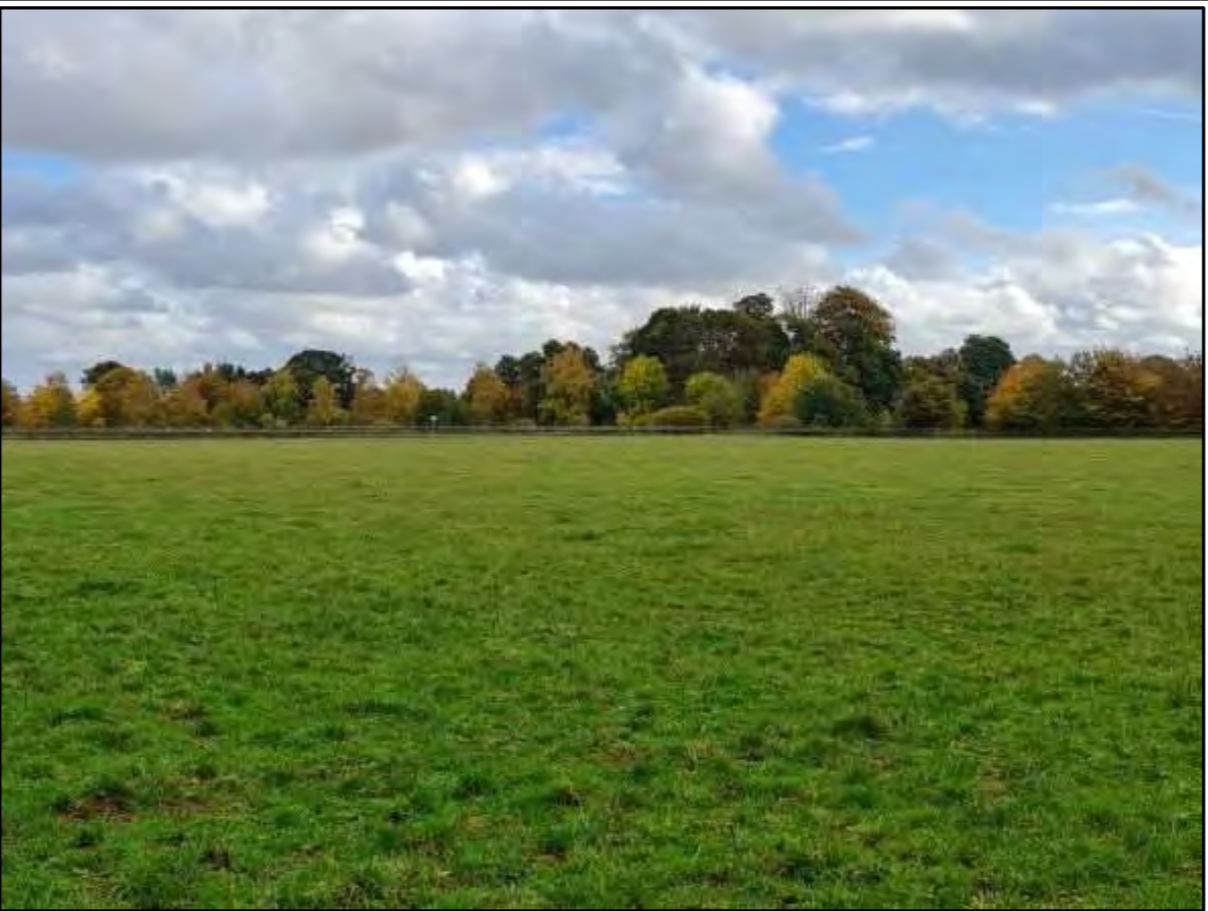
View from the north western corner of the field, towards the south eastern corner. Shows the wooden rail fencing and the wooded area beyond.

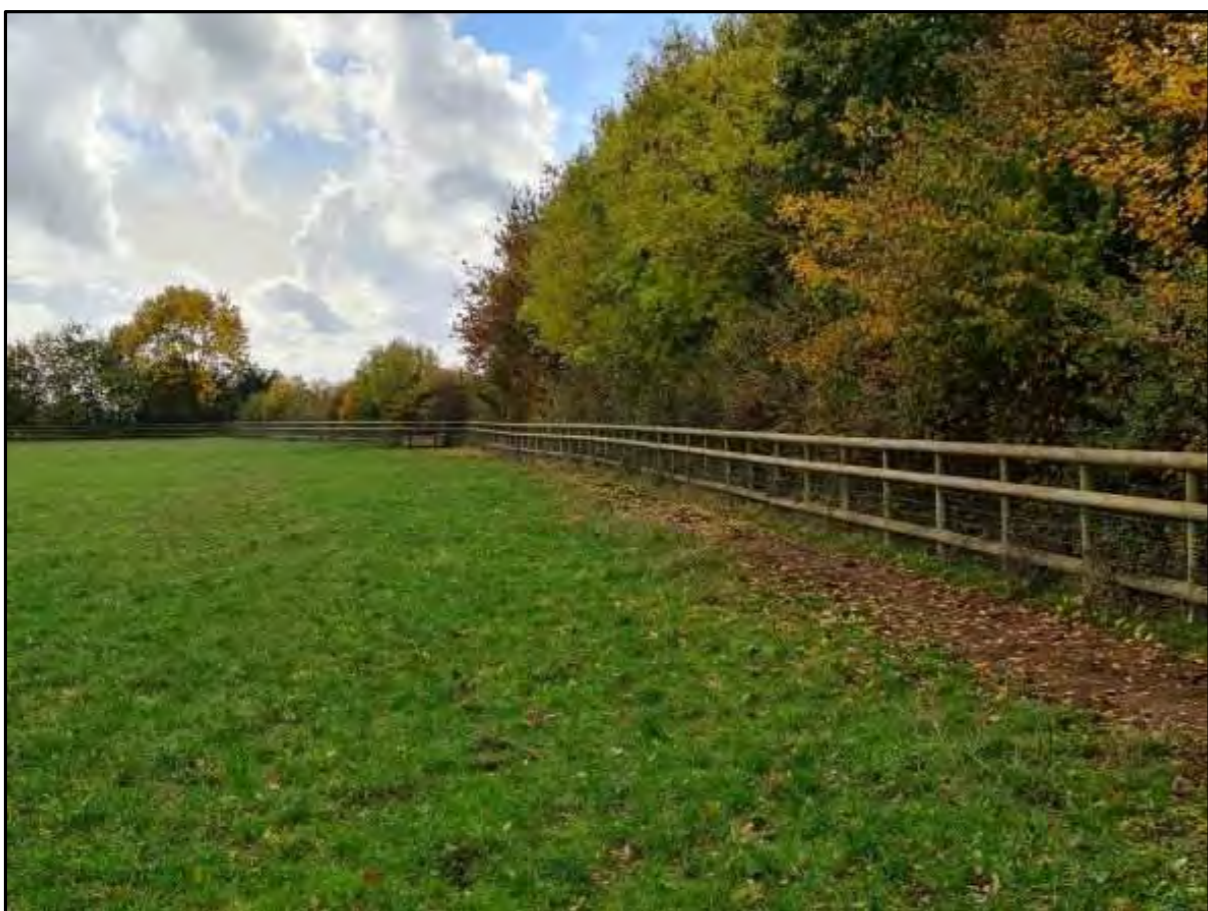
View from the south western corner, along the southern boundary. Shows the wood rail fencing and the trees along the boundary.

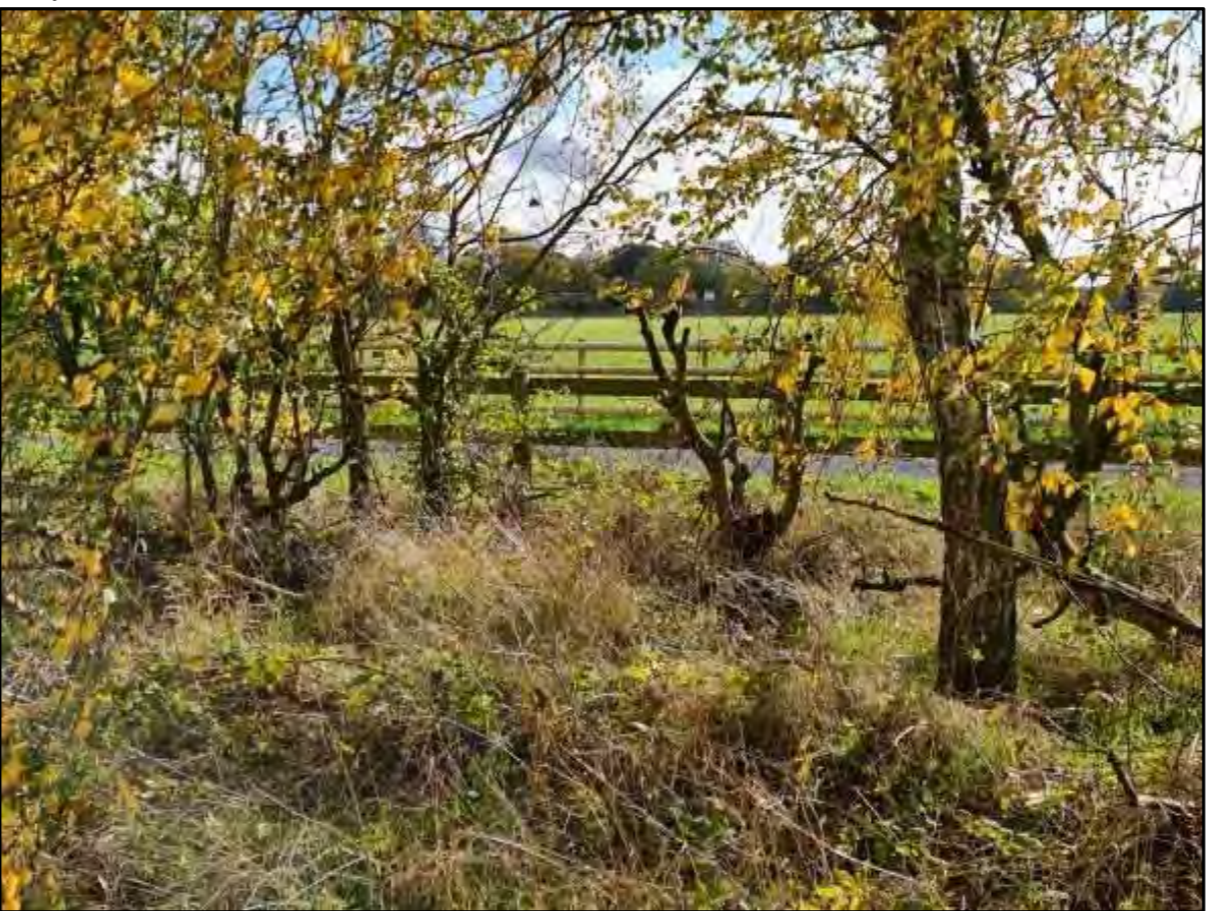
View through the southern boundary, shows an overgrown ditch in the foreground, beyond which are the trees, a second wooden fence and another farm road.
