From: Trevor Dixon <Trevor.Dixon@Cherwell-DC.gov.uk>
Sent: 10 November 2020 16:28
To: Lauren Bond
Subject: RE: Contaminated Land Enquiry (20-1803.01)

We are undertaking a Phase I Environmental Assessment for Mondelez UK International, Jacobs Douwe, Edberts, Ruscite Avenue, Banbury, OX16 2QU (a site boundary plan is below- area in red).

Southam Road Retail Park, Banbury
Ground Stability and Phase 1 Contaminated Land Desk Study

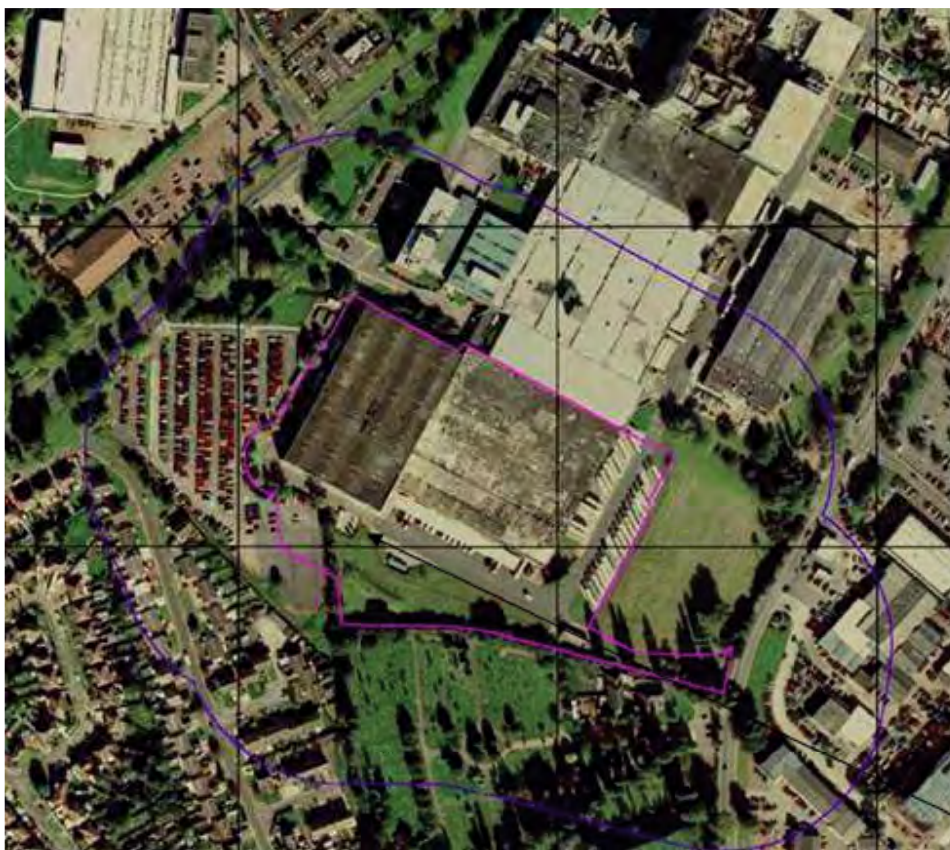
Location of Tanks

Both tanks were converted to diesel storage in April 1992, effectively decommissioning these tanks from a petroleum licencing perspective.
The final petroleum licence shows a capacity of 27,276 litres petrol.

Please find attached photos of the 2 plans.
Please see your site boundary plan showing the tank location in relation to the whole site.

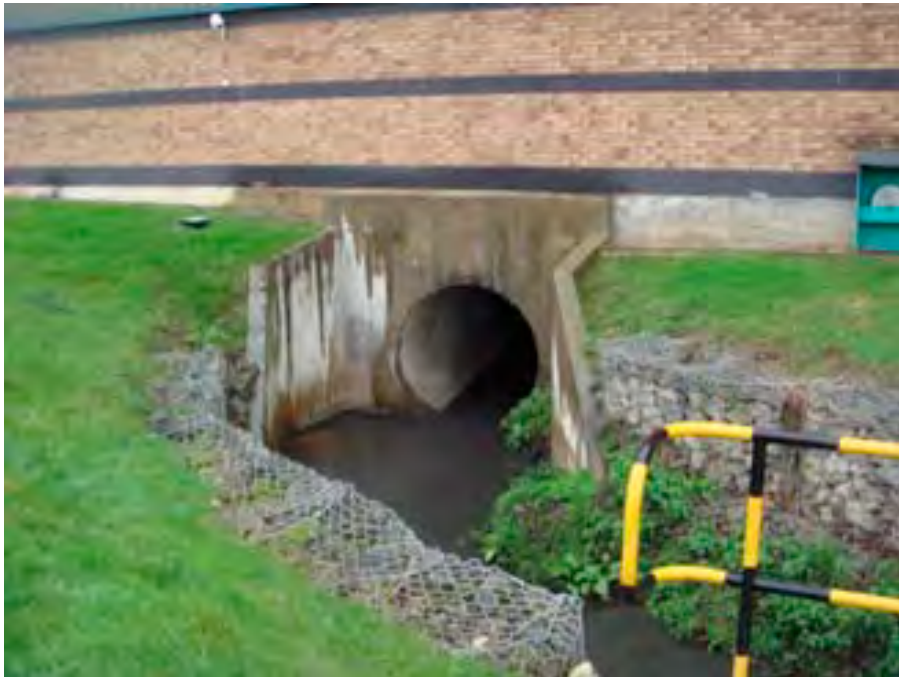
Plate 1: View of Birds Brook discharge from culvert beneath warehouse building.

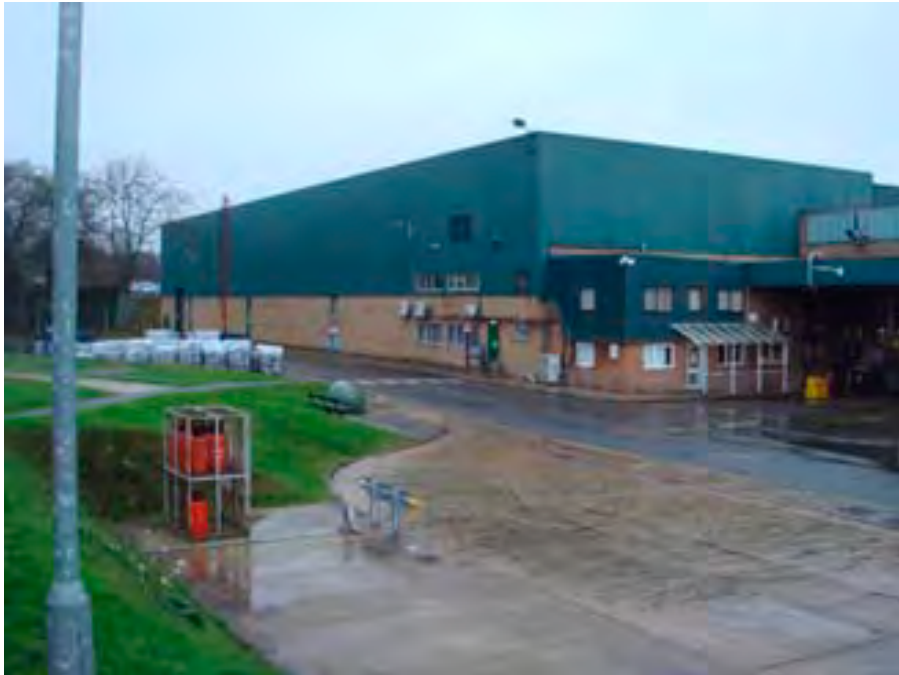
Plate 4: View of south west corner of warehouse unit. Location of former fuel filling station is in foreground on concrete apron.

Along the southern site boundary, Mr Jackson indicated the former location of a fuel filling station and banded fuel tanks which have been removed. The timing and type of decommissioning work carried out on the underground fuel storage tanks serving the filling station could not be confirmed by Mr Jackson, although the tanks appeared to have been buried in a landscape embankment to the west of the former fuel filling area. A concrete surface slab demarks the probable location of the tanks. A separate earth bund was observed to the south of the former fuel filling area, which Mr Jackson indicated was a noise attenuation bund constructed to reduce the noise impact of the warehouse on the residential area beyond the southern site boundary.

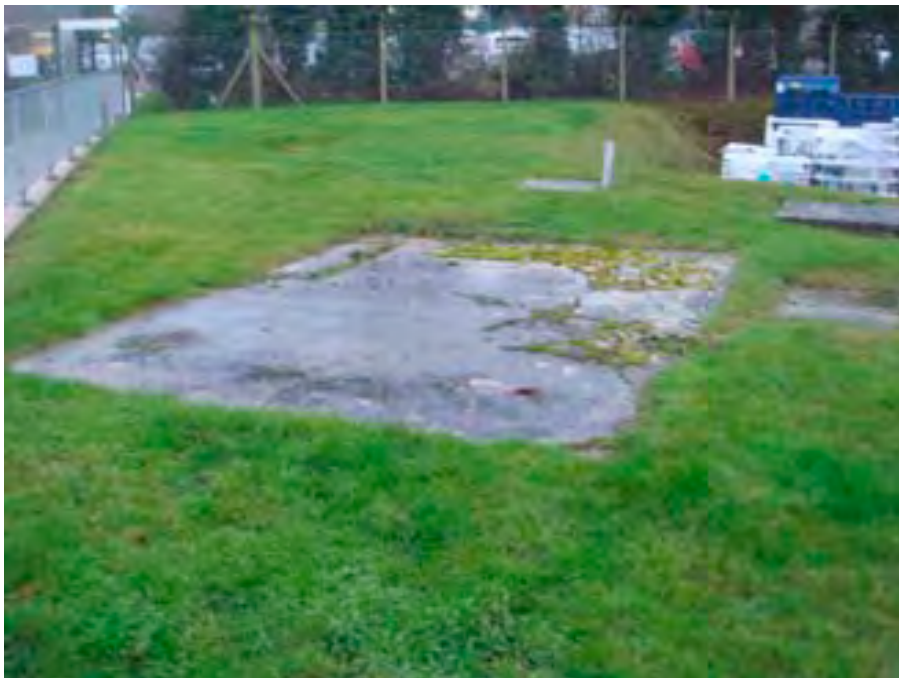
Plate 6: Possible location of decommissioned underground fuel storage tanks.

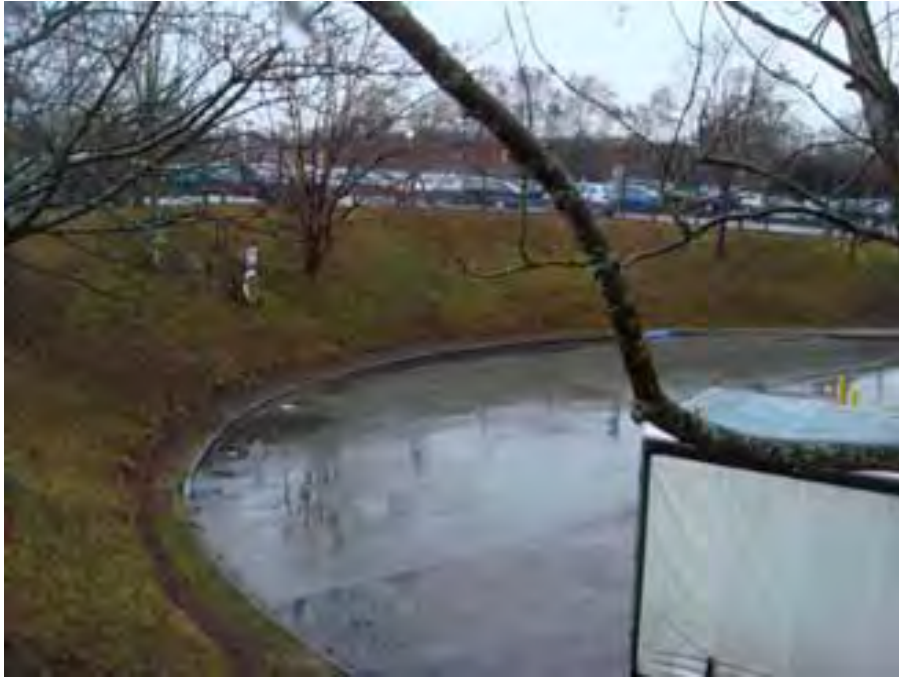
Plate 7: View of embankment on south west site boundary with Kraft car park beyond.

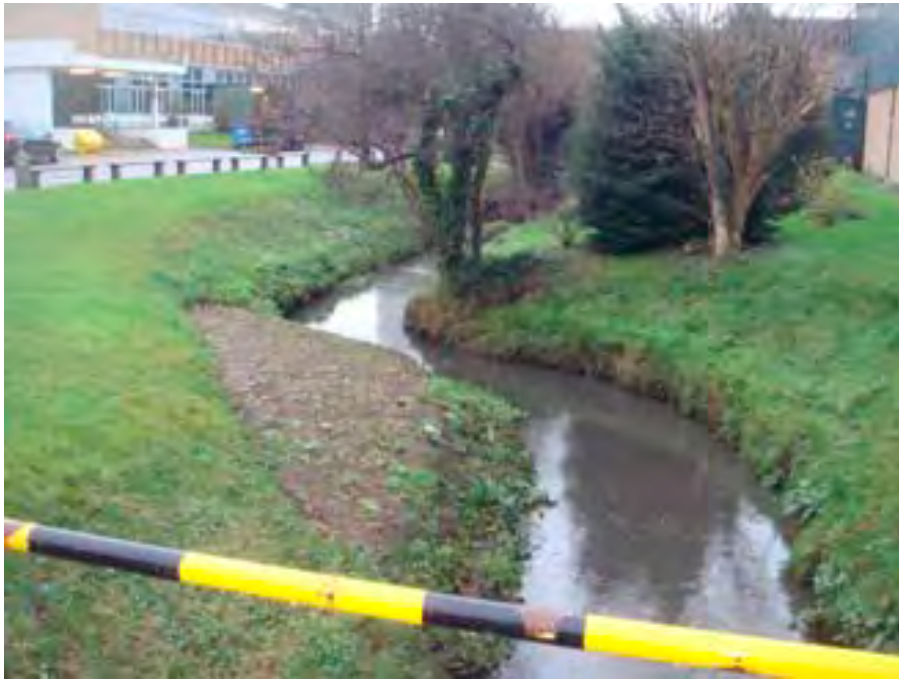
Plate 9: View of Birds Brook flowing along northern site boundary.
