Southam Road Retail Park, Banbury
Ground Stability and Phase 1 Contaminated Land Desk Study

1.2 Geotechnical Engineering Ltd was instructed directly by the client, Kraft Foods UK Production Limited, to undertake a review of an existing Phase 1 Desk Study and investigation on site by others and conduct a borehole investigation at the location of the new structural alterations. The investigation on site was then to be used to give comments and recommendations on the findings with respect to the new evaporator installation. The scope of works included within this report is in general accordance with our Estimate Ref: T12878.

Ground Conditions Desk Study

Hydrock Ref: R/161279/001

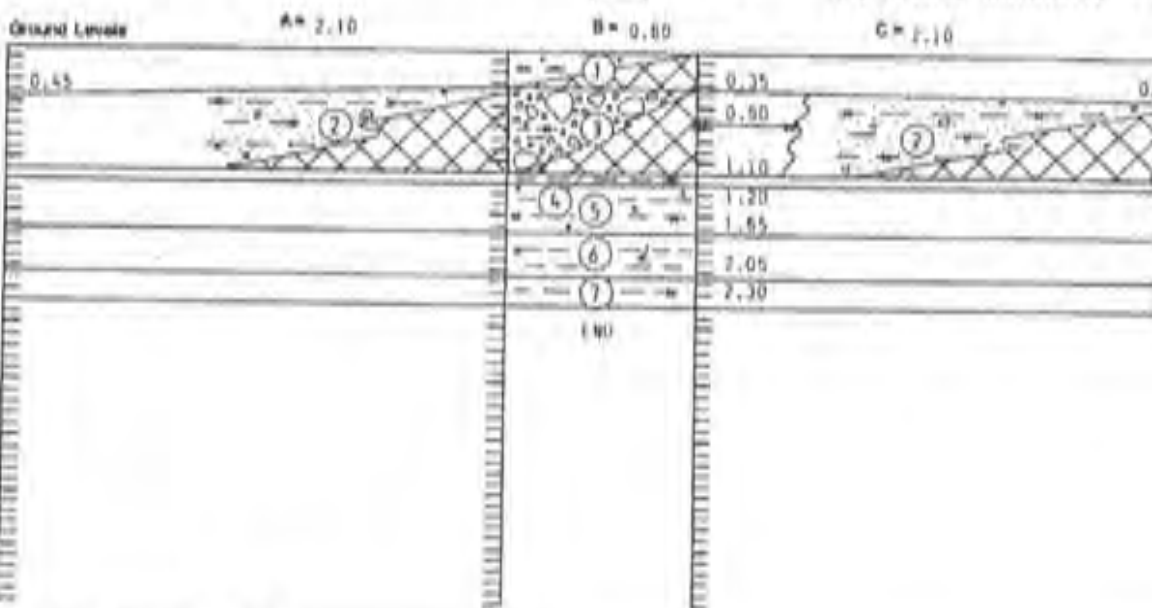
TRIAL PIT RECORD

Project	PROPOSED NEW COMPUTER ROOM	Client	GENERAL FOODS	Trial Pit	1
Location	RUSCOTE AVENUE, BANBURY	Engineer	D G I INTERNATIONAL PLC	Project No.	B7-5535
Location Plan

Total Pit Plan	Date	20.2.07
Bearing	Plant	Case
	Shoring	None
	Stability	Spalling to 1.10m, overbreak 0.1 side
	Water	No groundwater encountered

Samples and Tests			Strata	
Depth	Type	Strength	Reference	Description
		kN/m ²	1	Isbnill, occasional gravel. MADE GROUND.
			2	Soft to firm dark orange brown very sandy very silty clay with much angular sandstone gravel, some brick and concrete fragments upto rubble size. Occasional wire and reinforcement bars. MADE GROUND.
			3	'loose' angular gravel cobble and boulder sized fragments of brick and concrete, planks of wood, wire plastic etc. with some dark orange brown v sandy very silty clay. Lenses of soft light grey silty clay. MADE GROUND

1.0	J			
1.20	H/V	130		
1.3	H/V	85	4	Firm dark grey green silty CLAY, organic rich, with traces of roots and decaying vegetation.
1.4	H/V/J	85		
1.5	H/V	35	5	Firm light grey and orange brown silty (CLAY/clayey) SILT with some fine to coarse angular rounded gravel, Occasional shell fragments.

1.80	J.H.P	100		DISTURBED LIAS CLAY.
1.95	H.P	130		
2.3	J.H/V	80	6	Firm to stiff light blue grey and orange brown very closely fissured silt/CLAY/clayey SILT. Root traces present. LOWER LIAS CLAY (WEATHERED).
		(Disturbed)		
			7	Stiff becoming very stiff (light blue grey thickly laminated very closely fissured silty CLAY/clayey SILT. Hard in parts. Discoloured orange brown along fissures. LOWER LIAS CLAY.

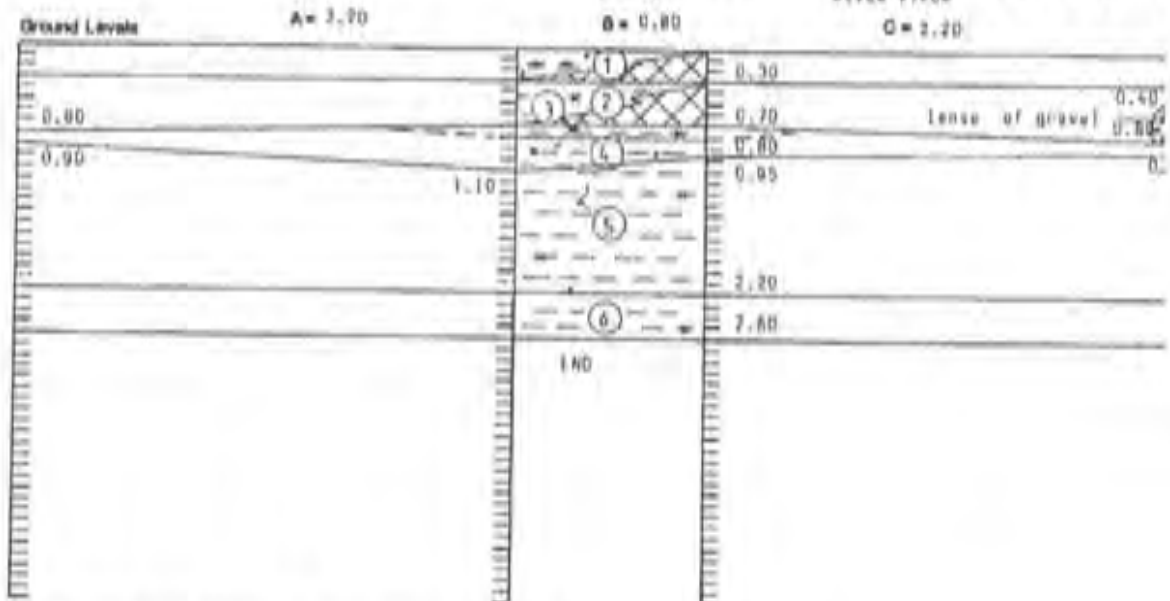
Project PROPOSED NEW COMPUTER ROOM Client GENERAL FOODS Trial Pit 2
 Location RUSCOTE AVENUE, BARBURY Engineer D G I INTERNATIONAL PLC Project No. 87-5530
 Location Plan Trial Pit Plan

Bearing SW Date 20.2.87
 Plant Case
 Shoring None
 Stability Stable
 Water Very slight seepages along level below 2.70m

Samples and Tests			Strata	
Depth	Type	Strength	Reference	Description
		kN/m ²	1	Install, base rounded gravel. MADE GROUND.
0.50	J.H/V	126	2	Fine light brown grey and orange brown silty clay, very sandy in parts w/ occasional small pockets of topsoil and gravel. MADE GROUND.

0.70	H/V	94	3	Fine dark grey green silty clay, organic rich with traces of decaying root and vegetation.
0.80	H/V	100	4	Fine to stiff light orange brown, grey and green brown silty CLAY/clayey SILT with some fine to coarse rounded gravel. Occasional sand sized subminuted shell fragments. GLACIALLY DISTURBED LIAS CLAY.

1.0	J.H/V	80		
1.1	H/V	112	5	Fine to stiff and stiff light blue grey discoloured orange brown poorly laminated very closely fissured silty CLAY/clayey SILT. Occasional root traces. WEATHERED LOWER LIAS CLAY.

1.2	H/P	100		
1.3	H/P	100		
1.4	H/P	100		
1.5	H/V	110	6	Stiff to very stiff light blue grey thickly laminated closely fa very closely fissured silty CLAY/clayey SILT. Discoloured orange brown along fissures. Becoming hard and very thinly bedded from 2.30m. LOWER LIAS CLAY

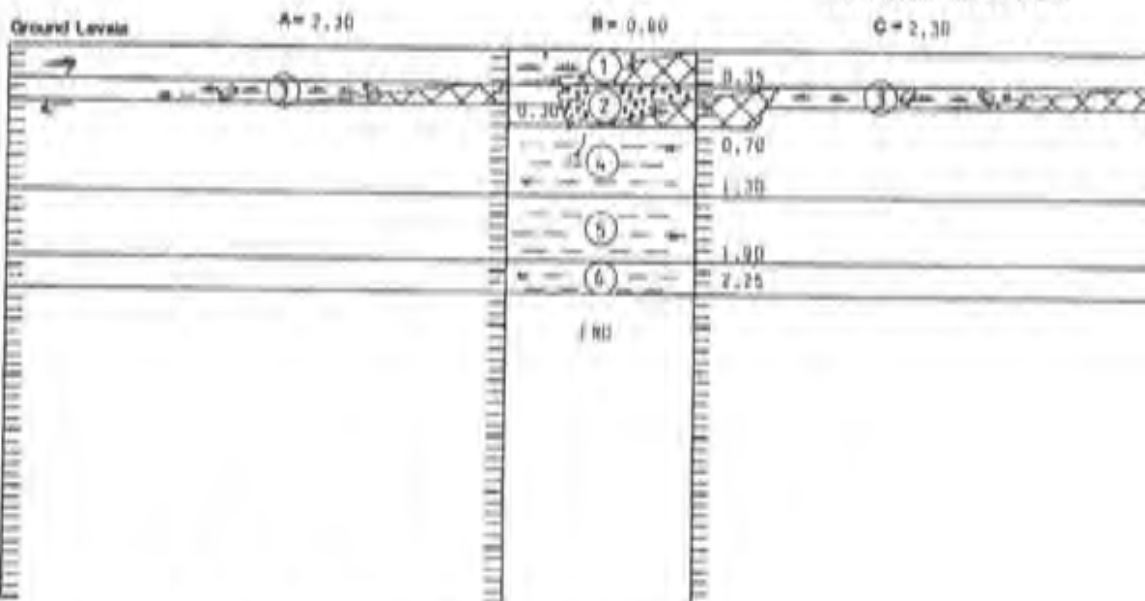
Stability Stable

Water Very slight water seepage along laminations below 1.00m

Samples and Tests			Strata	
Depth	Type	Strength	Reference	Description
		kN/m ²	1	Topsoil, some rounded gravel. MADE GROUND.
			2	Land drain 100mm diameter in gravel surround. Soft light grey clay used backfill. Land drain dry. MADE GROUND.

0.70	H/V	135	3	Topsoil intermixed with bricks with lenses of fine orange brown sandy silty clay and gravel. MADE GROUND.
0.9	H/V	160		
1.0	J, H/P	190	4	Fine to stiff and stiff light blue grey, orange brown and grey green poorly laminated, very closely fissured silty CLAY/clayey SILT. Root traces present. WEATHERED LIAS CLAY.

1.1	H/V	190		
1.2	H/V	130		
1.3	H/V	110		
1.4	H/V	105		
1.5	H/P	175	5	Stiff light blue grey very close to closely fissured thickly laminated silty CLAY/clayey SILT. Discoloured orange brown along fissures. LOWER LIAS CLAY

1.8	J, H/V	150		
2.25	J		6	Hard light to dark blue grey thickly laminated and closely fissured silty CLAY/clayey SILT. Fissures ironstained, tending to very weak mudstone to base. LOWER LIAS CLAY.

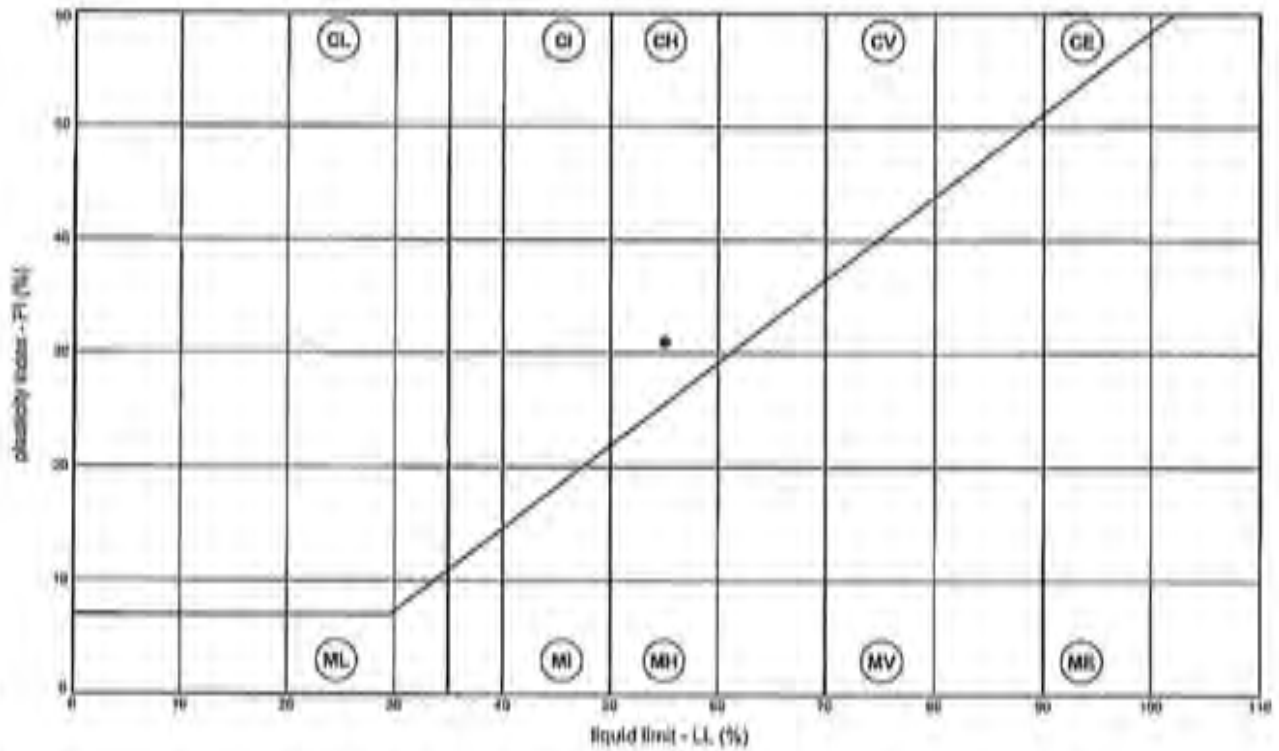
BH/TP No.	depth (m)	LL	PL	PI	remarks
● BH01	1.10	55	24	31

7.2.2 A single Atterberg Limit and Moisture Content test was undertaken on a sample of cohesive Head Deposit at a depth of 1.1m bgl. The results indicate a Moisture Content of 25%. The modified results indicate clays of a medium volume change potential and a high plasticity, the Head Deposit is derived from the underlying Lower Lias Clay and would possess similar volume change potential characteristics.

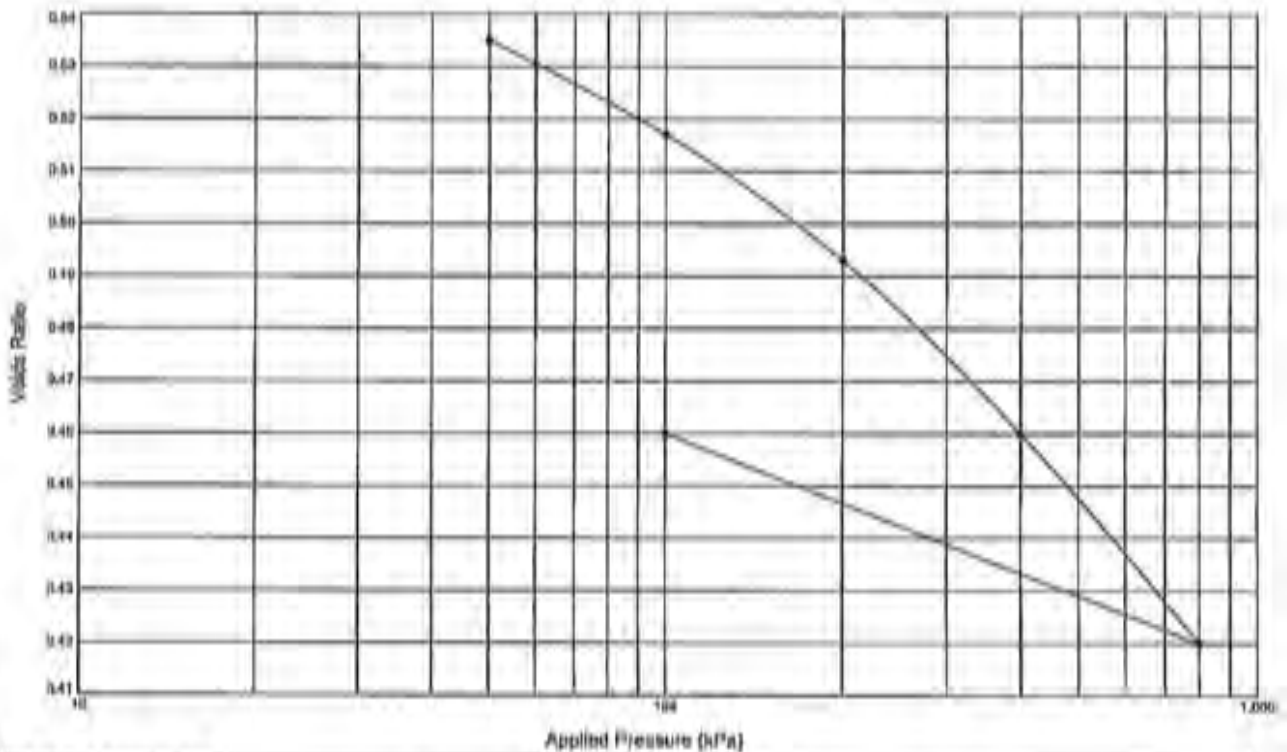
BH/TP No. BH01
 SAMPLE No./TYPE 24C
 SAMPLE DEPTH (m) 5.80
 SPECIMEN DEPTH (m) 6.80

DESCRIPTION Grey slightly sandy CLAY

Test and sample details			Test results			
specimen diameter	(mm)	63.48	pressure stage (kPa)	voids ratio	laboratory coefficients of	
specimen height	(mm)	19.04			compressibility (m ² /MN)	consolidation (m ² /year)
initial moisture content	(%)	18.1	50	0.536		
final moisture content	(%)	20.3	100	0.517	0.235	7.23
initial bulk density	(Mg/m ³)	2.06	200	0.493	0.161	4.60
initial dry density	(Mg/m ³)	1.74	400	0.460	0.110	5.93
initial voids ratio		0.548	800	0.420	0.069	4.05
initial degree of saturation	(%)	94	100	0.460	0.041	
particle density	(Mg/m ³)	42.70				
swelling pressure	(kPa)	N/A				
P ₁₀ to P ₁₀₀ kPa	(kPa)	-				
laboratory temperature	(°C)	21				
method of time fitting		root time				
remarks: if densities particle density has been entered on an assumed value Specimen swelled on first load stage at 50kPa					CONTRACT	CHECKED
					25186	WJ

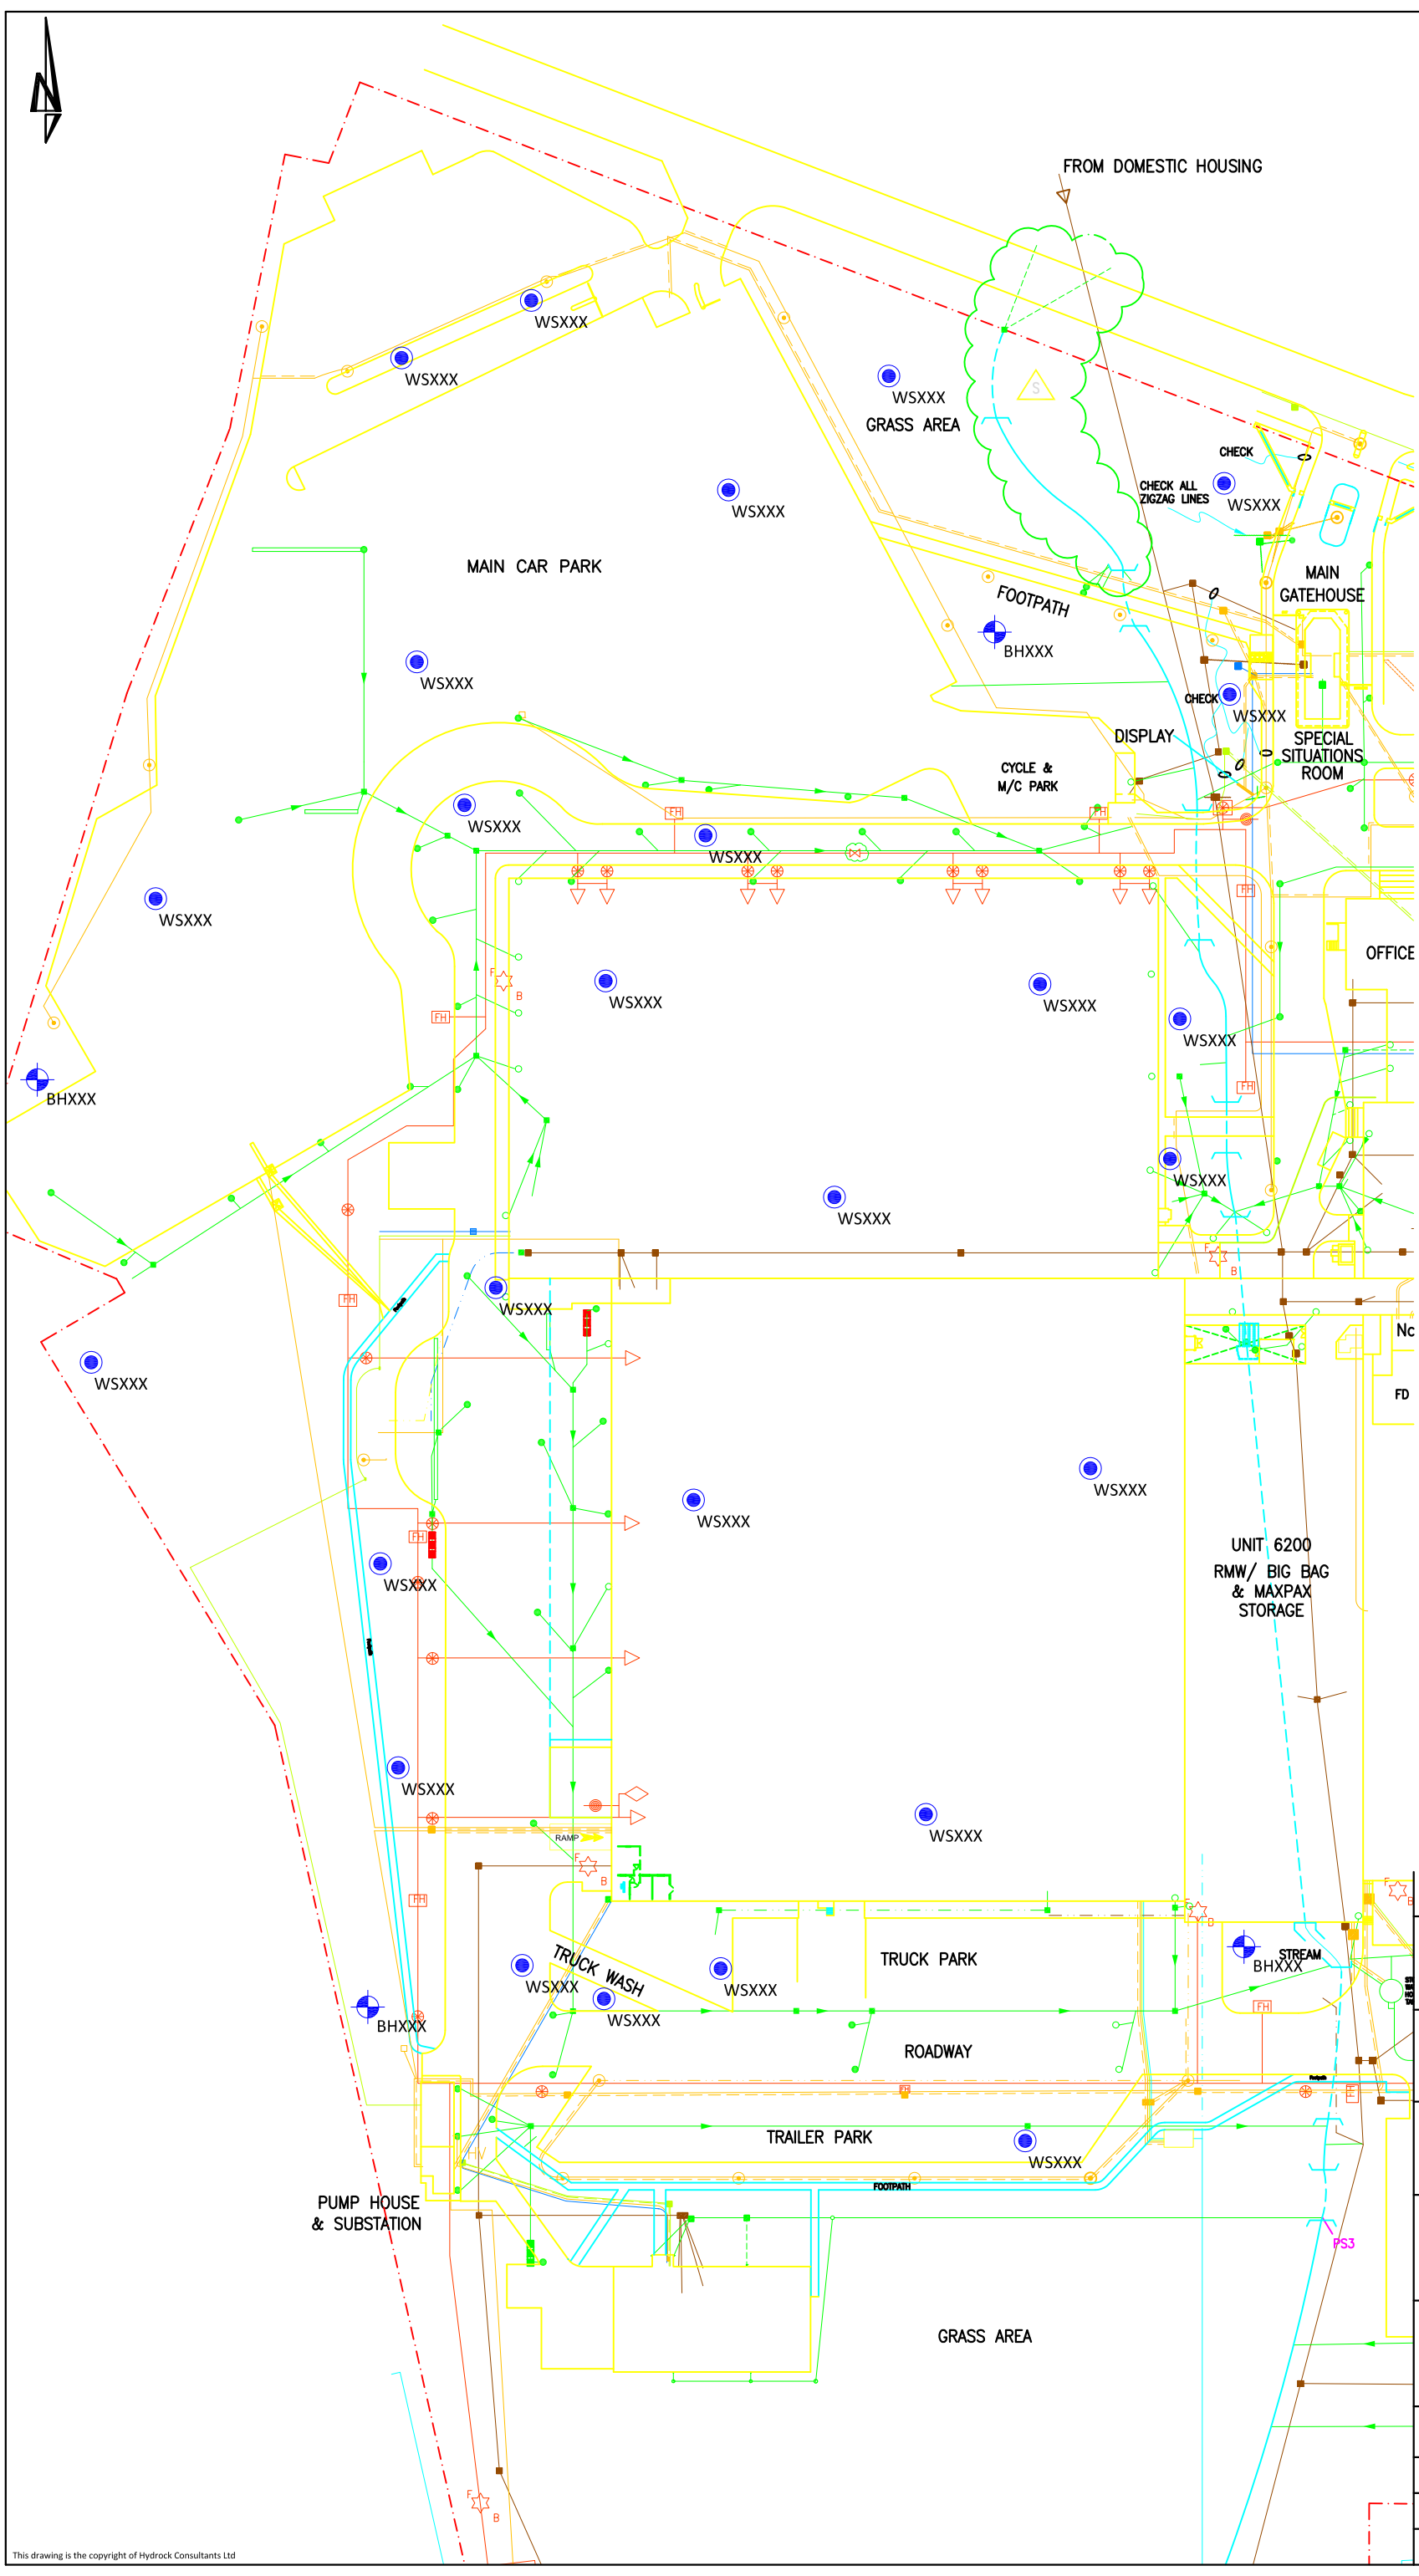
Architect:	
Client:	SAVILLS
Project Title:	KRAFT PHASE 2
Drawing Title:	Proposed Exploratory Hole Location Plan
Drawing Status:	DRAFT
Hydrock Job No:	C161279
Drawn:	NT
Checked:	AB
Scale @ A3:	1:1100
Date:	24/05/16
Issue Date:	24/05/16
Drawing Number:	C161279/D003
Revision:	-

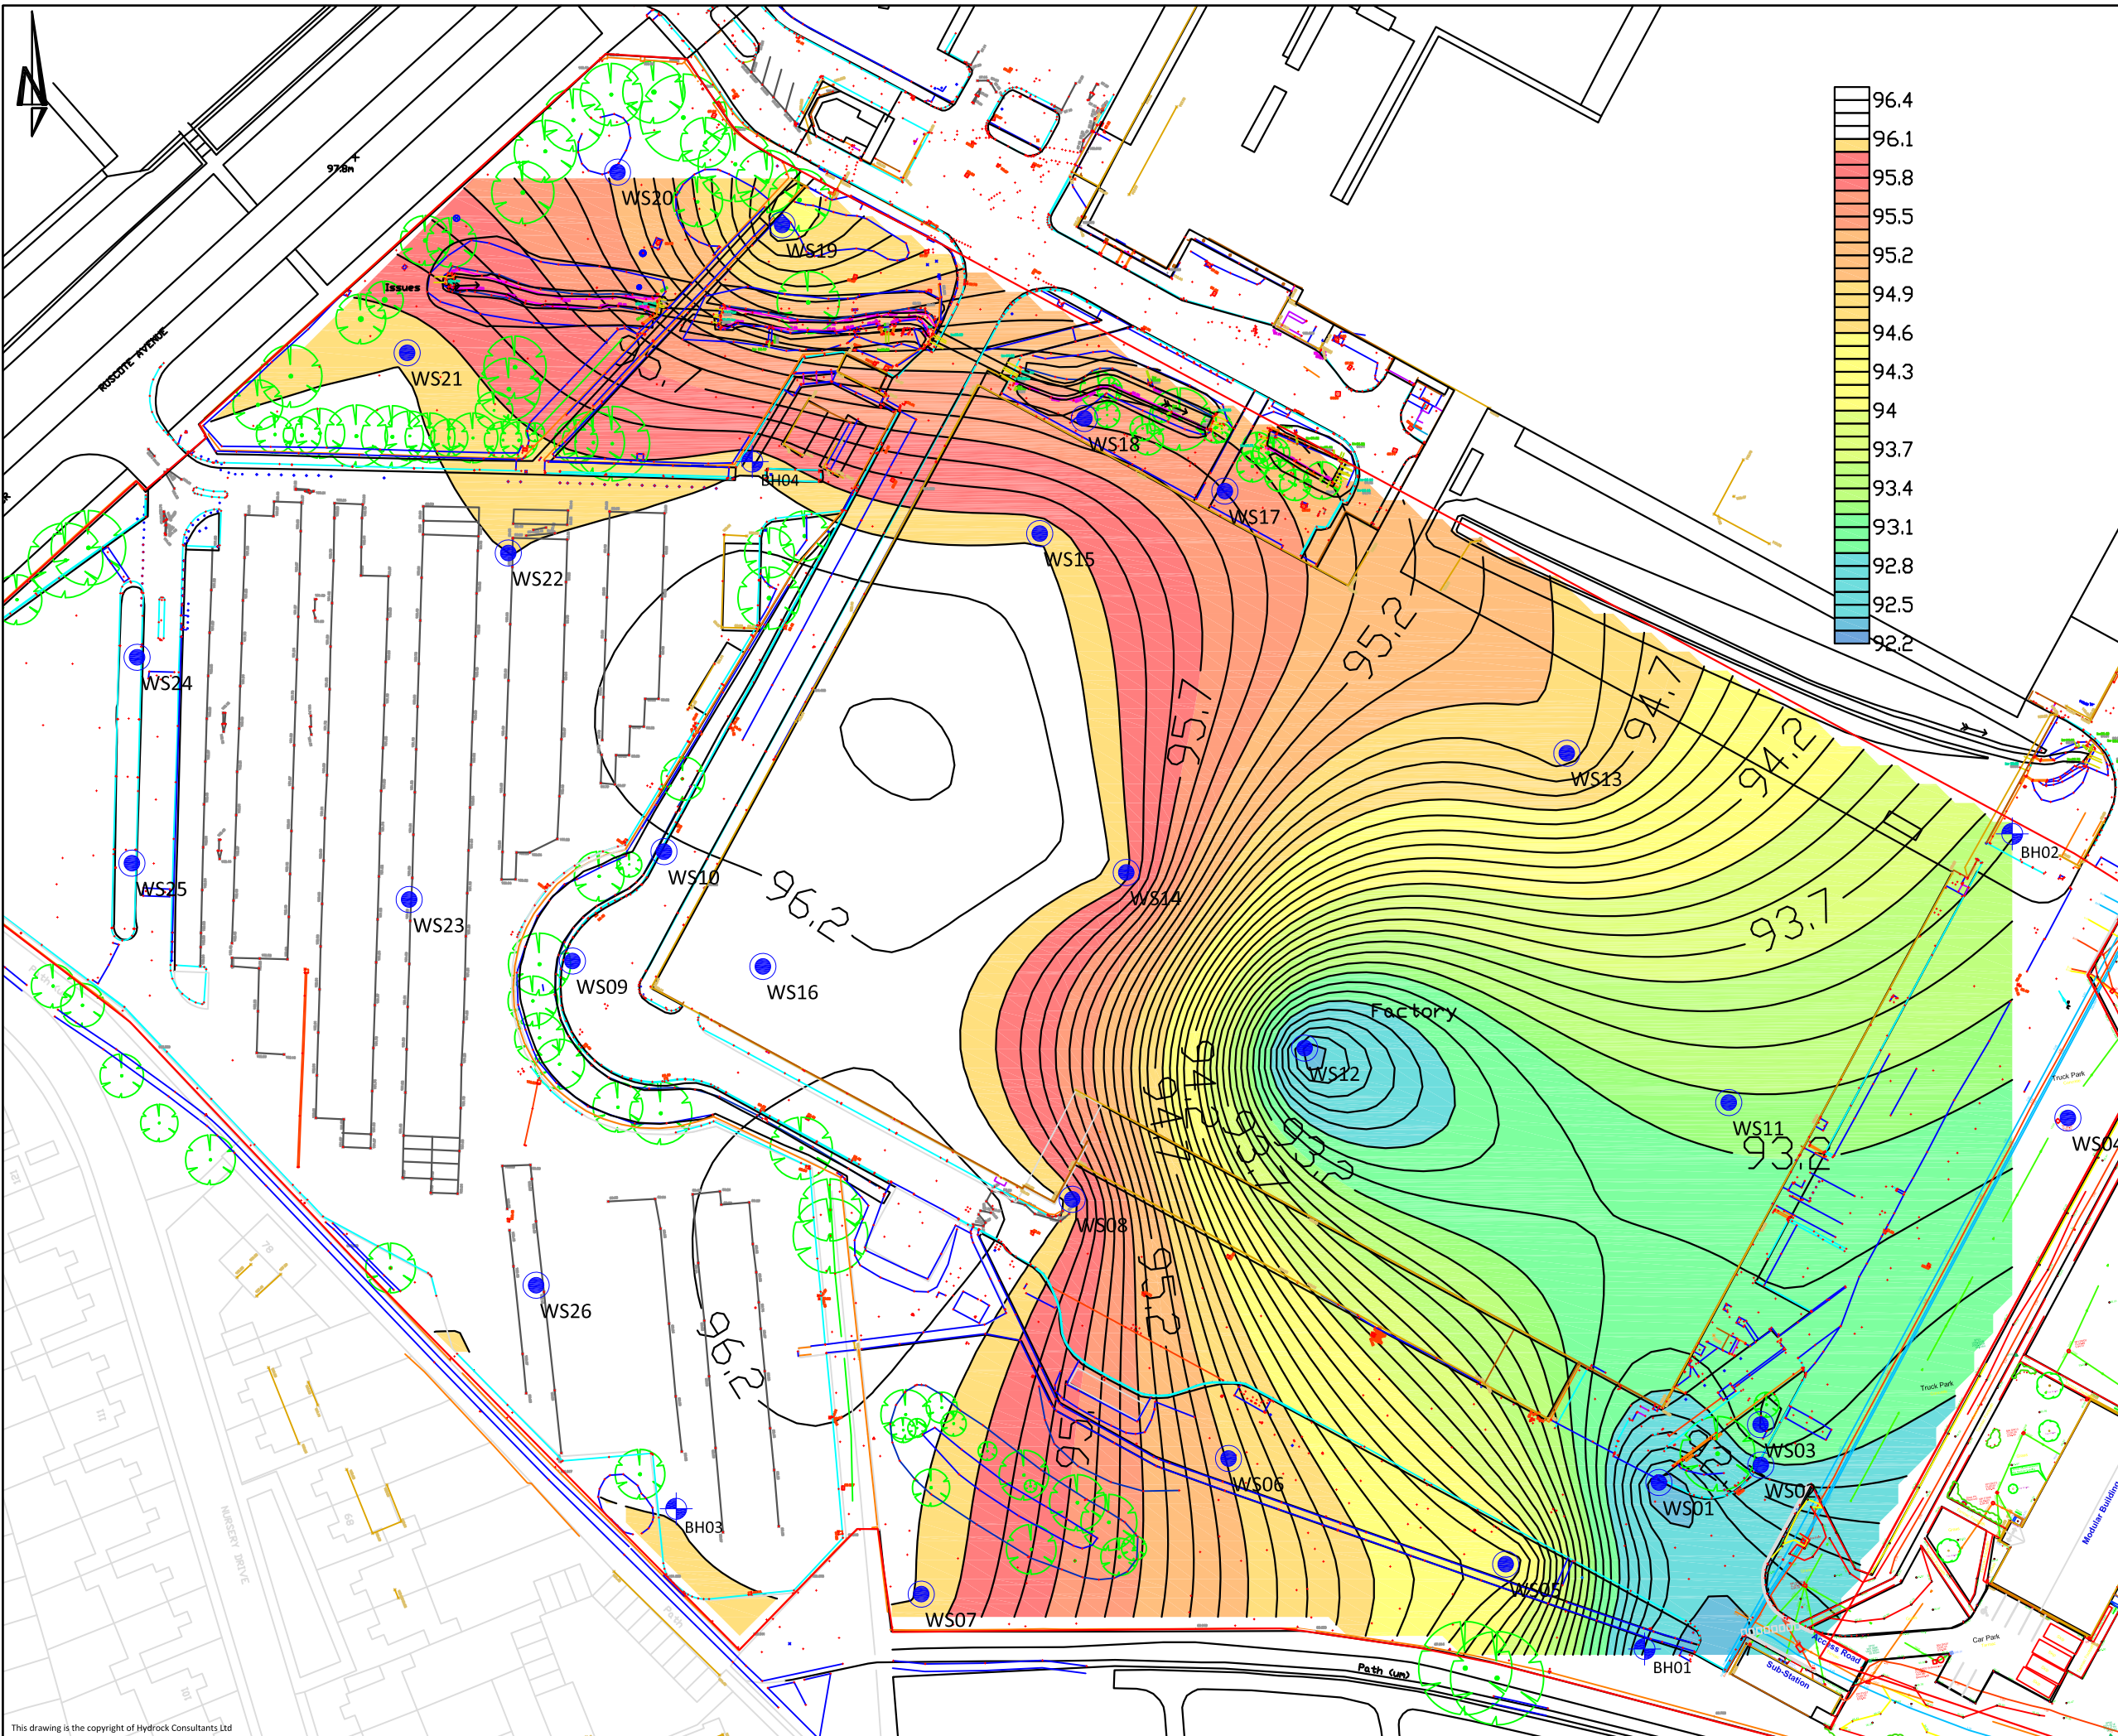
Hydrock Consultants Ltd 3 Hawthorn Park Holdenby Road Spratton, Northampton NN6 8LD T +44 (0)1604 842888 northampton@hydrock.com www.hydrock.com				
Client:				
DB Symmetry Ltd				
Project Title:				
KRAFT PHASE 2				
Drawing Title:				
Base of Alluvium (mAOD)				
Drawing Status:				
FINAL				
Hydrock Job No:				
C/161279				
Drawn	Checked	Scale @ A3	Date	Issue Date
NT	SC	1:1000	06/07/16	06/07/16
Drawing Number:				Revision:
KRF-HYD-02-XX-DR-G-005				-

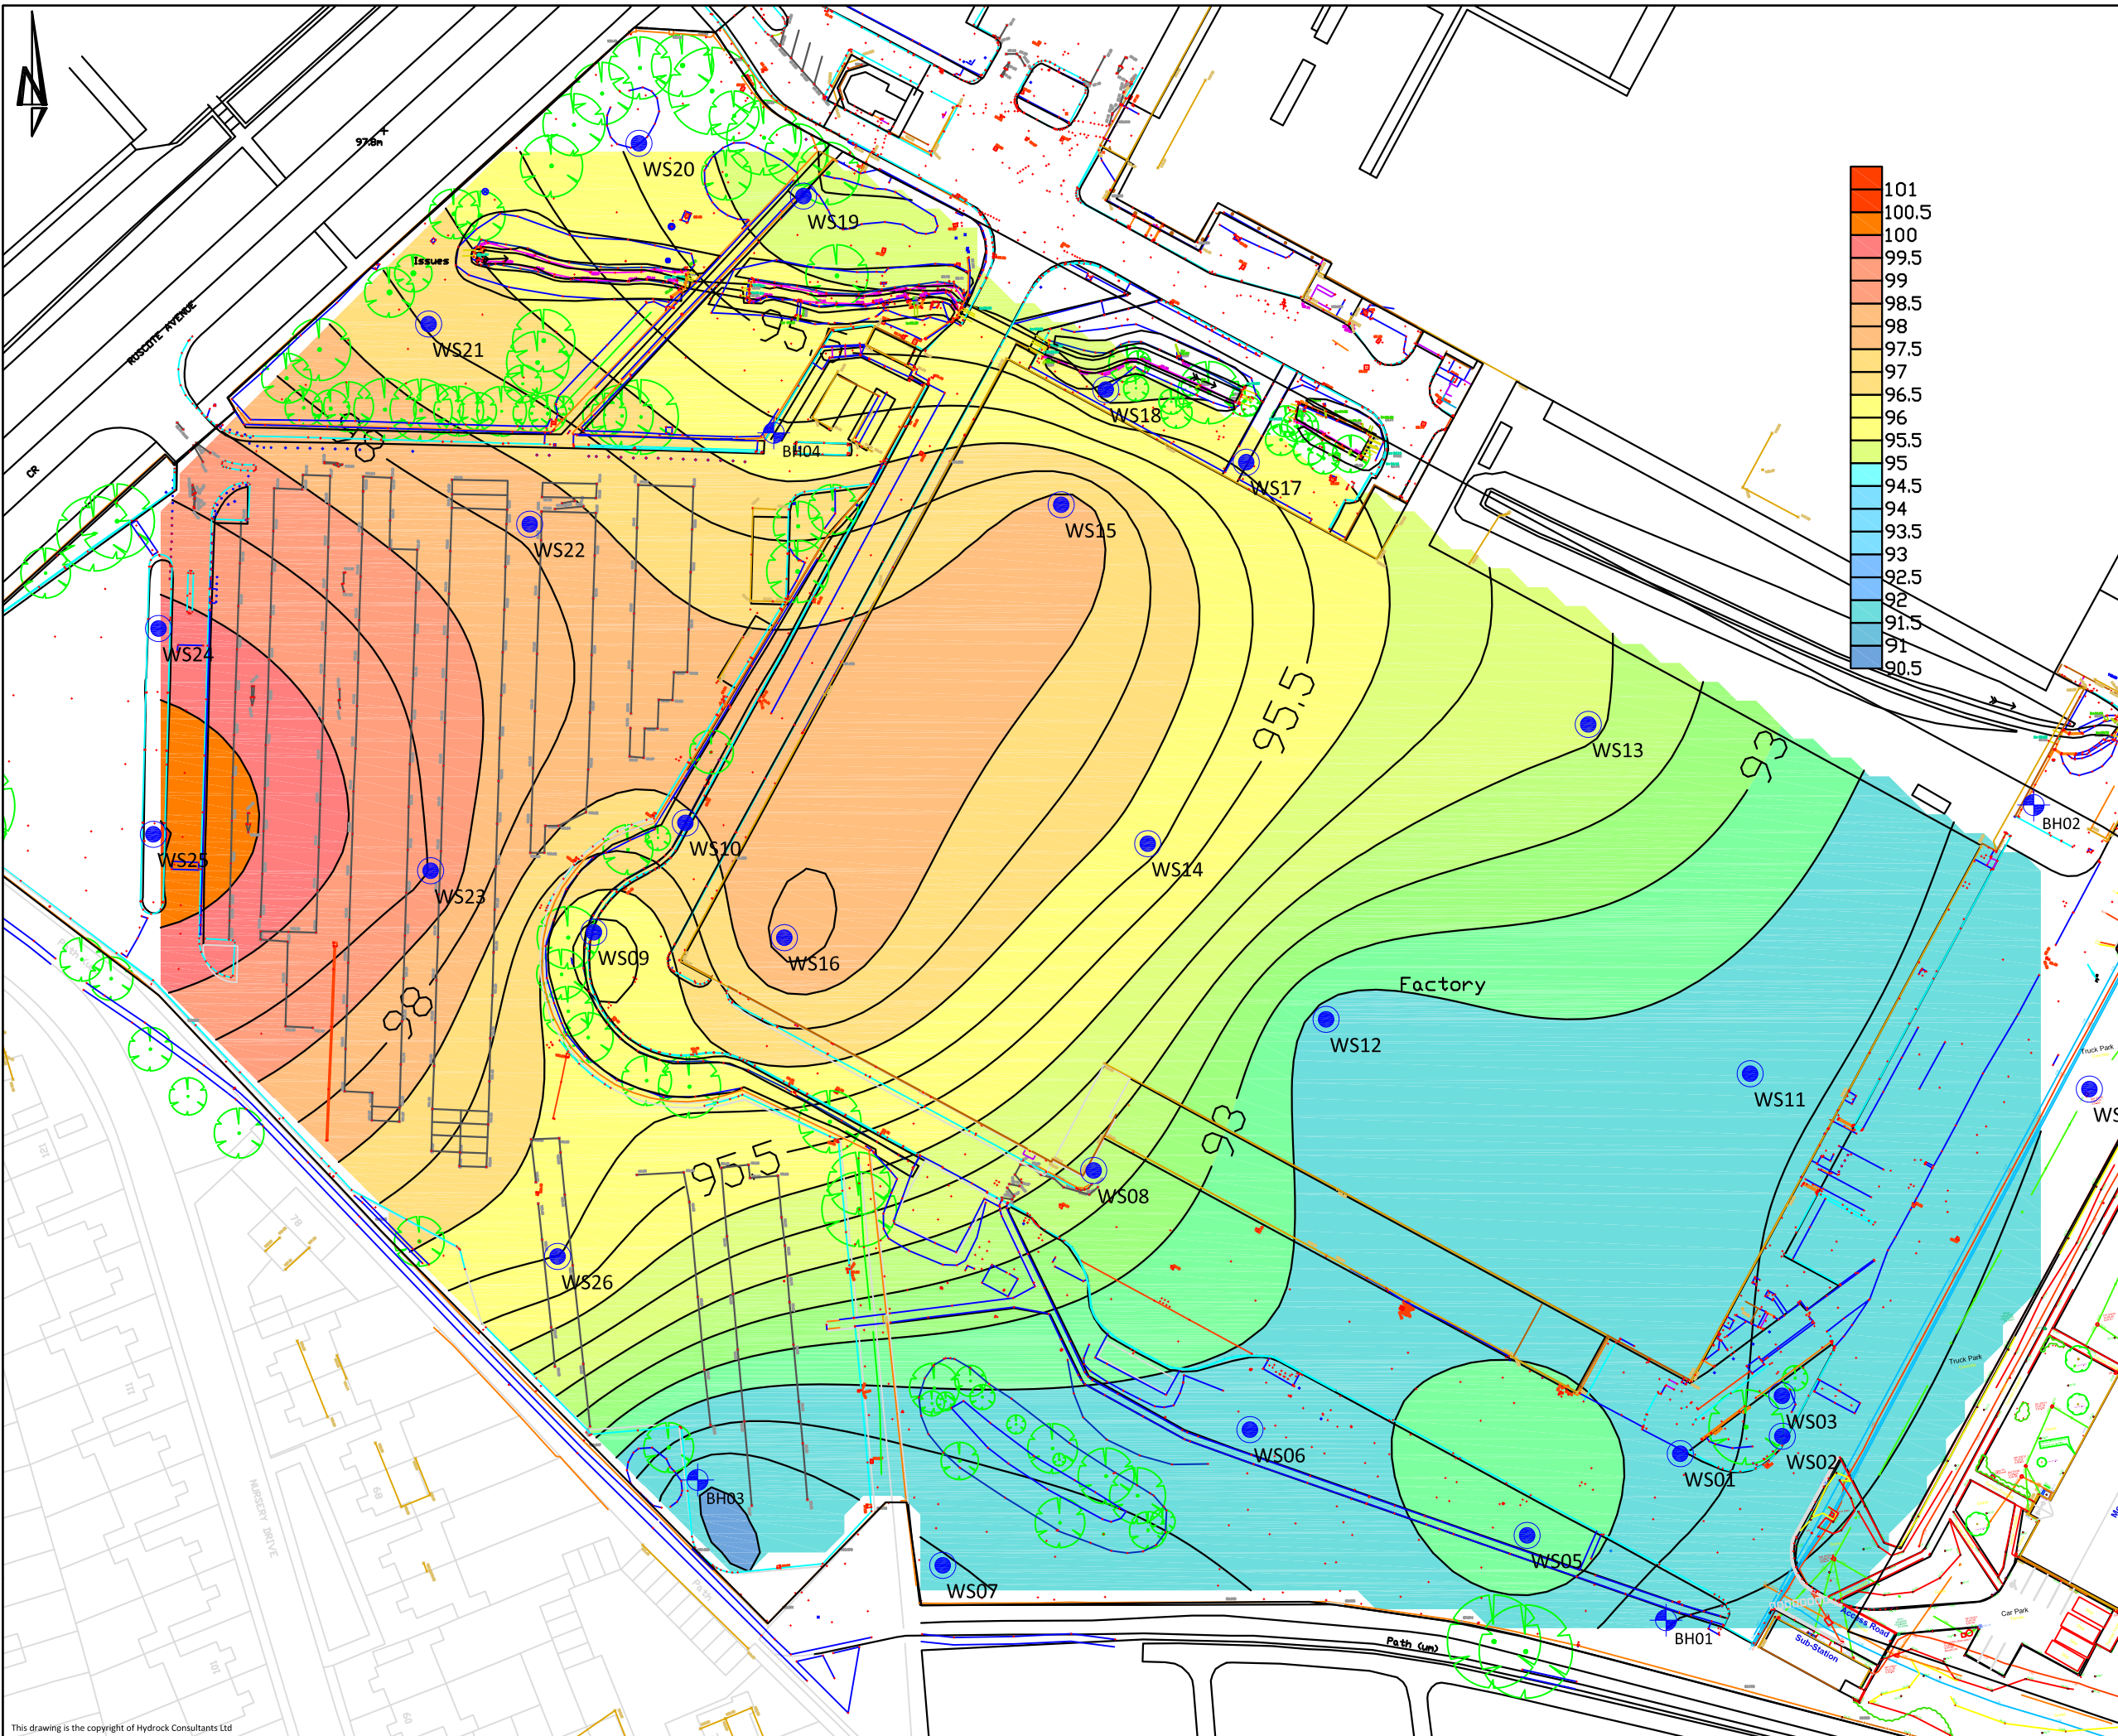
Hydrock Consultants Ltd 3 Hawthorn Park Holdenby Road Spratton, Northampton NN6 8LD T +44 (0)1604 842888 northampton@hydrock.com www.hydrock.com				
Client:				
DB Symmetry Ltd				
Project Title:				
KRAFT PHASE 2				
Drawing Title:				
Top of Charmouth Mudstone (m AOD)				
Drawing Status:				
FINAL				
Hydrock Job No:				
C/161279				
Drawn	Checked	Scale @ A3	Date	Issue Date
NT	SC	1:1000	06/07/16	06/07/16
Drawing Number:				Revision:
KRF-HYD-02-XX-DR-G-D006				-

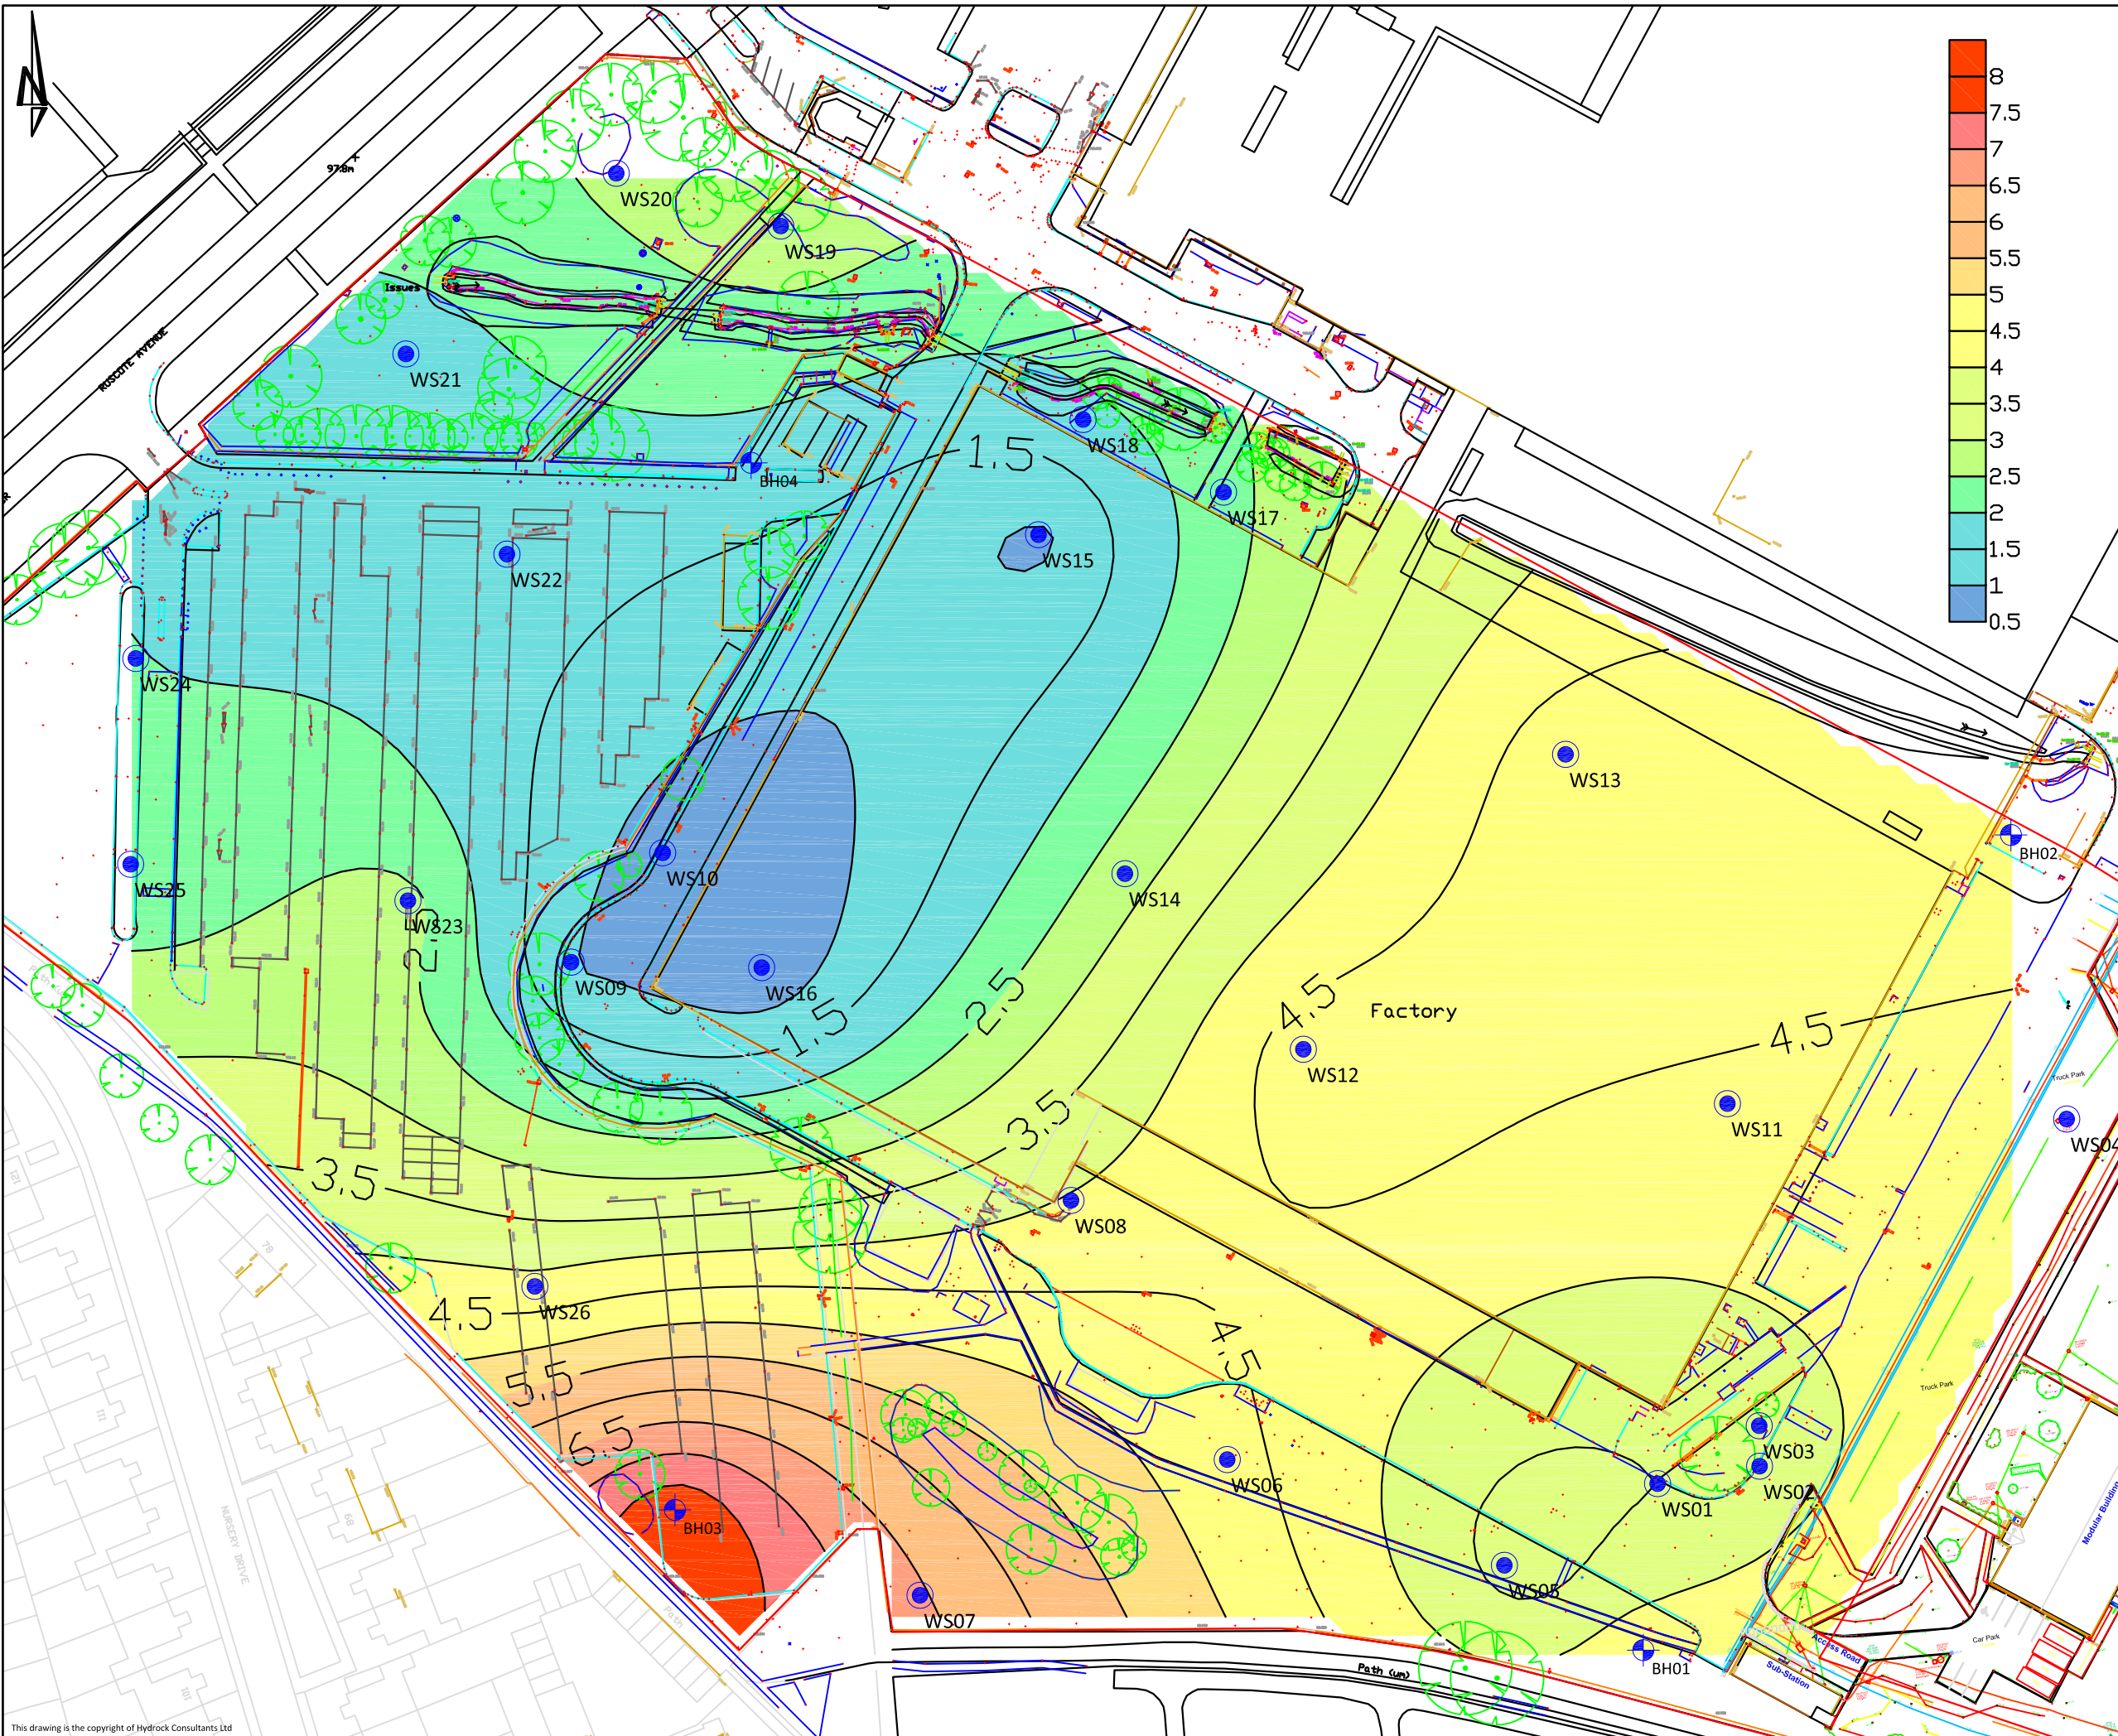
<small>Hydrock Consultants Ltd 3 Hawthorn Park Holdenby Road Spratton, Northampton NN6 8LD T +44 (0)1604 842888 northampton@hydrock.com www.hydrock.com</small>				
Client: DB Symmetry Ltd				
Project Title: KRAFT PHASE 2				
Drawing Title: Top of Charmouth Mudstone (mbgl)				
Drawing Status: DRAFT				
Hydrock Job No: C/161279				
Drawn	Checked	Scale @ A3	Date	Issue Date
NT	SC	1:1000	06/07/16	06/07/16
Drawing Number: KRF-HYD-02-XX-DR-007				Revision: -
