410511/01

SOUTH WEST BICESTER  
OXFORDSHIRE  
GROUND INVESTIGATION  
FACTUAL AND INTERPRETATIVE REPORT

PROJECT TITLE:  
SOUTH WEST BICESTER  
GROUND INVESTIGATION

GROUND CONDITIONS  
ENCOUNTERED - INDICATIVE

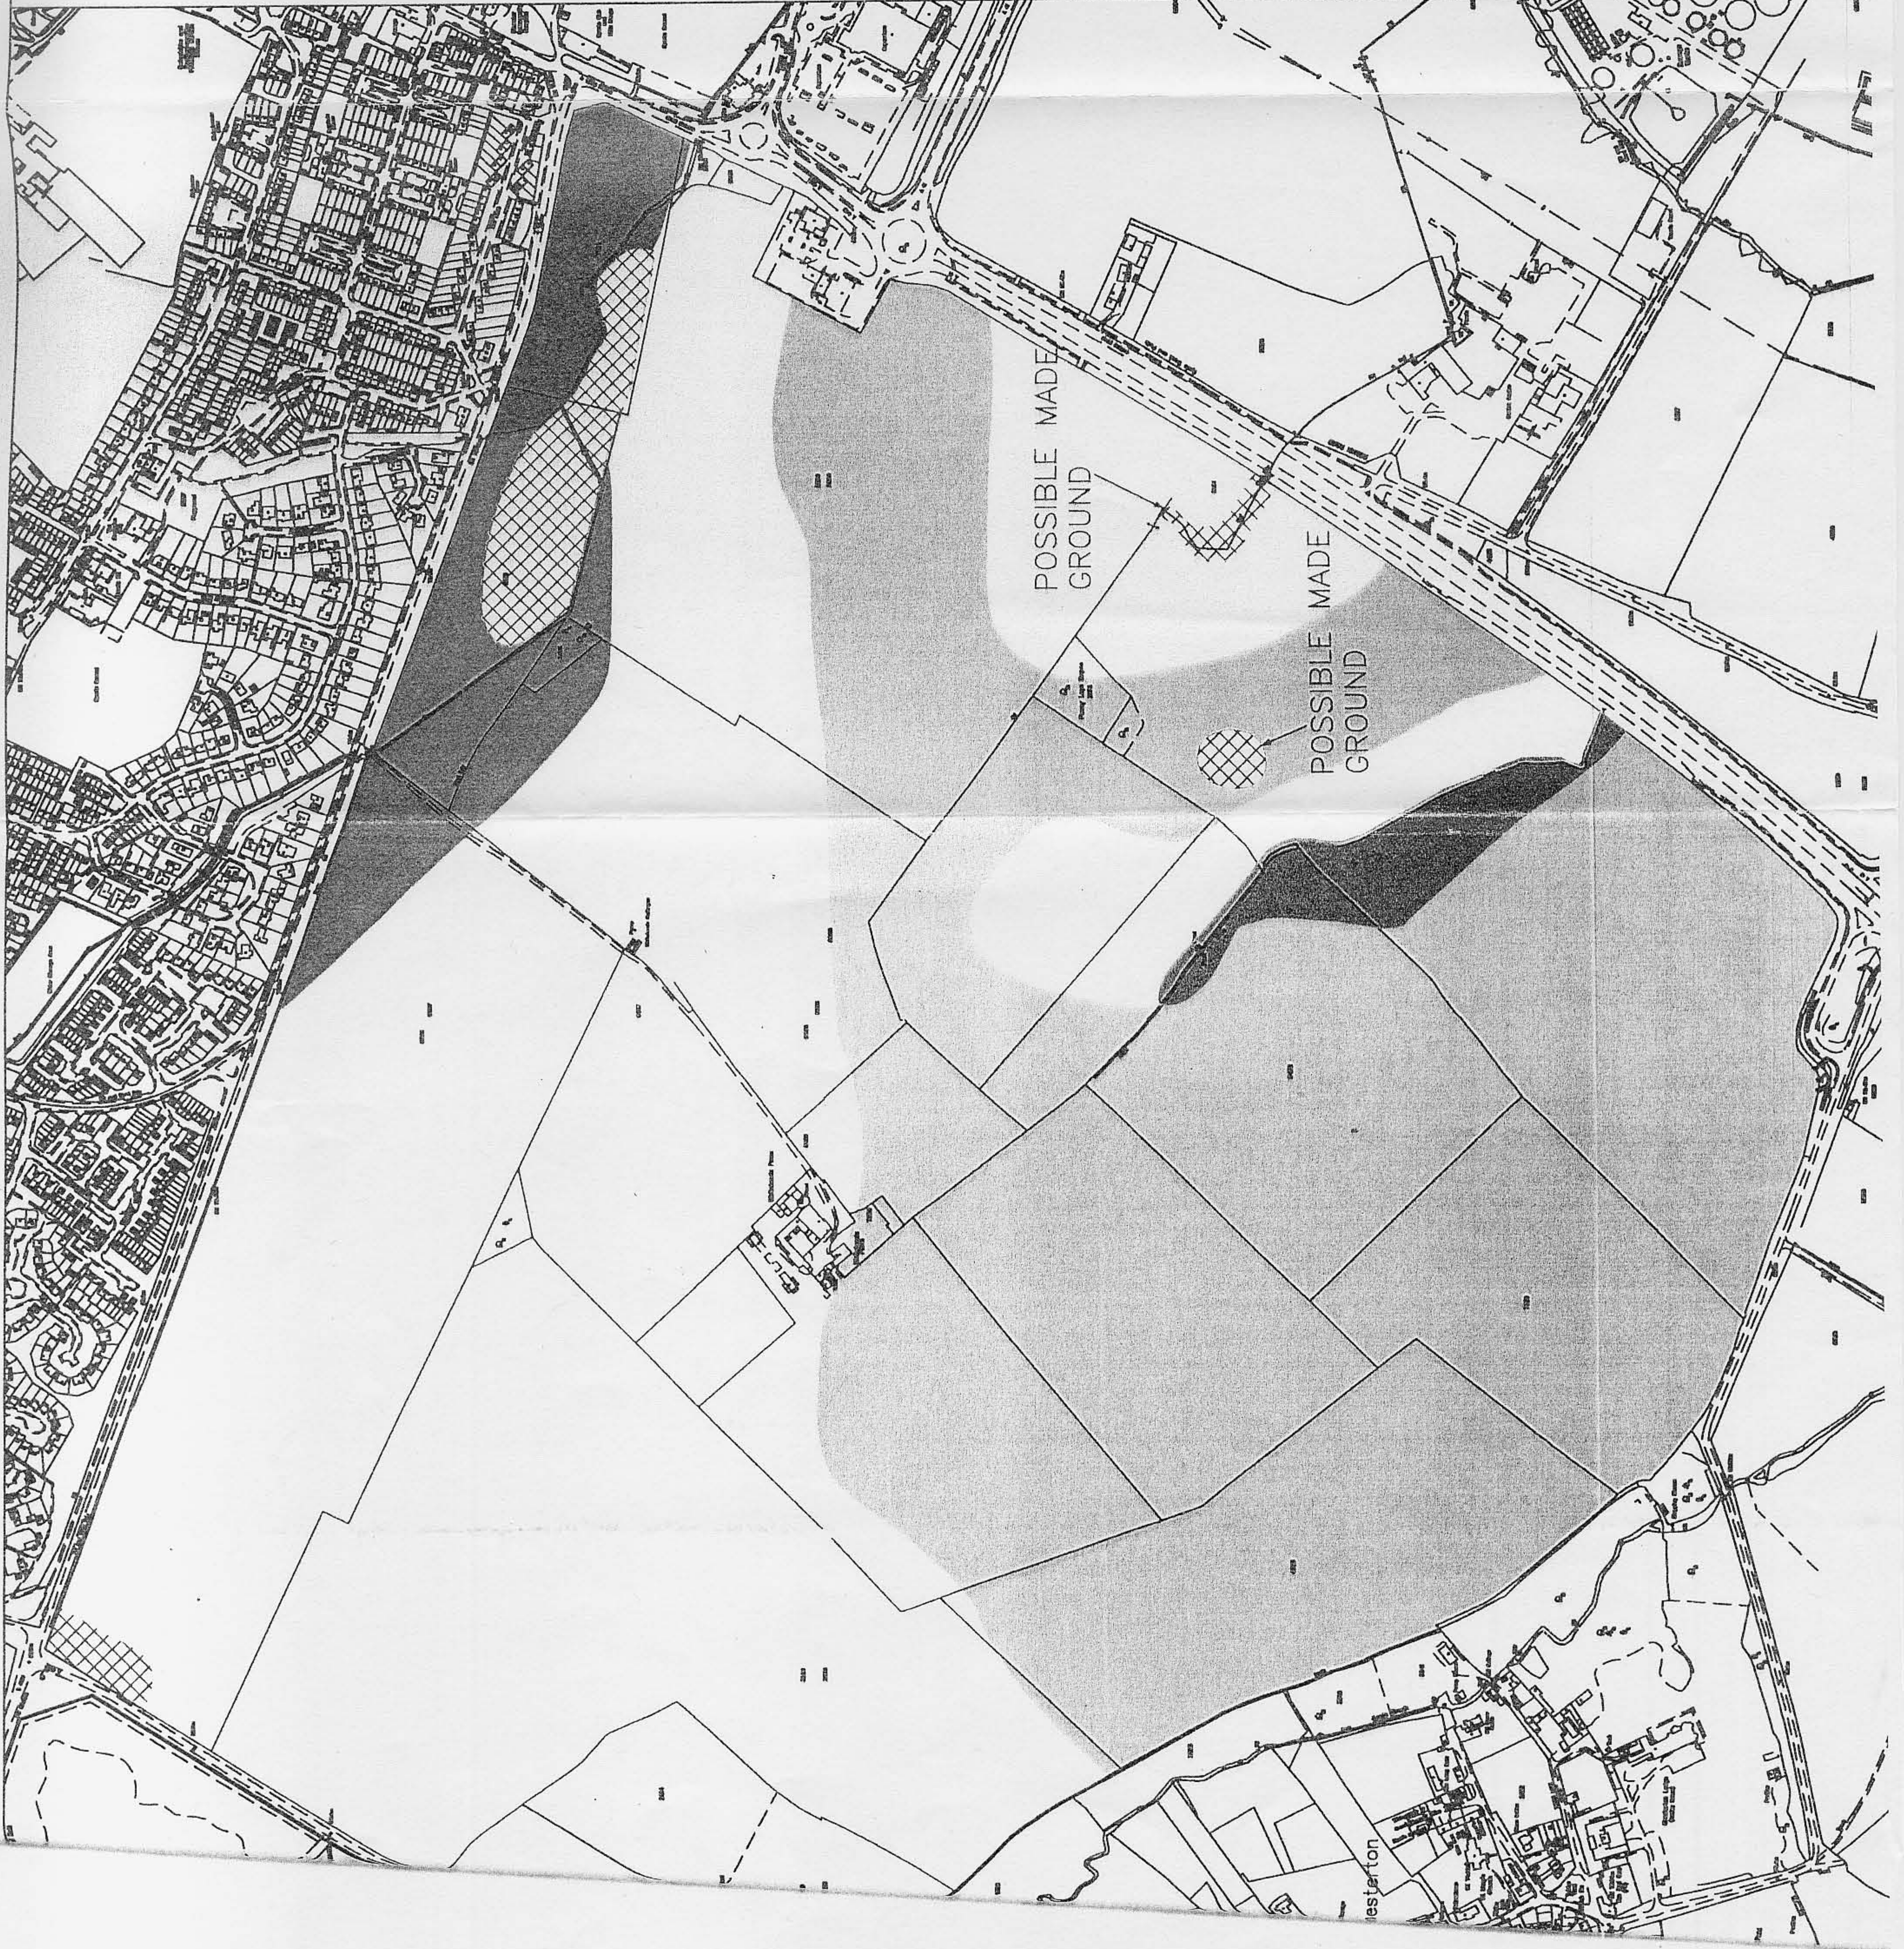
PROJECT NO: 410511 DRAWING NO: FIGURE 2

A summary of approximate areas of the different soils and rocks encountered is given in **Figure 2**. These broadly follow the arrangement of the geological map for the area, although it should be noted that our site investigation does not represent a detailed mapping exercise and that a degree of simplification has been adopted, with conditions being considered primarily in engineering terms.

The boundaries given in **Figure 2** are generally estimated between widely spaced exploratory holes and should thus be regarded as only indicative. Further detailed investigation of individual plots would be required to confirm this initial estimate.

The investigation has identified that the site is underlain by Cornbrash, Kellaways Clay and Forest Marble, with limited areas of alluvium and made ground. An indicative plan showing their possible distribution is given in **Figure 2**.

The strata encountered generally confirmed the published geology of an area of made ground in the north west of the site, with the addition of made ground in the north eastern area of the site and other probably localised areas of fill in the central eastern area of the site.

Alluvial deposits were encountered in the south eastern area of the site comprising predominantly sand between 1m and 1.8m thick, and in the north eastern corner as a thin layer of soft clay and peat to less than 1m depth below ground level.

Kellaways Clay was encountered in much of the southern and south western area of the site. This comprised predominantly stiff clay (highly to completely weathered mudstone) between 0.5m and 2.5m thick, and either gradually becoming a weak to very weak mudstone with increasing depth or was underlain by limestone (the Combrash).

Combrash was encountered in the much of the northern area of the site. This comprised predominantly coarse granular material (highly to completely weathered limestone) between 0.5m and 2.5m thick, and either was underlain by generally moderately weak to moderately strong limestone or a stiff to very stiff clay, this representing completely weathered mudstone of the Forest Marble Formation. Grading results for the Combrash identified a range from a silty sandy gravel to a very clayey very silty sandy gravel.

Forest Marble Formation was encountered in the north eastern area of the site and underlying the Cornbrash where the base of this layer was penetrated. The Forest Marble Formation comprised either a moderately strong light grey limestone, (weathered to a granular material on the upper surface) or a predominantly stiff to very stiff clay (highly to completely weathered mudstone). The clay was found to be between 0.5m and 2.5m thick, becoming a weak mudstone with increasing depth, with occasional beds of moderately weak siltstone. Grading results for the Cornbrash identified a range from a silty sandy gravel to a very clayey very silty sandy gravel.
