**Land at Whitelands Farm, South West Bicester**  
**Remediation Register**  
Countryside Properties Ltd

February 2010

Issue/revision	Issue 1	Revision 1	Revision 2	Revision 3
Remarks	Draft			
Date	February 2010			
Prepared by	H Gardiner			
Signature				
Checked by	K C Law			
Signature				
Authorised by	K C Law			
Signature				
Project number	12370399/001			
Report Number	12370399/001/02

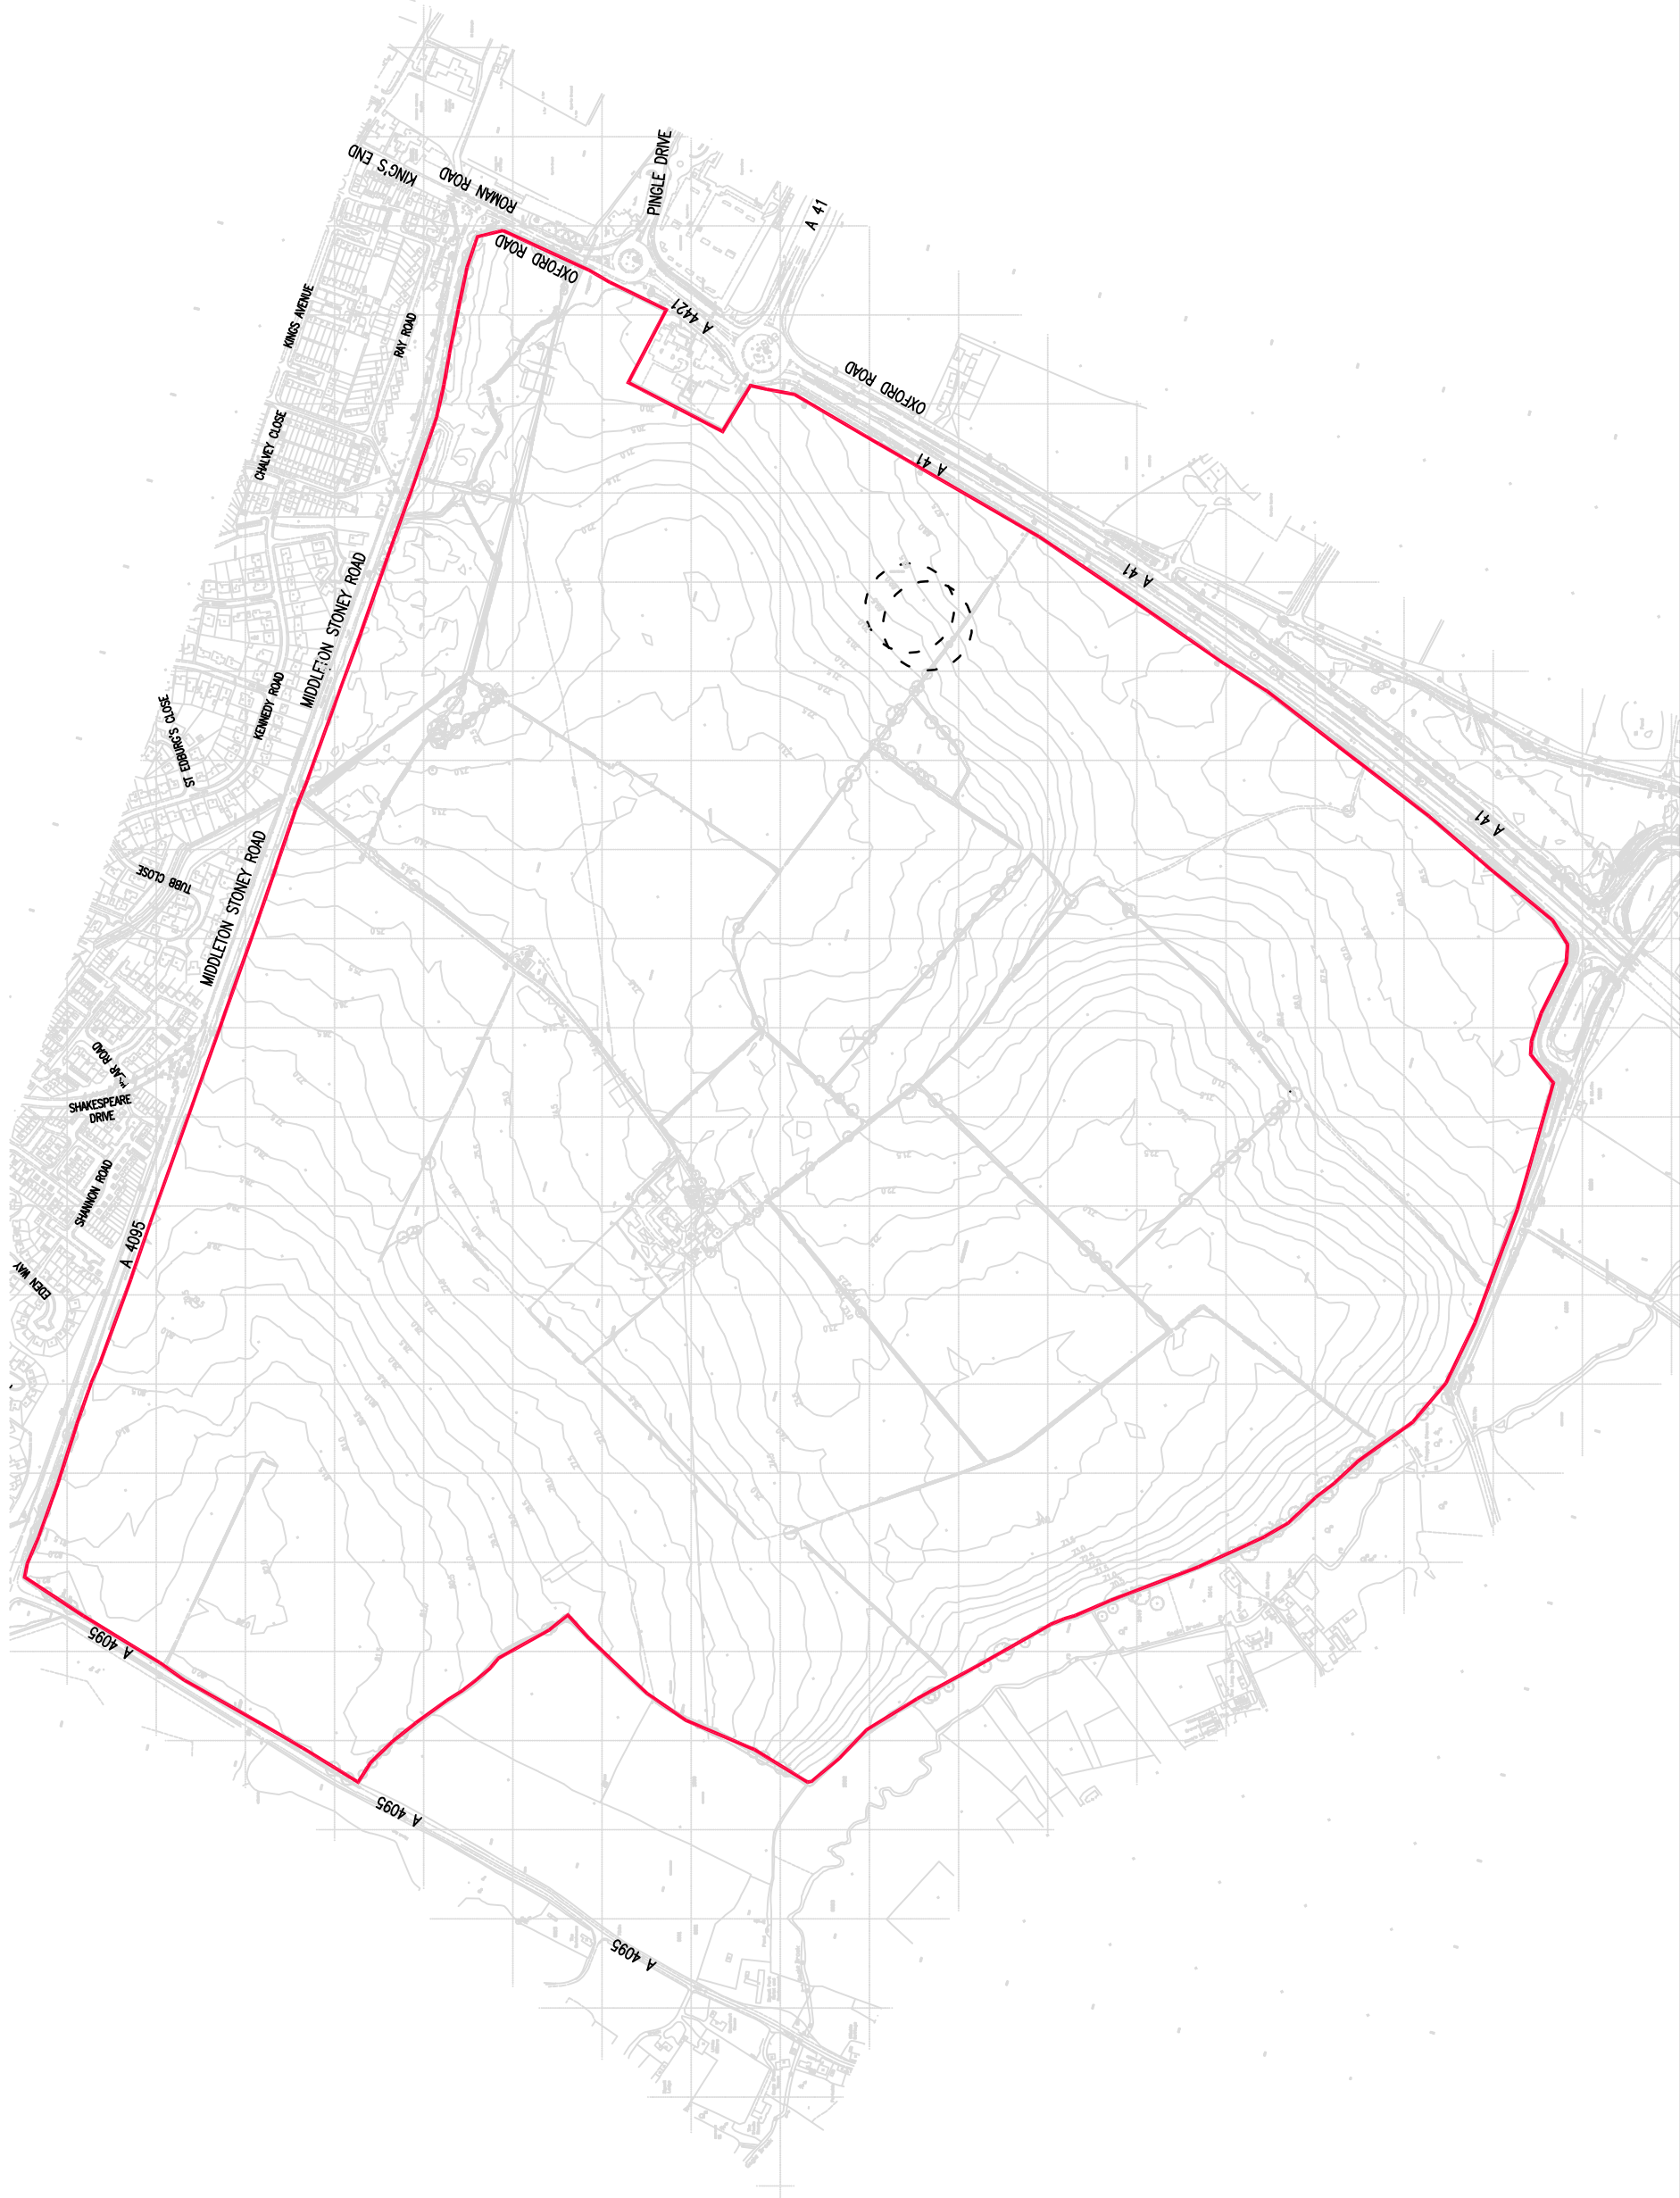
## Figure 2 Site Layout Plan

The site layout is presented in 2.

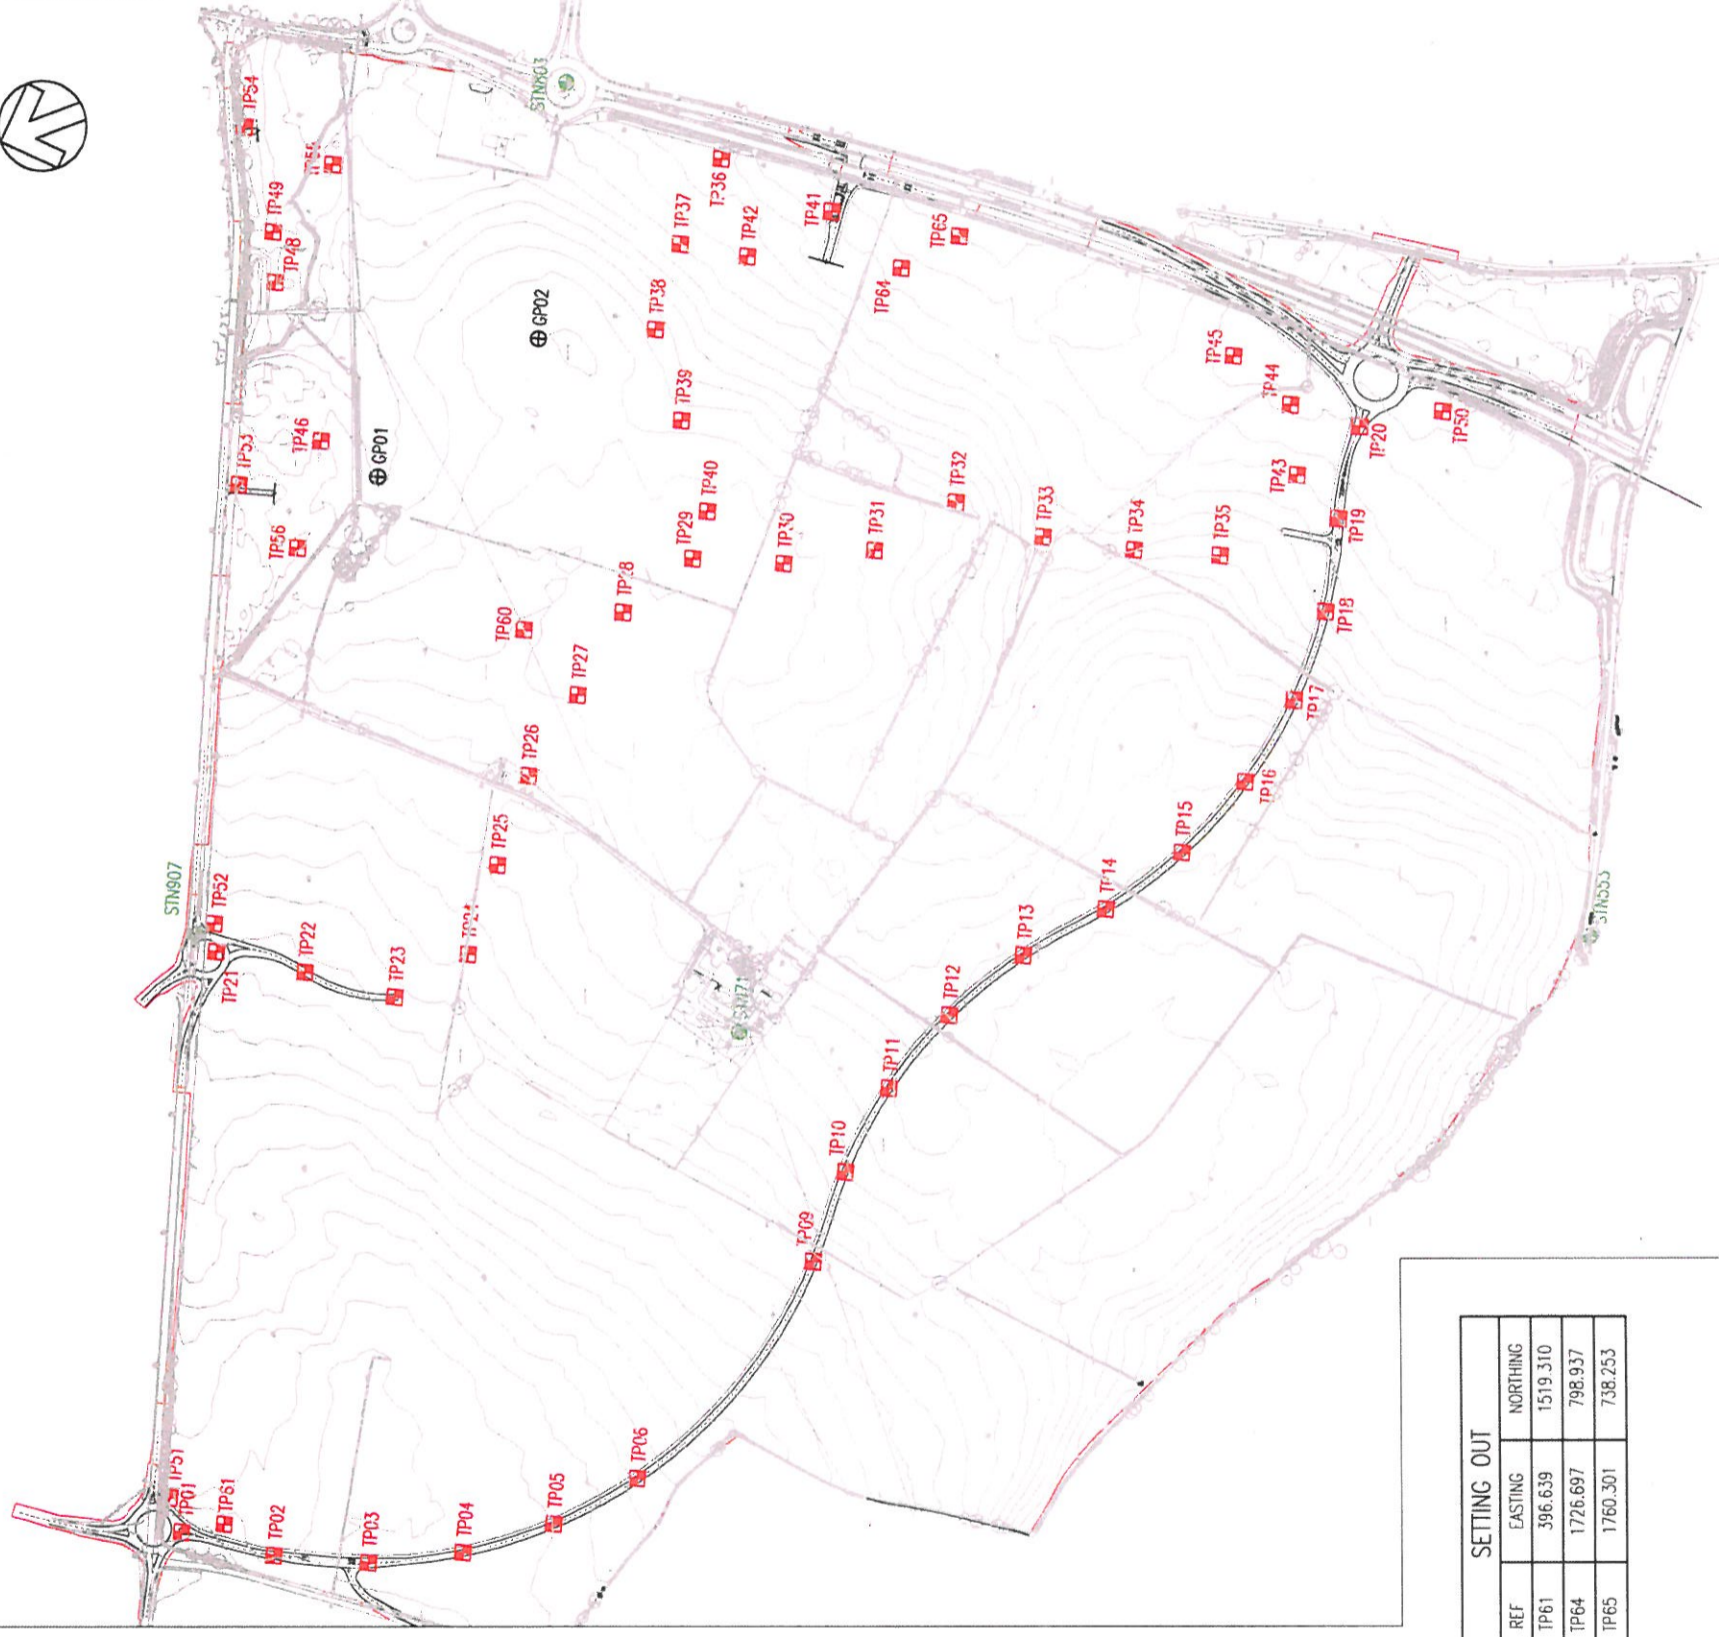
Appendix C Exploratory Hole Location Plan –  
WSP Report 12370178/001 (2007)

CUSTOMER:	COUNTRYSIDE PROPERTIES		
ARCHITECT:	SOUTH WEST BICESTER		
PROJECT:	SOUTH WEST BICESTER		
TITLE:	FIGURE 2: TRIAL PIT LOCATION PLAN		
SCALE @ A3:	AS SHOWN	CHECKED:	TFK
CAD FILE:	1546-SI-01	DESIGN-DRAWN:	DAH
PROJECT No:	11011546	DATE:	July 2007
DRAWING No:	1546/SI/01	REV:	F
© WSP Group plc

3. WSP 12370178/001 (2007)	188 hectares (Appendix C)	Arsenic within all natural soil across the site, and nickel within the Topsoil and Made Ground within Area A.  Made Ground within the northern corner of the site	Made Ground must be removed to a depth of 1m, and may not be used as engineered fill. Made Ground maybe suitable for used within noise bunds.	Not required  Since the investigation, published Soil Guideline Values have become less stringent for arsenic and nickel, and as a result, the majority of previously reported elevated levels are no	No action	Pending

The exploratory hole location plan is presented in Appendix C.

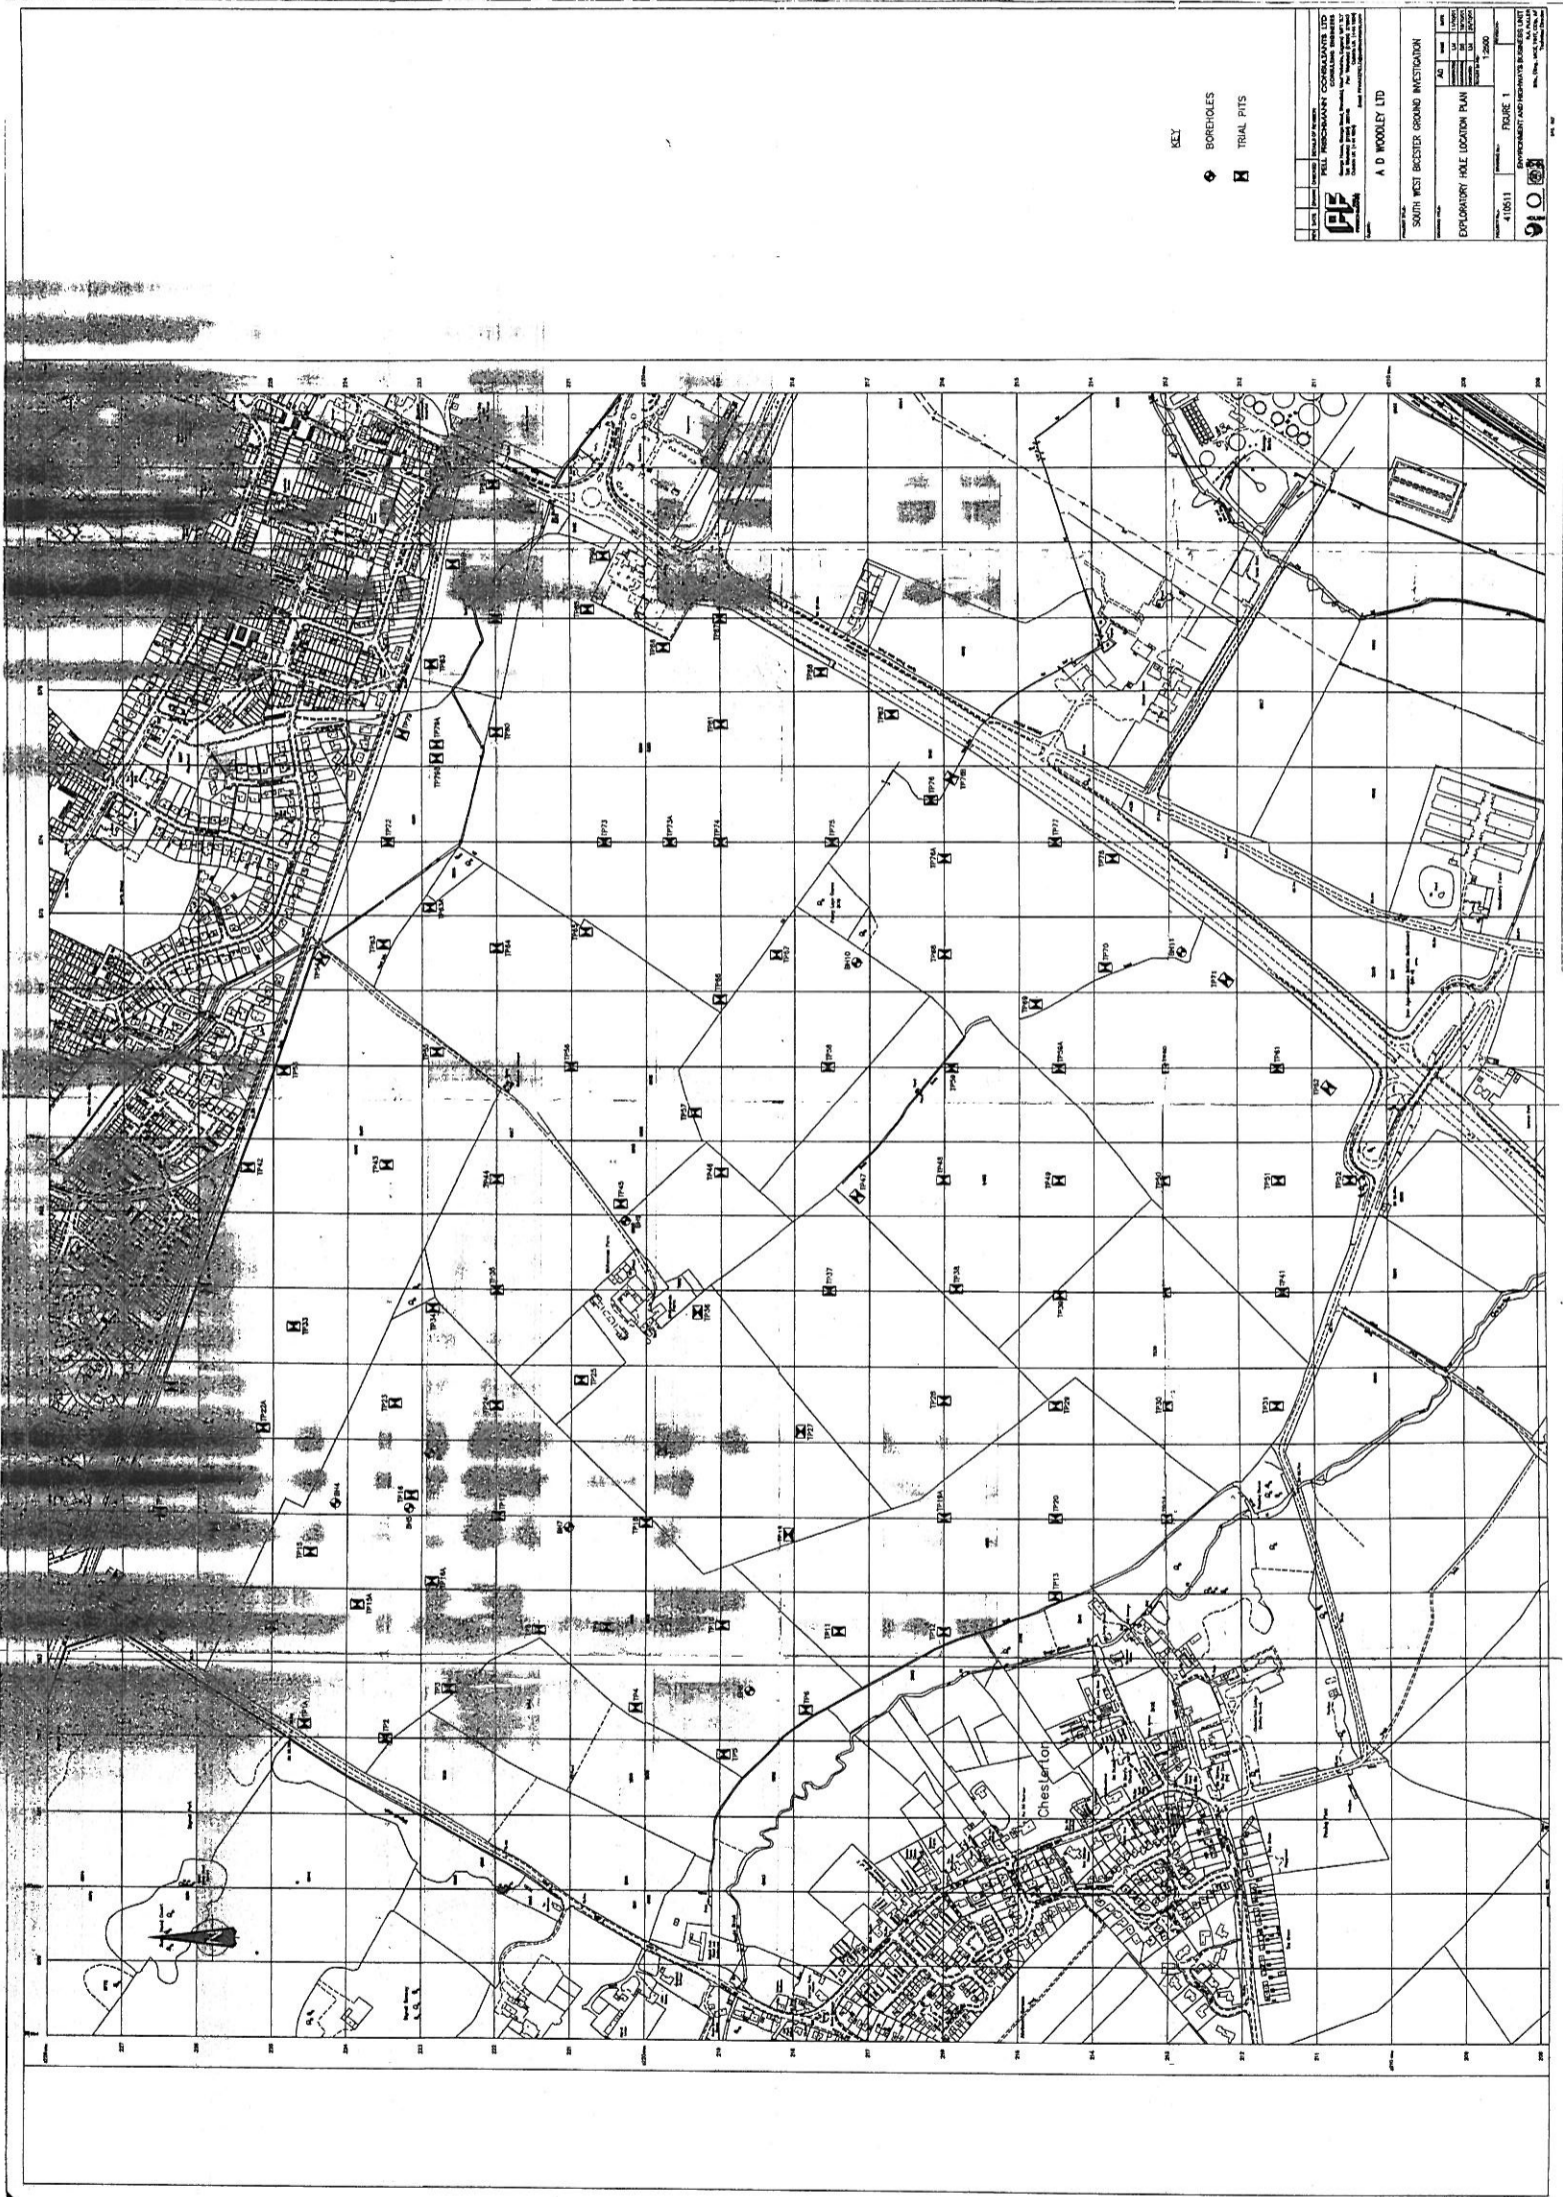
Appendix D Exploratory Hole Location Plan –  
Pell Frischmann Report 410511/01 (2001)

The exploratory hole location plan is presented in Appendix D.

4. Pell Frischmann 410511/01 (2001)	188 hectares (Appendix D)	Immobile heavy metals within the north west corner of the site.	Not required provided a clean break layer is used in landscaped areas.	Not required	No action	Pending
<b>GENERAL ISSUES</b>						
Asbestos		N/A	Possibly within farmhouse buildings	Asbestos to be removed by a specialist contractor. Asbestos-containing materials should be either removed to landfill or safely placed within the formation of roads after seeking conformation with the relevant statutory body.	N/A	Pending
Unidentified areas of contaminations		N/A	Site-wide	Any areas of possible contamination (within landscaped areas) not previously identified during the site investigations	N/A	Pending
