PHASE I & PHASE II GEO-ENVIRONMENTAL SITE INVESTIGATION

Oxford Road, Bicester

REC Report: 80137
Issued: August 2011

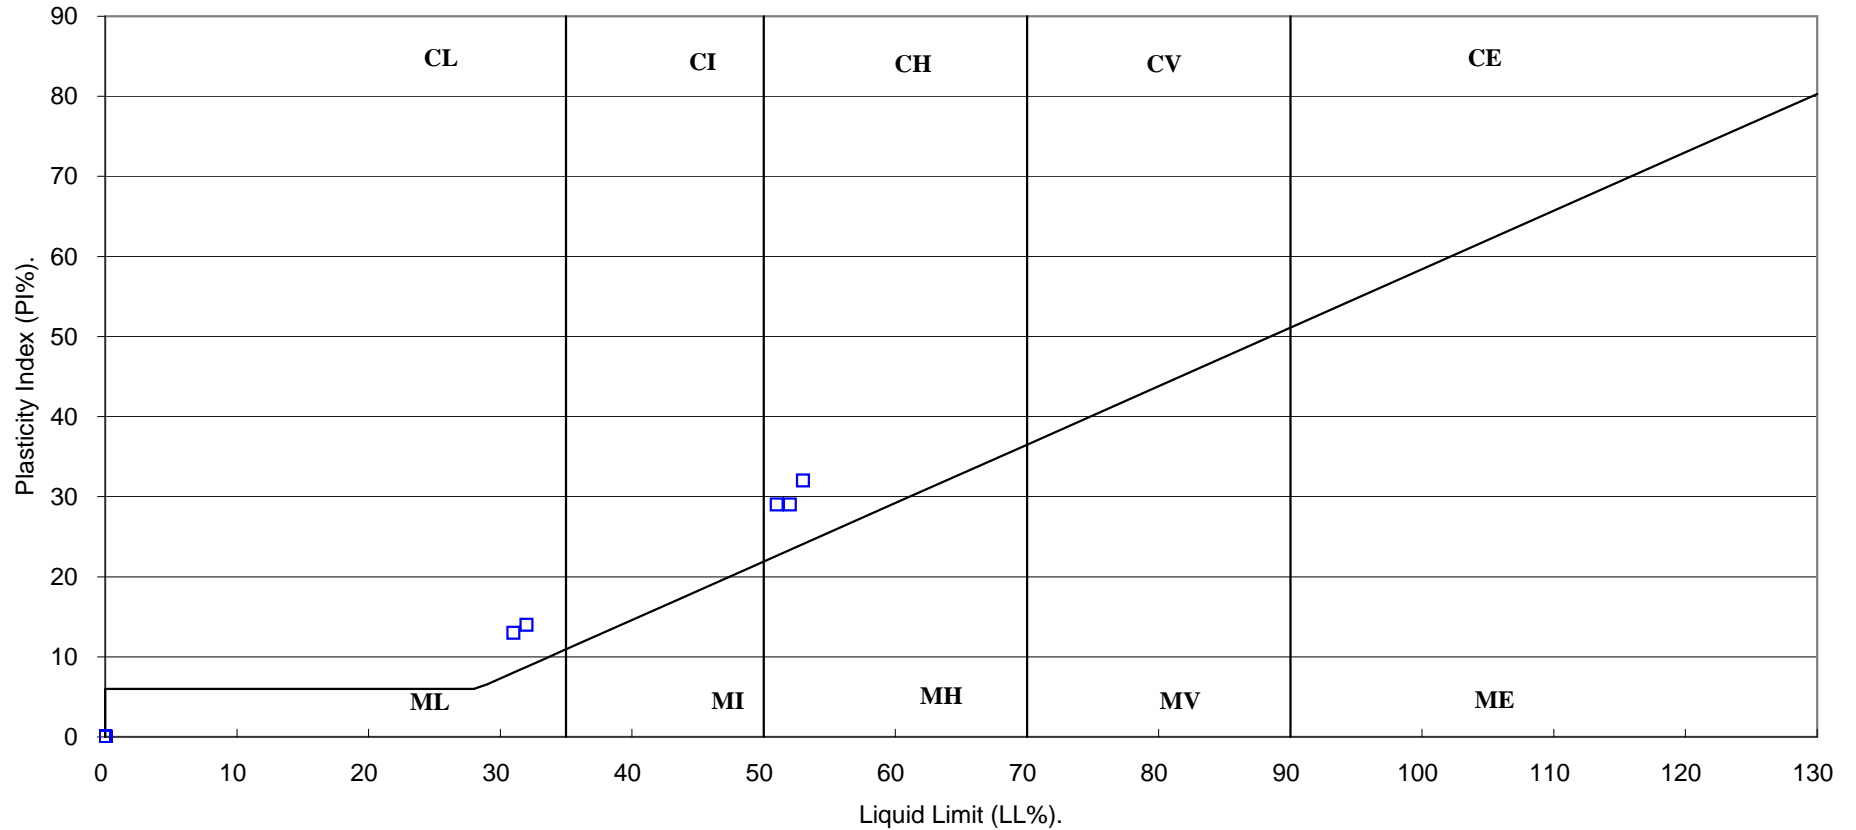
PLASTICITY CHART FOR CASAGRANDE CLASSIFICATION.

Hole Number	Sample Number	Sample Type	Depth m	Moisture Content % <small>Clause 3.2</small>	Bulk Density Mg/m ³ <small>Clause 7.2</small>	Dry Density Mg/m ³ <small>Clause 7.2</small>	Particle Density Mg/m ³ <small>Clause 8.</small>	Liquid Limit % <small>Clause 4.3/4.4</small>	Plastic Limit % <small>Clause 5.</small>	Plasticity Index % <small>Clause 6.</small>	% Passing .425mm	Remarks
TP102		D	0.20	19				52	23	29	80	High plasticity CH.
TP104		D	0.50	29				51	22	29	87	High plasticity CH.
WS102		D	1.70	20				31	18	13	70	Low plasticity CL.
WS105		B	1.40-1.90	16				32	18	14	70	Low plasticity CL.
WS105		D	0.20	26				53	21	32	80	High plasticity CH.

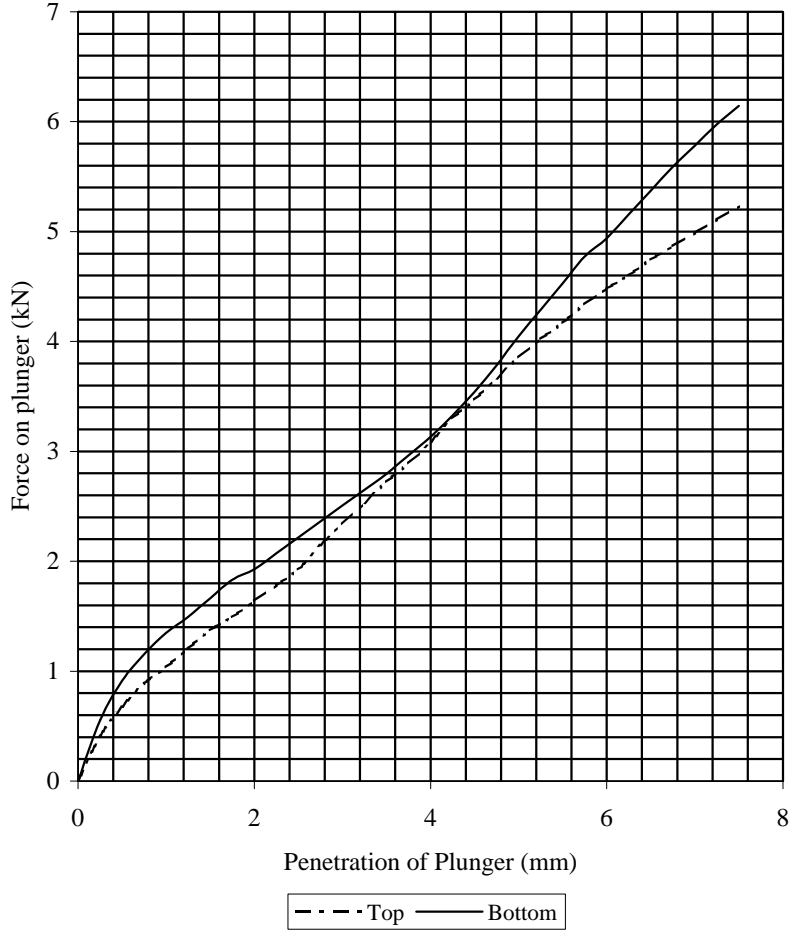
Hole Number: **TP101** Depth (m): **0.45-0.60**

Initial Sample Conditions		Test Conditions		Method of compaction 2.5Kg Rammer			
Moisture Content:	13	Surcharge Kg:	4.20	Final Moisture Content %		C.B.R. Value %	
Bulk Density Mg/m3:	1.99	Soaking Time hrs	0	Sample Top	13	Sample Top	19.3
Dry Density Mg/m3:	1.76	Swelling mm:	0	Sample Bottom	13	Sample Bottom	20.2
Percentage retained on 20mm BS test sieve:	39	Remarks: See Summary of Soil Description.

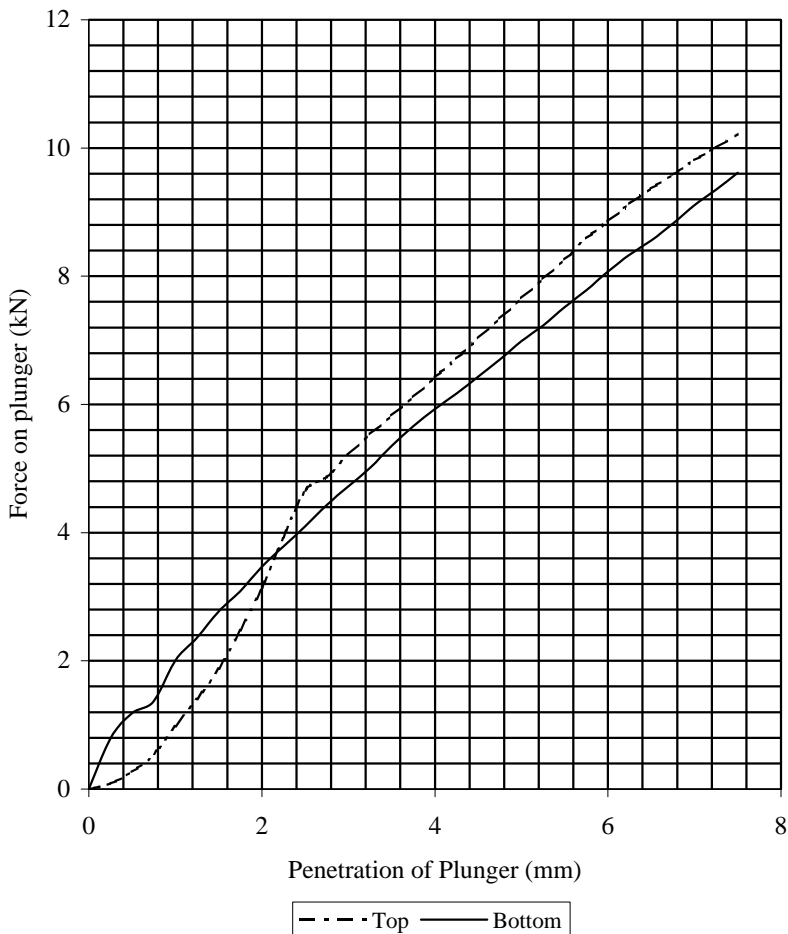
Hole Number: **TP102** Depth (m): **0.75-1.00**

Initial Sample Conditions		Test Conditions		Method of compaction 2.5Kg Rammer			
Moisture Content:	11	Surcharge Kg:	4.20	Final Moisture Content %		C.B.R. Value %	
Bulk Density Mg/m3:	2.17	Soaking Time hrs	0	Sample Top	11	Sample Top	38.3
Dry Density Mg/m3:	1.97	Swelling mm:	0	Sample Bottom	10	Sample Bottom	34.9
Percentage retained on 20mm BS test sieve:	73	Remarks: See Summary of Soil Description.

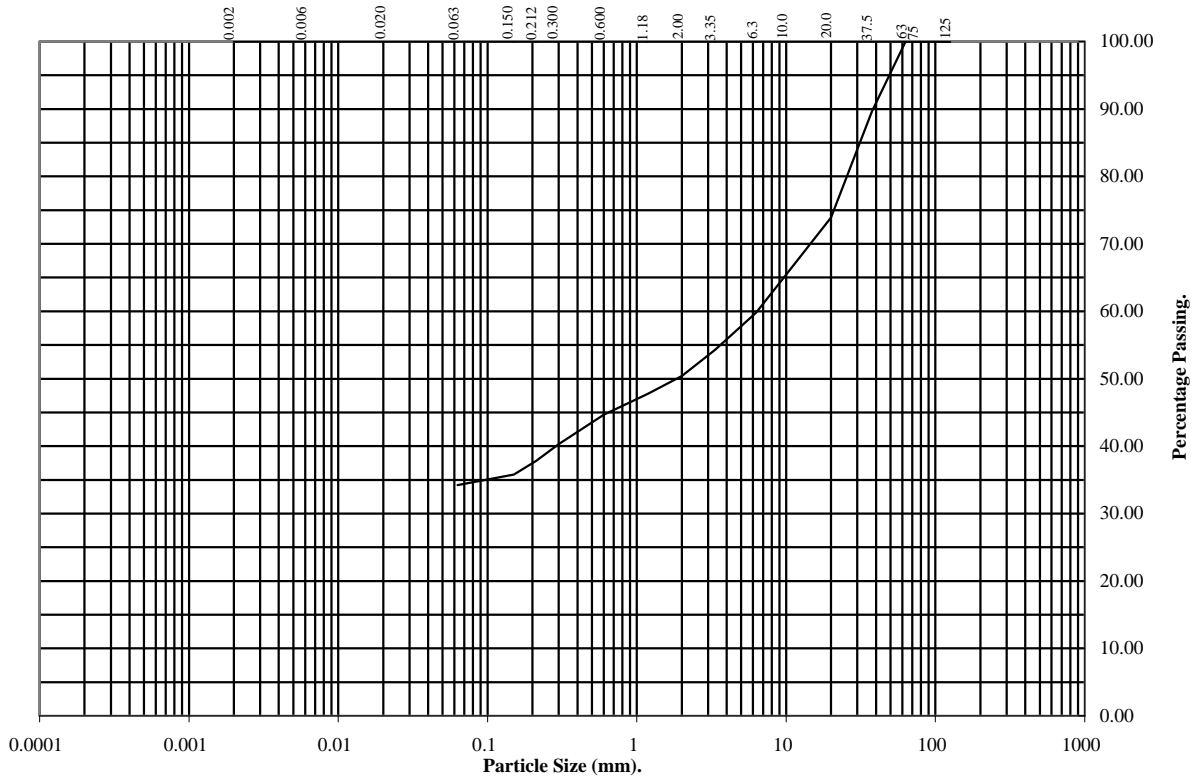
BS Test Sieve	Percentage Passing
125	100
75	100
63	100
37.5	90
20	74
10	65
6.3	60
3.35	54
2	50
1.18	48
0.6	45
0.3	40
0.212	38
0.15	36
0.063	34

Soil Fraction	Total Percentage
Cobbles	0
Gravel	50
Sand	16
Silt / Clay	34

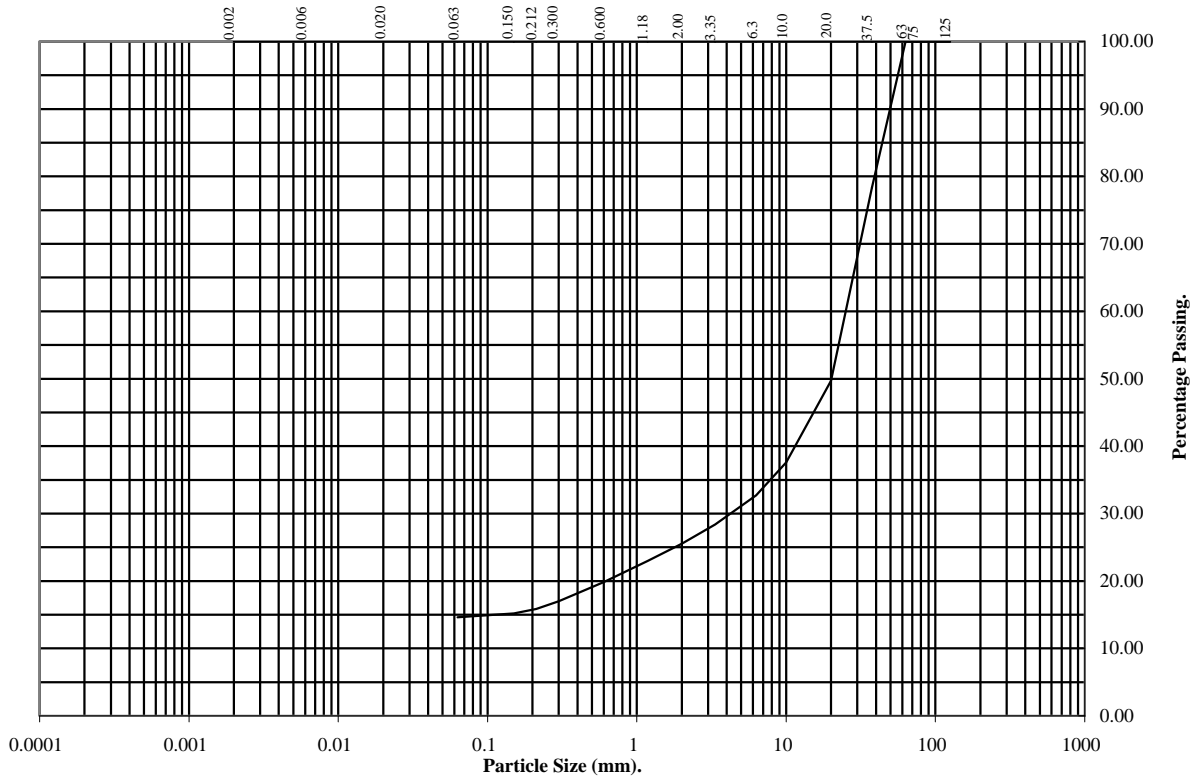
BS Test Sieve	Percentage Passing
125	100
75	100
63	100
37.5	78
20	50
10	38
6.3	33
3.35	28
2	26
1.18	23
0.6	20
0.3	17
0.212	16
0.15	15
0.063	15

Soil Fraction	Total Percentage
Cobbles	0
Gravel	74
Sand	11
Silt / Clay	15

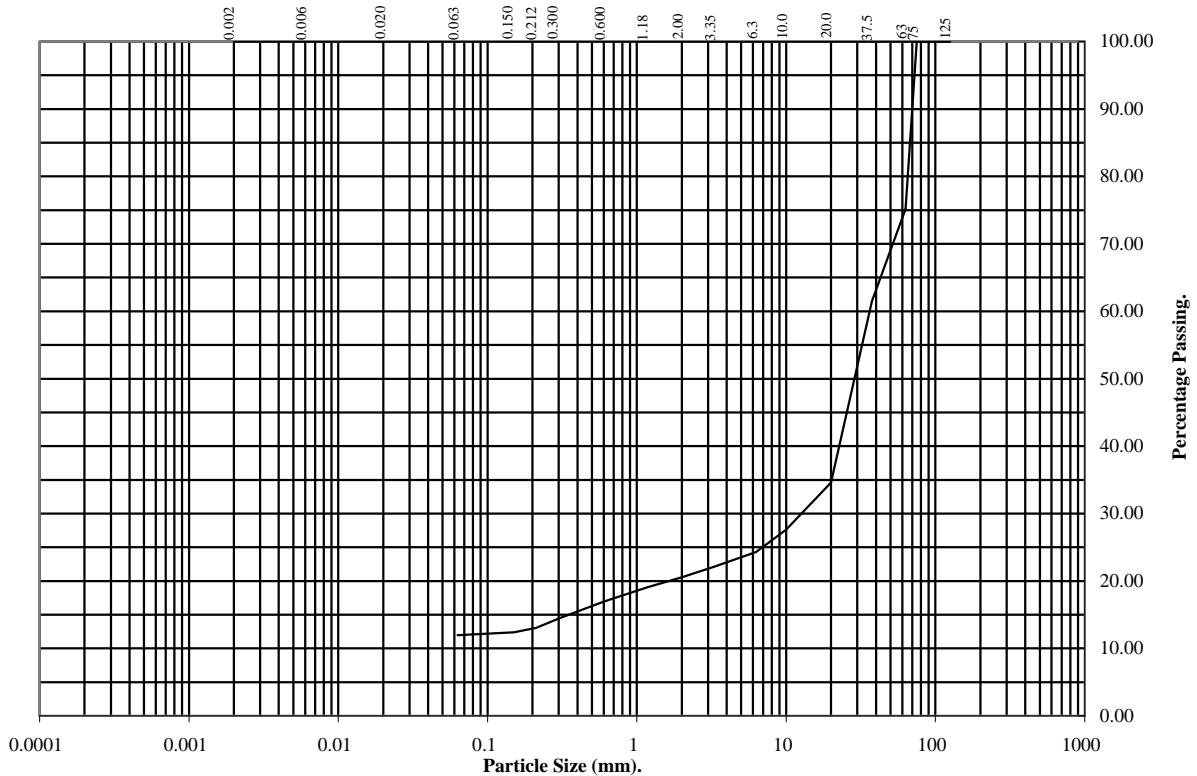
BS Test Sieve	Percentage Passing
125	100
75	100
63	75
37.5	62
20	35
10	28
6.3	24
3.35	22
2	21
1.18	19
0.6	17
0.3	14
0.212	13
0.15	12
0.063	12

Soil Fraction	Total Percentage
Cobbles	25
Gravel	54
Sand	9
Silt / Clay	12

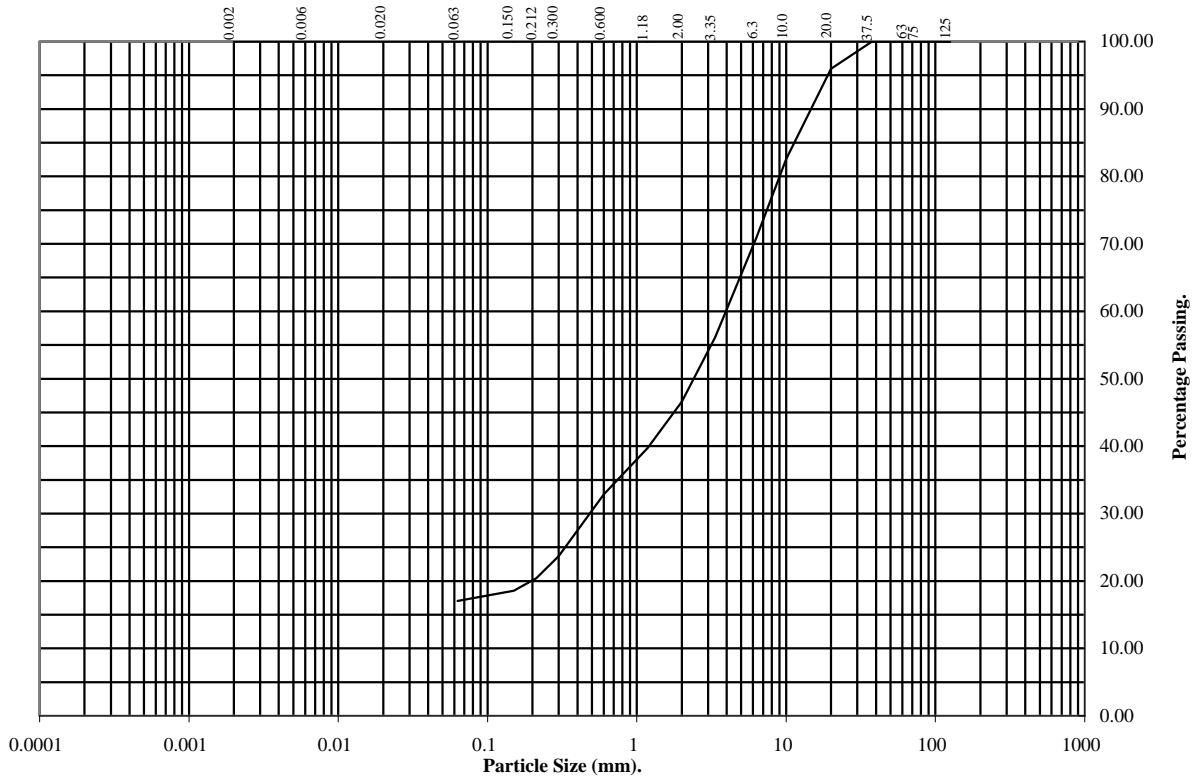
BS Test Sieve	Percentage Passing
125	100
75	100
63	100
37.5	100
20	96
10	83
6.3	71
3.35	56
2	47
1.18	40
0.6	33
0.3	24
0.212	20
0.15	19
0.063	17

Soil Fraction	Total Percentage
Cobbles	0
Gravel	53
Sand	30
Silt / Clay	17

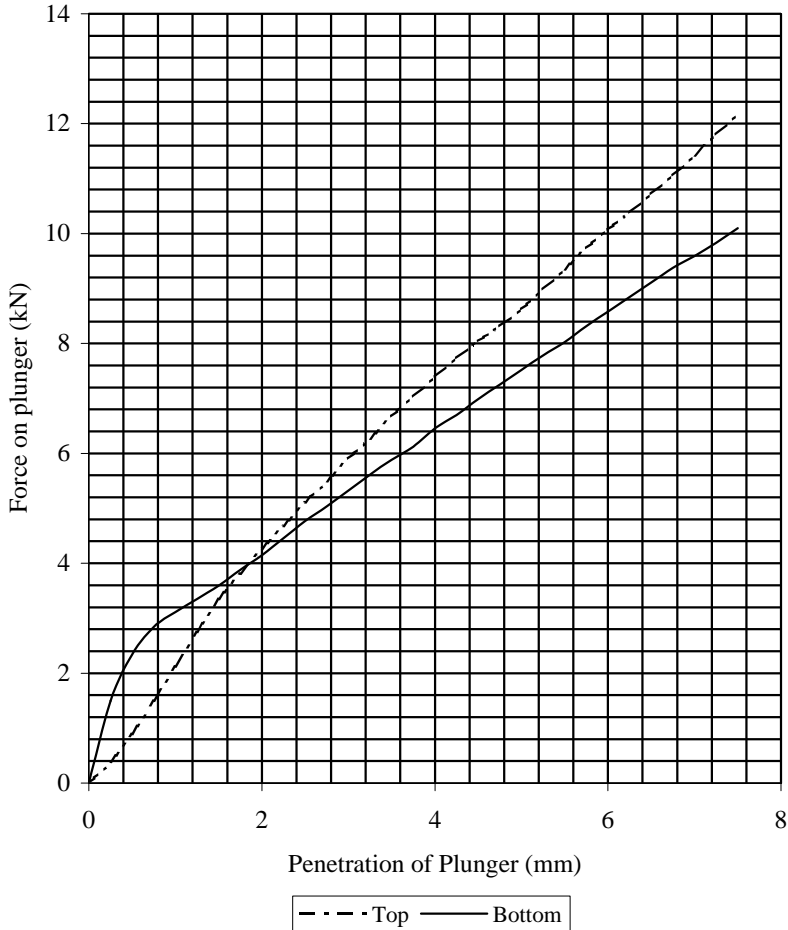
Hole Number: **WS102** **Depth (m):** **0.50-1.00**

Initial Sample Conditions		Test Conditions		Method of compaction 2.5Kg Rammer			
Moisture Content:	6.4	Surcharge Kg:	4.20	Final Moisture Content %		C.B.R. Value %	
Bulk Density Mg/m3:	2.10	Soaking Time hrs	0	Sample Top	6.3	Sample Top	43.1
Dry Density Mg/m3:	1.98	Swelling mm:	0	Sample Bottom	6.5	Sample Bottom	37.6
Percentage retained on 20mm BS test sieve:	11	Remarks: See Summary of Soil Description.

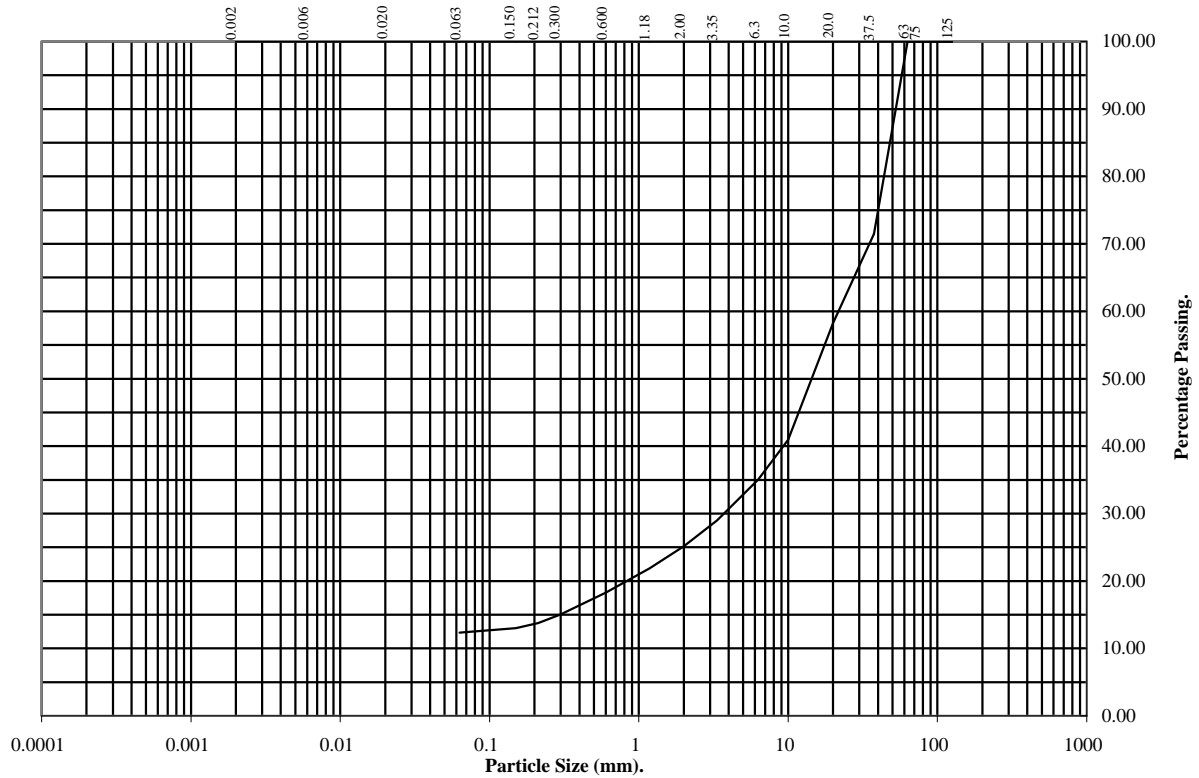
BS Test Sieve	Percentage Passing
125	100
75	100
63	100
37.5	71
20	58
10	41
6.3	35
3.35	29
2	25
1.18	22
0.6	18
0.3	15
0.212	14
0.15	13
0.063	12

Soil Fraction	Total Percentage
Cobbles	0
Gravel	75
Sand	13
Silt / Clay	12

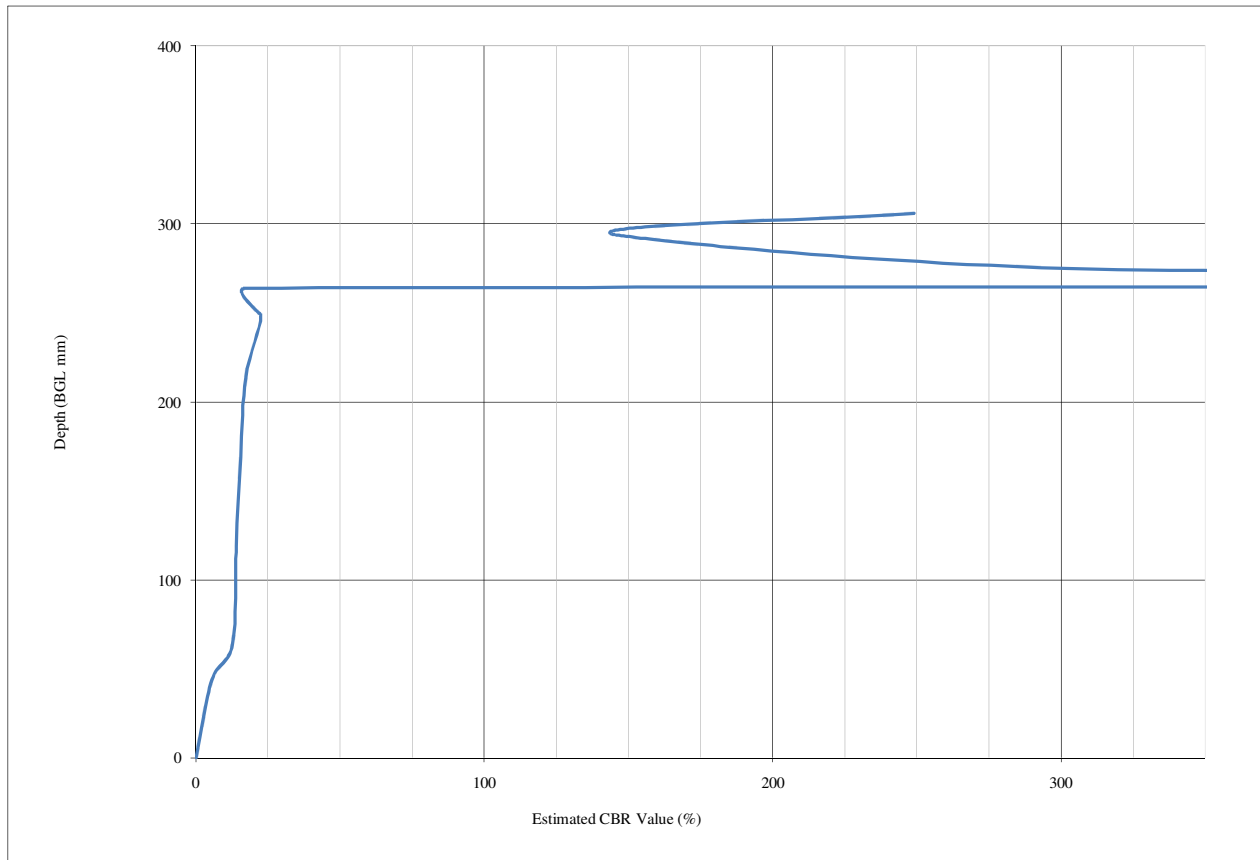
Estimated California Bearing Ratio Graph

Site Name	Oxford Road, Bicester	Test Date:	04/08/2011
Site Ref	80137	Test Location:	C1
Test No.:	CBR1	Easting:	
Initial Depth :	0mm	Northing:	
Final Depth (mm BGL):	306mm

Start Depth (mm) BGL	Finish Depth (mm) BGL	No. of Blows	Blows Per Layer	DCP mm/Blows	Ave Estimated Layer (CBR %)
0	264	15	15	17.60	14.57
264	352	94	79	1.11	269.45

Average CBR Value of 14.57% at 200mm bgl

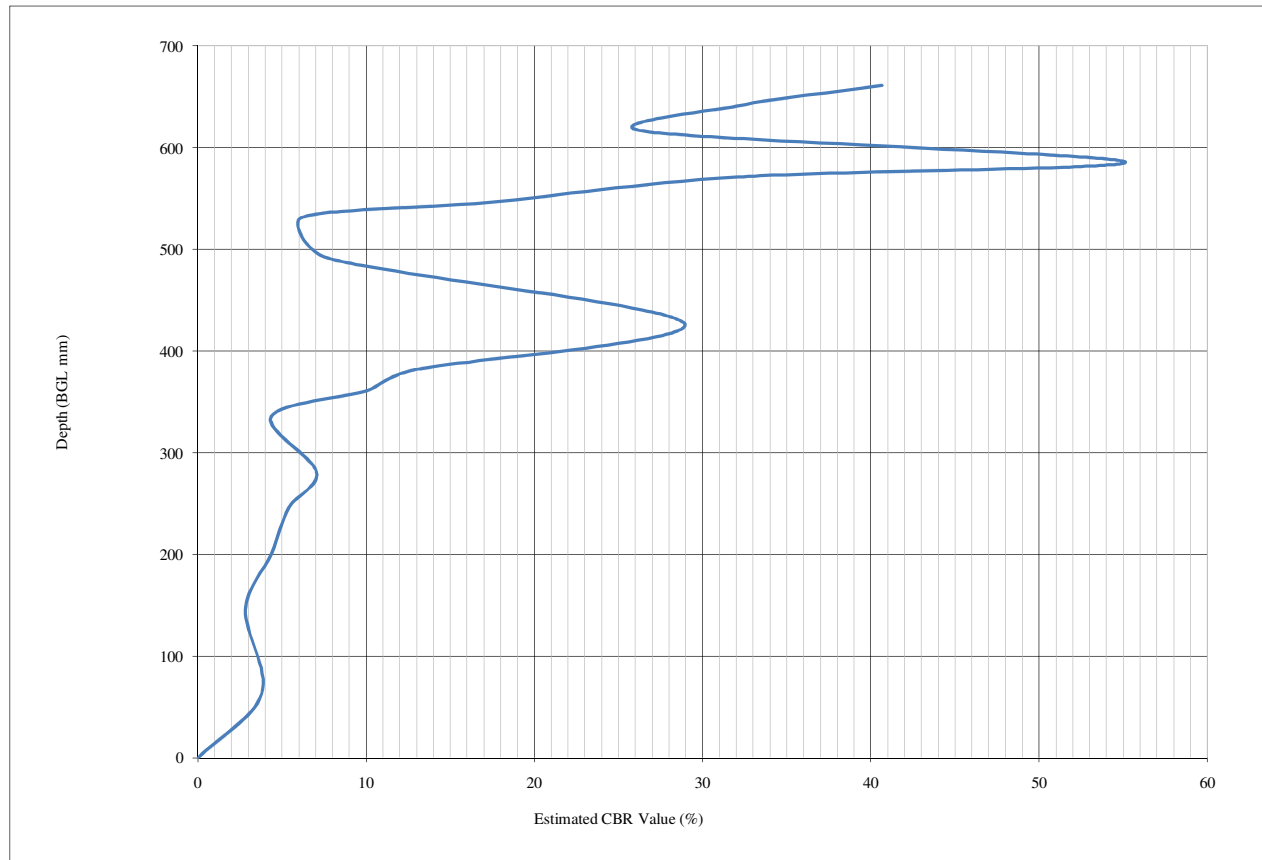
Estimated California Bearing Ratio Graph

Site Name	Oxford road, Bicester	Test Date:	04/08/2011
Site Ref	80137	Test Location:	C2
Test No.:	CBR2	Easting:	
Initial Depth :	0mm	Northing:	
Final Depth (mm BGL):	661mm

Start Depth (mm) BGL	Finish Depth (mm) BGL	No. of Blows	Blows Per Layer	DCP mm/Blows	Ave Estimated Layer (CBR %)
0	381	3	8	47.63	5.09
381	781	55	52	7.69	34.95

Average CBR Value of 34.95% at 500mm bgl

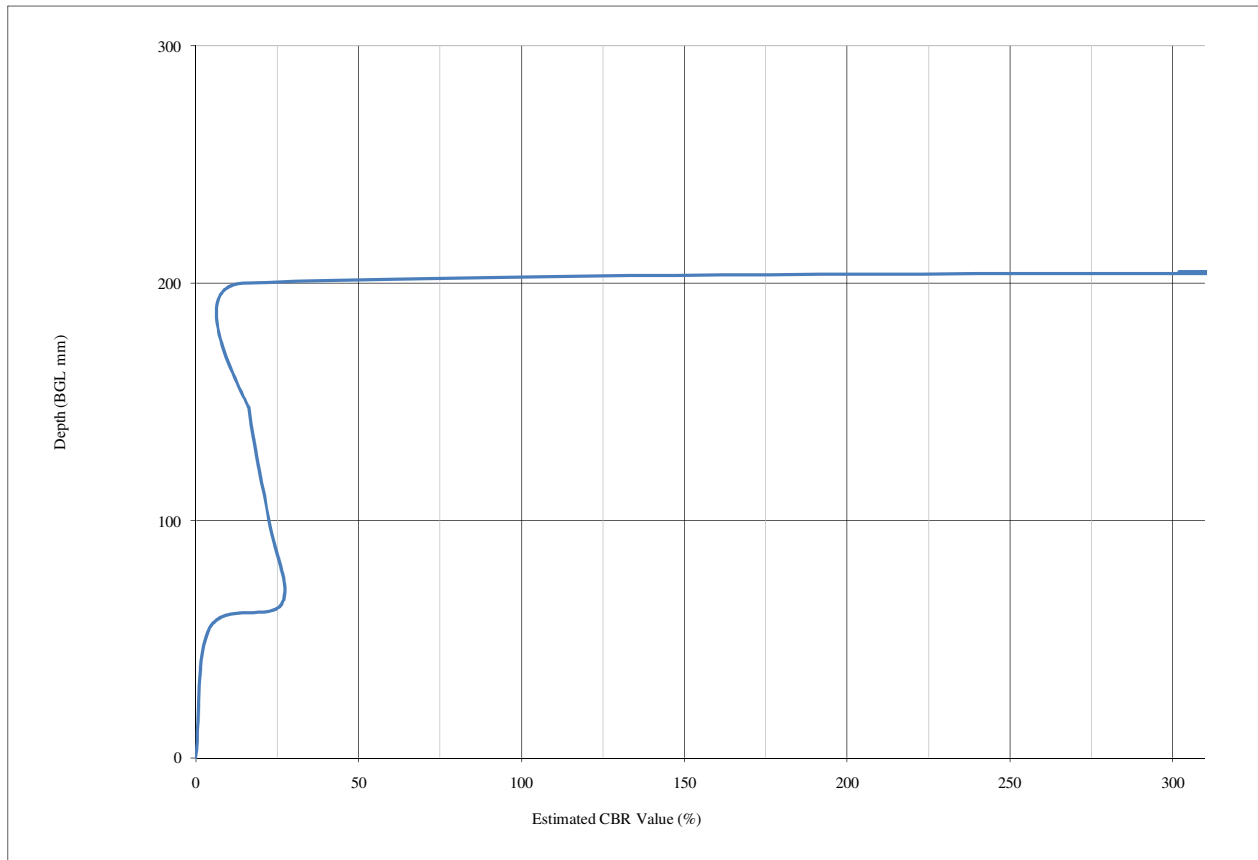
Estimated California Bearing Ratio Graph

Site Name	Oxford Road, Bicester	Test Date:	04/08/2011
Site Ref	80137	Test Location:	C3
Test No.:	CBR3	Easting:	
Initial Depth :	0mm	Northing:	
Final Depth (mm BGL):	205mm

Start Depth (mm) BGL	Finish Depth (mm) BGL	No. of Blows	Blows Per Layer	DCP mm/Blows	Ave Estimated Layer (CBR %)
0	200	11	11	18.18	14.08
200	205	20	9	0.56	562.11

Average CBR Value of 14.08% at 200mm bgl

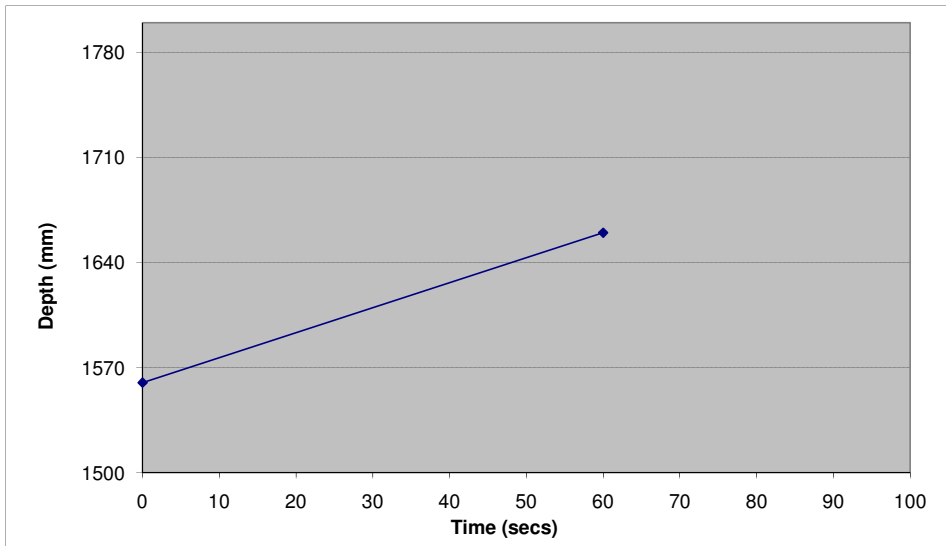
Infiltration volume	2.98E-04	m ³
Time	-55	sec

Soil Infiltration Rate 3.37E-04 m/s

Location	Depth (m)	Material	Test No.	Soil Infiltration Rate (m/s)
WS101	1 to 2.00m	Gravelly SAND overlying sandy GRAVEL	Test No.1	3.37 ⁻⁴
WS104	1 to 1.90m	Sandy GRAVEL overlying gravelly silty SAND	Test No. 1	8.35 ⁻⁶

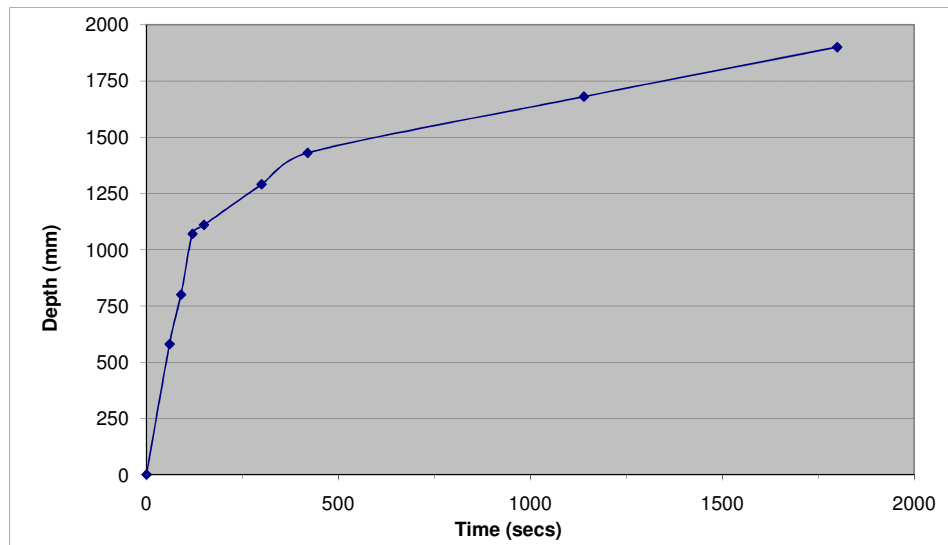
Standpipe Soakaway Test - WS104

Infiltration volume	2.74E-03	m ³
Time	-1500	sec

Soil Infiltration Rate 8.35E-06 m/s
