Report On Field visit to South West Bicester: Pingle Brook

Project No: 11011546

Date: June 23, 2006

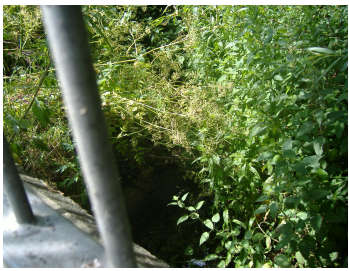
<p>Brook u/s of culvert (Looking towards u/s)</p>	<p>Brook u/s of Culvert on Oxford Road:</p> <ul style="list-style-type: none"> ○ The Brook flows perpendicular to the culvert entrance before being conveyed under Oxford Road. The Brook is almost entirely covered by trees, bushes and shrubs and not accessible from road or even from the farm. ○ Size of culvert: 1.60m wide, 1.2 m high, IL= 67.275m AOD ○ However, existing vertical opening is now only 0.8m and remaining 0.4 m has been silted . Moreover, the route of the Brook is diverted around the high land on its left hand bank which accounts for it elaborate route. ○ The Brook immediate u/s of the culvert is completely covered by bushes and shrubs and difficult to see its present condition approximately a reach of around 30 m u/s from Oxford road.

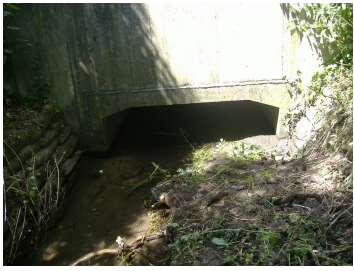
<p>Brook d/s of culvert (Looking u/s)</p>	<p>Brook d/s of Culvert on Oxford Road:</p> <ul style="list-style-type: none"> ○ Brook cross section downstream of the culvert on the Oxford Road is different than u/s. ○ Immediate d/s of the culvert the section is shown.

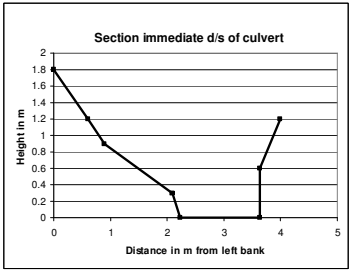
<p>Brook downstream of culvert (Looking d/s)</p>	<p>Immediately d/s of the culvert, the shape of the Brook is trapezoidal. The bottom width varies from 2 – 2.6m. Around 30 m d/s from the culvert, there are sheet piles (not shown in Picture) that are vertically placed. The section at this location is shown:</p>
