South West Bicester

Technical appendix 5:
Ground conditions
and contamination

Technical Appendix 5 Ground Conditions and Contamination

Technical Appendix: Ground Conditions and Contamination

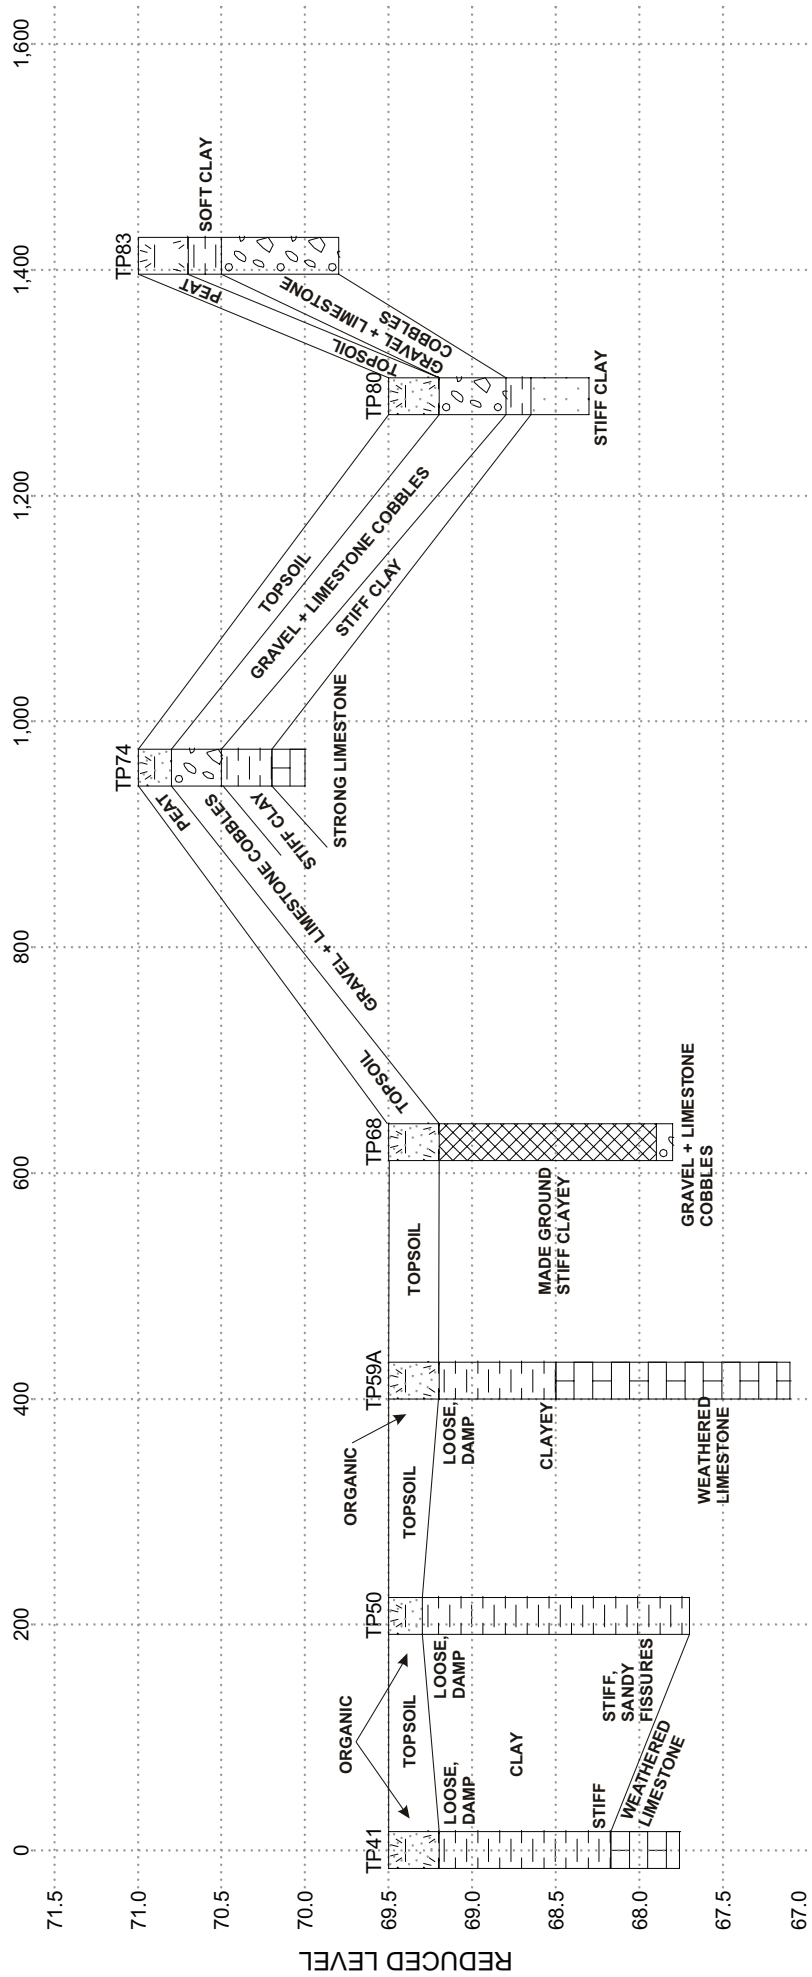
TITLE
SOUTH WEST BICESTER
SUBSURFACE SECTION 8
