New Waitrose Store, Southam Road, Banbury

**Phase 1 Ground Condition
(Geotechnical and Contamination) Assessment**

Project Ref: 26004/3501 | Rev: 7 | Date: May 2015

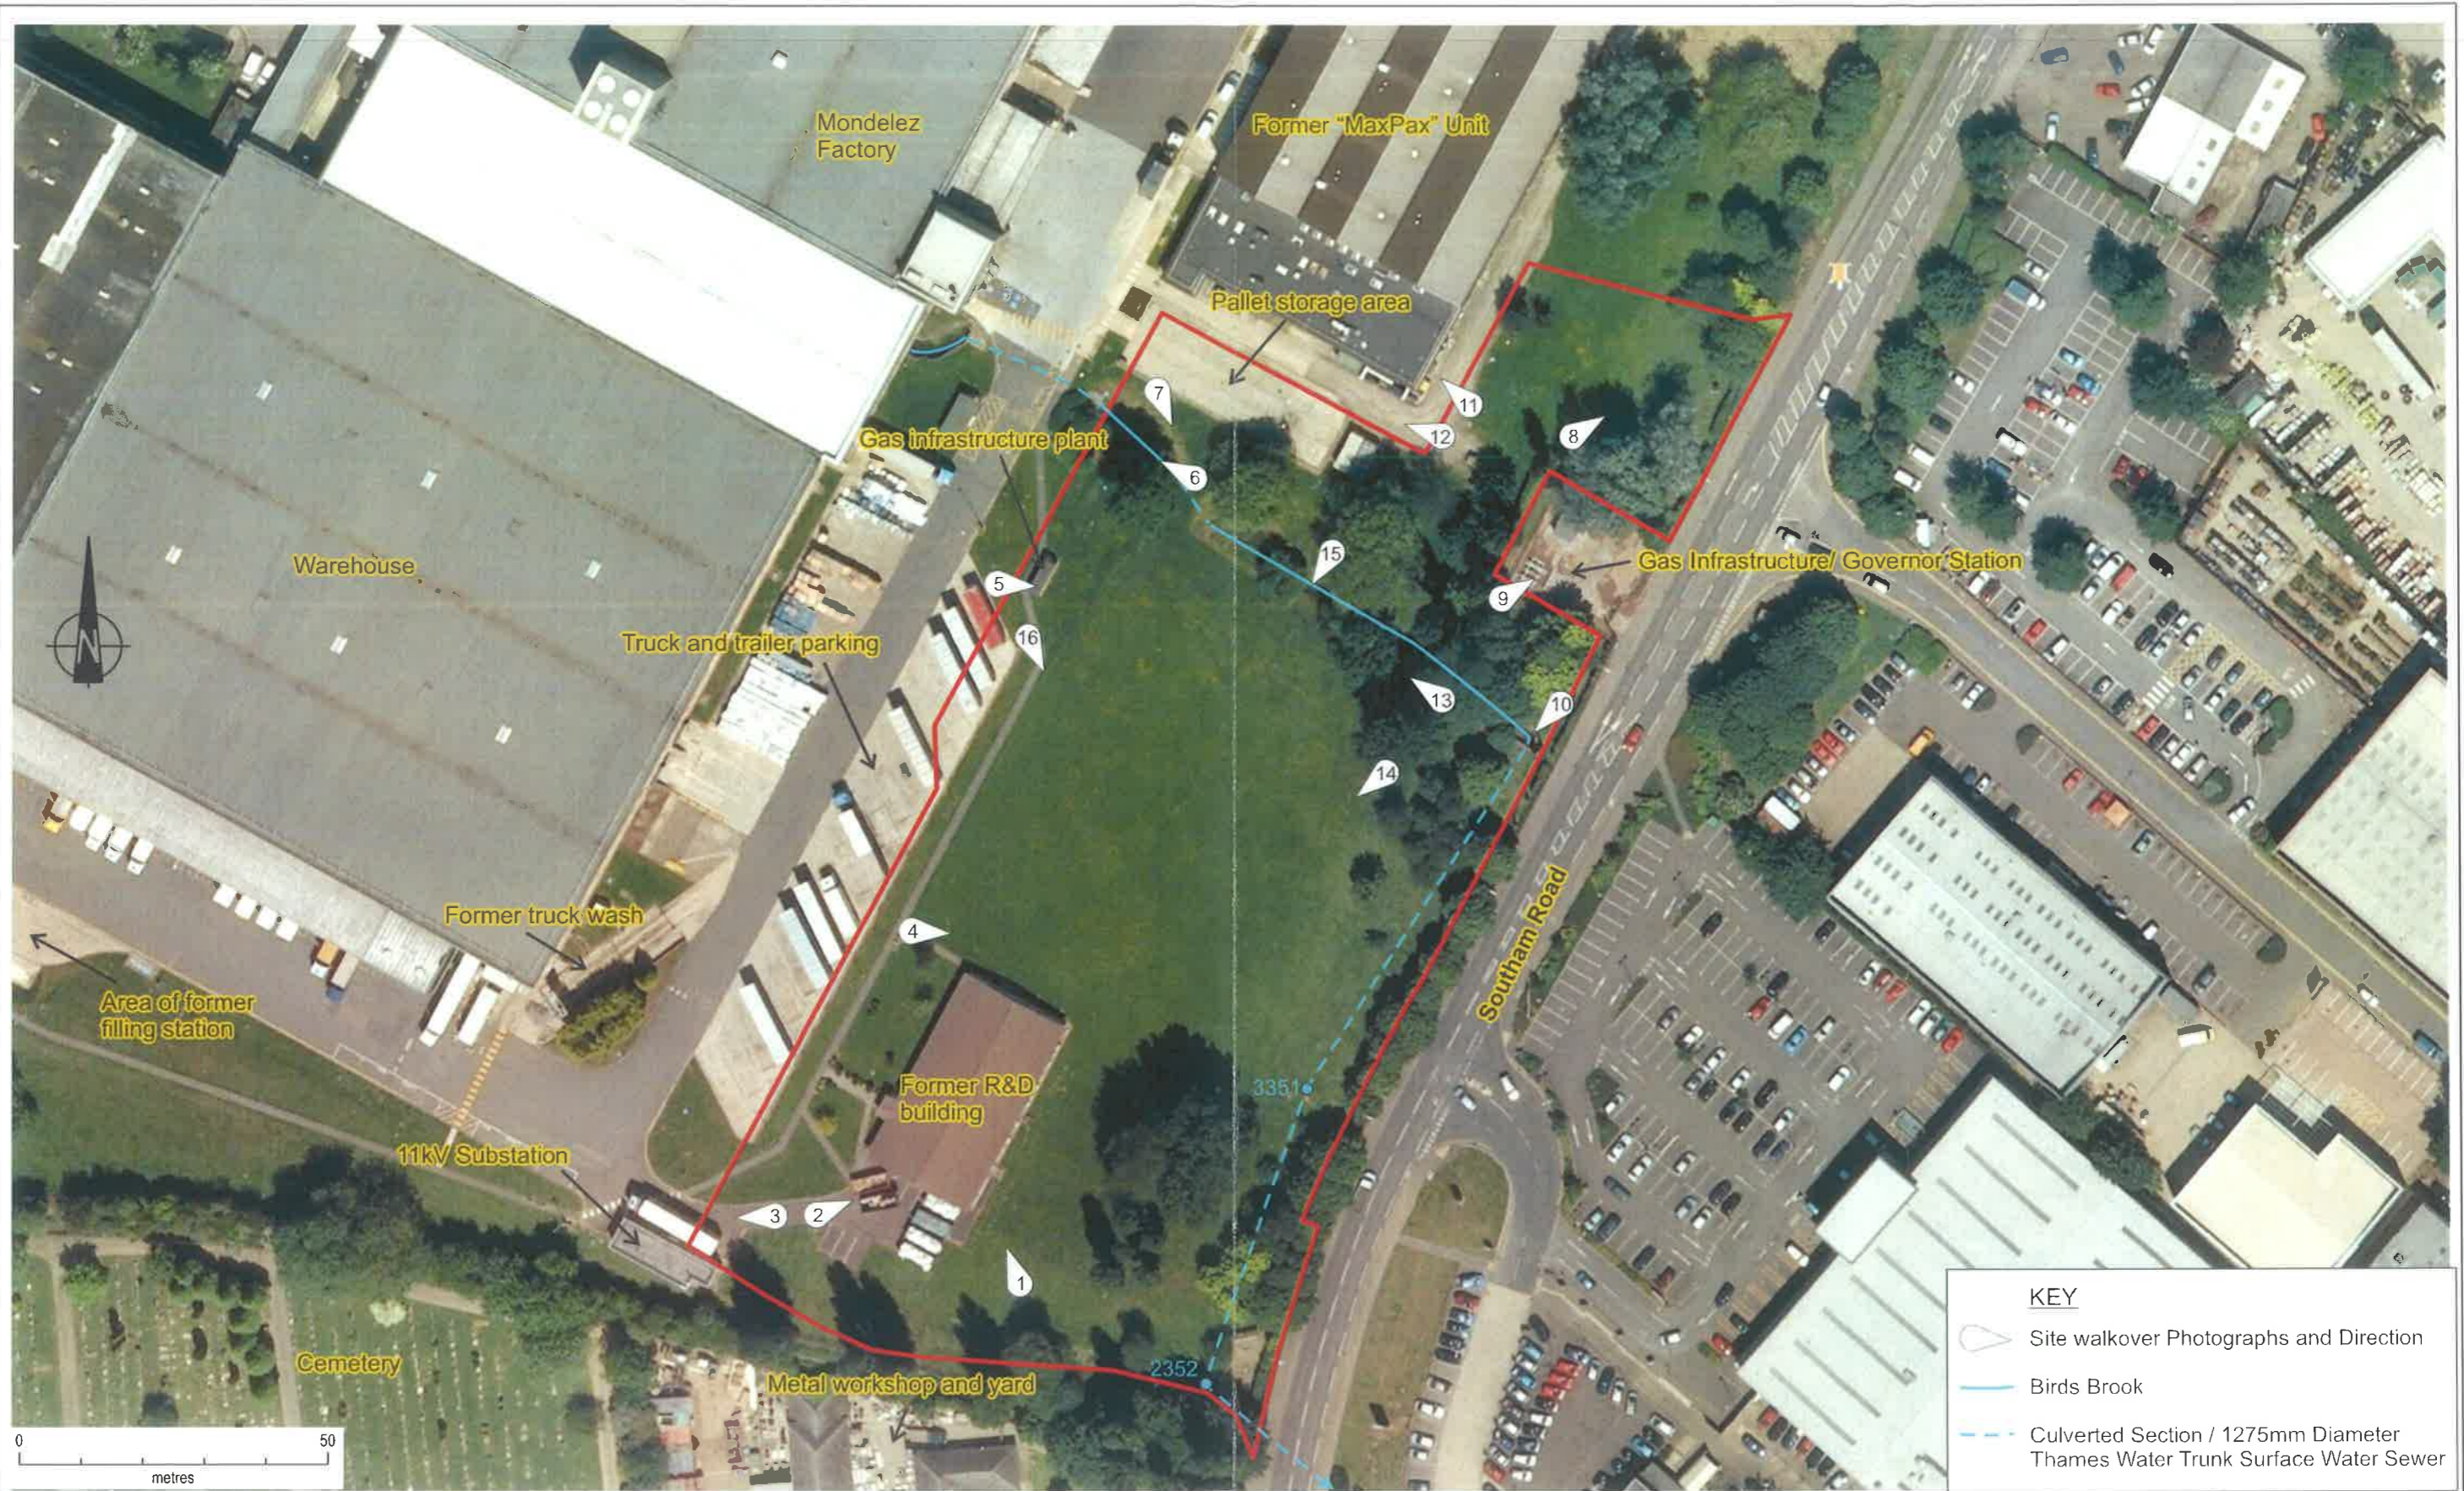
FIGURE 2

KEY	
	Site walkover Photographs and Direction
	Birds Brook
	Culverted Section / 1275mm Diameter Thames Water Trunk Surface Water Sewer

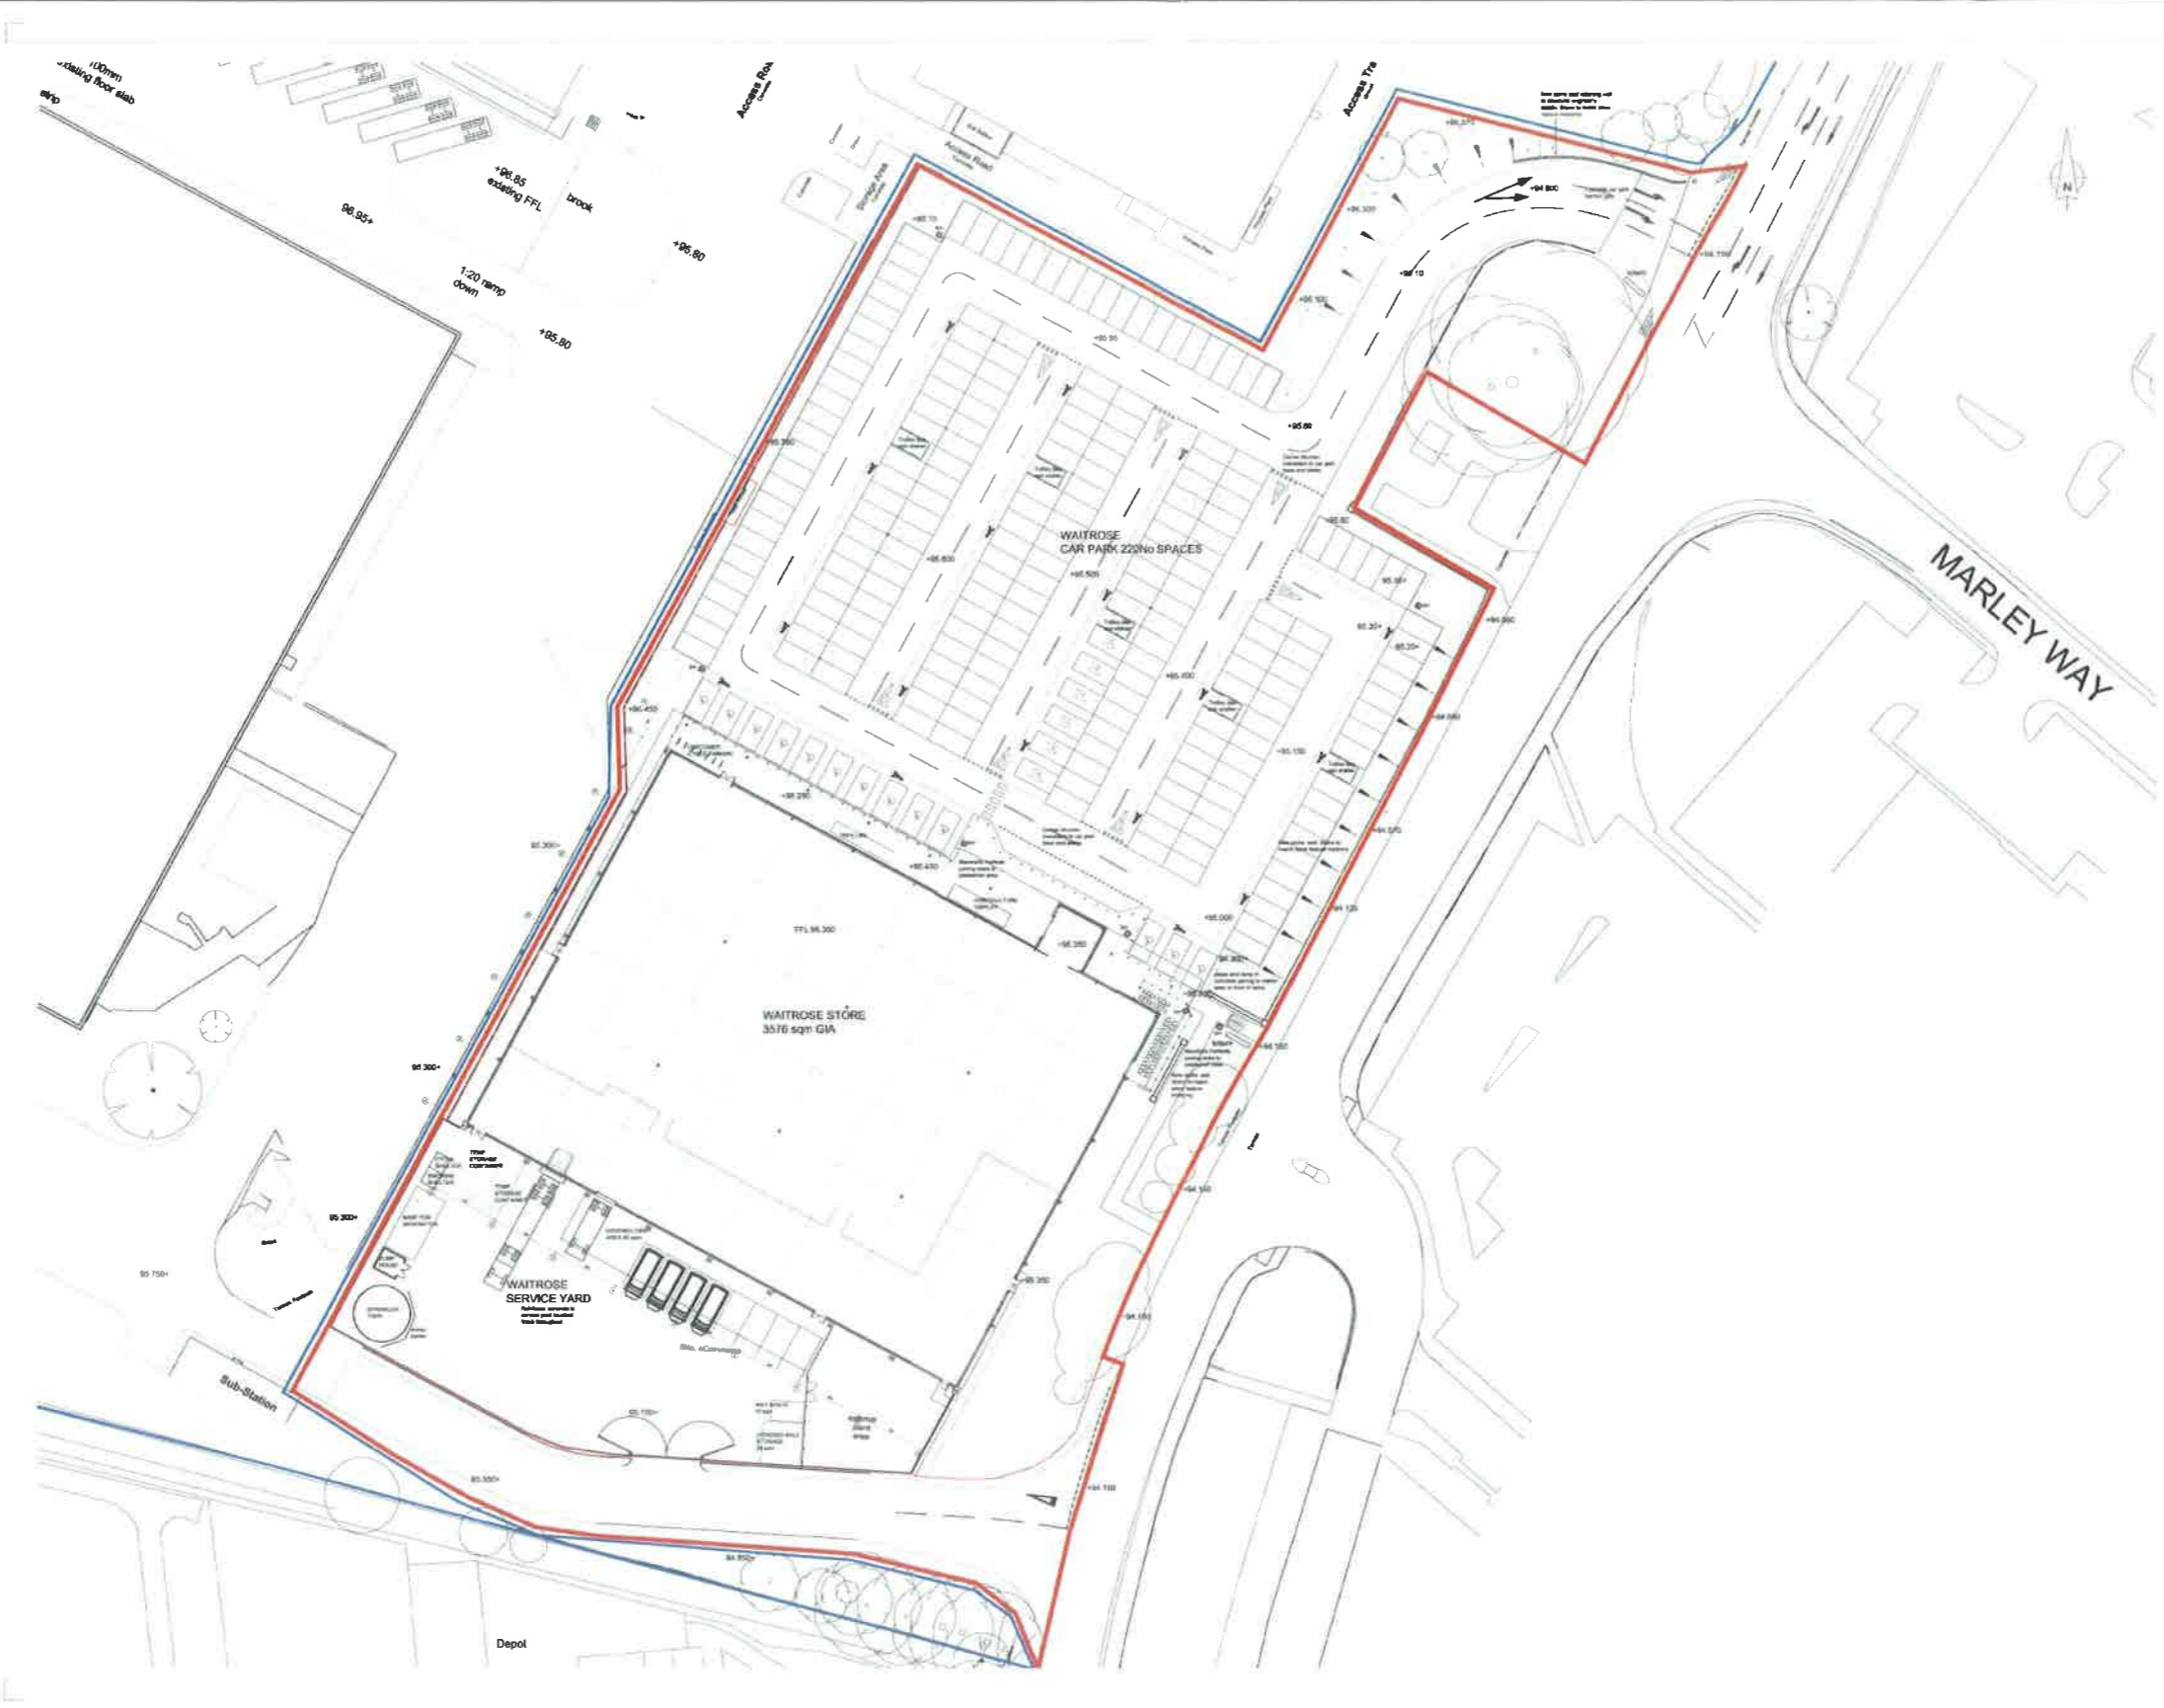
The National Grid Reference of the site centre is approximately SP 452 414, and its general location is shown on **Figure 1**. Salient site and local features are shown on **Figure 2**.

The current land use information is based on a walkover inspection undertaken by a PBA geotechnical engineer on the 20th November 2014. Photographs taken during the site walkover (Photographs 1 - 16) are presented in **Appendix B** with their locations presented on **Figure 2**.

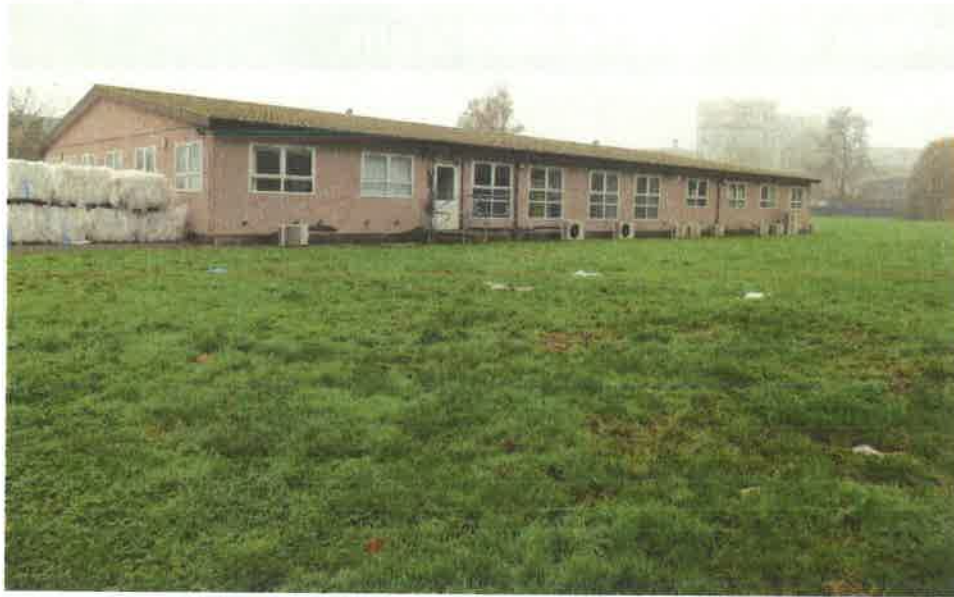
Photo 1: View of vacant office building located in the south-western area of the study site, looking north-west from southern site boundary. This building is labelled as "R&D Building" on the Kraft topographical survey.

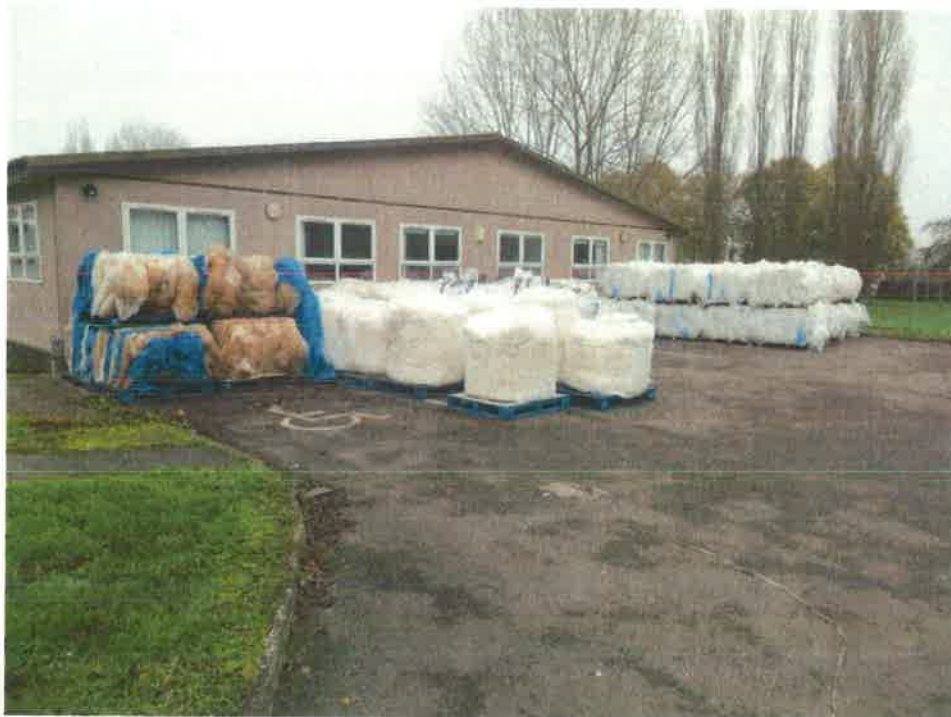
Photo 2: View of southern end of vacant office building and car park looking north-east from southern site boundary. The materials on the pallets were packaged and bound, probably awaiting off-site recycling.

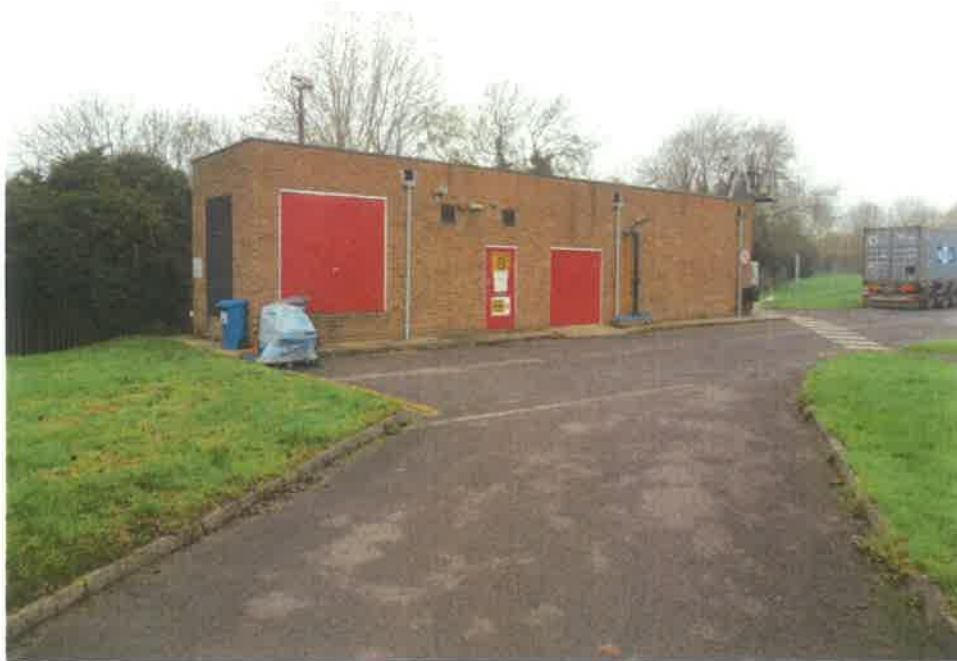
Photo 3: View of electrical sub-station located beyond the south west corner of the study site boundary, looking south west from the southern site boundary.

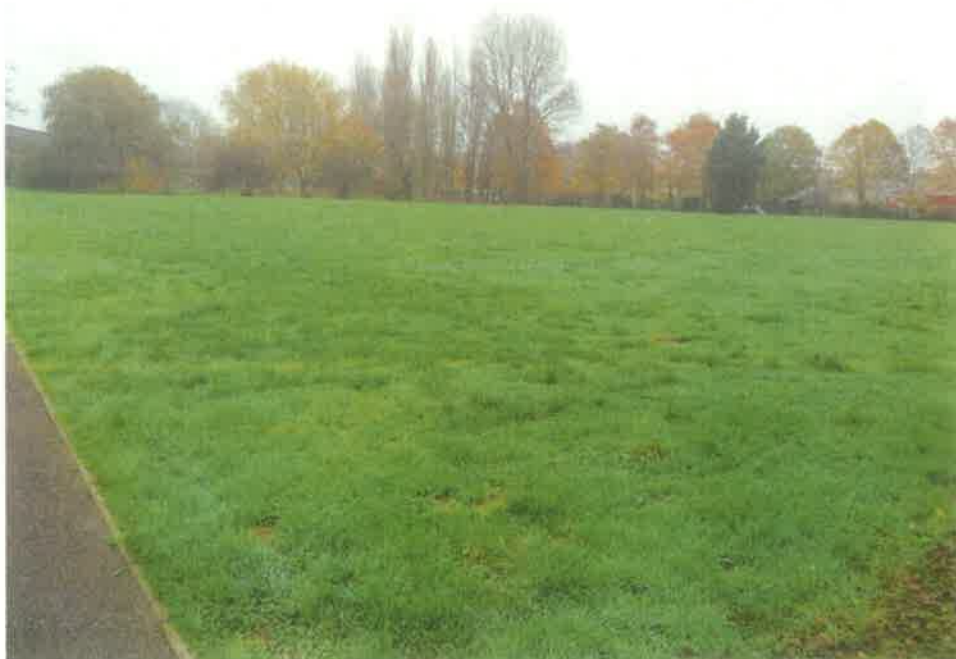
Photo 4: General view of open grass area which forms the main portion of the study site, looking north east from western site boundary.

The study site area is mainly an area of open grassland within the Mondelez International complex [Photos 4, 14 & 16]. Isolated trees line the banks of the watercourse (the Birds Brook) flowing through the northern half of the study site including ash, apple and aspen (a form of poplar). Mature stands of trees are present in the north-east and south-east corners of the study site including poplar, maple, rowan and birch. The eastern study site boundary is lined by lime trees (TEP, 2010). A disused single storey office building (of temporary construction form) is located in the south west corner of the study site with pallets of materials, presumably stored prior to recycling, located in the small car park area to the south of the office building [Photos 1 & 2]. A small building associated with the main gas supply to the factory is located in the north western site area [Photo 5]; records from Scotia Gas Networks show this building to be fed by a medium pressure gas mains from Southam Road.

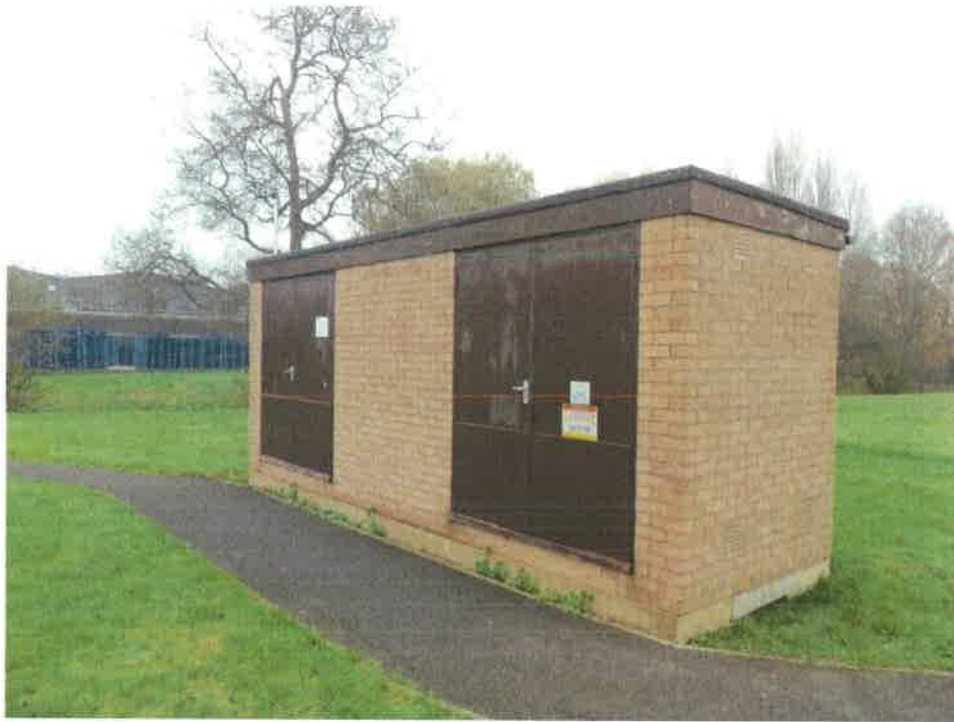
Photo 5: View of gas infrastructure installation located on the western site boundary, looking north-east.

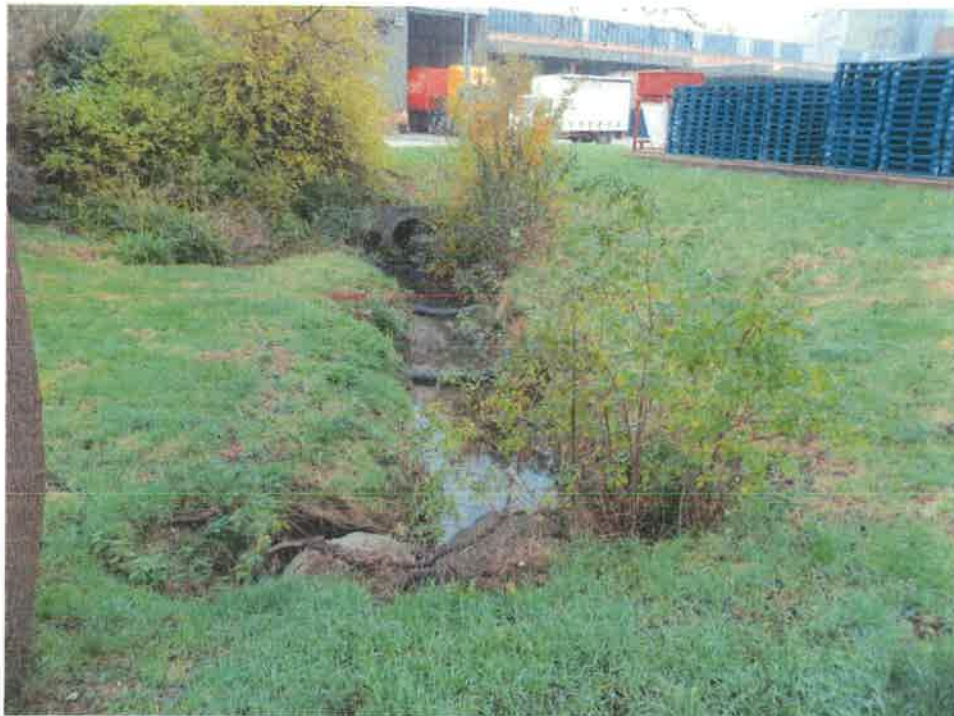
The Birds Brook is present mainly in open channel in the northern part of the site [Photos 6 & 13] and is culverted along the eastern site boundary, adjacent to the Southam Road [Photo 10]. The culverted section of the watercourse is shown on Thames Water records as one of their assets – a 1275mm diameter trunk surface water sewer. The approximate alignment of the culverted section is shown on Figure 2. Surface water outfalls, presumably from the factory site, into the brook were observed during the site walkover [Photo 15]. North of the Birds Brook, in the north-western area of the study site, is a pallet storage area located on concrete hardstanding [Photo 12].

Photo 6: View of Birds Brook as it emerges from a culvert looking west. There are two booms across the brook channel at this location, presumably to contain any accident discharges of pollution to the watercourse.

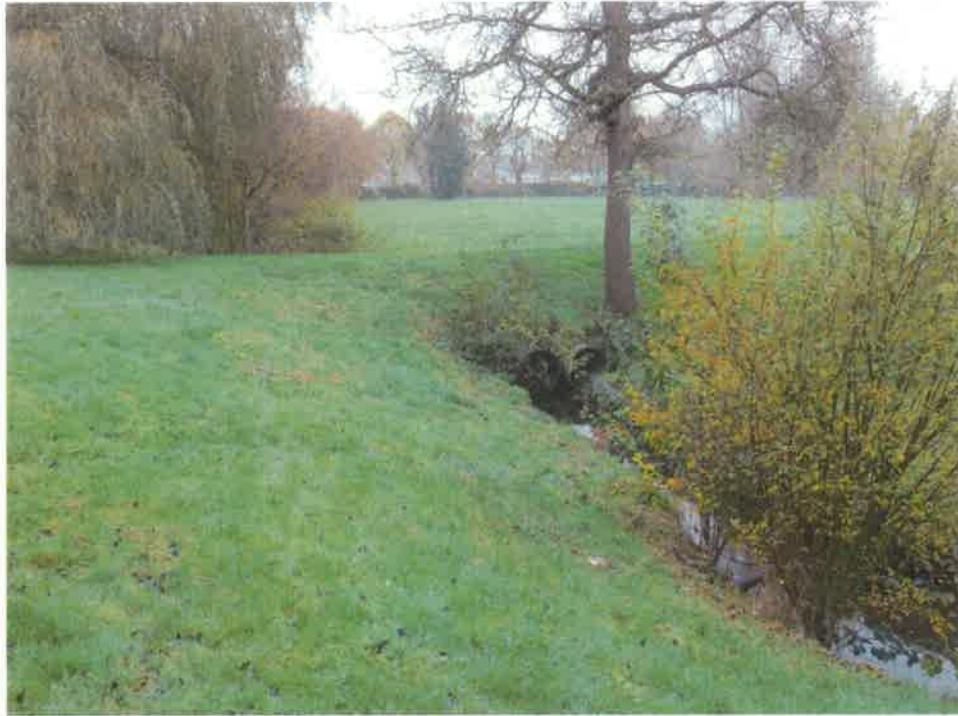
Photo 7: View towards earth "bridge" over Birds Brook in the north-western corner of the study site. The watercourse flows through two circular concrete pipes over this short section.

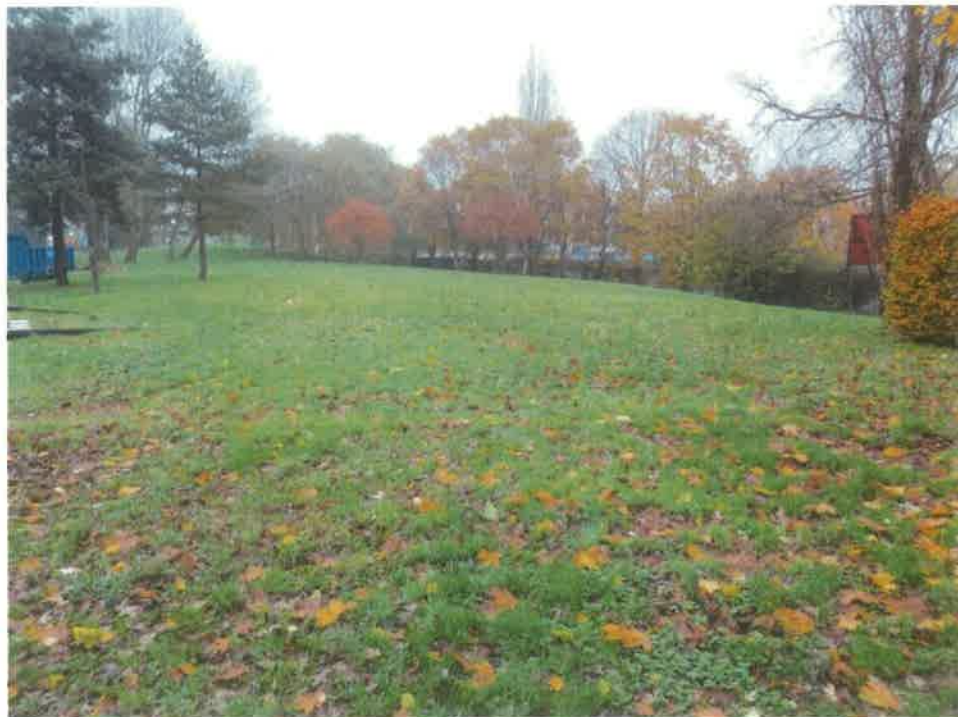
Photo 8: View of open grassed area in the north-eastern corner of the study site looking north.

The study site is bordered to the north and west by the wider Mondelez International factory site. An area of truck parking and a disused truck wash borders the western site boundary with a large warehouse present beyond the parking area. The northern site boundary is partly bordered by a factory unit [Photo 11]. The rest of the northern site boundary is bordered by an area of open grass [Photo 8].

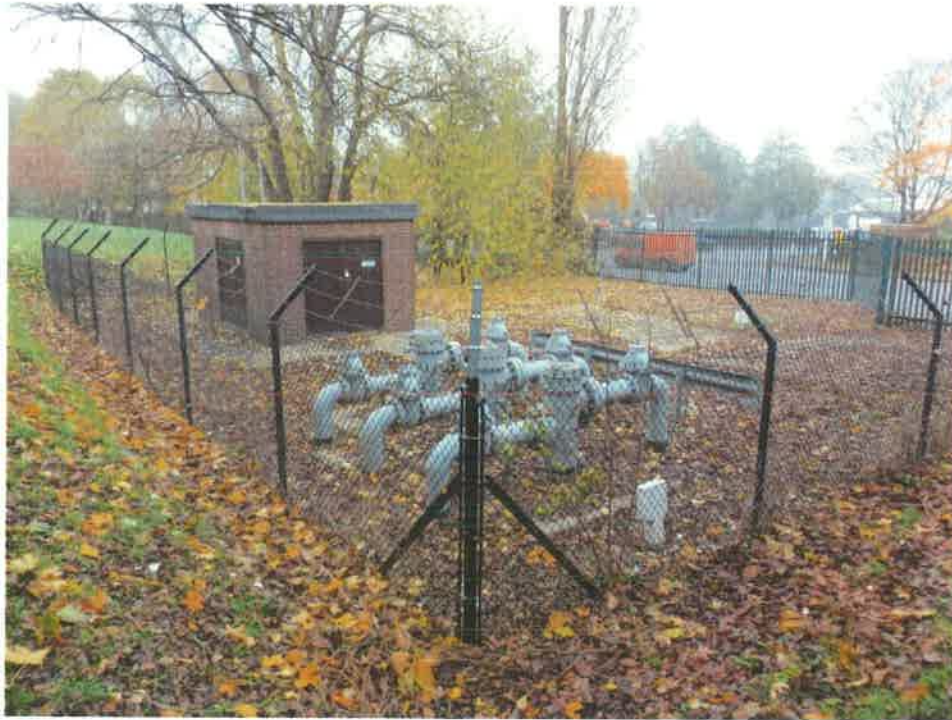
Photo 9: View towards gas infrastructure station located outside the eastern site boundary, looking north-east from eastern site boundary. The station is located on a small, square cut platform at a lower level than the study site in this area.

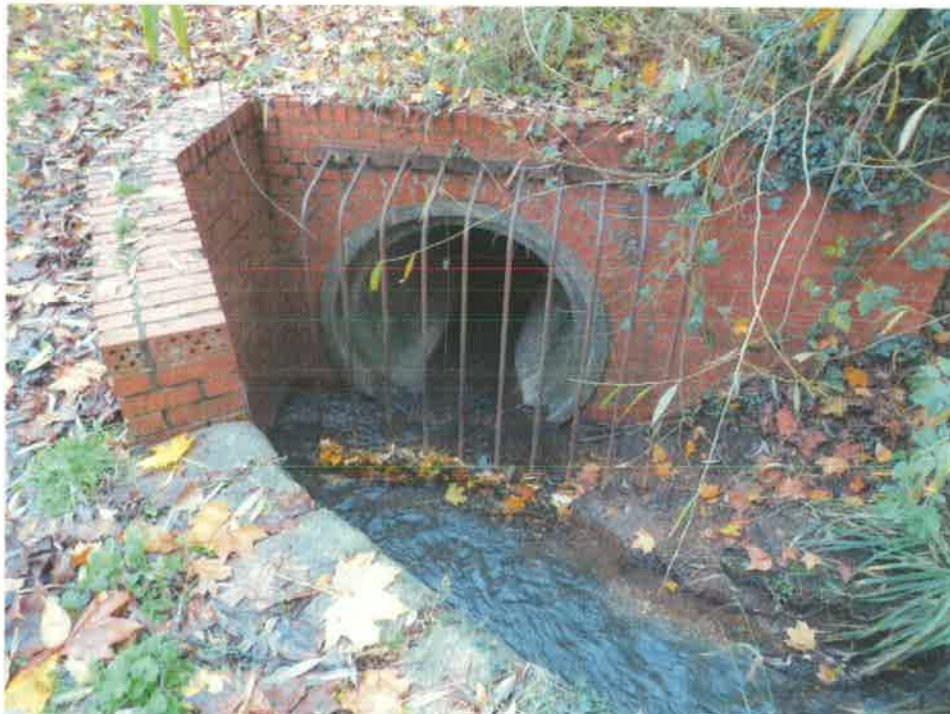
Photo 10: View of Birds Brook as it diverts in a southerly direction into a culvert which runs down the eastern site boundary, looking south from the eastern site boundary.

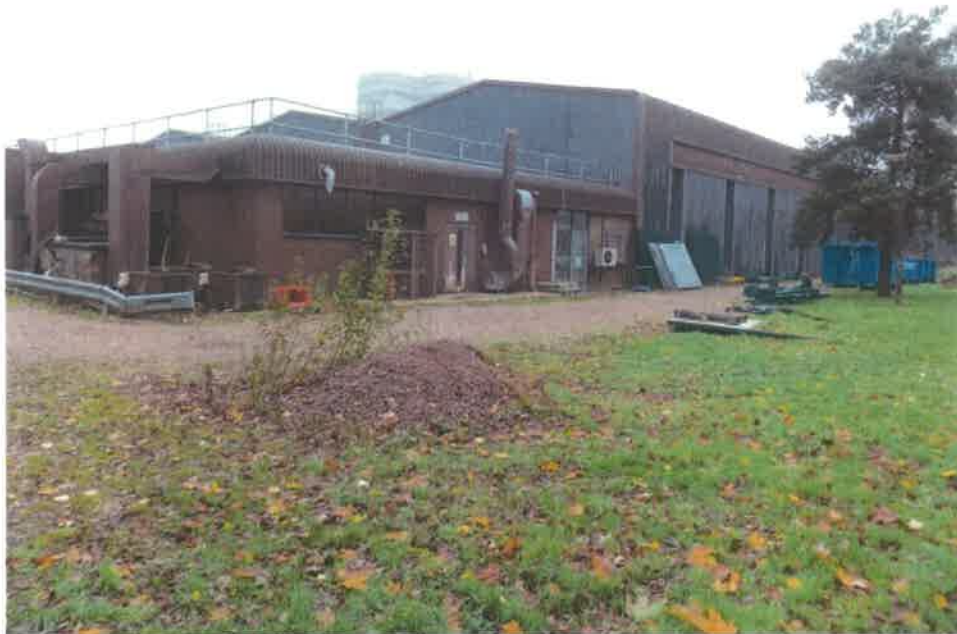
Photo 11: View towards factory building located beyond the northern site boundary, looking north-west. This building is labelled as "Max Pax Building" on the Kraft topographical survey.

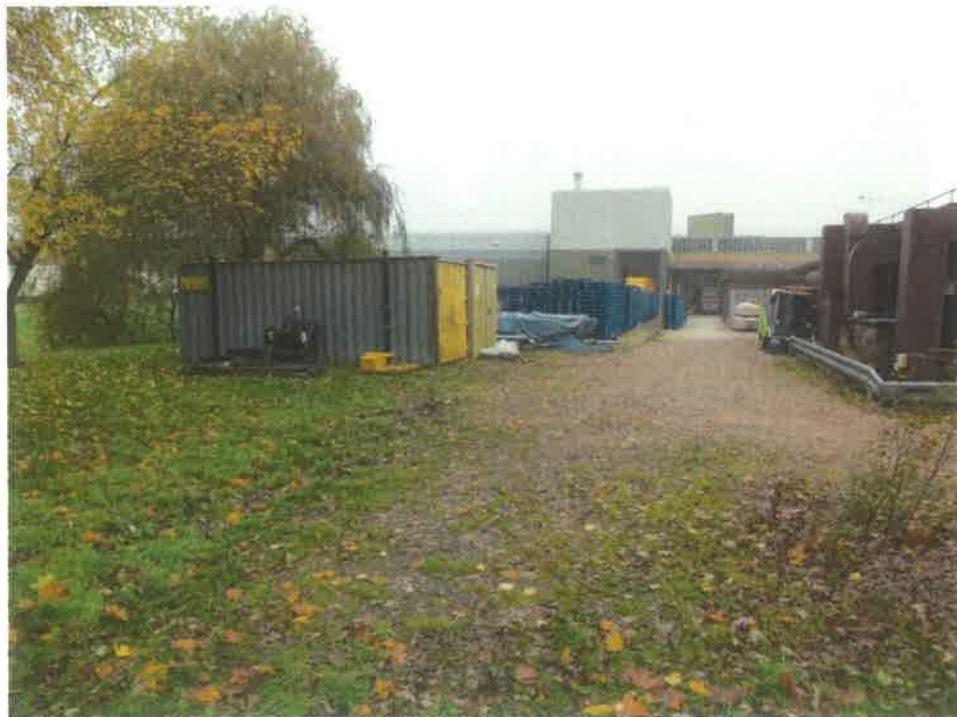
Photo 12: View of pallet storage area located in the north-west corner of the site, looking west.

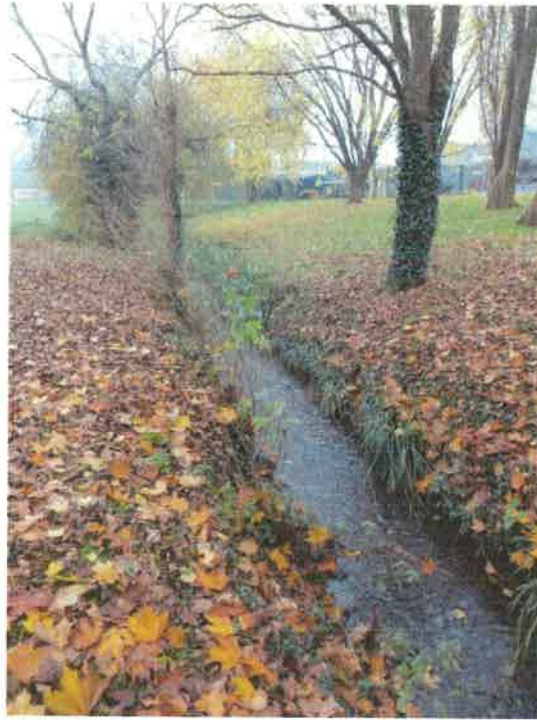
Photo 13: View of Birds Brook looking west from north-eastern area of the site.

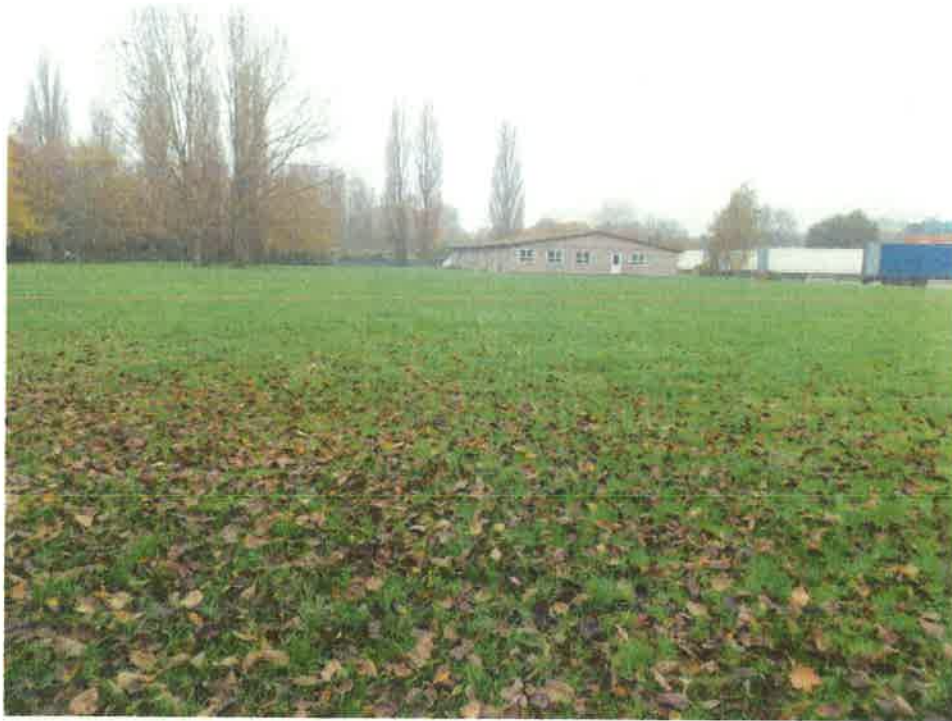
Photo 14: General view of the central portion of the site, looking south-west from northern area.

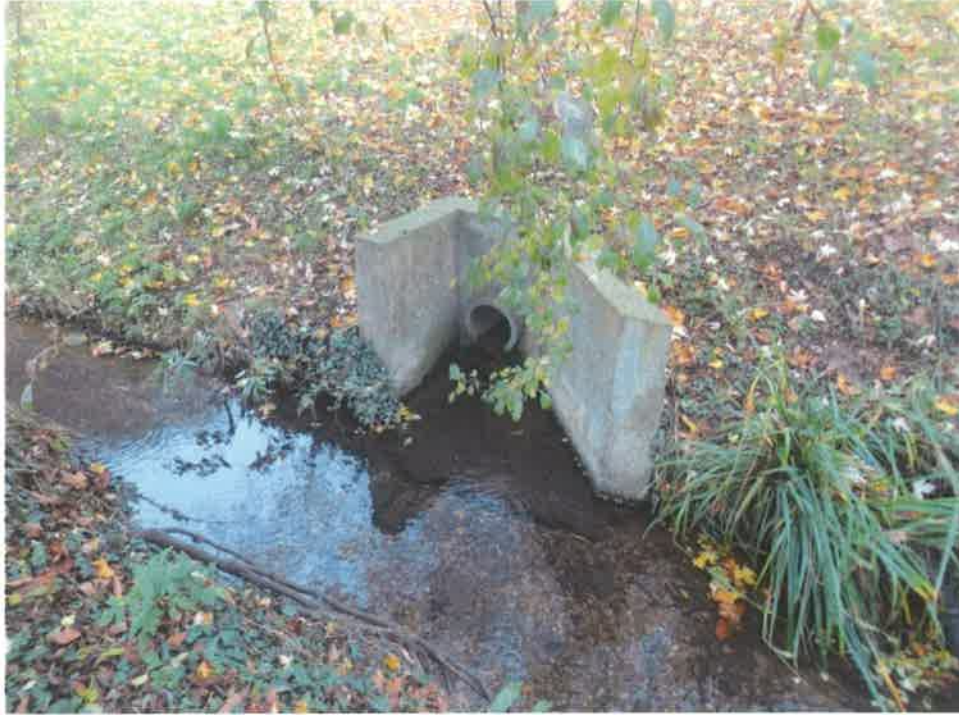
Photo 15: View of one of the surface water outfalls into Birds Brook. This outfall is located on the northern bank of the brook, looking north.

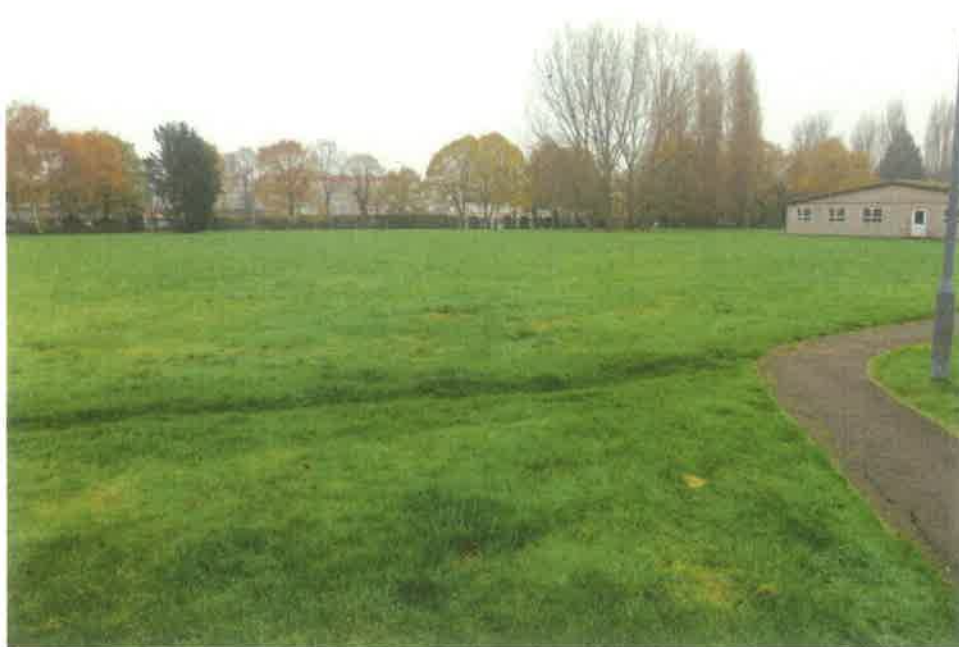
Photo 16: General view of the central portion of the site, looking south-east from western site boundary adjacent to truck park.
