Heyford Free School

Proposed Sports
Facilities
Existing Condition
Survey Report (REV.3)

EXISTING CONDITION SURVEY REPORT

Date: March 2015

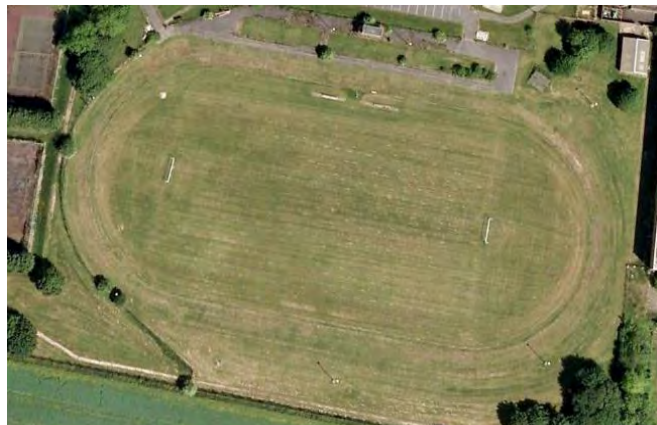
The study area principally comprises the redundant footprint of an Athletics track, within which is a central grass pitch. The boundaries of the area are currently formed by the former site perimeter fence to the South (with agricultural fields beyond), redundant terracing and ‘grandstand’ to the North, former air base land currently under redevelopment to the East, and the footprint of redundant games courts to the West (identified as facility D on Drawing No. K. 0158 34-4). The approximate area of the site including all margins equates to 1.80 ha. (TBV)

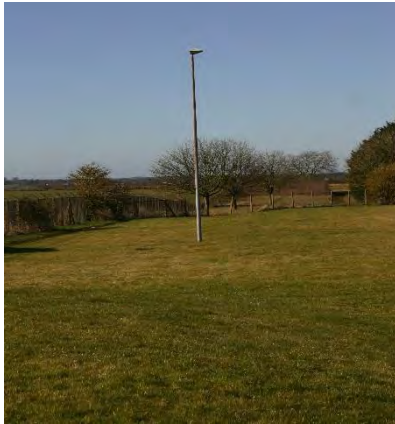
The margin to the South of the Athletics Track is characterised by a mounded land form of approximately 0.75m above the immediate surrounding ground levels. It is possible that this area was formed from the excess soil arising's from the re-engineering of the site; however this will need to be confirmed through more invasive sampling if any consideration to reform this feature is planned in subsequent site redevelopment.

Area to South of redundant Athletics Track – mounded land form

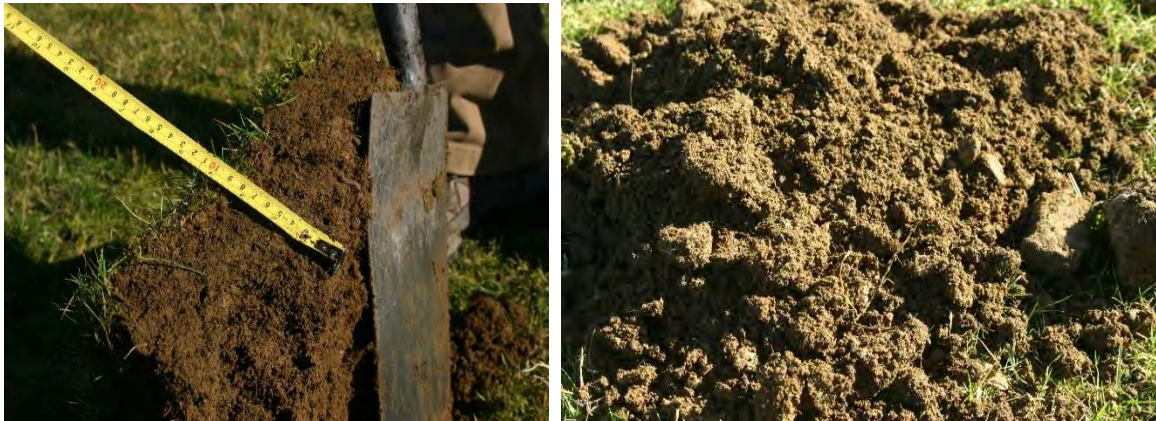
4.1.3.3 An average recorded depth of 100mm identified topsoil was found across the area. The material was assessed as comprising a dark brown predominantly silty clay classification soil matrix with fragmented limestone particles, and traces of fine graded re-worked materials present. Earthworm activity was also observed within samples. The topsoil layer overlays a substrate of fragmented limestone within a stiff reddish brown clay thought to be naturally occurring, and generally consistent with the recorded geology for the local area.

Examined soil profile on Area ③

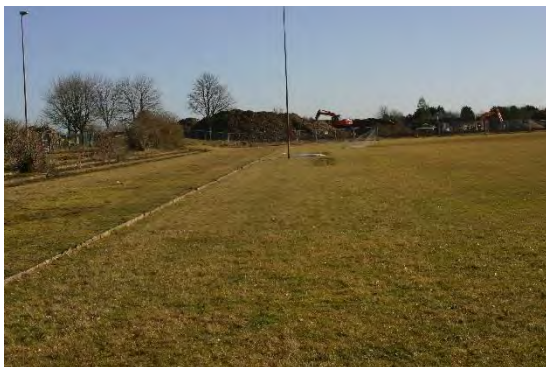
4.1.3.5 The footprint of the redundant Athletics Track is characterised by naturally occurring invasive moss and weed vegetation with sparse grass species present. The constructed profile will not sustain growth to an acceptable level for sport, and will require complete removal and replacement incorporating appropriate soil profiles. (**NOTE:** the presence of the noted ash / clinker material within the sub surface formation will require appropriate methods of contaminate testing to be undertaken before disturbance / removal, in accordance with relevant guidance).

Track footprint to left delineated by concrete kerb edge.

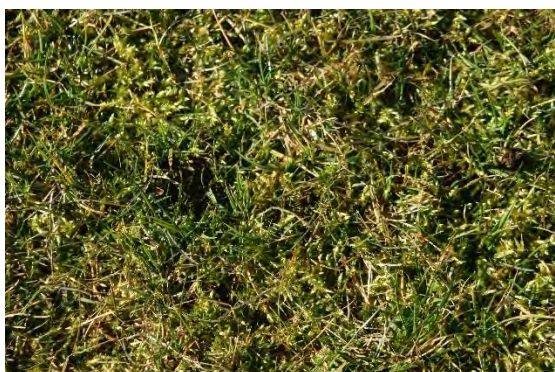
4.1.4.5 The quality of turf was generally poor across the playing area in terms of the percentage of non-desirable species evident at the time of inspection. There is an unacceptable percentage of weed infestation within the existing turf on the pitch. The effect of such a high proportion of undesirable species within the turf is that they will, if left unchecked, ultimately completely suppress the more desirable grass plants, as they are more adept at extracting any available water and nutrients from the soil and will crowd and shade grasses from light. In relation to the direct effect that a poor turf sward has on the playing of games, weeds will influence the characteristics of ball bounce and rolling and are generally less tolerant of the effects of wear caused by players' movement during games. If left unchecked the likelihood of increased competition from undesirable weed species becoming more widespread will significantly reduce the wearing capacity of the pitch.

Area ③: Illustrative areas of heavy weed infestation on pitch.

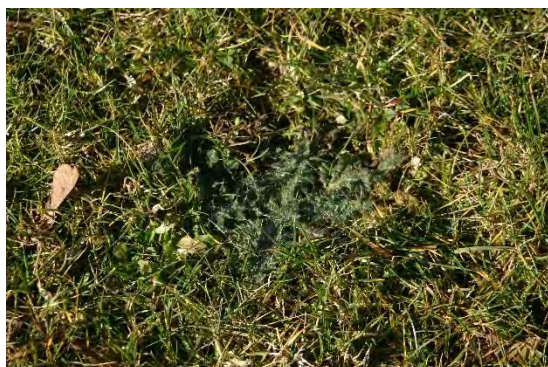
Low % of desirable grass plants within plot study areas.

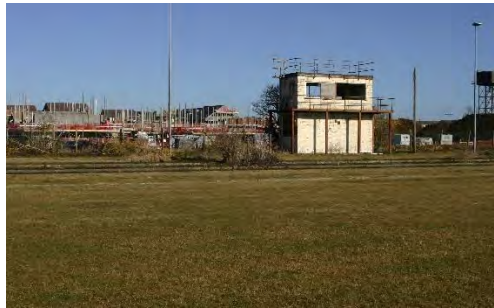
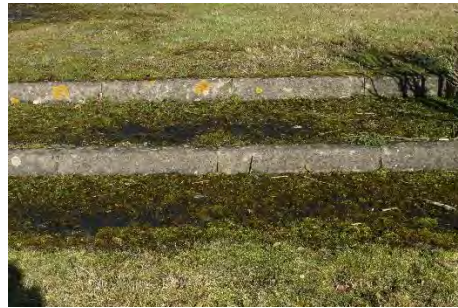
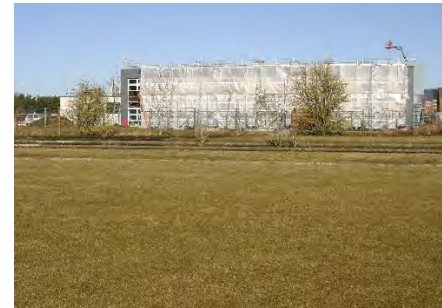
Redundant 'Grandstand' and terracing

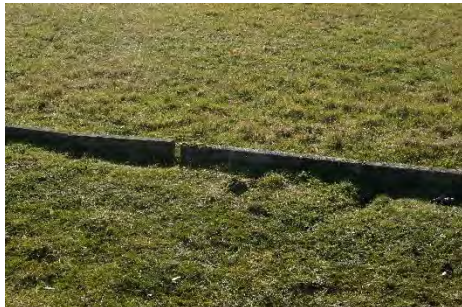
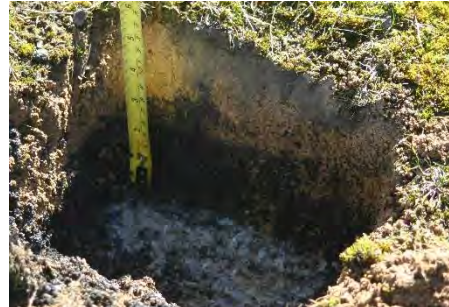
Redundant Athletics Track and ancillary features within site area

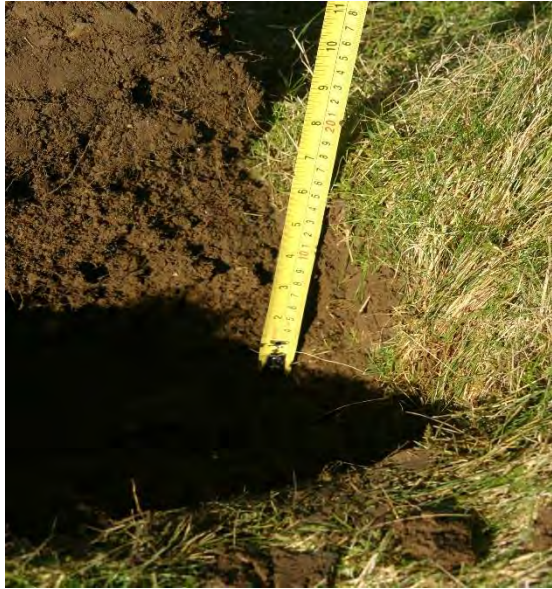
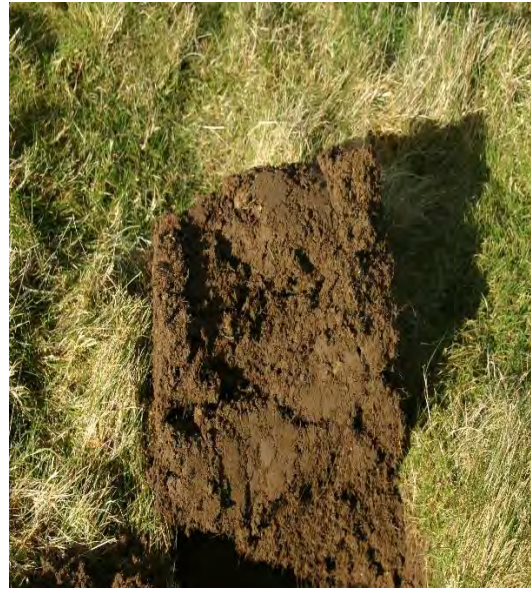
4.2.4.5 The footprint of the redundant Baseball diamonds are characterised by naturally occurring invasive moss and weed vegetation with sparse grass species present. The constructed profile will not sustain growth to an acceptable level for sport, and will require complete removal and replacement incorporating appropriate soil profiles.

Examined soil profile on Areas ⑤ and E

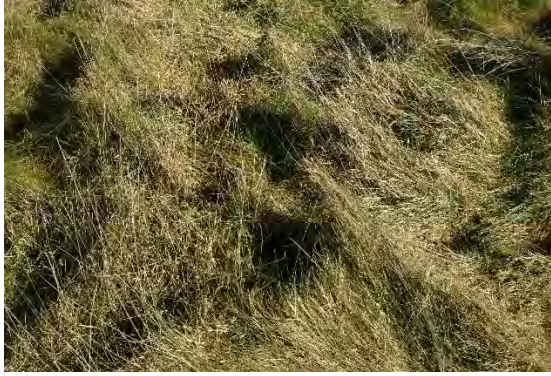
4.2.5.3 The quality and habit of turf growth was generally poor across the playing area in terms of the required values for sport, even at a recreational community use level. The effect of a high proportion of undesirable species within the turf is that they will, if left unchecked, ultimately completely suppress the more desirable grass plants, as they are more adept at extracting any available water and nutrients from the soil and will crowd and shade grasses from light. In relation to the direct effect that a poor turf sward has on the playing of games, weeds will influence the characteristics of ball bounce and rolling and are generally less tolerant of the effects of wear caused by players' movement during games. If left unchecked the likelihood of increased competition from undesirable weed species becoming more widespread will significantly reduce the wearing capacity of the pitch.

General condition of grass sward

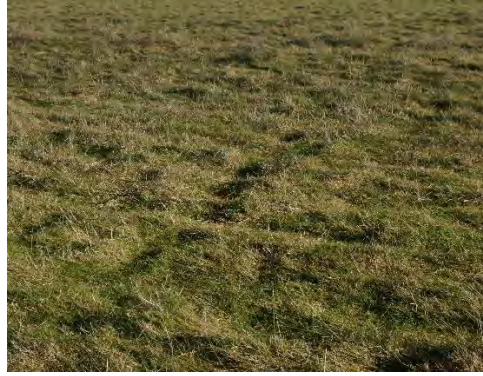
Low % of desirable grass plants within plot study areas.

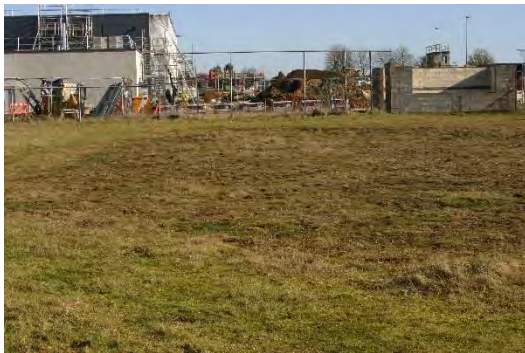
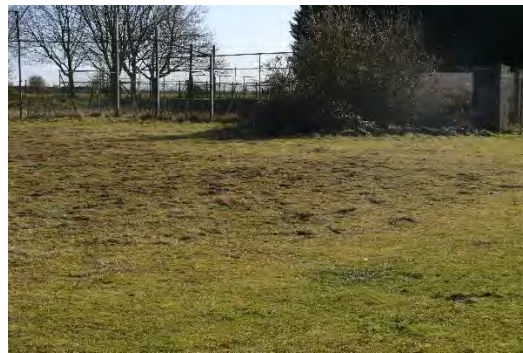
General view of site Southern Baseball diamond, fence and 'built' structures requiring removal

- 'Team' buildings and associated terracing.
- All of the Baseball diamond footprints.
- Paved features.
- Fence structures.

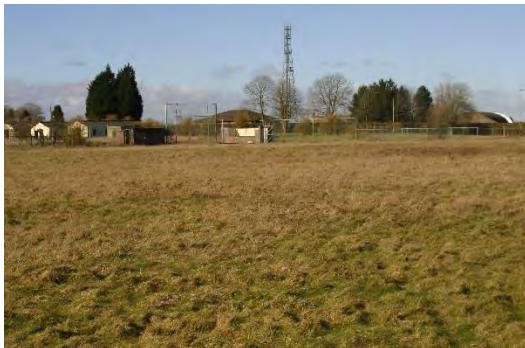
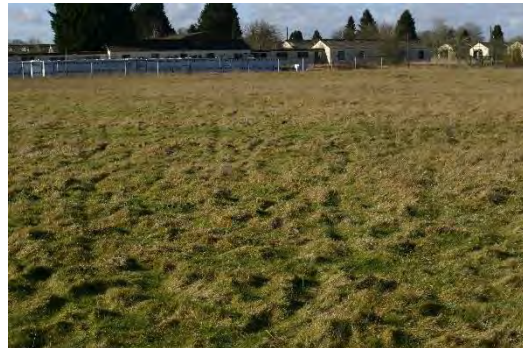
General view of site Northern Baseball diamond, fence and 'built' structures requiring removal

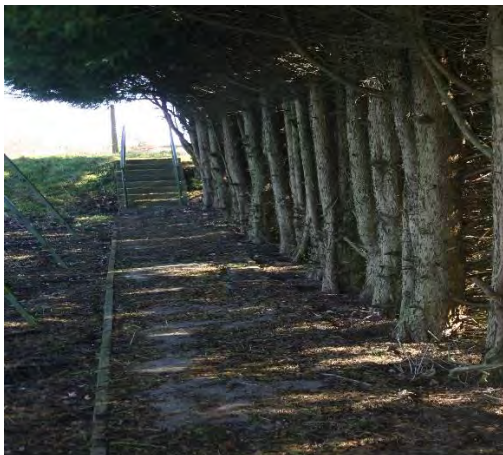
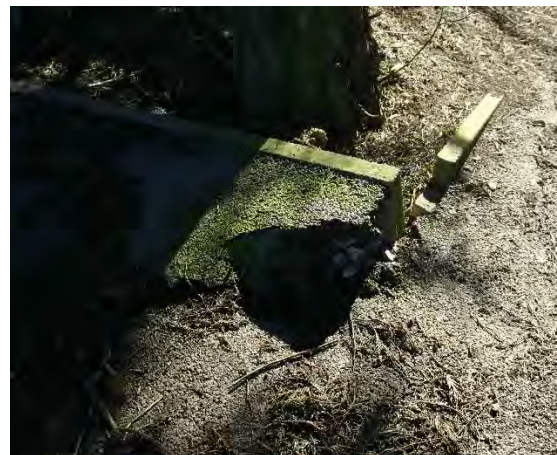
Tree root damage to surfaces common to all areas
