**SURVEY OF TREES AT GREEN LANE, CHESTERTON**

PROJECT: Land at Green Lane, Chesterton

TITLE: Tree Protection Plan

DRAWING NUMBER: 8364/02 Rev A 3/3

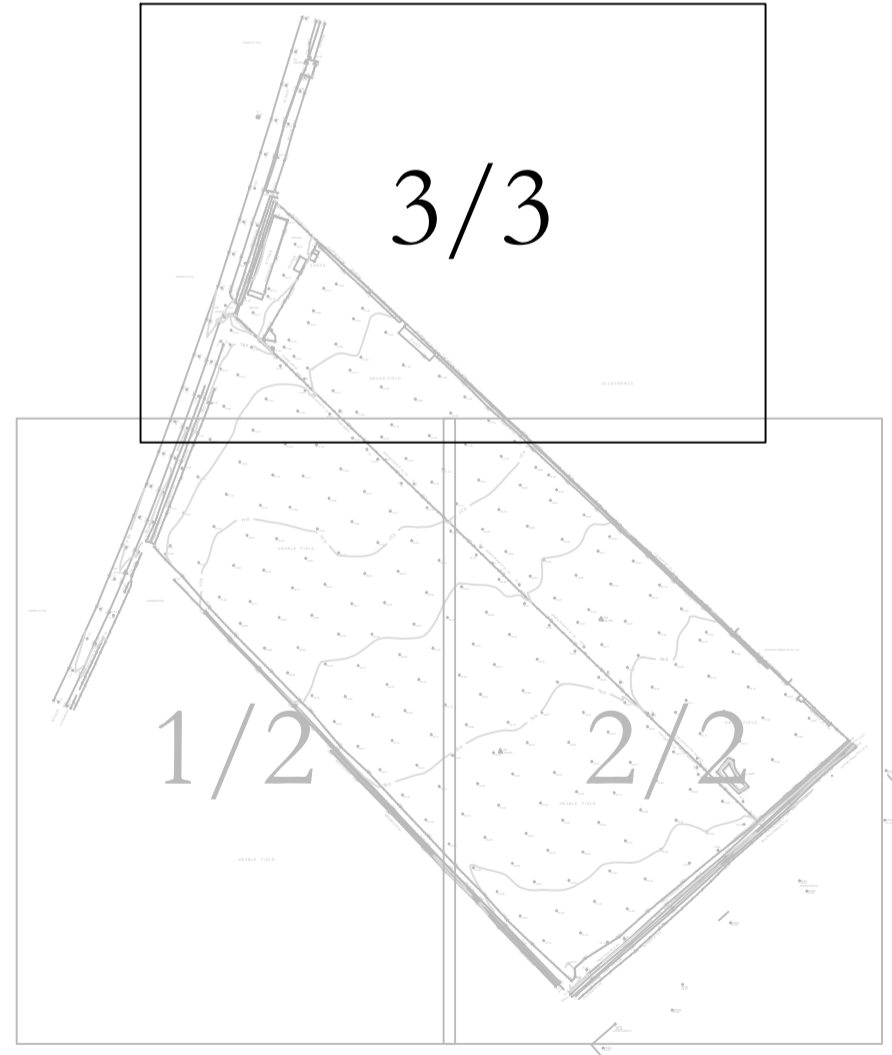
Carriageway widened to provide a minimum of 4.8m width with full height kerb provided along side of proposed footway

Entrance feature fence to separate detail

Wildflower meadow and native shrub planting  
'Wildlife Enhancement'
