Factual soakaway test report

313035-02 (00)

Title: Factual soakaway test report: Chesterton

Client: Taylor Wimpey (Oxfordshire)

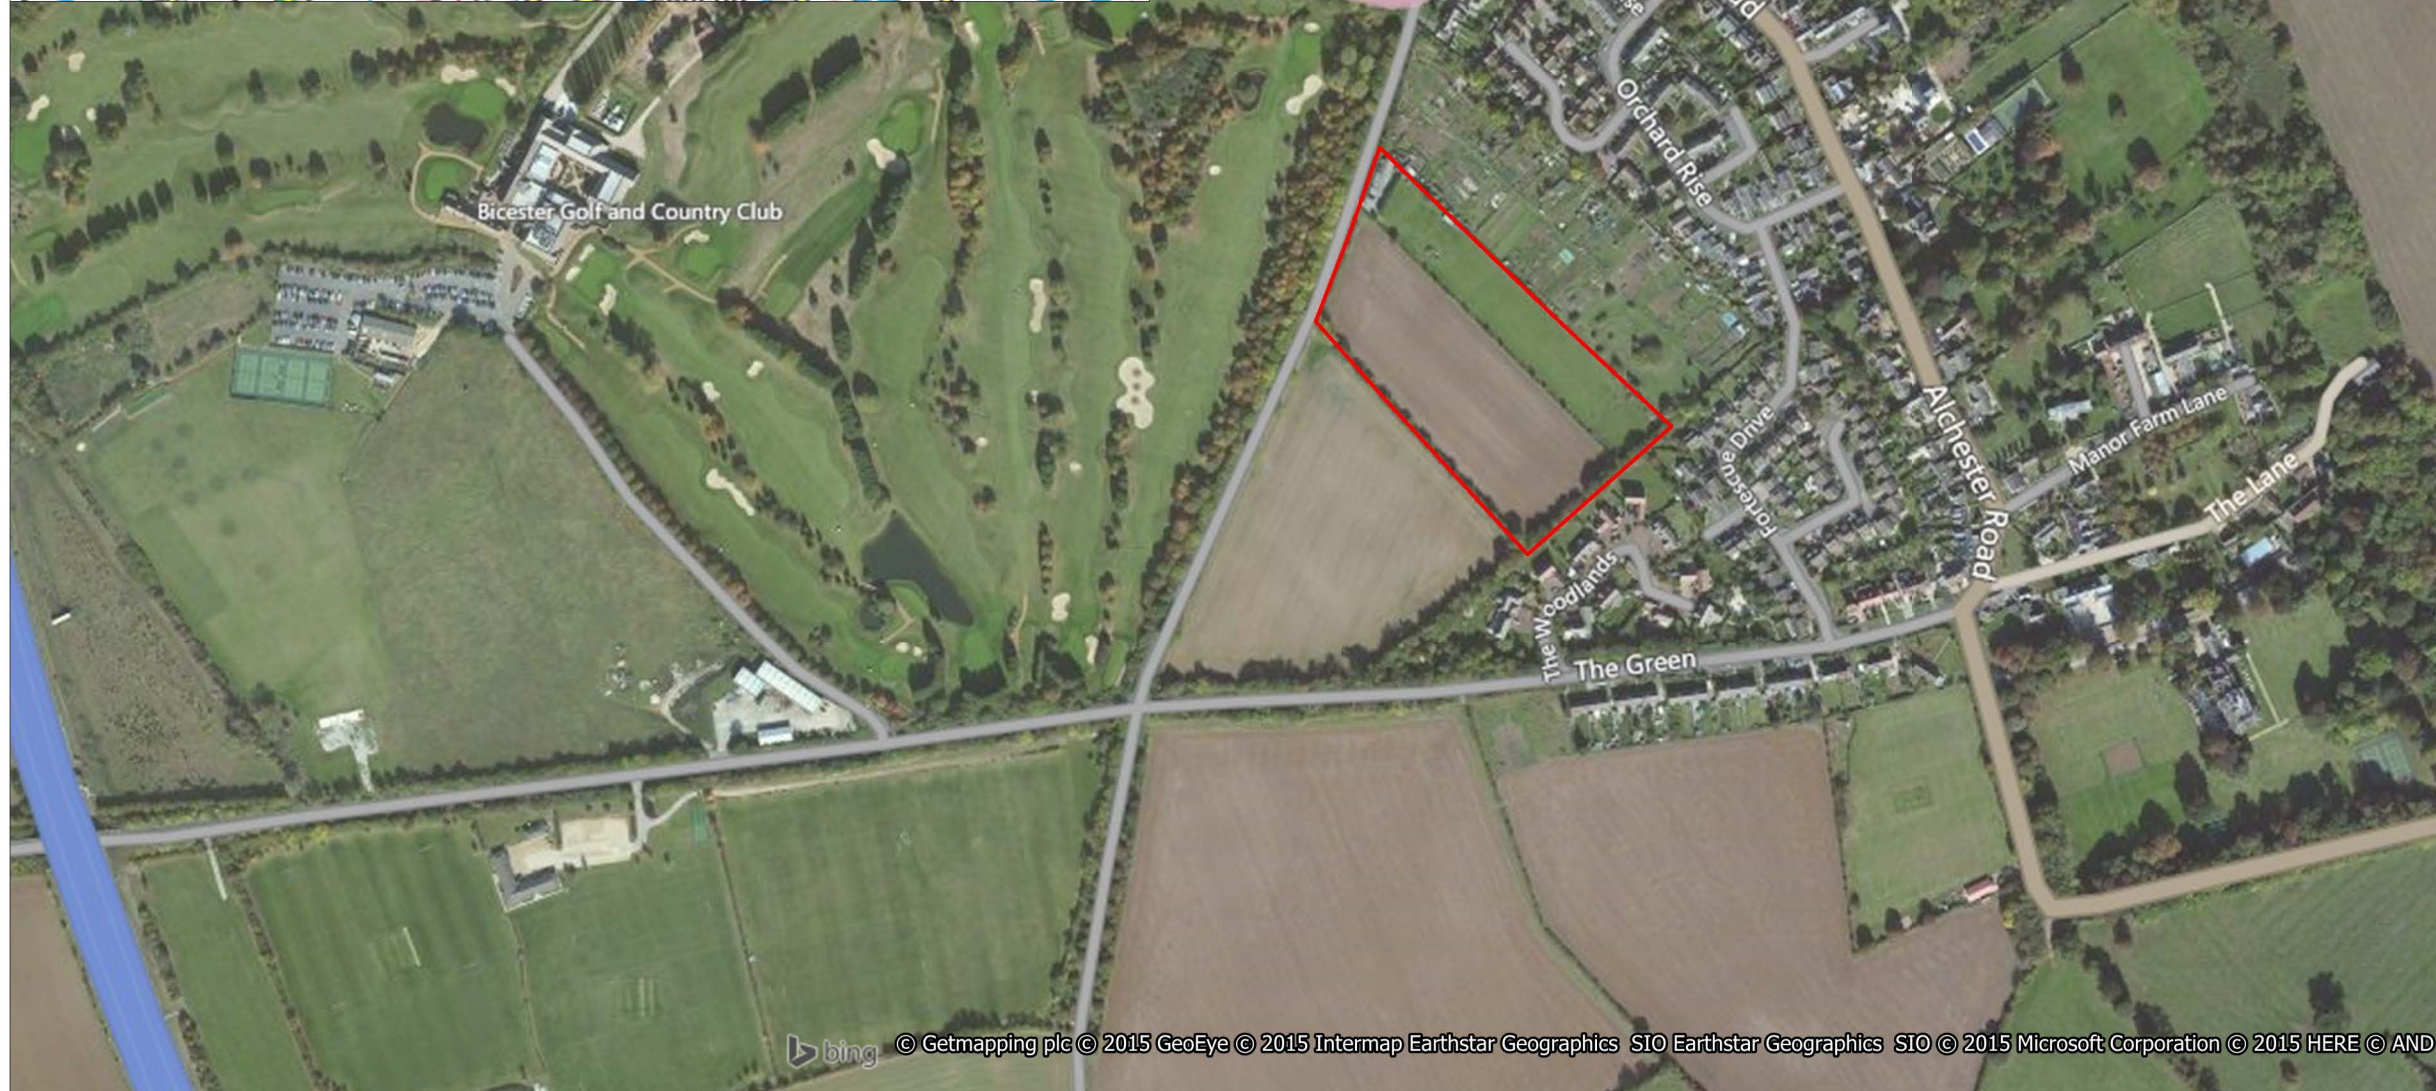
Indicative site boundary

- Indicative site boundary
- + CBR
- ⊕ Foundation pit
- X Trial pit
- X Trial pit and soakaway
- ▲ Window sample
