# Chesterton

Geo-environmental site assessment

313035-01(00)

JULY 2015

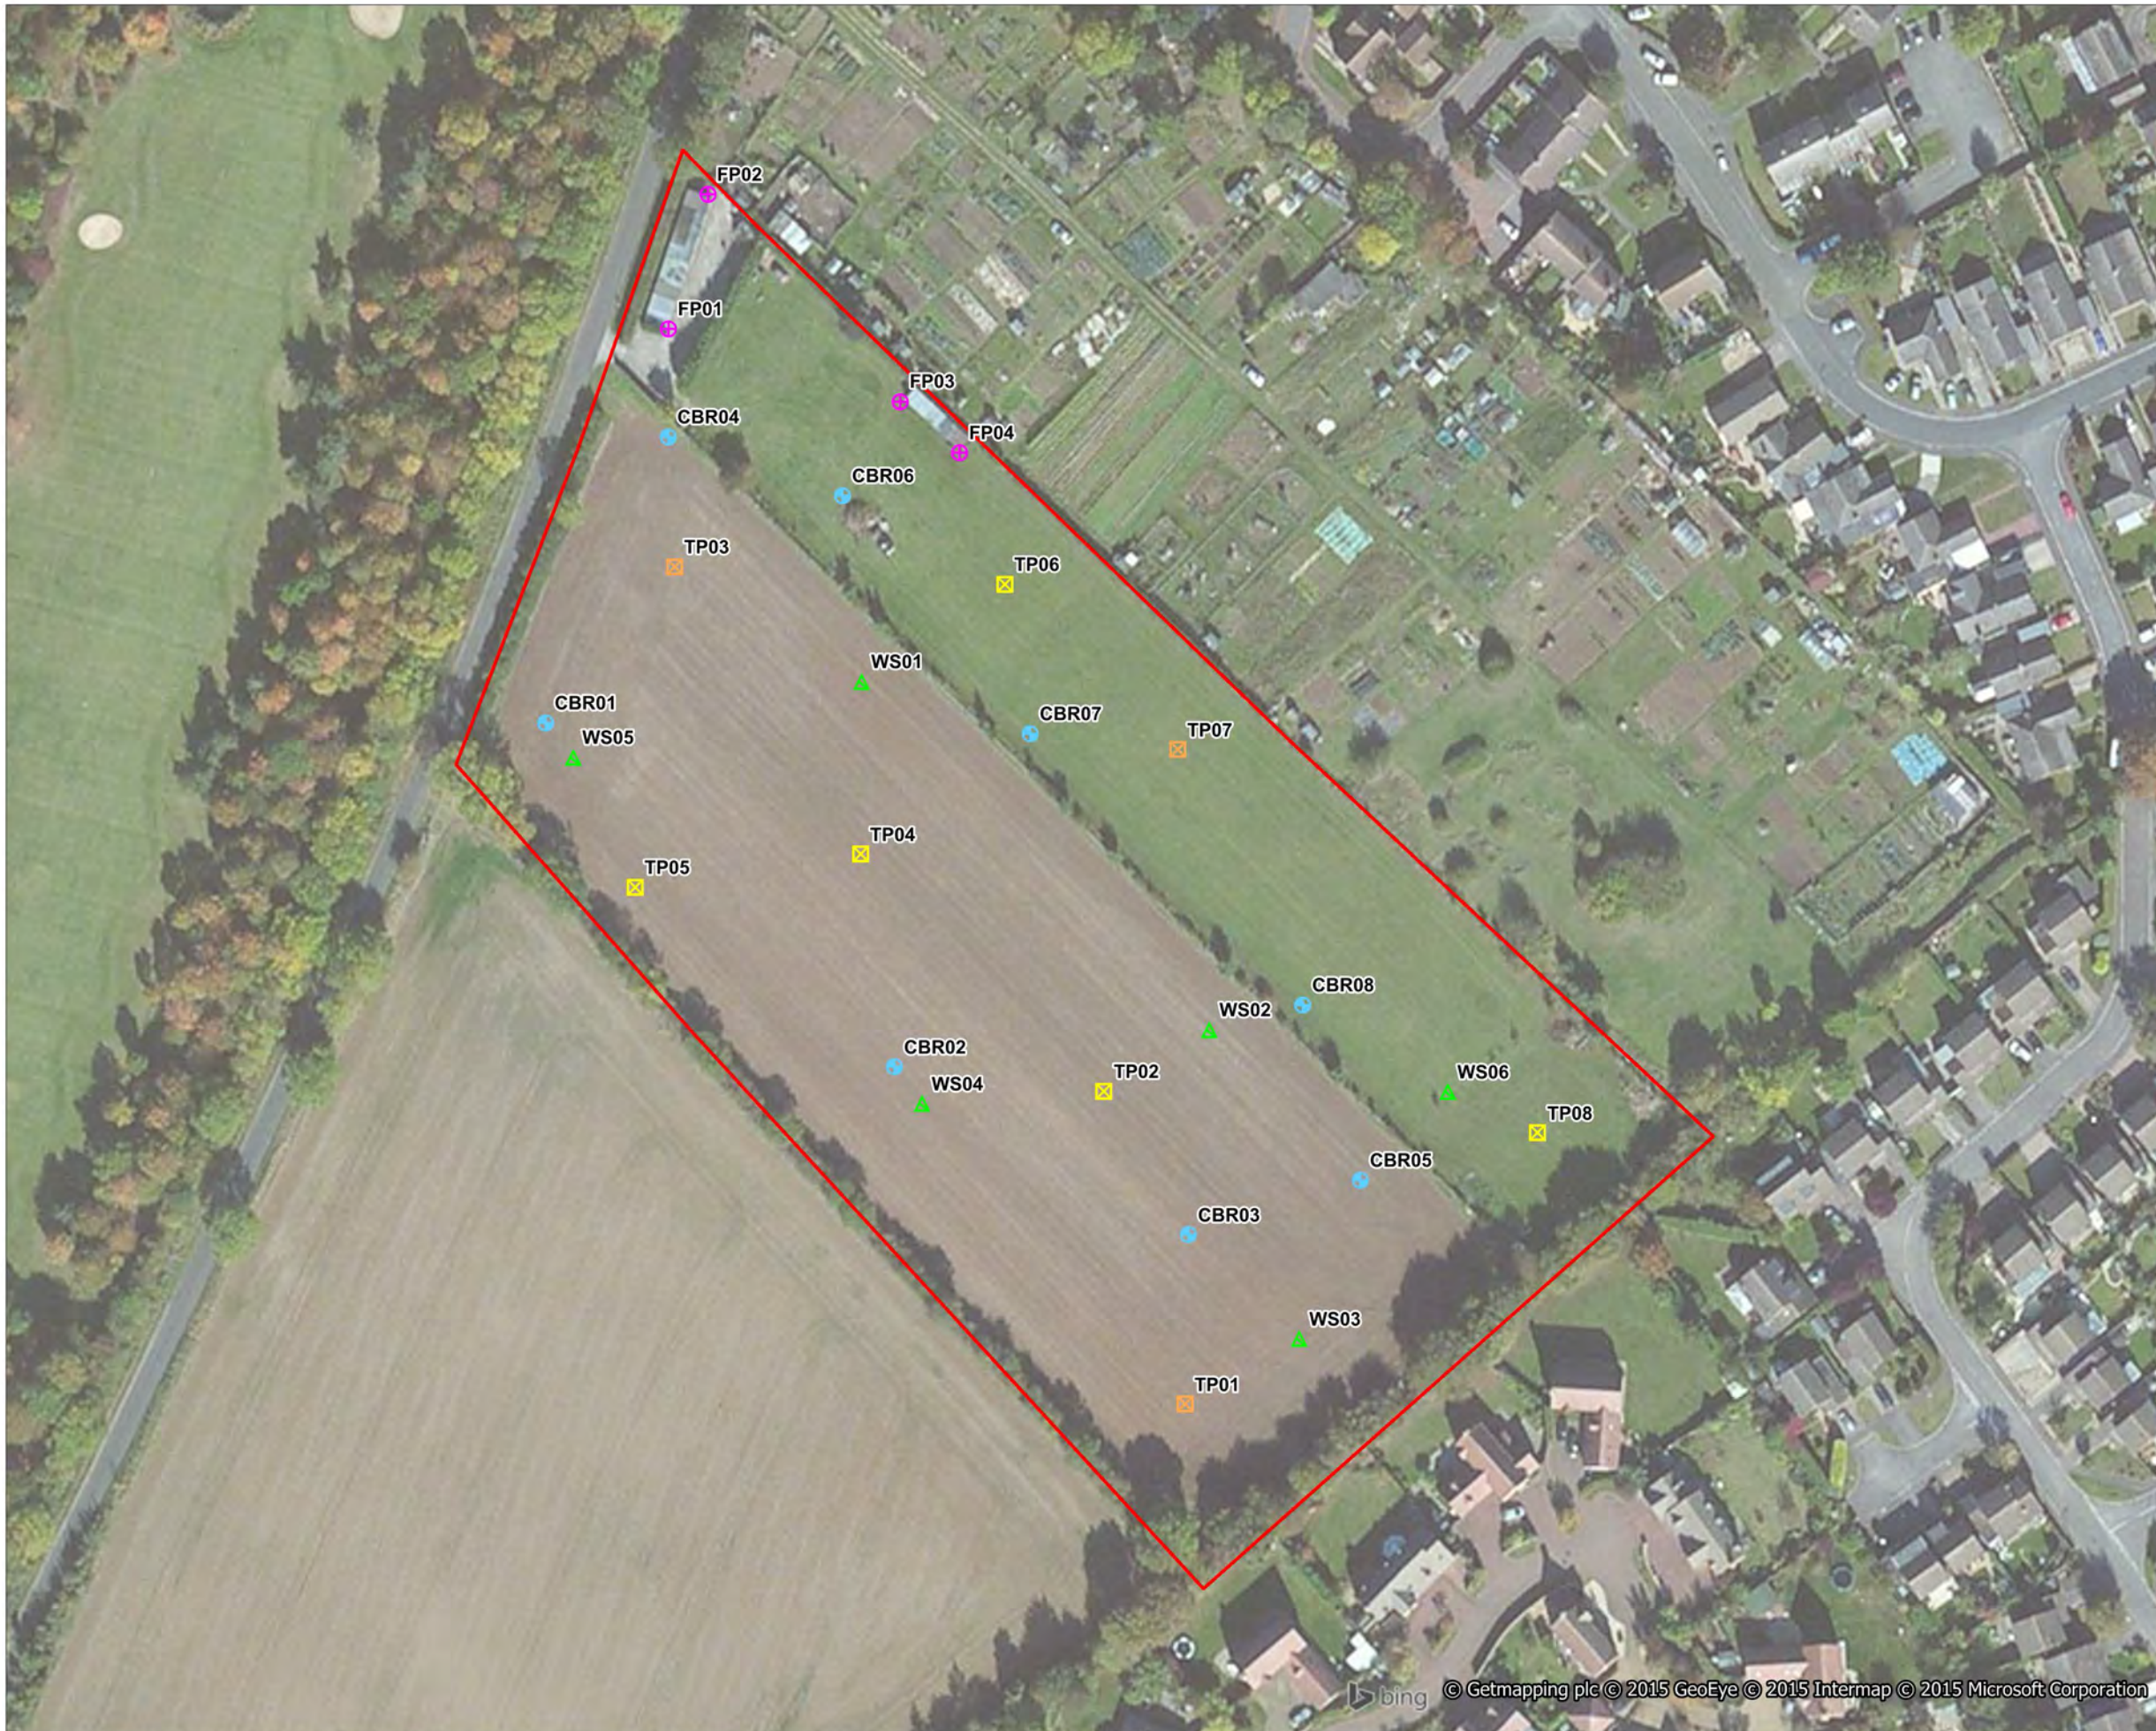
- Indicative site boundary
- + CBR
- + Foundation pit
- X Trial pit
- X Trial pit and soakaway
- ▲ Window sample

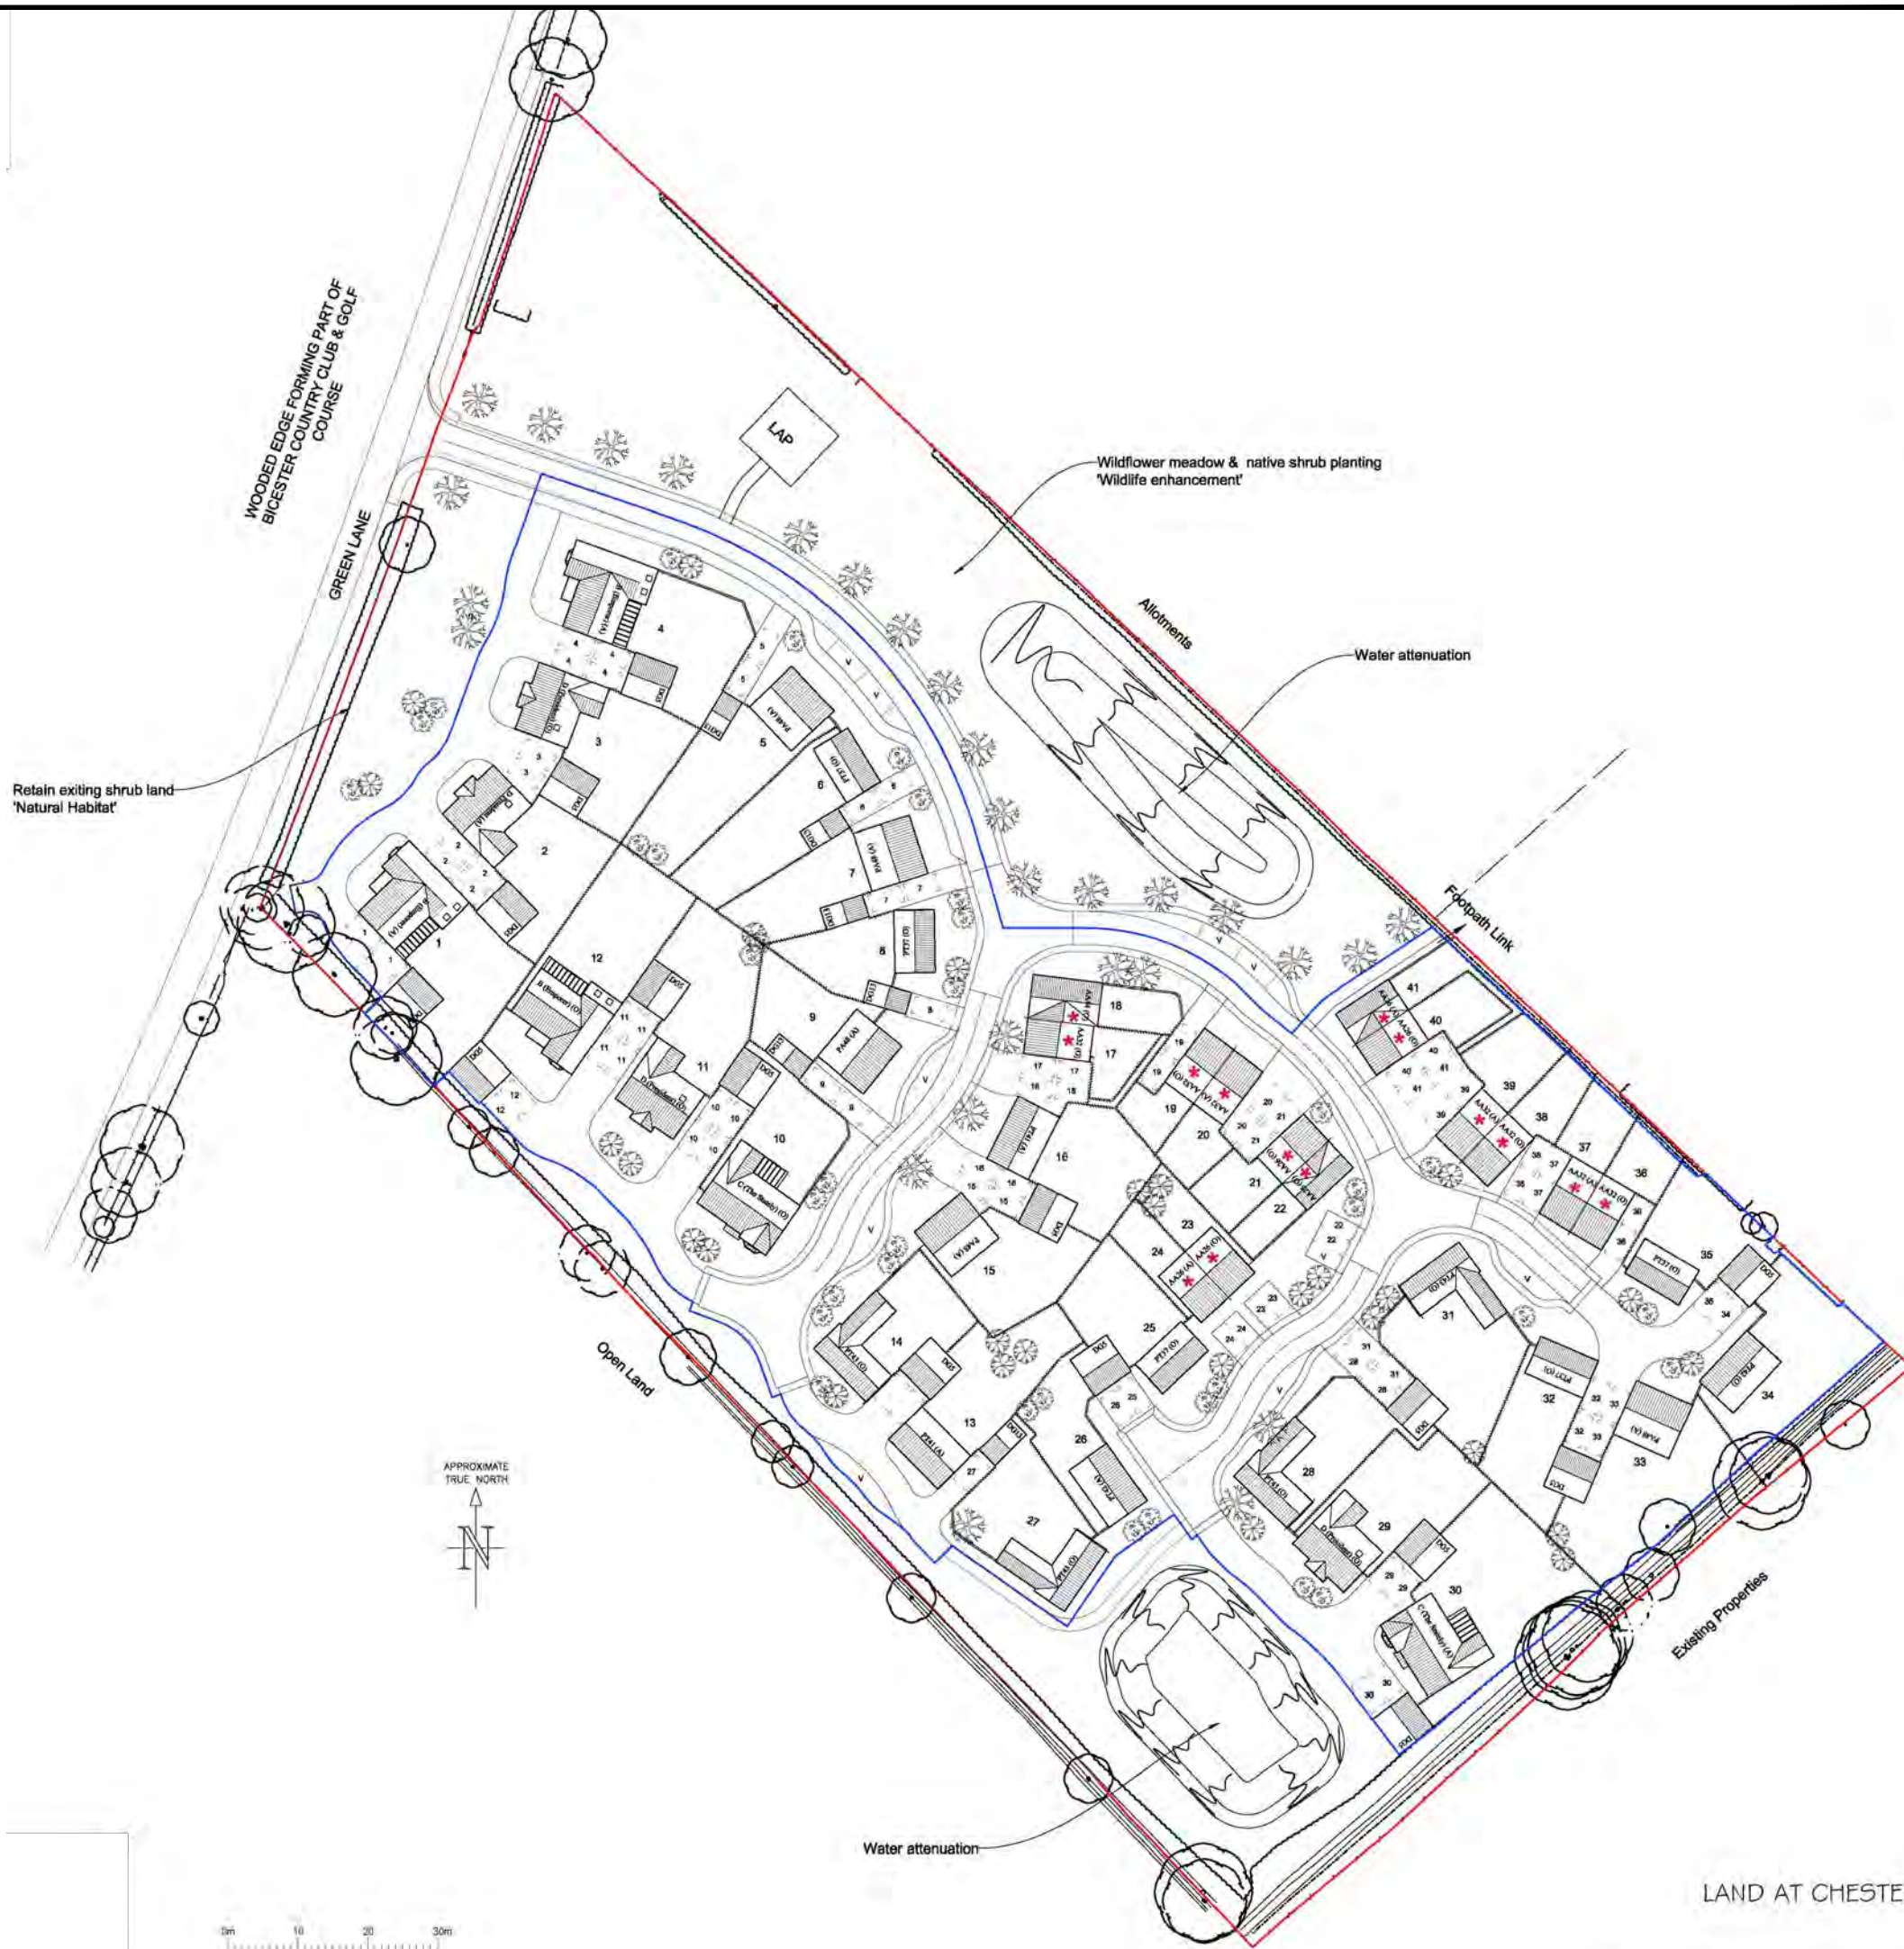
Site Plan from Life Space Design, dated August 2014

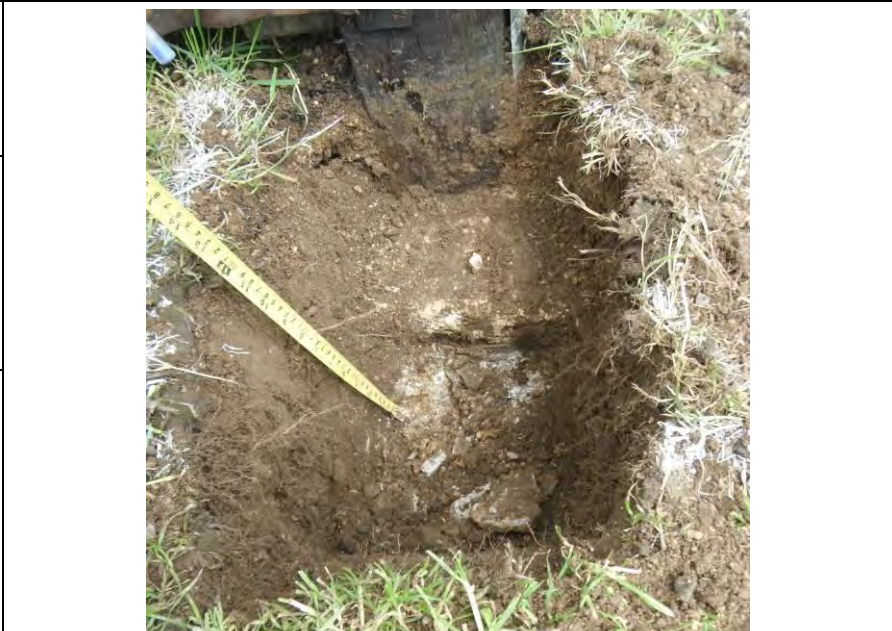
<b>Photo No.</b> 4	<b>Date:</b> 20.05.15

<b>Direction Photo Taken:</b> N/A		
<b>Description:</b> Foundation inspection pit at FP03

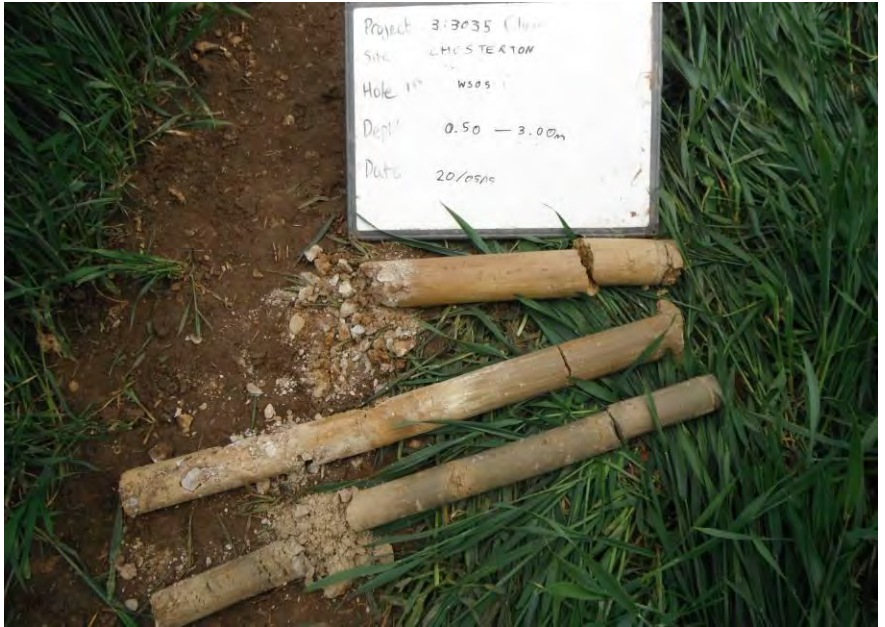
<b>Photo No.</b> 5	<b>Date:</b> 20.05.15

<b>Direction Photo Taken:</b> N/A		
<b>Description:</b> Recovered soils from WS05

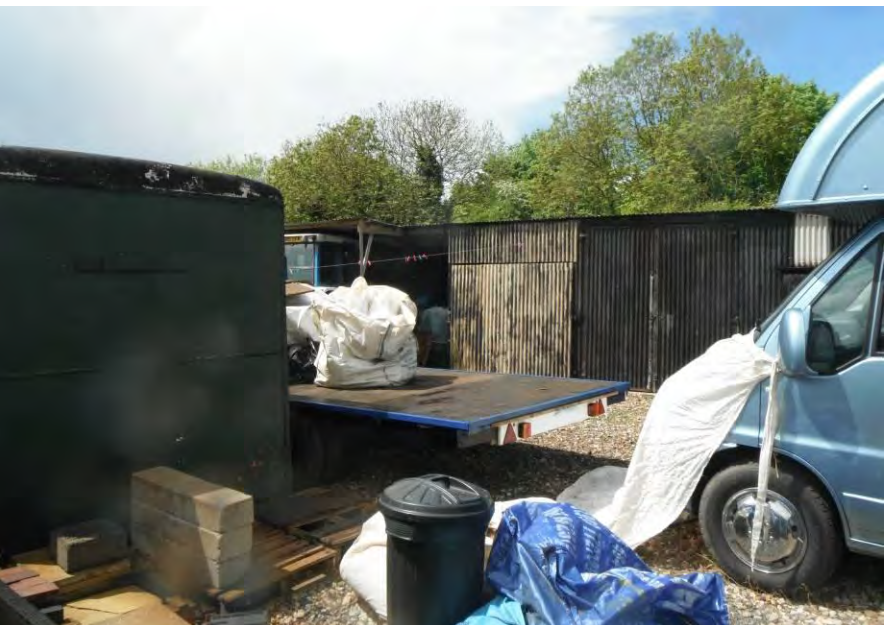
<b>Photo No.</b> 6	<b>Date:</b> 20.05.15

<b>Direction Photo Taken:</b> West		
<b>Description:</b> Stored materials within the compound area of the site
