Factual soakaway test report

313035-02 (00)

Title: Factual soakaway test report: Chesterton

Client: Taylor Wimpey (Oxfordshire)

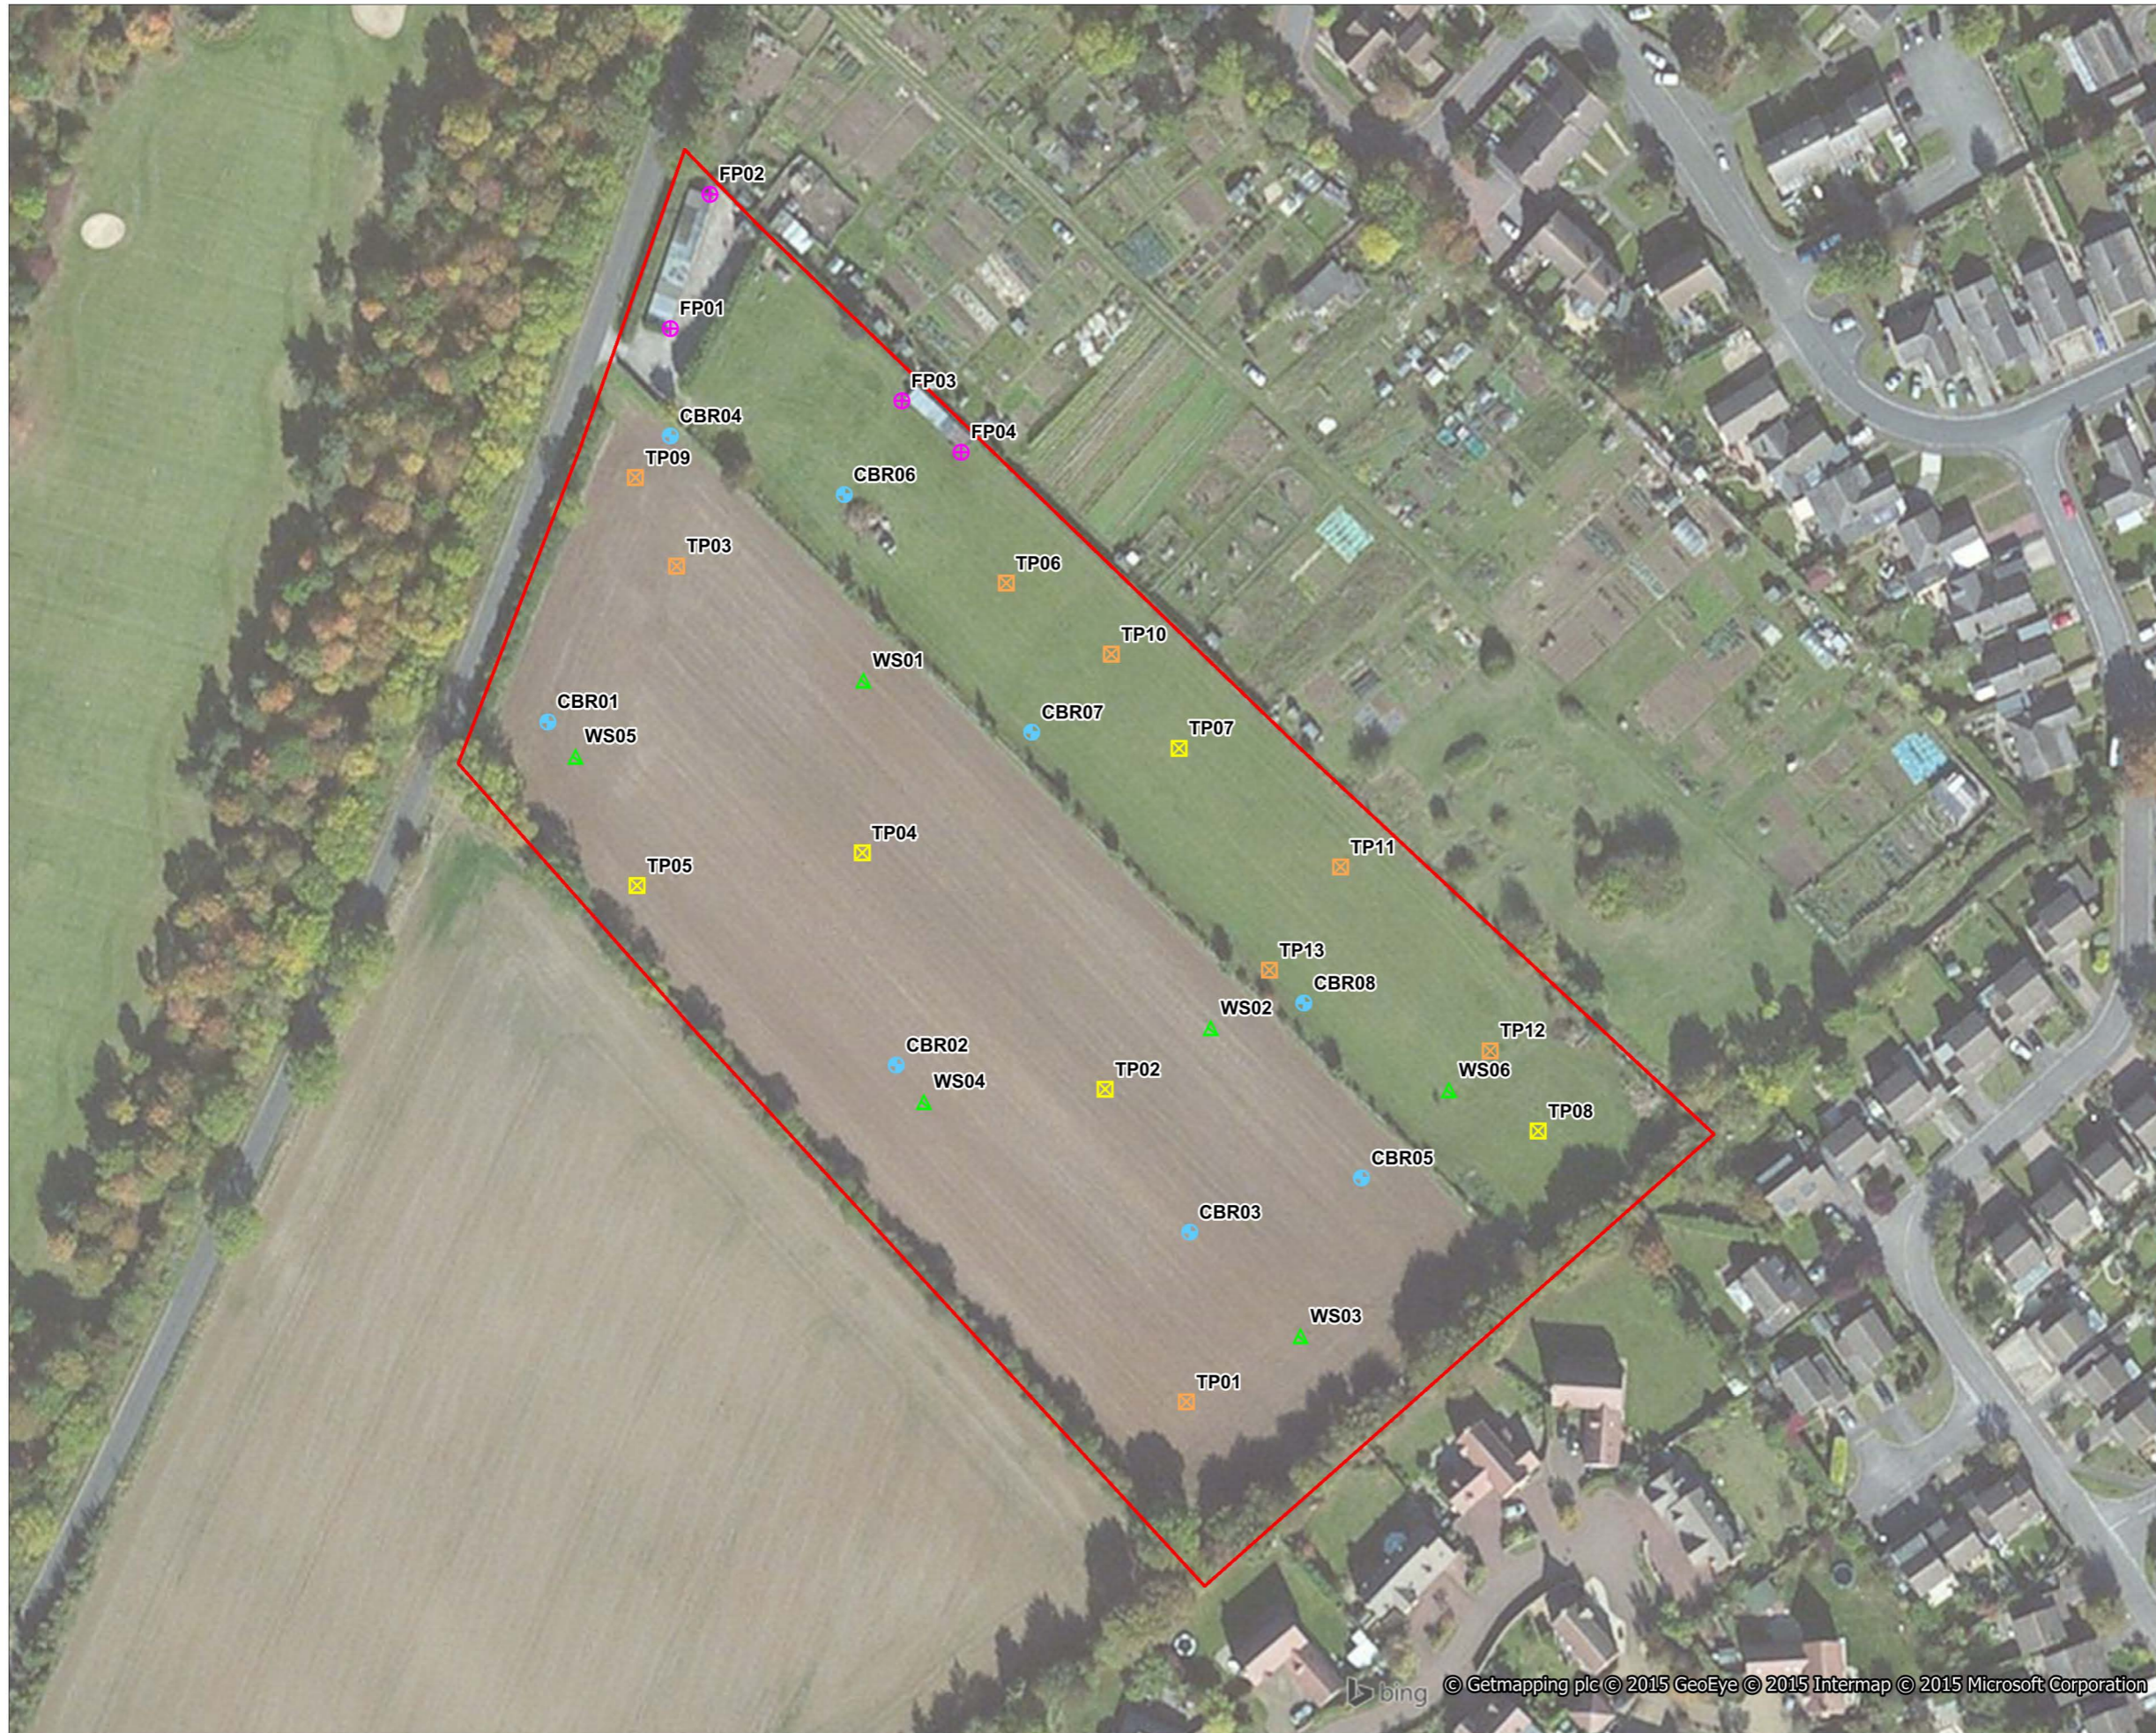
Figure 2
Exploratory Hole Location Plan

- Indicative site boundary
- + CBR
- ⊕ Foundation pit
- ⊠ Trial pit
- ⊠ Trial pit and soakaway
- △ Window sample

The testing strategy was primarily focused on the characterisation of the shallow Cornbrash Formation; in order to confirm the infiltration characteristics of the formation. The testing was undertaken at the locations and depths specified by the Engineer.

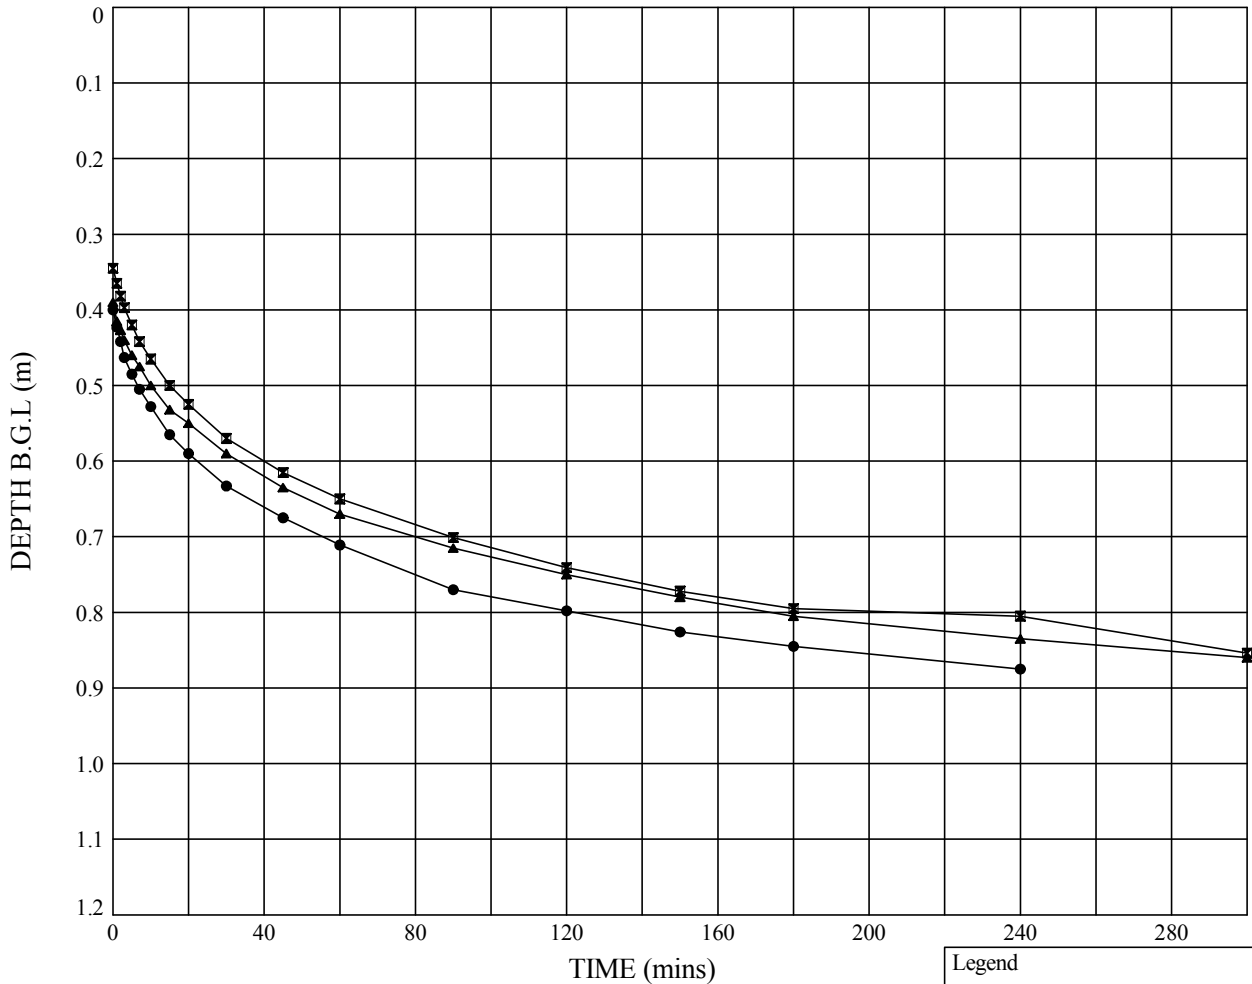
Soakaway Test - Position ID : TP9

PLOT OF DEPTH OF WATER BELOW GROUND LEVEL AGAINST TIME

Test 1	Test 2	Test 3	
Pit start depth:	= 1.10	1.10	1.10	m
Pit final depth:	= 1.10	1.10	1.10	m
Effective depth, D_e	= 0.70	0.76	0.71	m
Effective storage volume, V_{p75-25}	= 1.2180	1.3137	1.2354	m^3
Surface area, a_{p50}	= 6.3500	6.5755	6.3910	m^2
Time, t_{p75-25}	= 19380	51333	25538	secs
Infiltration rate, f	= 9.90×10^{-6}	3.89×10^{-6}	7.57×10^{-6}	m/s

Please note test data was extrapolated to obtain $t_{p75-tp25}$. Notes: Test 2 - Standing water in pit prior to test., Test 3 - Standing water in pit prior to test.

As can be seen from the above, infiltration rates within the Cornbrash Formation ranged between 2.41×10^{-4} m/s and 3.89×10^{-6} m/s. Infiltration rates were typically recorded at 10^{-4} m/s or 10^{-5} m/s, while infiltration rates noted in TP09 were typically 10^{-6} m/s.

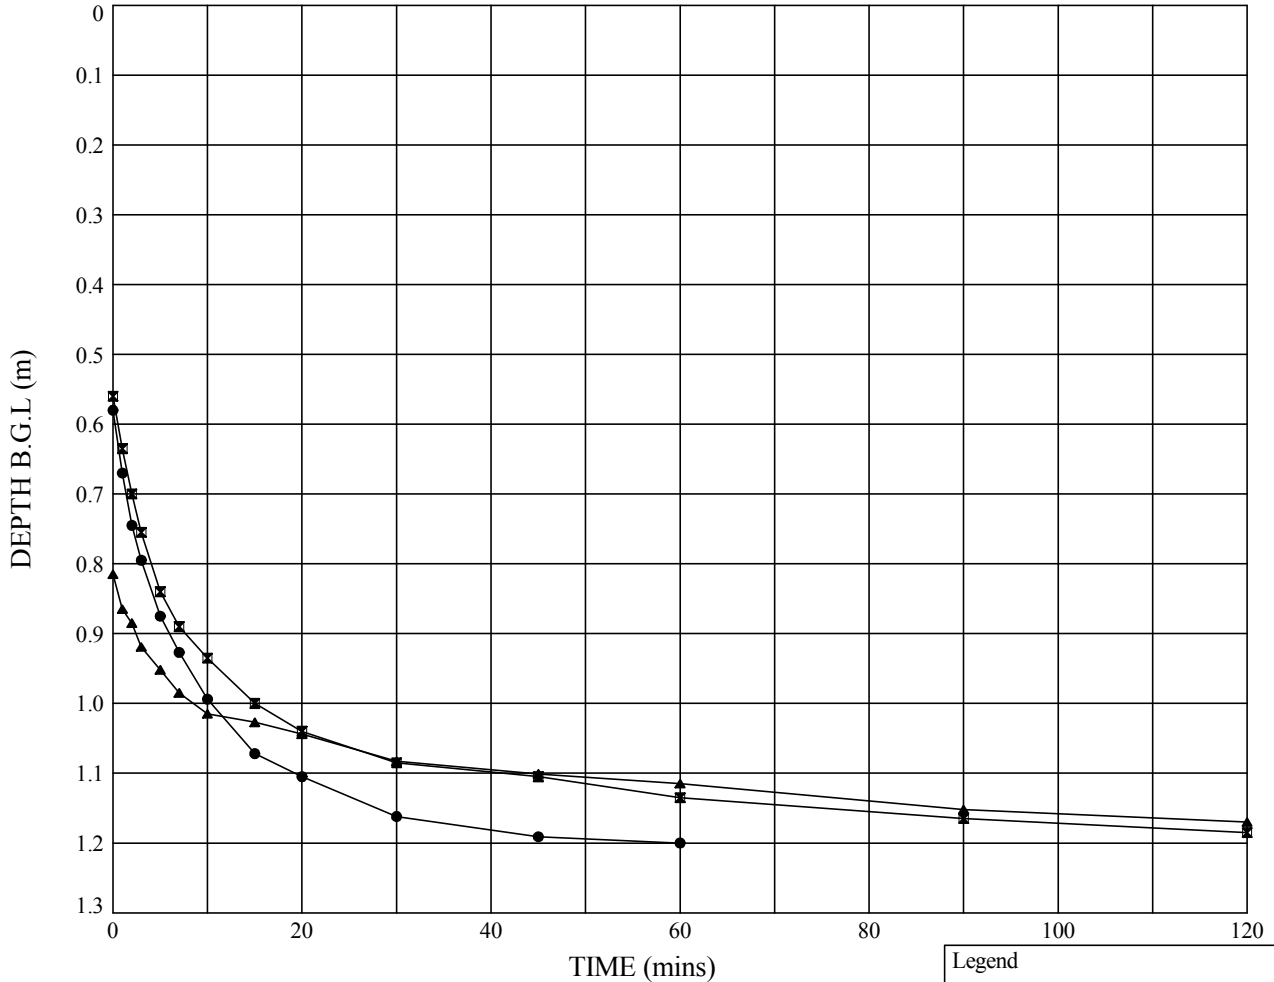
Soakaway Test - Position ID : TP10

PLOT OF DEPTH OF WATER BELOW GROUND LEVEL AGAINST TIME

Test 1	Test 2	Test 3	
Pit start depth:	= 1.20	1.20	1.20	m
Pit final depth:	= 1.20	1.20	1.19	m
Effective depth, D_e	= 0.62	0.64	0.37	m
Effective storage volume, V_{p75-25}	= 0.7440	0.7680	0.4440	m^3
Surface area, a_{p50}	= 4.5080	4.5760	3.6580	m^2
Time, t_{p75-25}	= 684	1058	2115	secs
Infiltration rate, f	= 2.41×10^{-4}	1.59×10^{-4}	5.74×10^{-5}	m/s

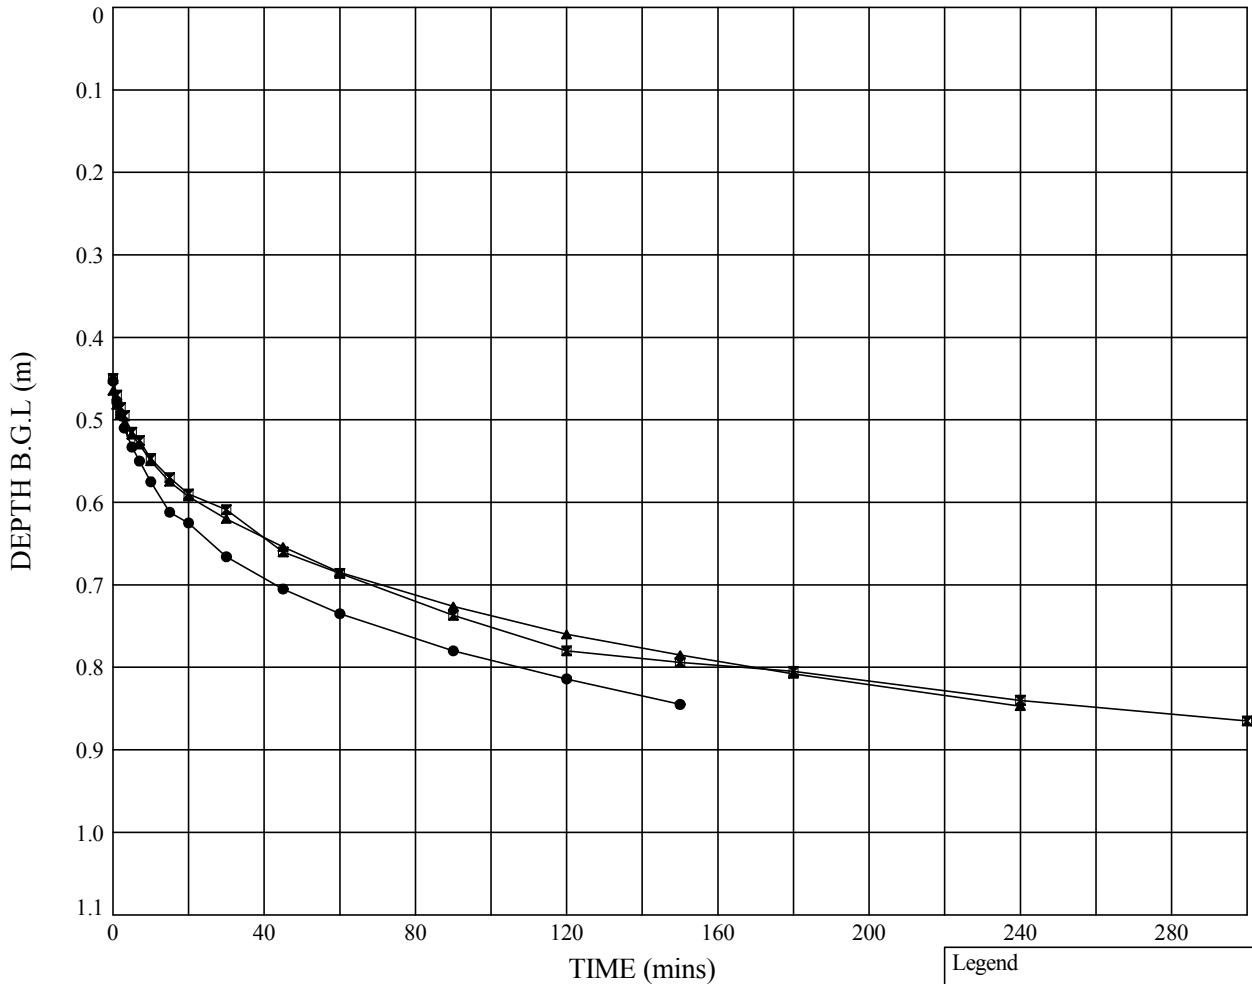
Soakaway Test - Position ID : TP11

PLOT OF DEPTH OF WATER BELOW GROUND LEVEL AGAINST TIME

Test 1	Test 2	Test 3	
Pit start depth:	= 1.01	1.01	0.98	m
Pit final depth:	= 1.01	0.98	0.98	m
Effective depth, D_e	= 0.56	0.53	0.51	m
Effective storage volume, V_{p75-25}	= 0.8884	0.8374	0.8135	m^3
Surface area, a_{p50}	= 5.4180	5.2900	5.2300	m^2
Time, t_{p75-25}	= 9755	13871	13254	secs
Infiltration rate, f	= 1.68×10^{-5}	1.14×10^{-5}	1.17×10^{-5}	m/s

Please note test data was extrapolated to obtain $t_{p75-tp25}$.

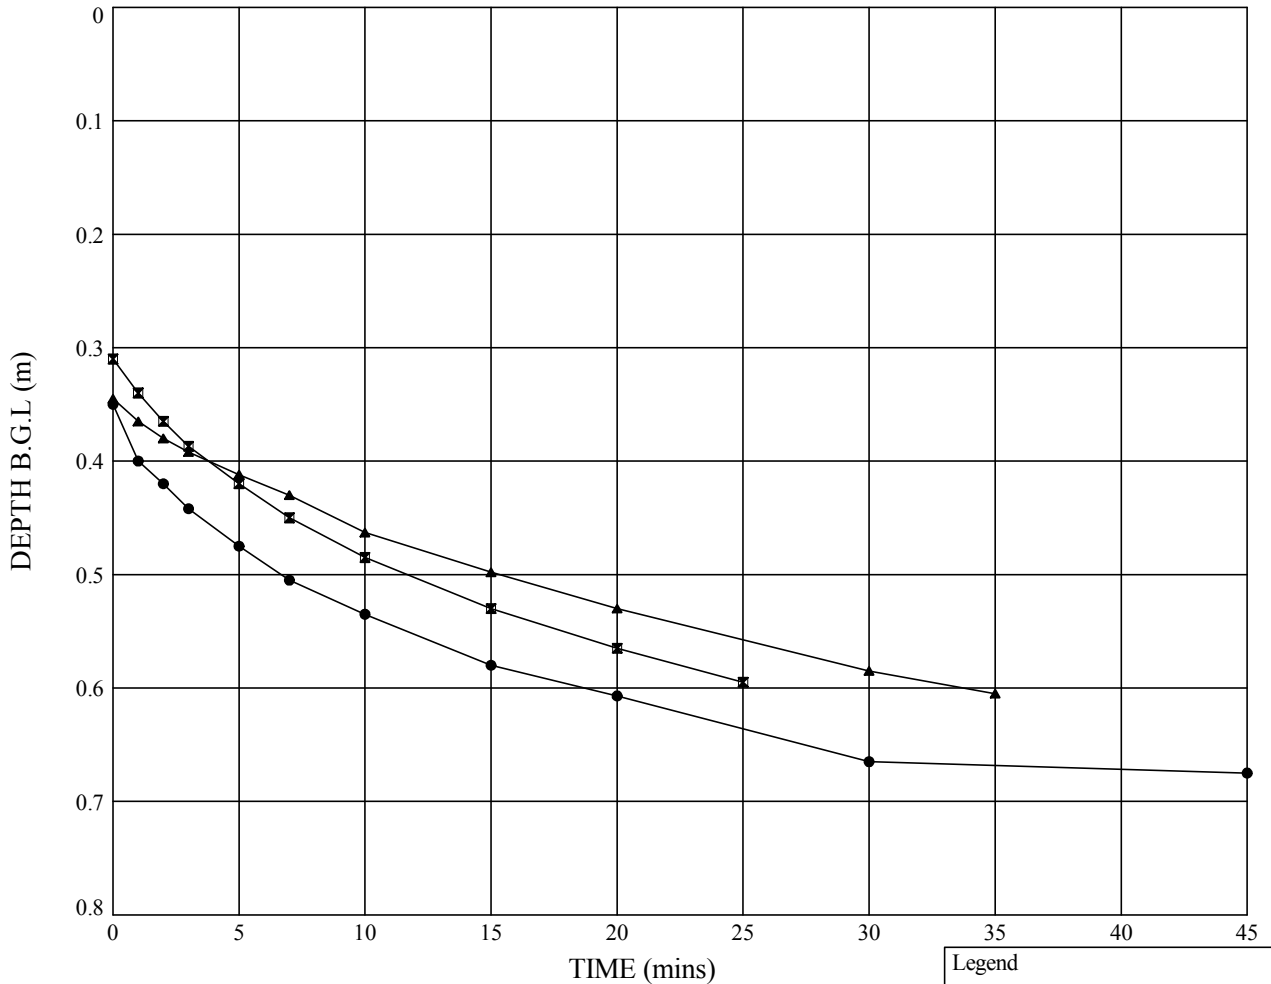
Soakaway Test - Position ID : TP12

PLOT OF DEPTH OF WATER BELOW GROUND LEVEL AGAINST TIME

Test 1	Test 2	Test 3	
Pit start depth:	= 0.68	0.68	0.68	m
Pit final depth:	= 0.68	0.68	0.68	m
Effective depth, D_e	= 0.33	0.37	0.33	m
Effective storage volume, V_{p75-25}	= 0.4388	0.4928	0.4455	m^3
Surface area, a_{p50}	= 3.9025	4.0505	3.9210	m^2
Time, t_{p75-25}	= 902	1156	1510	secs
Infiltration rate, f	= 1.25×10^{-4}	1.05×10^{-4}	7.52×10^{-5}	m/s

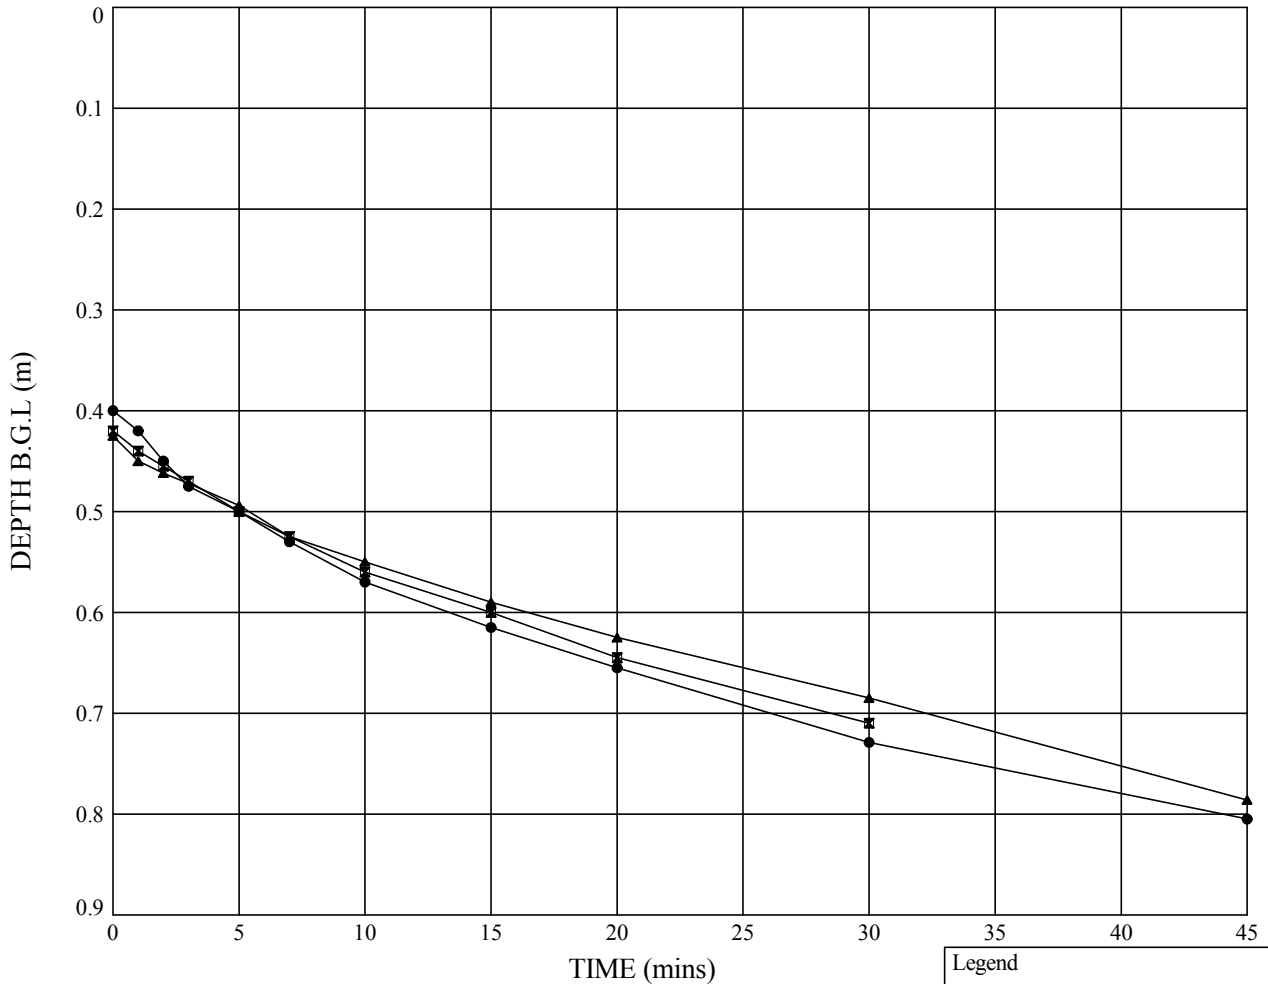
Soakaway Test - Position ID : TP13

PLOT OF DEPTH OF WATER BELOW GROUND LEVEL AGAINST TIME

Test 1	Test 2	Test 3	
Pit start depth:	= 0.81	0.81	0.81	m
Pit final depth:	= 0.81	0.81	0.81	m
Effective depth, D_e	= 0.41	0.39	0.38	m
Effective storage volume, V_{p75-25}	= 0.5670	0.5390	0.5320	m^3
Surface area, a_{p50}	= 4.3390	4.2630	4.2440	m^2
Time, t_{p75-25}	= 1290	1410	1622	secs
Infiltration rate, f	= 1.01×10^{-4}	8.97×10^{-5}	7.73×10^{-5}	m/s
