# Chesterton

Supplementary factual soakaway test report

313035-03 (00)

NOVEMBER 2016

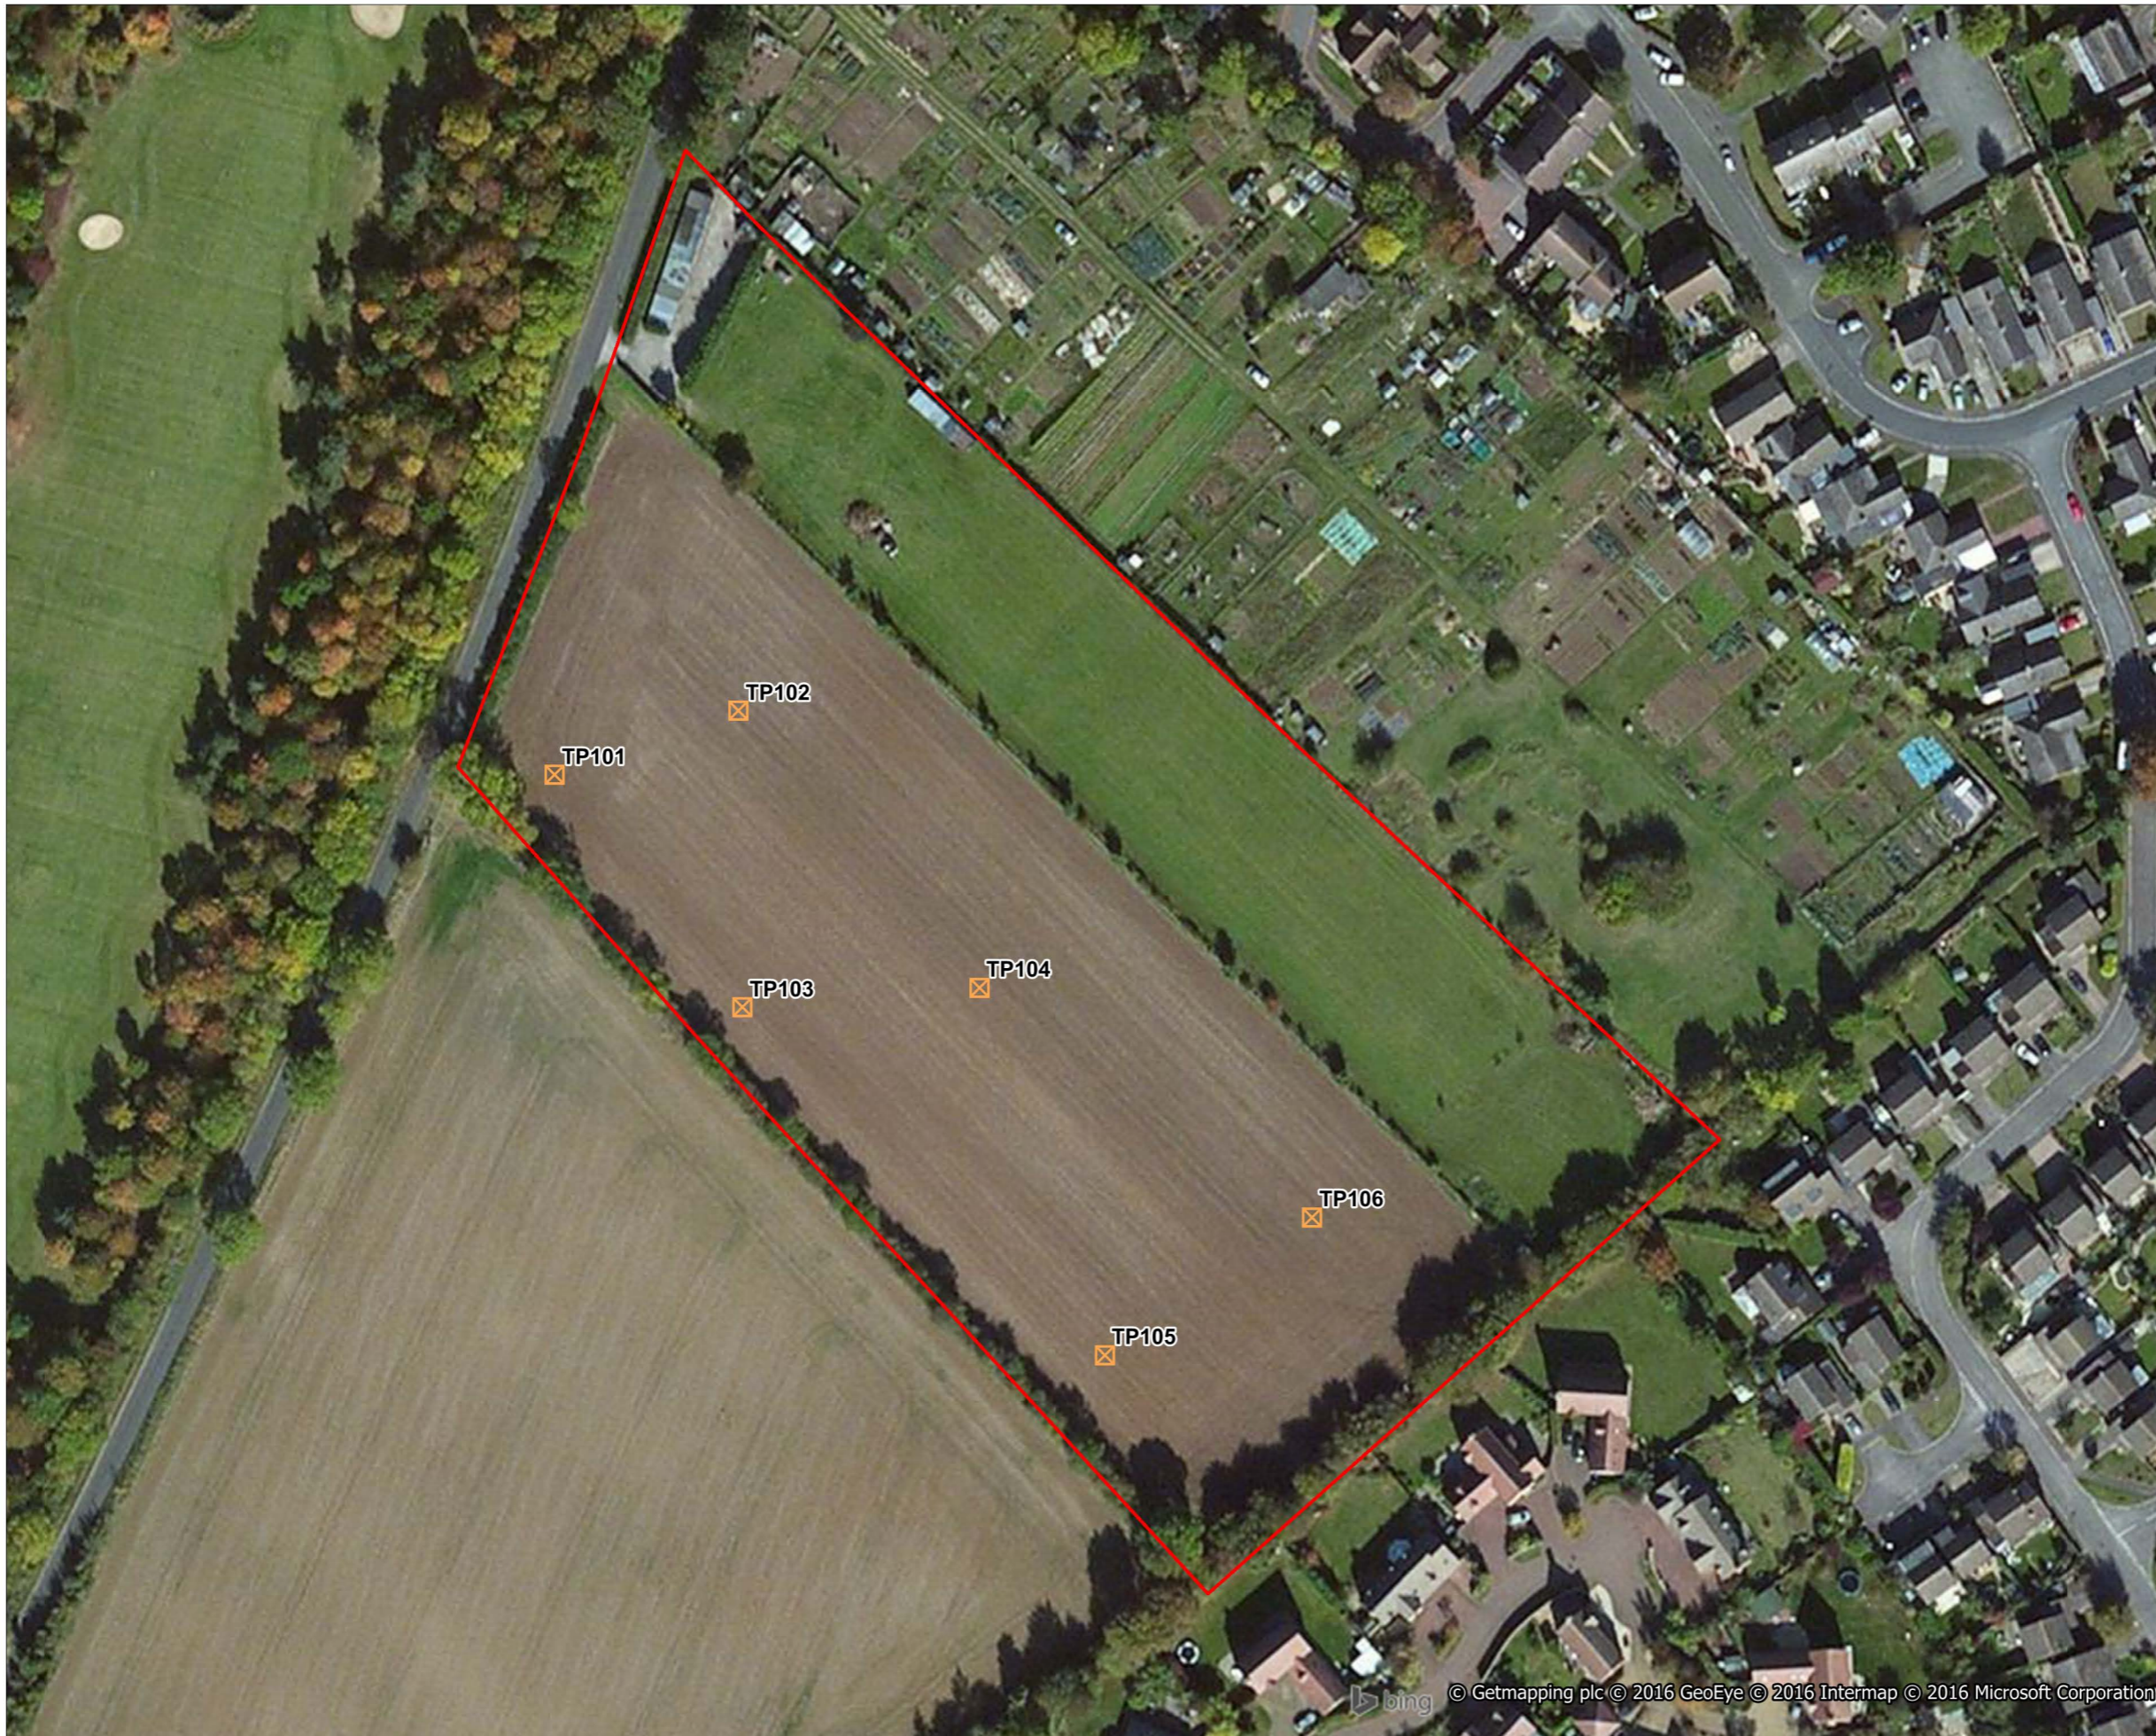
Figure 2  
Exploratory Hole Location Plan

- Indicative site boundary
- Trial pit and soakaway

The testing strategy was primarily focused on the characterisation of the shallow Cornbrash Formation; in order to confirm the infiltration characteristics of the formation. The testing was undertaken at the locations and depths specified by the Engineer. Three of the exploratory locations (TP101, TP103 and TP104), were targeted to investigate the infiltration characteristics beneath the proposed roadways on the site. Two of the exploratory locations were located to target the infiltration characteristics of strata underlying the proposed gardens (TP02 and TP06) and one beneath the proposed attenuation pond in the southeast corner of the site (TP05).

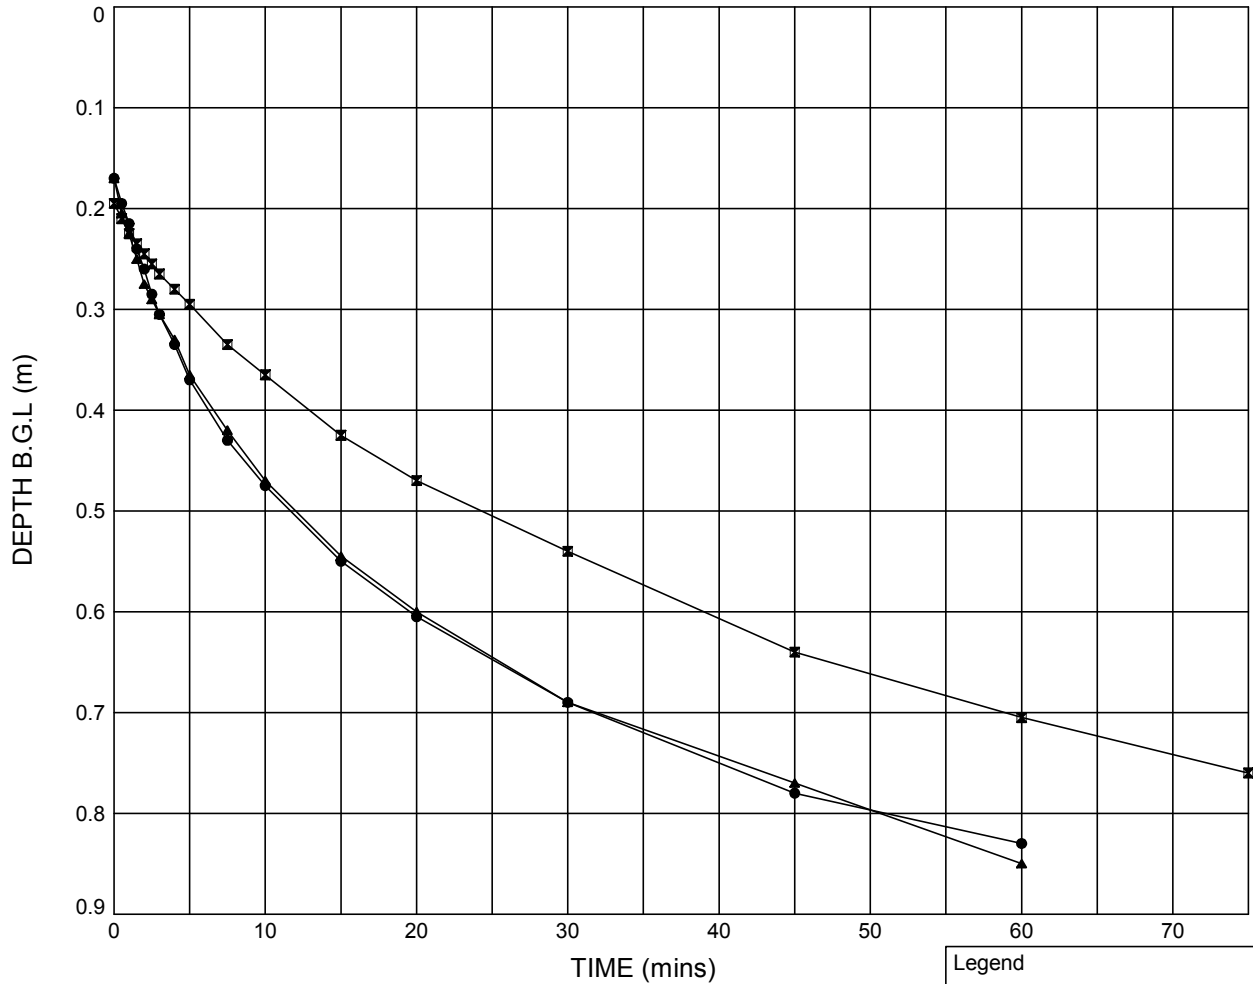
Soakaway Test - Position ID : TP101

## Plot of Depth of Water Below Ground Level Against Time

Test 1	Test 2	Test 3	
Pit start depth:	= 0.93	<b>0.93</b>	0.93	m
Pit final depth:	= 0.93	<b>0.93</b>	0.93	m
Effective depth, $D_e$	= 0.76	<b>0.74</b>	0.76	m
Effective storage volume, $V_{p75-25}$	= 0.3724	<b>0.3602</b>	0.3724	$m^3$
Surface area, $a_{p50}$	= 2.5760	<b>2.5235</b>	2.5760	$m^2$
Time, $t_{p75-25}$	= 2017	<b>3606</b>	2072	secs
Infiltration rate, $f$	= $7.17 \times 10^{-5}$	<b><math>3.96 \times 10^{-5}</math></b>	$6.98 \times 10^{-5}$	m/s

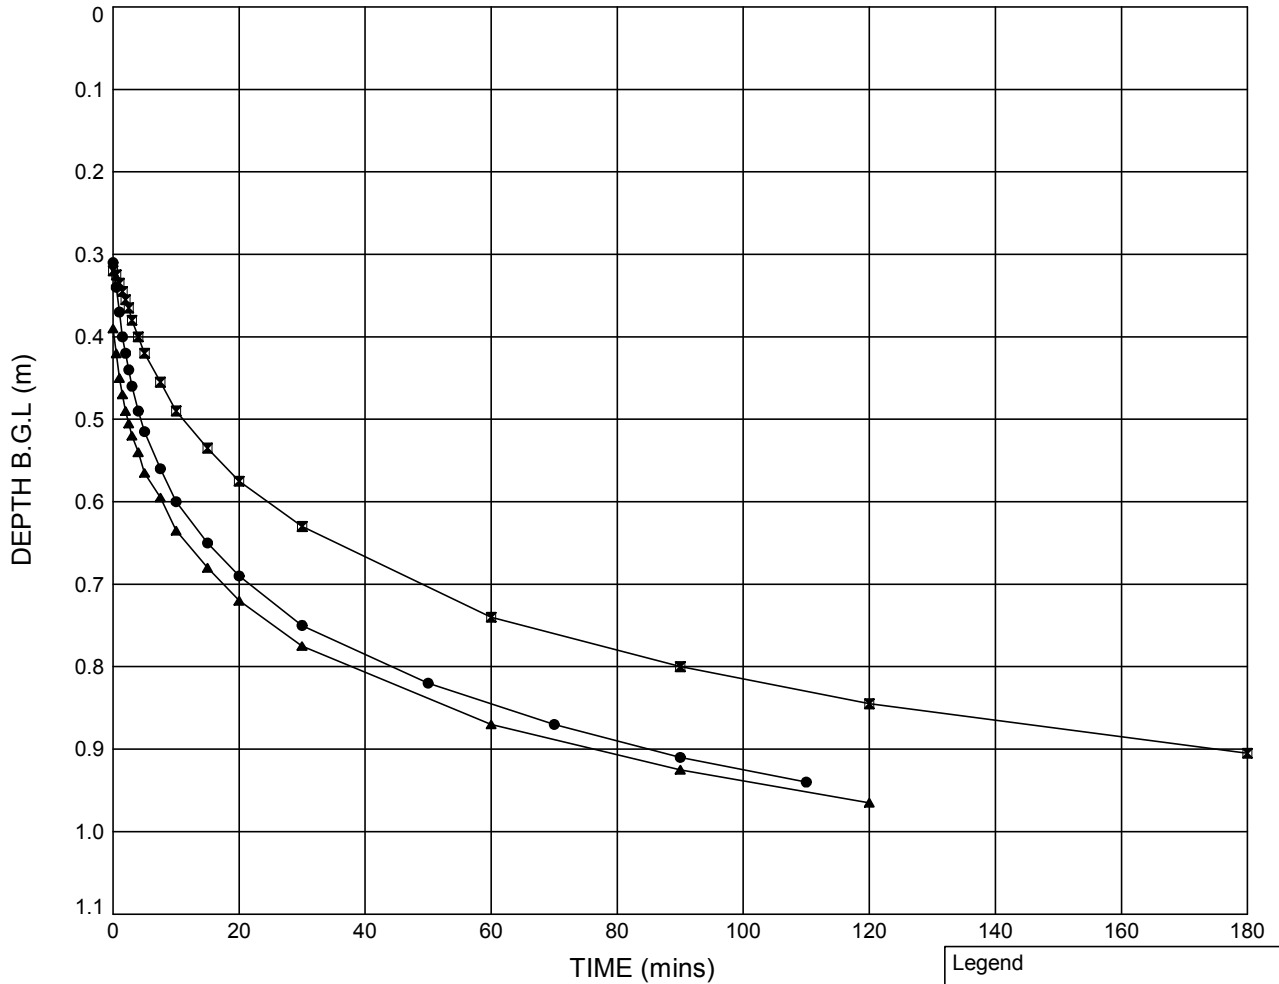
Soakaway Test - Position ID : TP102

## Plot of Depth of Water Below Ground Level Against Time

Test 1	Test 2	Test 3	
Pit start depth:	= 1.14	1.14	1.14	m
Pit final depth:	= 1.14	1.14	1.14	m
Effective depth, $D_e$	= 0.83	0.82	0.75	m
Effective storage volume, $V_{p75-25}$	= 0.5229	0.5166	0.4725	$m^3$
Surface area, $a_{p50}$	= 3.3350	3.3100	3.1350	$m^2$
Time, $t_{p75-25}$	= 5992	11767	6276	secs
Infiltration rate, $f$	= $2.62 \times 10^{-5}$	$1.33 \times 10^{-5}$	$2.40 \times 10^{-5}$	m/s

Please note test data was extrapolated to obtain  $t_{p75-tp25}$ .

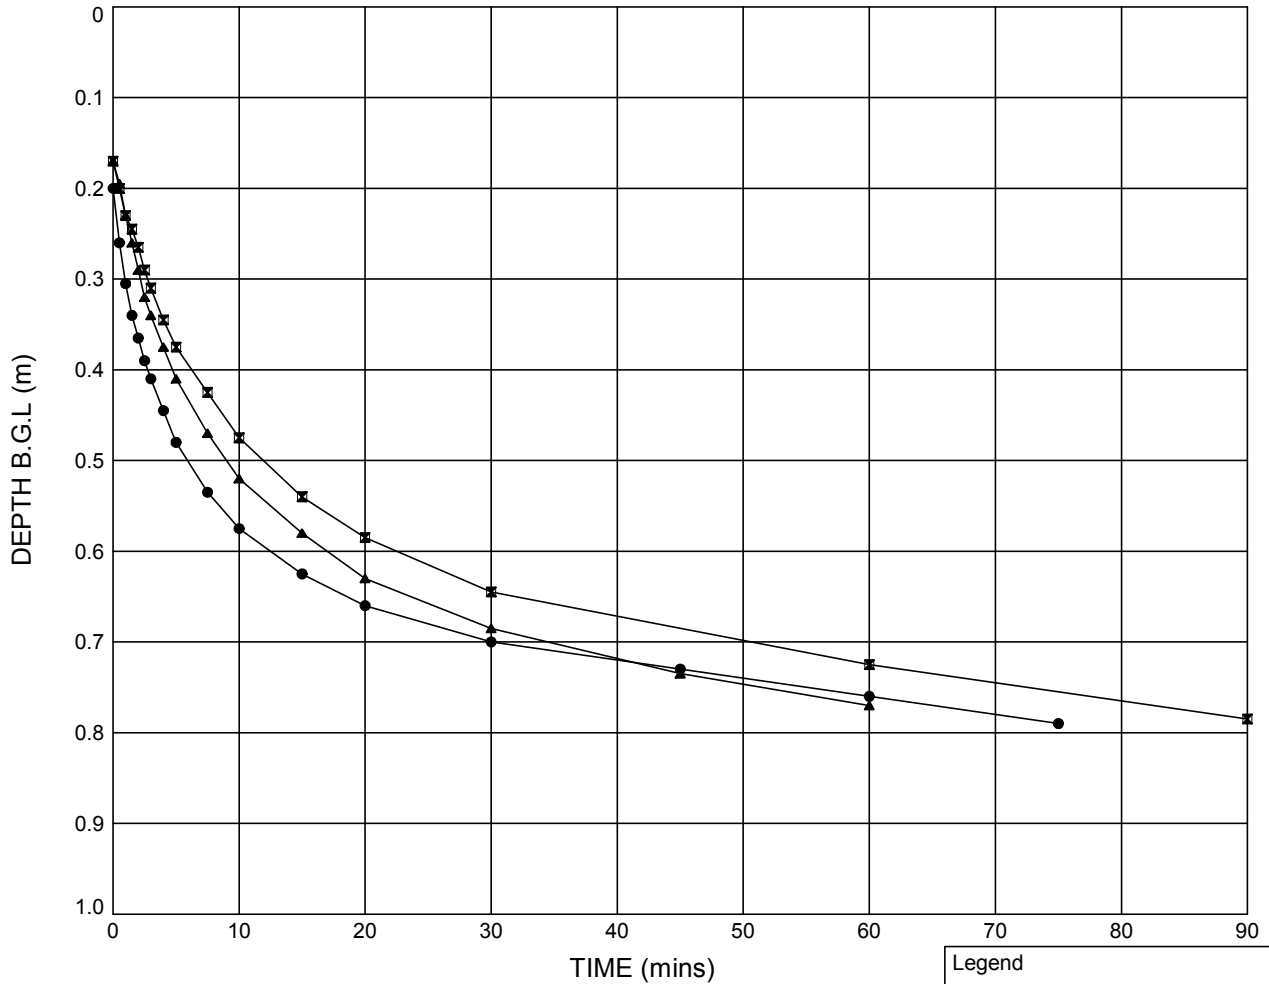
Soakaway Test - Position ID : TP103

## Plot of Depth of Water Below Ground Level Against Time

Test 1	Test 2	Test 3	
Pit start depth:	= 0.95	0.95	0.95	m
Pit final depth:	= 0.95	0.95	0.95	m
Effective depth, $D_e$	= 0.75	0.78	0.78	m
Effective storage volume, $V_{p75-25}$	= 0.4200	0.4368	0.4368	$m^3$
Surface area, $a_{p50}$	= 2.8450	2.9140	2.9140	$m^2$
Time, $t_{p75-25}$	= 3528	4220	2991	secs
Infiltration rate, $f$	= $4.18 \times 10^{-5}$	$3.55 \times 10^{-5}$	$5.01 \times 10^{-5}$	m/s

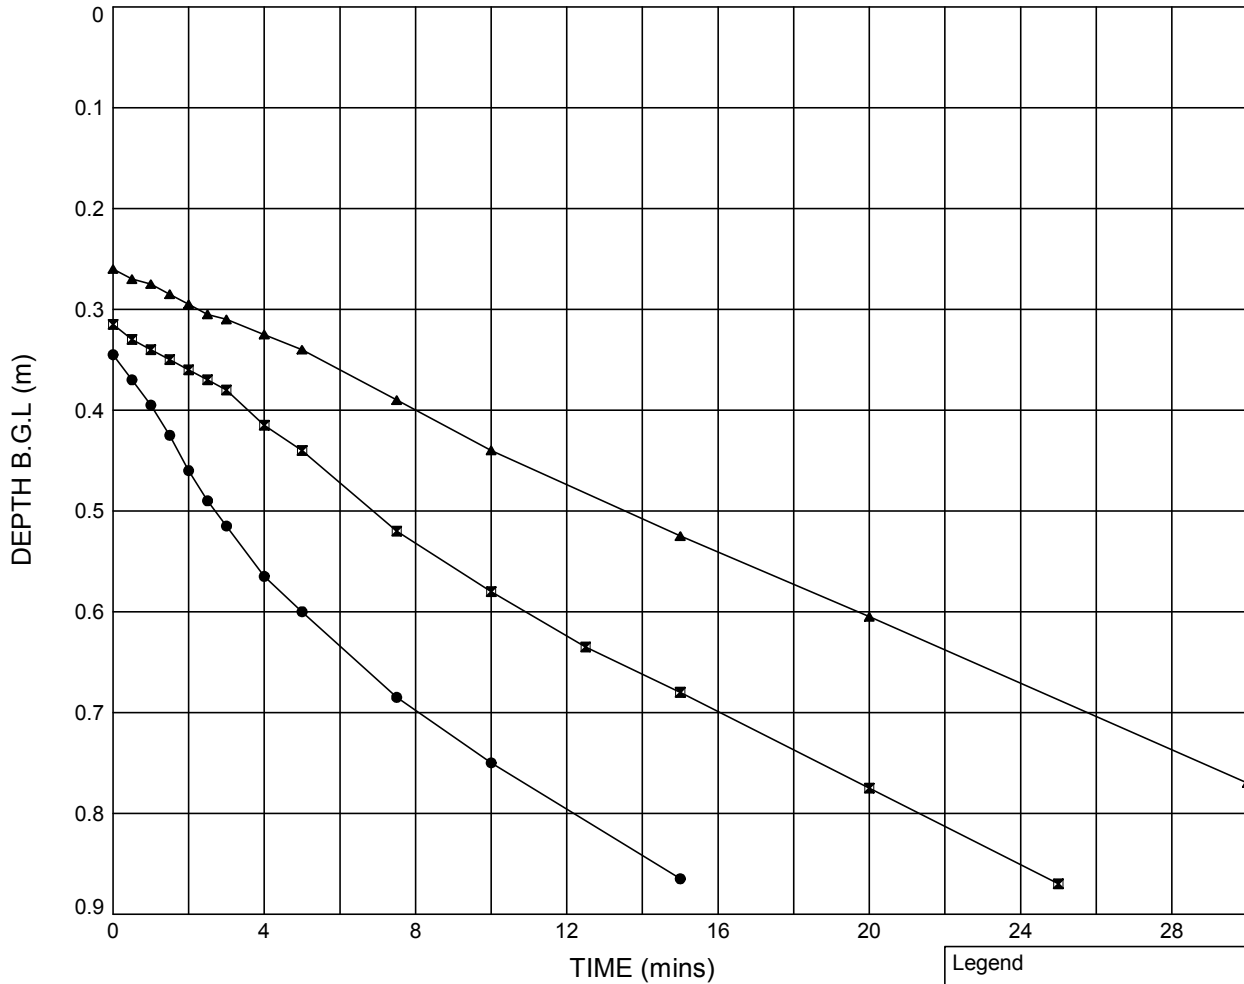
Soakaway Test - Position ID : TP104

## Plot of Depth of Water Below Ground Level Against Time

Test 1	Test 2	Test 3	
Pit start depth:	= 0.93	0.93	<b>0.93</b>	m
Pit final depth:	= 0.93	0.93	<b>0.93</b>	m
Effective depth, $D_e$	= 0.59	0.62	<b>0.67</b>	m
Effective storage volume, $V_{p75-25}$	= 0.3686	0.3875	<b>0.4221</b>	$m^3$
Surface area, $a_{p50}$	= 2.7225	2.7975	<b>2.9350</b>	$m^2$
Time, $t_{p75-25}$	= 537	850	<b>1210</b>	secs
Infiltration rate, $f$	= $2.52 \times 10^{-4}$	$1.63 \times 10^{-4}$	<b><math>1.19 \times 10^{-4}</math></b>	m/s

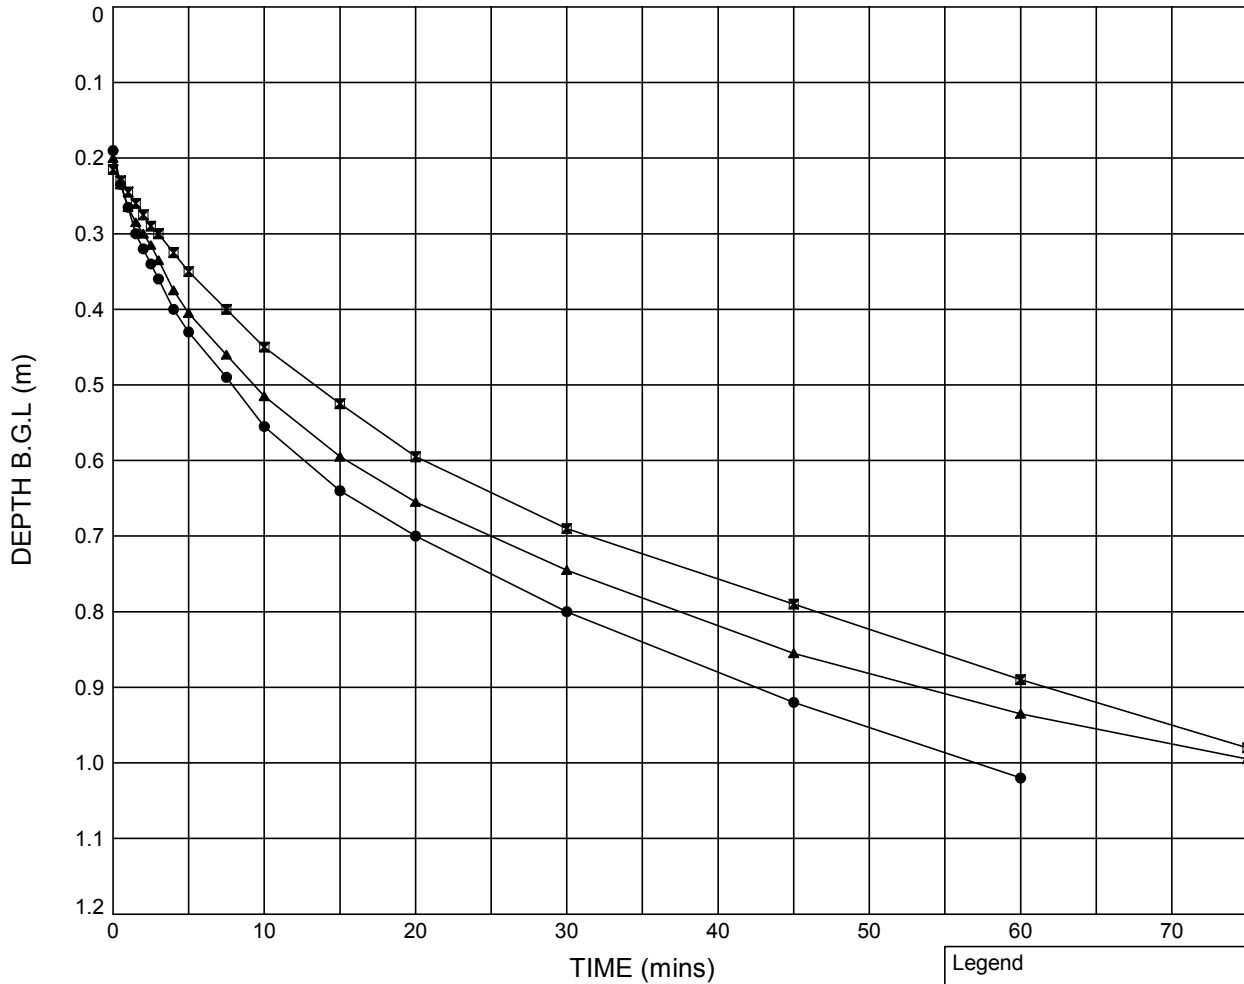
Soakaway Test - Position ID : TP105

## Plot of Depth of Water Below Ground Level Against Time

Test 1	Test 2	Test 3	
Pit start depth:	= 1.20	1.20	1.20	m
Pit final depth:	= 1.20	1.20	1.20	m
Effective depth, $D_e$	= 1.00	1.01	0.99	m
Effective storage volume, $V_{p75-25}$	= 0.6650	0.6717	0.6550	$m^3$
Surface area, $a_{p50}$	= 3.9300	3.9560	3.8910	$m^2$
Time, $t_{p75-25}$	= 3402	2616	3593	secs
Infiltration rate, $f$	= $4.97 \times 10^{-5}$	$6.49 \times 10^{-5}$	$4.69 \times 10^{-5}$	m/s

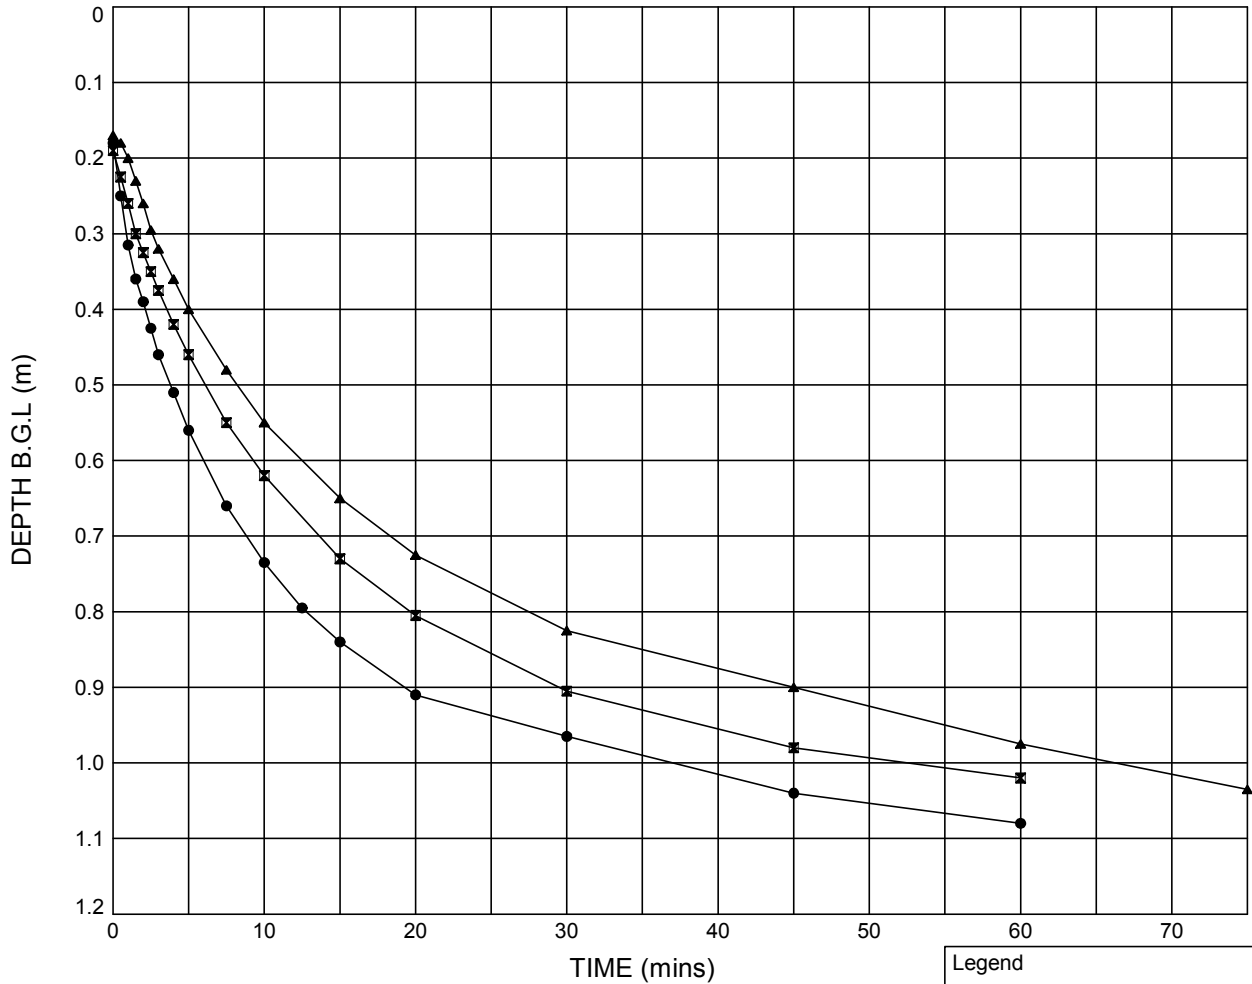
Soakaway Test - Position ID : TP106

## Plot of Depth of Water Below Ground Level Against Time

Test 1	Test 2	Test 3	
Pit start depth:	= 1.20	1.20	1.20	m
Pit final depth:	= 1.20	1.20	1.20	m
Effective depth, $D_e$	= 1.02	1.01	1.03	m
Effective storage volume, $V_{p75-25}$	= 0.6783	0.6717	0.6850	$m^3$
Surface area, $a_{p50}$	= 3.9820	3.9560	4.0080	$m^2$
Time, $t_{p75-25}$	= 1423	2036	2858	secs
Infiltration rate, $f$	= $1.20 \times 10^{-4}$	$8.34 \times 10^{-5}$	$5.98 \times 10^{-5}$	m/s
