STEEPLE ASTON VILLAGE ARCHIVE

CEDAR LODGE, NORTH SIDE, STEEPLE ASTON

Final report on architectural history

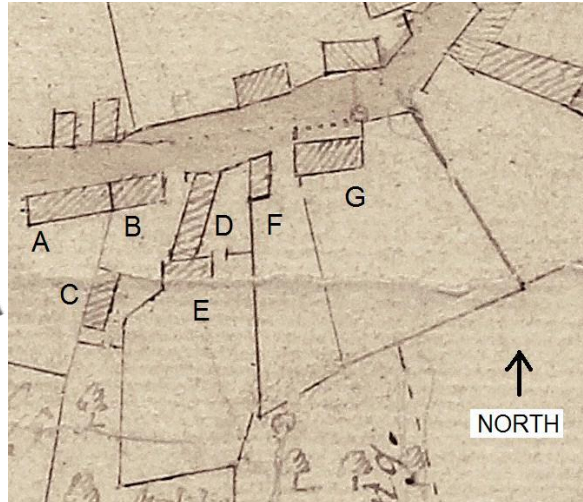
On close inspection of the 1768 Inclosure Map following the visit, it is apparent that there were previously three buildings on the site that is currently occupied by Cedar Lodge. These are shown below (right map), and inspection shows that they are divided by boundaries suggesting three separate sites, although not necessarily in different ownership. This compares with the 1900 OS map (left map) which shows the current single site configuration.

Reading from left to right along the south side of North Street, the 1768 map shows firstly a long frontage divided into two attached dwellings A and B. A would appear to be what is now Cedar Cottage, but it seems that B was demolished after 1768. In its place, as can be seen from the 1900 map, are the narrow outbuildings of the present day Cedar Lodge which run back at an angle to the road, and which now join up with C, a slightly wider building to the south of them on the boundary line – a building which appears to have been extant in 1768. This may have been a barn or other agricultural building, accessed from the south.

The next building D is set end-on to the road, at a slight angle to it, and at its southerly end is a small separate but joined building E orientated parallel to the road. The position of E is very similar to the current location of the western end of Cedar Lodge. The longer building D linking it to the road, however, seems to have disappeared without trace (if indeed it was a building). The close created by B and D has an opening onto the road near to the current position of Cedar Lodge's secondary site entrance which was previously its primary entrance – see later). Next along the road to the east is a smaller building F end-on to the road, directly opposite the almshouses, followed by another larger building G opposite the gap between the almshouses and the school, and in a location currently occupied by Cedar Lodge's main site entrance. The site boundary line opposite the east end of the school building corresponds exactly with its counterpart on the 1900 map. If the placing of buildings on the 1768 map is taken to be reasonably accurate, as it is believed to be, then the only elements of building on the Cedar Lodge site surviving from 1768 are C and (ii) possibly E. See discussion of this later in this report.

1900 OS map (above); 1768 map (right)

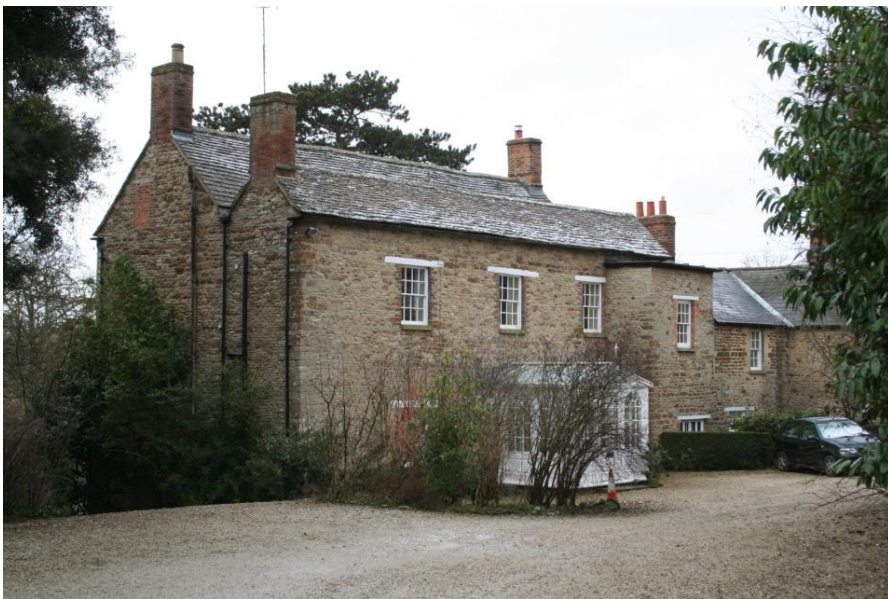
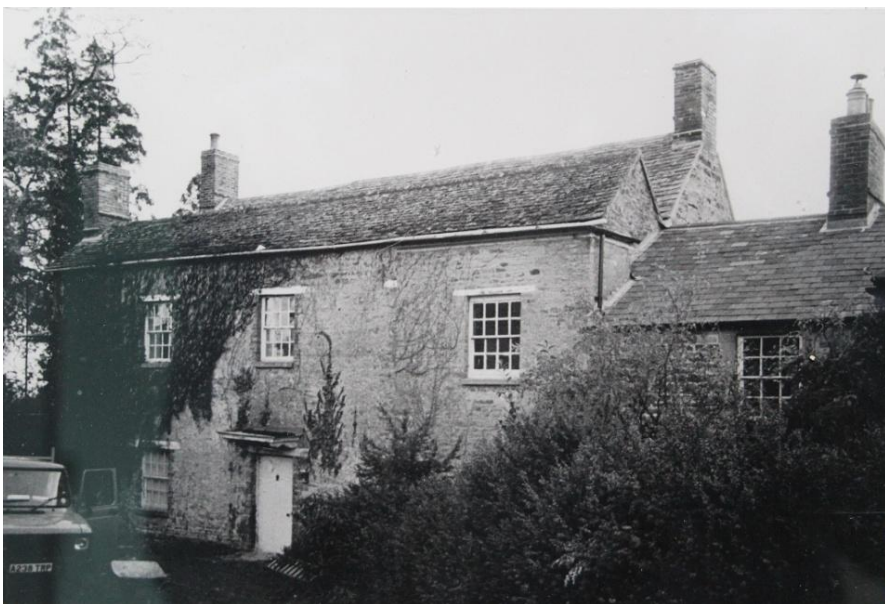
The house as it is currently configured presents a very odd face to the road, because this north frontage - of what is essentially a double-pile house - is to the lesser of the two ranges. The gable ends, visible from the street approach, show that the roof of this elevation is lower and of much lesser depth than that of its counterpart. The more typical M-roof section found in a few houses in Steeple Aston has here been modified so that normally equal halves have become worse than one third/ two thirds (internal spans are 6 feet and 15 feet respectively). The windows on this north elevation, whilst of symmetrical arrangement, are of lower status than those on the south frontage. Window heads are spanned by simple timber lintels, without any chamfering or mouldings. The central "front door" however is wider than its counterpart on the south elevation, and has a panelled canopy on brackets. The overall impression is that the north elevation represents the service side of the house, despite the location of what appears to be the main entrance. This is reinforced by the addition of a two-storey flat roofed extrusion (possibly early C20th) to the right of the front door, which contains a WC at ground floor level. There is also a further building attached to the west end of the main house, set two steps lower at ground floor level and with a much shallower roof pitch. This contains a number of service rooms.

The garden front, facing south, is clearly meant to be the most impressive elevation. As well as another centrally positioned door, there are symmetrically arranged windows of much greater size and impact, having a triple sash design with narrower windows flanking a wider one. These were probably replacement windows for earlier smaller ones, possibly carried out after 1810 when windows of this style were apparently invented by Thomas Wyatt. Above the central doorway is a Georgian roundel window. Until 1994 the ground sloped steeply up to the south front of the house with no terracing as there is now, making it unlikely that the "garden front" was ever used as the principal entrance. The north front internal floor level is slightly below external ground level.

*Above: north front in 2010
Below south front in 2012.*

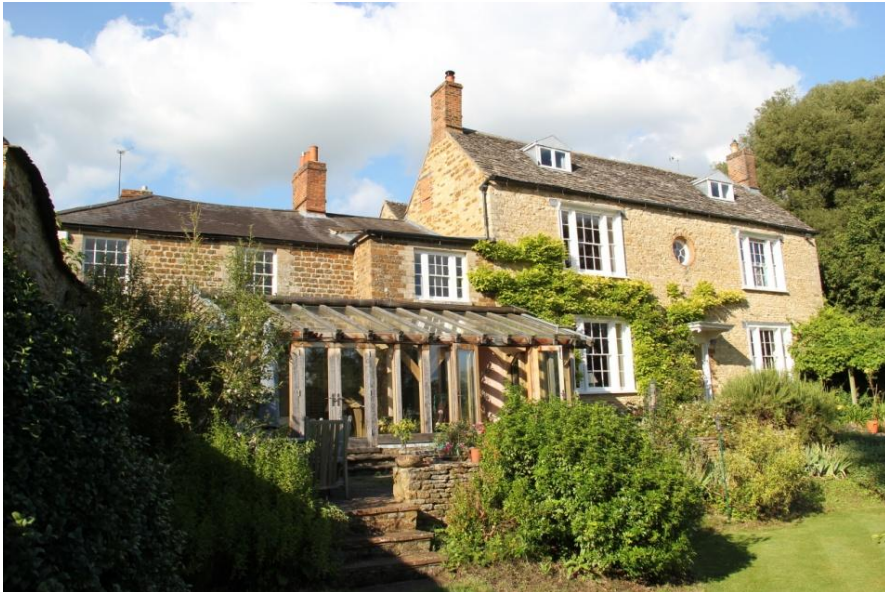
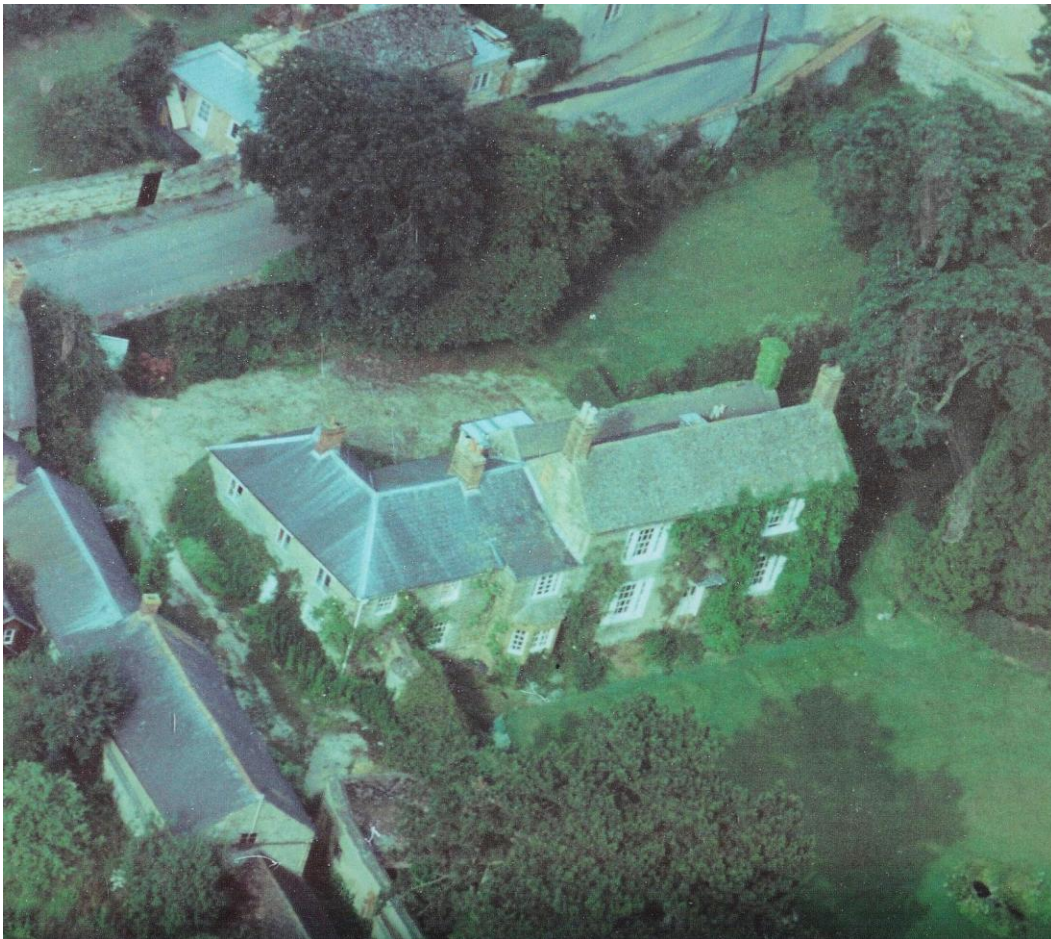
The aerial photo above from the 1970s shows Cedar Lodge before a second access was opened off the road. The photo below believed to be from the 1900s shows the garden front. It is clear that the lower range to the left was set back from the main elevation; the linking section with bay window and extended roof (visible in the aerial photo) was added between the dates of the two photos. Note also the tall dormers in the earlier photo, their complete absence in 1970s and their reinstatement in modern times. The ridge of the lower range exactly meets the valley gutter of the taller range.

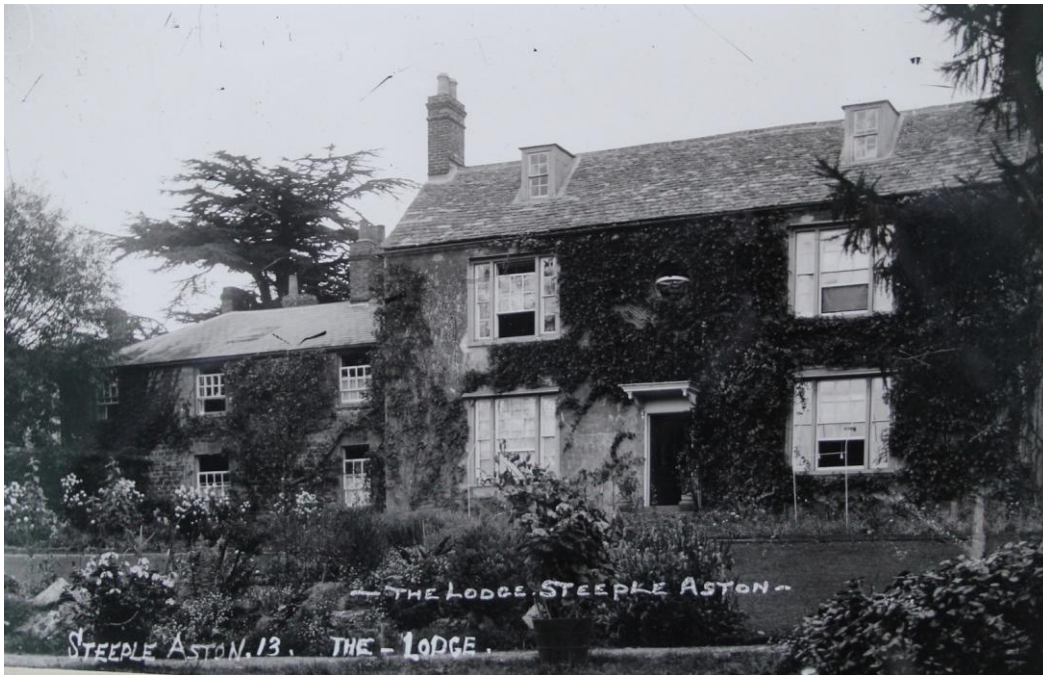
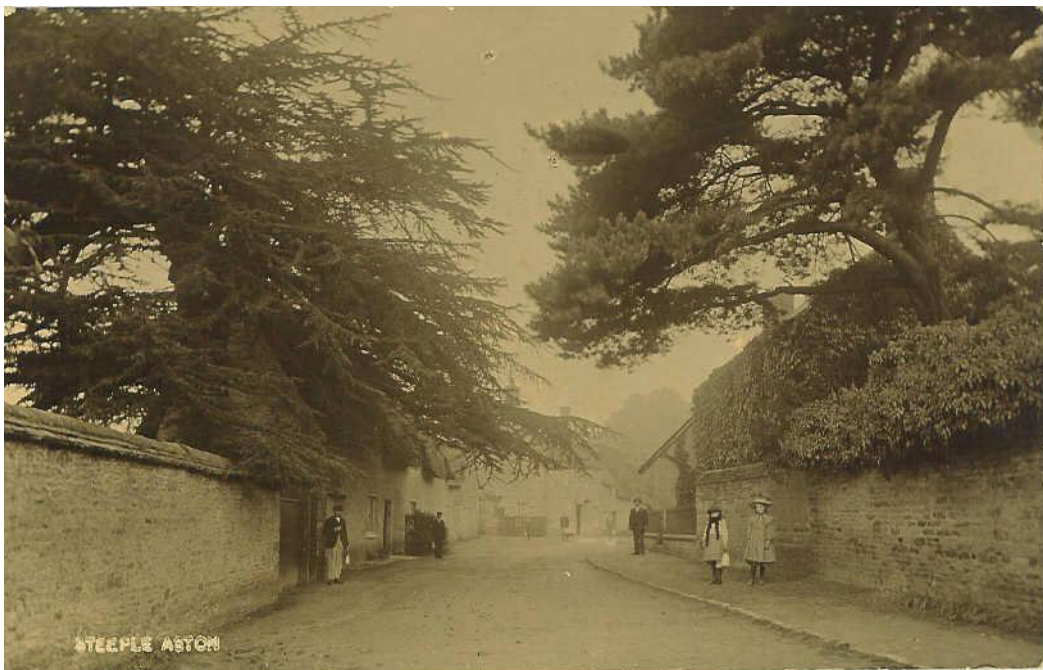
The eponymous cedar (left side) over the gateway to the Lodge around 1910

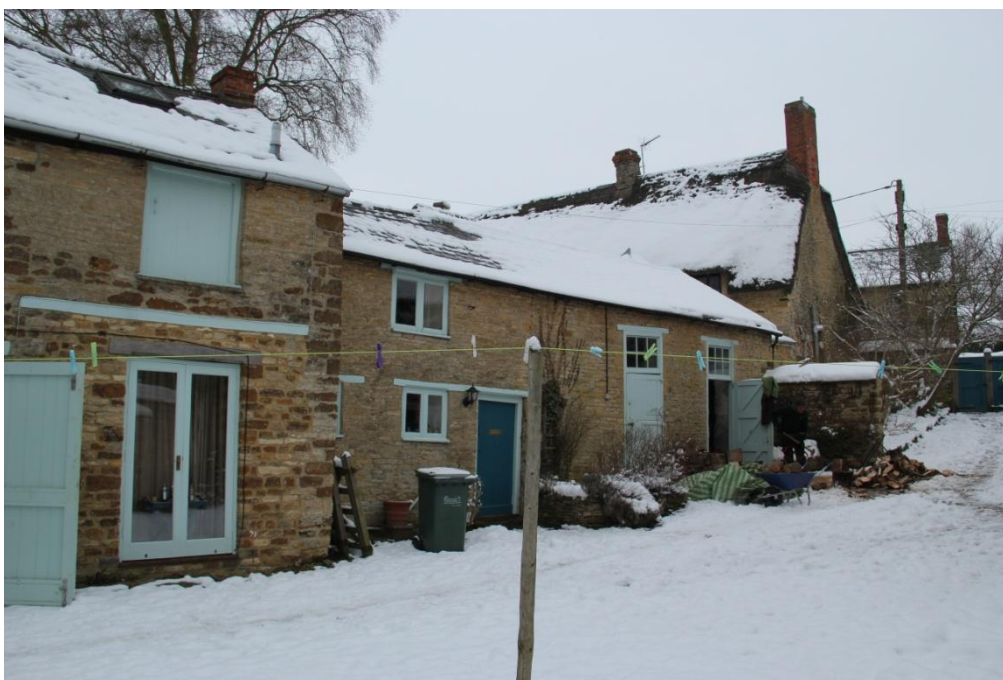
A range of outbuildings runs roughly parallel to the angled wall containing the remains of the bread oven, including a small barn, storage rooms and stables. Some of these outbuildings were converted as the groom’s cottage. The evidence of the maps of 1768 and 1900 is that the building shown on the left of the photo below (building C) was in existence before 1768, and that the lower buildings adjacent were constructed subsequently.

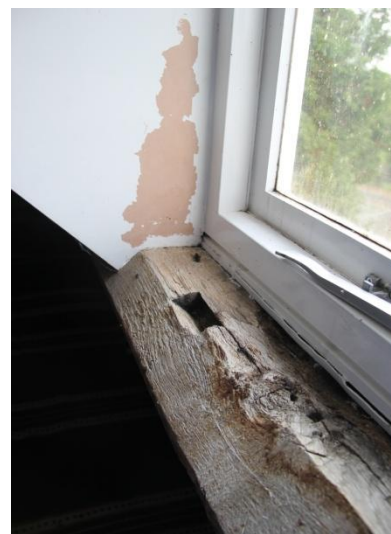
The two apparently contemporary parallel gable roofs share a valley wall-plate; the longitudinal wall was not constructed to take the load of the valley gutter. There are paired common rafters

without ridge pieces. In the lower roof, the common rafters measure 3.25 x 2.75 in. at a pitch of 15 in., with a principal rafter being 4 x 2.75 in. There are collar trusses, joined with single pairs of loose-tenon purlins with mortised upper and lower rafters. All in good quality, pit-sawn oak with pegged un-numbered assembly (except for one truss marked II).

This is a high quality roof both in terms of structure and of materials. The overall width of the building did not require two parallel roofs, suggesting that fashion may have been a major influence in the choice of design. Both these factors suggest a high status building. The structure, in particular the lack of ridge piece, suggests a construction date either within the late seventeenth or at the latest, early eighteenth centuries. The purlins show evidence of the removal of rafters to create dormers on the south slope. The rafters are, unusually, mortised into the purlins rather than notched and nailed. The attic has clearly been used historically as accommodation (lath and plaster finishes).
