Express Preliminary UXO Risk Assessment

Client	Curtins
Project	Great Wolf Lodge, Chesterton
Site Address	Great Wolf Lodge, Chesterton, Oxfordshire, OX26 1TE
Report Reference	EP8343-00
Date	06/03/19
Originator	AH

Detailed Unexploded Ordnance (UXO) Risk Assessment

Project Name	Great Wolf Lodge
Client	Curtins
Site Address	Great Wolf Lodge, Bicester Hotel Golf & Spa, Chesterton, Bicester OX26 1TE
Report Reference	DA8343-00
Date	3 rd April 2019
Originator	JMa

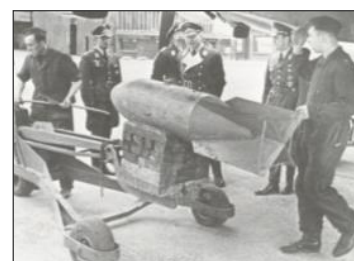
SC 250kg High Explosive Bomb

Bomb Weight	245-256kg (540-564lb)
Explosive Weight	125-130kg (276-287lb)
Fuze Type	Electrical impact/mechanical time delay fuze.
Bomb Dimensions	1640 x 512mm (64.57 x 20.16in)
Body Diameter	368mm (14.5in)
Use	Against railway installations, embankments, flyovers, underpasses, large buildings and below-ground installations.
Remarks	It could be carried by almost all German bomber aircraft, and was used to notable effect by the Junkers Ju-87 Stuka (Sturzkampfflugzeug or dive-bomber).

SC250 bomb being loaded onto German bomber

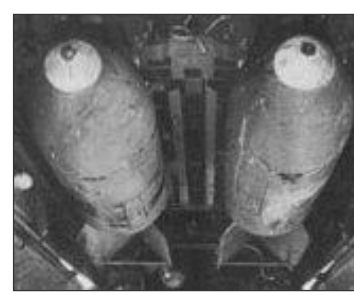
SC 500kg High Explosive Bomb

Bomb Weight	480-520kg (1,058-1,146lb)
Explosive Weight	250-260kg (551-573lb)
Fuze Type	Electrical impact/mechanical time delay fuze.
Bomb Dimensions	1957 x 640mm (77 x 25.2in)
Body Diameter	470mm (18.5in)
Use	Against fixed airfield installations, hangars, assembly halls, flyovers, underpasses, high-rise buildings and below-ground installations.
Remarks	40/60 or 50/50 Amatol TNT, triallene. Bombs recovered with Triallene filling have cylindrical paper wrapped pellets 1-15/16 in. in length and diameter forming

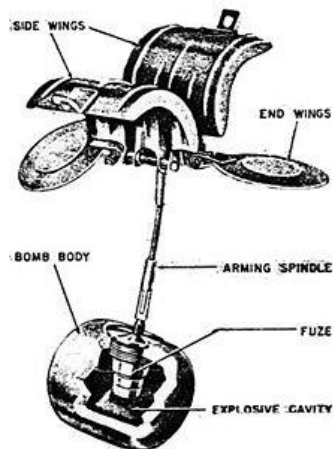
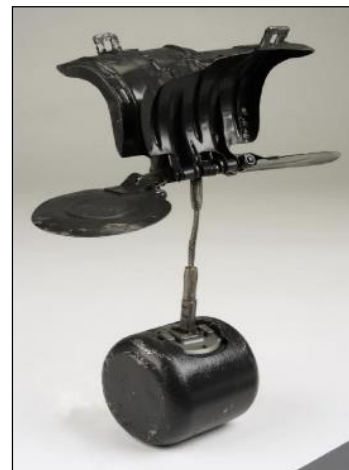
SD2 Anti-Personnel 'Butterfly Bomb'

Bomb Weight	Approx. 2kg (4.41lb)
Explosive Weight	Approx. 7.5oz (225 grams) of Amatol surrounded by a layer of bituminous composition.
Fuze Type	41 fuze (time) , 67 fuze (clockwork time delay) or 70 fuze (anti-handling device)
Body Diameter	3in (7.62 cm) diameter, 3.1in (7.874) long
Use	Designed as an anti-personnel/ fragmentation weapon. They were delivered by air, being dropped in containers of 23-144 sub-munitions that opened at a predetermined height, thus scattering the bombs.
Remarks	Very rare. First used against Ipswich in 1940, but were also dropped on Kingston upon Hull, Grimsby and Cleethorpes in June 1943, amongst various other targets in UK. As the bombs fell the outer case flicked open by springs which caused four light metal drogues with a protruding 5 inch steel cable to deploy in the form of a parachute & wind vane which armed the device as it spun.

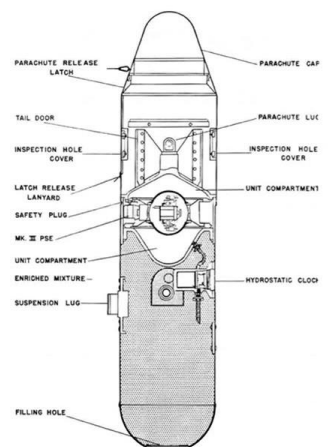
Parachute Mine (Luftmine B / LMB)

Bomb Weight	Approx. 990kg (2176lb)
Explosive Weight	Approx. 705kg (1,554lb)
Fuze Type	Impact/ Time delay / hydrostatic pressure fuze
Dimensions	2.64m x 0.64m (3.04m with parachute housing)
Use	Against civilian, military and industrial targets. Used as blast bombs and designed to detonate above ground level to maximise damage to a wider area.
Remarks	Deployed a parachute when dropped in order to control its descent. Had the potential to cause extensive damage in a 100m radius.

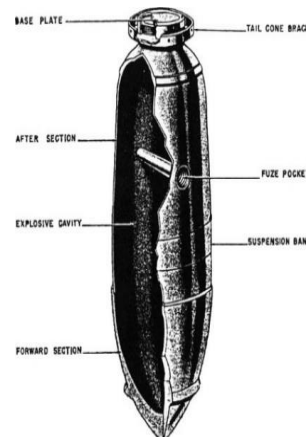
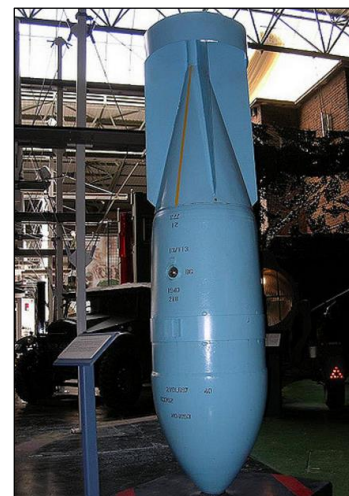
SC 1000kg

Bomb Weight	Approx. 993-1027kg (2,189-2,264lb)
Explosive Weight	Approx. 530-620kg (1168-1367lb)
Fuze Type	Electrical impact/mechanical time delay fuze.
Filling	Mixture of 40% amatol and 60% TNT, but when used as an anti-shiping bomb it was filled with Trialen 105, a mixture of 15% RDX, 70% TNT and 15% aluminium powder.
Bomb Dimensions	2800 x 654mm (110 x 25.8in)
Body Diameter	654mm (18.5in)
Use	SC type bombs are General Purpose Bombs used primarily for general demolition work. Constructed of parallel walls with comparatively heavy noses. They are usually of three piece welded construction.

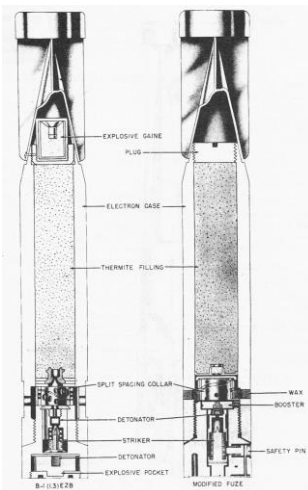
1kg Incendiary Bomb

Bomb Weight	Approx. 1.0 - 1.3kg (2.2 and 2.9lb)
Explosive Weight	Approx. 680g (1.5lb) Thermit 8-15gm Explosive Nitropenta
Fuze Type	Impact fuze
Bomb Dimensions	350 x 50mm (13.8 x 1.97in)
Body Diameter	50mm (1.97in)
Use	As incendiary – dropped in clusters on towns and industrial complexes
Remarks	Magnesium alloy case. Sometimes fitted with high explosive charge. The body is a cylindrical alloy casting threaded internally at the nose to receive the fuze holder and fuze.

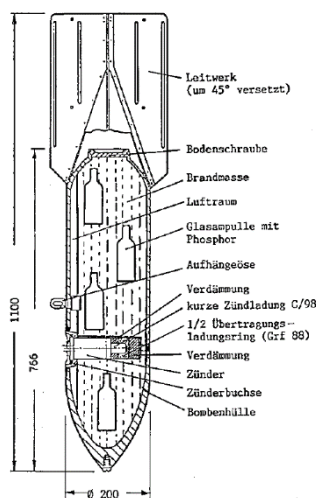
C50 A Incendiary Bomb

Bomb Weight	Approx. 41kg (90.4lb)
Explosive Weight	Approx. 0.03kg (0.066lb)
Incendiary Filling	12kg (25.5lb) liquid filling with phosphor igniters in glass phials. Benzine 85%; Phosphorus 4%; Pure Rubber 10%
Fuze Type	Electrical impact fuze
Bomb Dimensions	1,100 x 280mm (43.2 x 8in)
Use	Against any targets where an incendiary effect is required
Remarks	Early fill was a phosphorus/carbon disulphide incendiary mixture

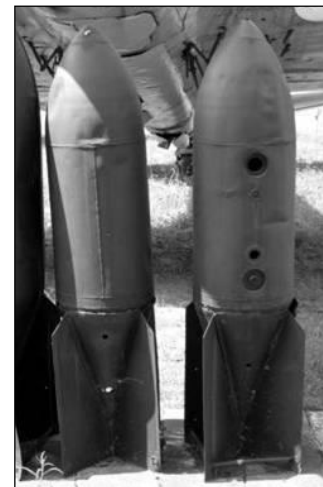
Flam C-250 Oil Bomb

Bomb Weight	Approx. 125kg (276lb)
Explosive Weight	Approx. 1kg (2.2lb)
Fuze Type	Super-fast electrical impact fuze
Filling	Mixture of 30% petrol and 70% crude oil
Bomb Dimensions	1,650 x 512.2mm (65 x 20.2in)
Body Diameter	368mm (14.5in)
Use	Often used for surprise attacks on ground troops, against troop barracks and industrial installations. Thin casing – not designed for ground penetration

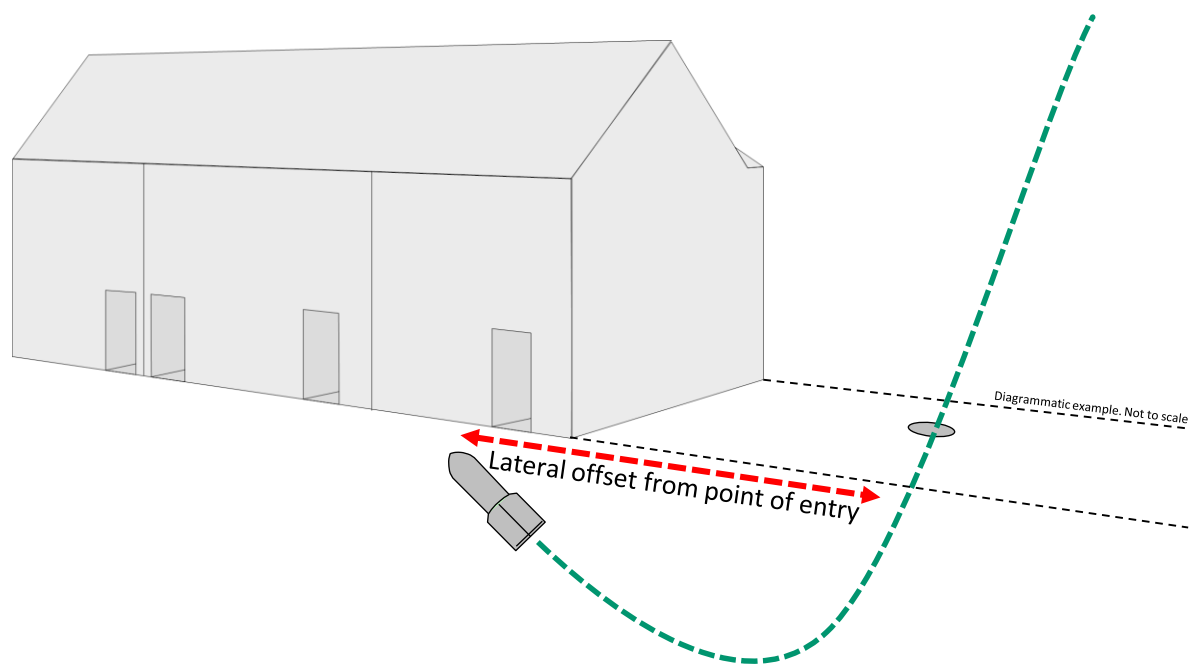
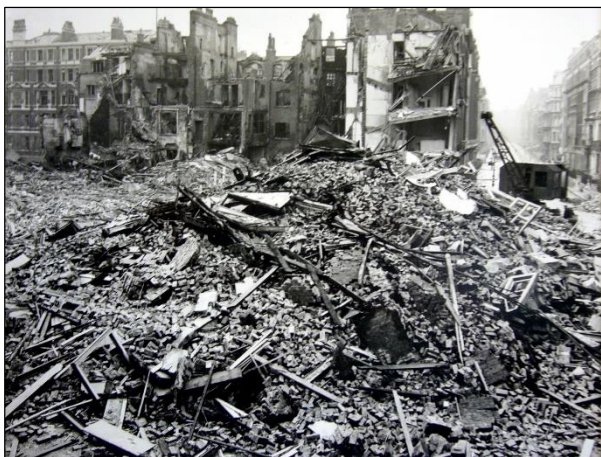
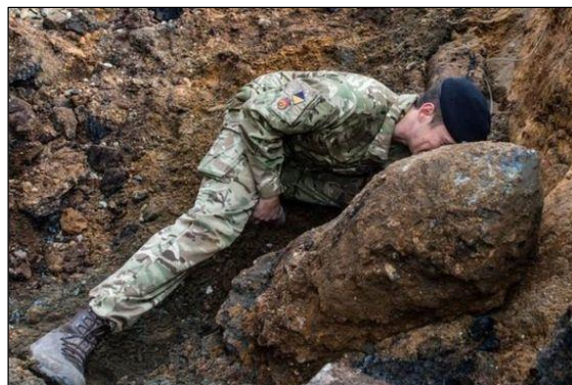
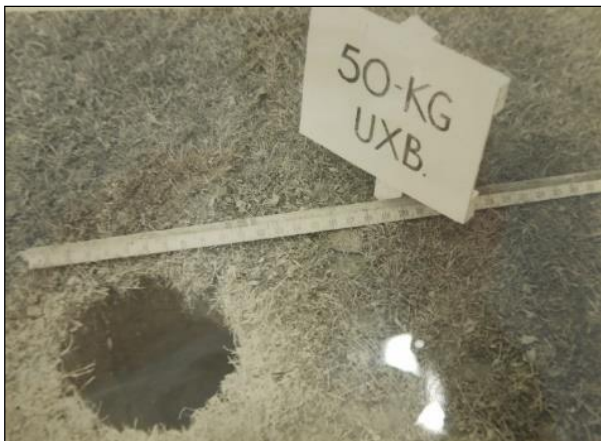
'J-Curve' Effect

Top: J-curve Effect - Due to angle of entry, unexploded bombs would often end their trajectory at a lateral offset from point of entry, often ending up beneath adjacent extant structures/sites. The photograph above shows 250kg bomb found in Bermondsey pointing upwards, demonstrating 'J-curve'

One of the most common scenarios for UXO going unnoticed was when a UXB fell into a 'bomb site' (such as the area shown **Top Left**), the entry hole of the bomb obscured by any debris and rubble present. Note that the entry hole of a 50kg UXB could be as little as 20cm in diameter (**Left**).

J-curve is the term used to describe the characteristic curve commonly followed by an aerial delivered bomb dropped from height after it penetrates the ground. Typically, as the bomb is slowed by its passage through underlying soils, its trajectory curves towards the surface. Many UXBs are found with their nose cone pointing upwards as a result of this effect. More importantly however is the resulting horizontal offset from the point of entry. This is typically a distance of about one third of the bomb's penetration depth, but can be higher in certain conditions (see **Annex F**).

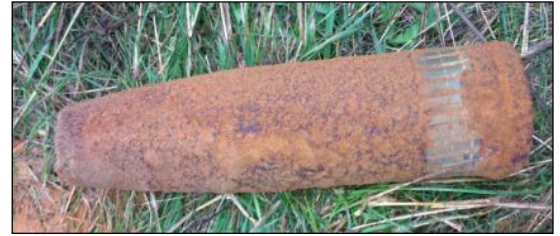
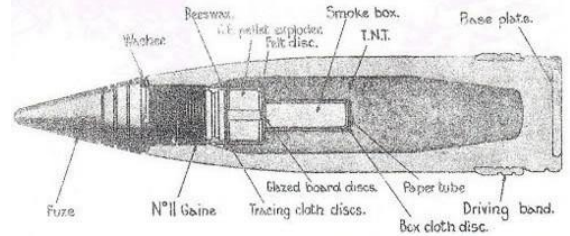
Projectile Weight	28lb (12.6 kg)
Explosive Weight	2.52lbs
Fuze Type	Mechanical Time Fuze
Dimensions	3.7in x 14.7in (94mm x 360mm)
Rate of Fire	10 to 20 rounds per minute
Use	The 3.7in AA Mks 1-3 were the standard Heavy Anti-Aircraft guns of the British Army.
Ceiling	30,000ft to 59,000ft

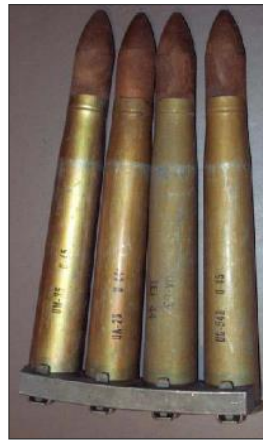
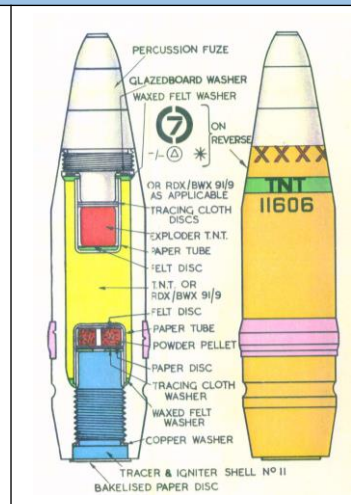
40mm Bofors Projectile

Projectile Weight	1.96lb (0.86kg)
Explosive Weight	300g (0.6lb)
Fuze Type	Impact Fuze
Rate of Fire	120 rounds per minute
Projectile Dimensions	40 x 180mm
Ceiling	23,000ft (7000m)
Remarks	Light quick fire high explosive anti-aircraft projectile. Each projectile fitted with small tracer element. If no target hit, shell would explode when tracer burnt out. Designed to engage aircraft flying below 2,000ft

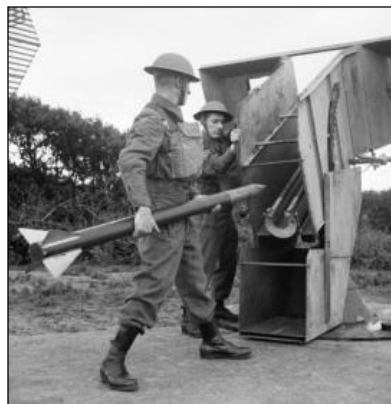
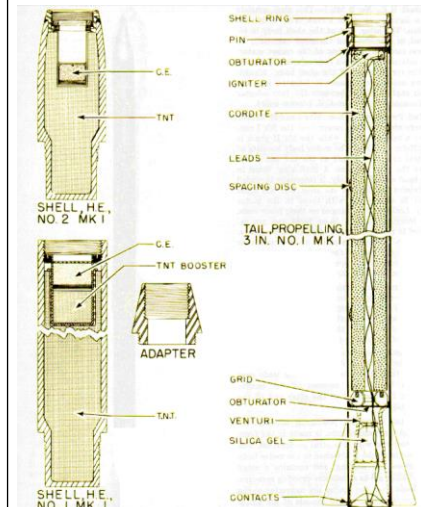
3in Unrotated Projectile (UP) Anti-Aircraft Rocket ("Z" Battery)

HE Projectile Weight	3.4kg (7.6lb)
Explosive Weight	0.96kg (2.13lb)
Filling	High Explosive – TNT. Fitted with aerial burst fuzing
Dimensions of projectile	236 x 83mm (9.29 x 3.25in)
Remarks	As a short range rocket-firing anti-aircraft weapon developed for the Royal Navy. It was used extensively by British ships during the early days of World War II. The UP was also used in ground-based single and 128-round launchers known as Z Batteries. Shell consists of a steel cylinder reduced in diameter at the base and threaded externally to screw into the shell ring of the rocket motor
