Great Wolf Lodge, Chesterton

Phase 1 Preliminary Site Risk Assessment

Curtins Ref: 071596.001-CUR-00-XX-RP-GE-00001-V00_FINAL

Issue Date: 18 April 2019

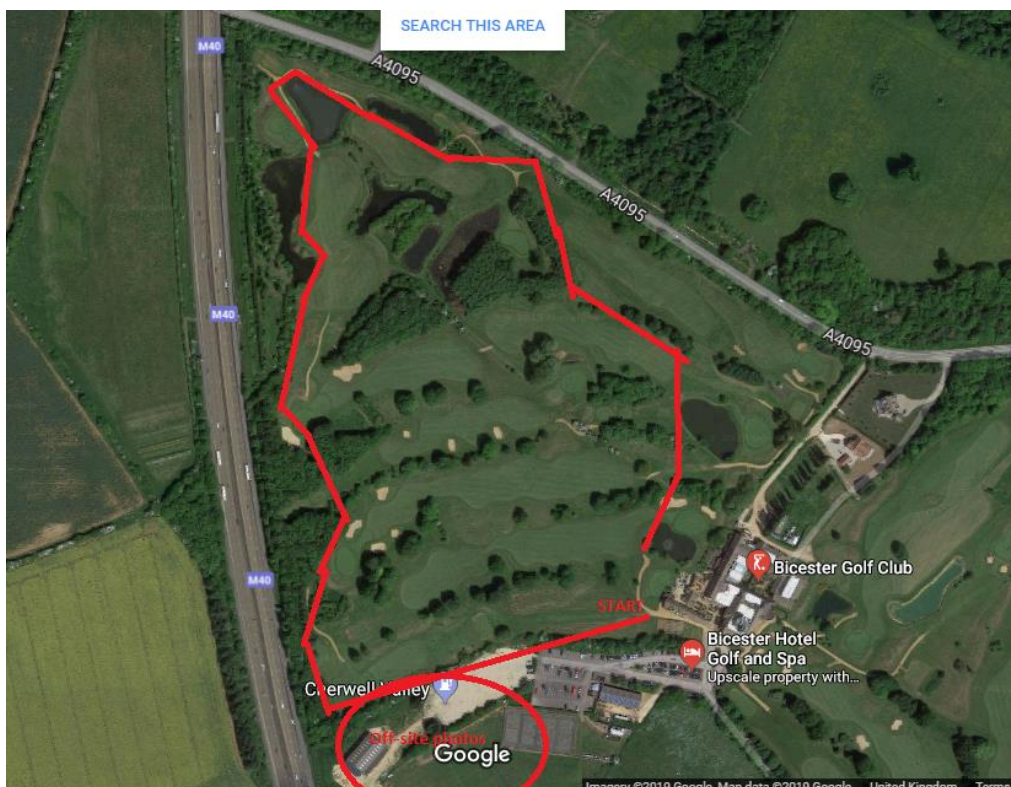
Figure 2-2: Site Reconnaissance Walking Route.

A site reconnaissance visit was carried out by a Curtins Senior Engineer on 27th March 2019. Full details of the site walk visit have been included as Appendix B. The walking route utilised during the site walk over visit is included as Figure 2-2 below

The site walkover visit confirmed that the site is indeed currently utilised as a golf course. Furthermore, it noted the following geo-environmental constraints to the future development of the site.

- Several mounds which (approximately 1.2 m to 2.0 m height) were observed on site as part of the golf course. These mounds are understood to have been created with re-worked natural soils; however, one of the mounds located on the northern boundary was noted to have brick and concrete in material at surface. It should be noted that the historical mapping (Appendix A) and also detailed in Section 3.0 records a small backfilled quarry is located in the northern part of the site and the nature of the backfill will need to be determined. The current

- Several ponds on-site, created from excavating to groundwater, with groundwater level observed as shallow;
- A number of mature trees across the site with the potential for heave following removal.
