Appendix 15.2

PHASE II GROUND INVESTIGATION REPORT

**REPORT ON
PRELIMINARY
PHASE II GROUND
INVESTIGATION
AT
LAND ADJACENT TO
JUNCTION 10 M40,
ARDLEY**

Client:	Albion Land Ltd
Report Title:	Report on Preliminary Phase II Ground Investigation at Land adjacent to Junction 10, M40, Ardley
Report Number:	AG3268-21-AM64
Report Status:	Validated Issue 2
Date:	August 2021

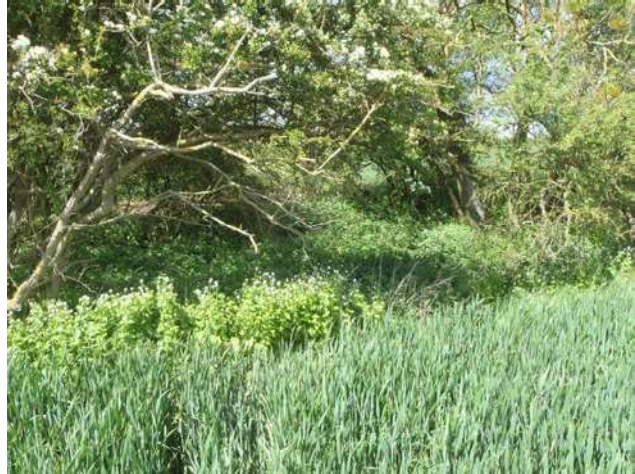
The eastern part of the site comprised cropped fields with a drainage ditch running along the hedge forming the northern site boundary and an approximately 0.5m deep depression just north of the centre filled with nettles and surrounded by trees. The depression may represent a former pond.

Depression in ground in eastern part of site
